Inspection Photos

API: 05-067-08150

Operator: XTO ENERGY INC

Inspection Number: 680602448

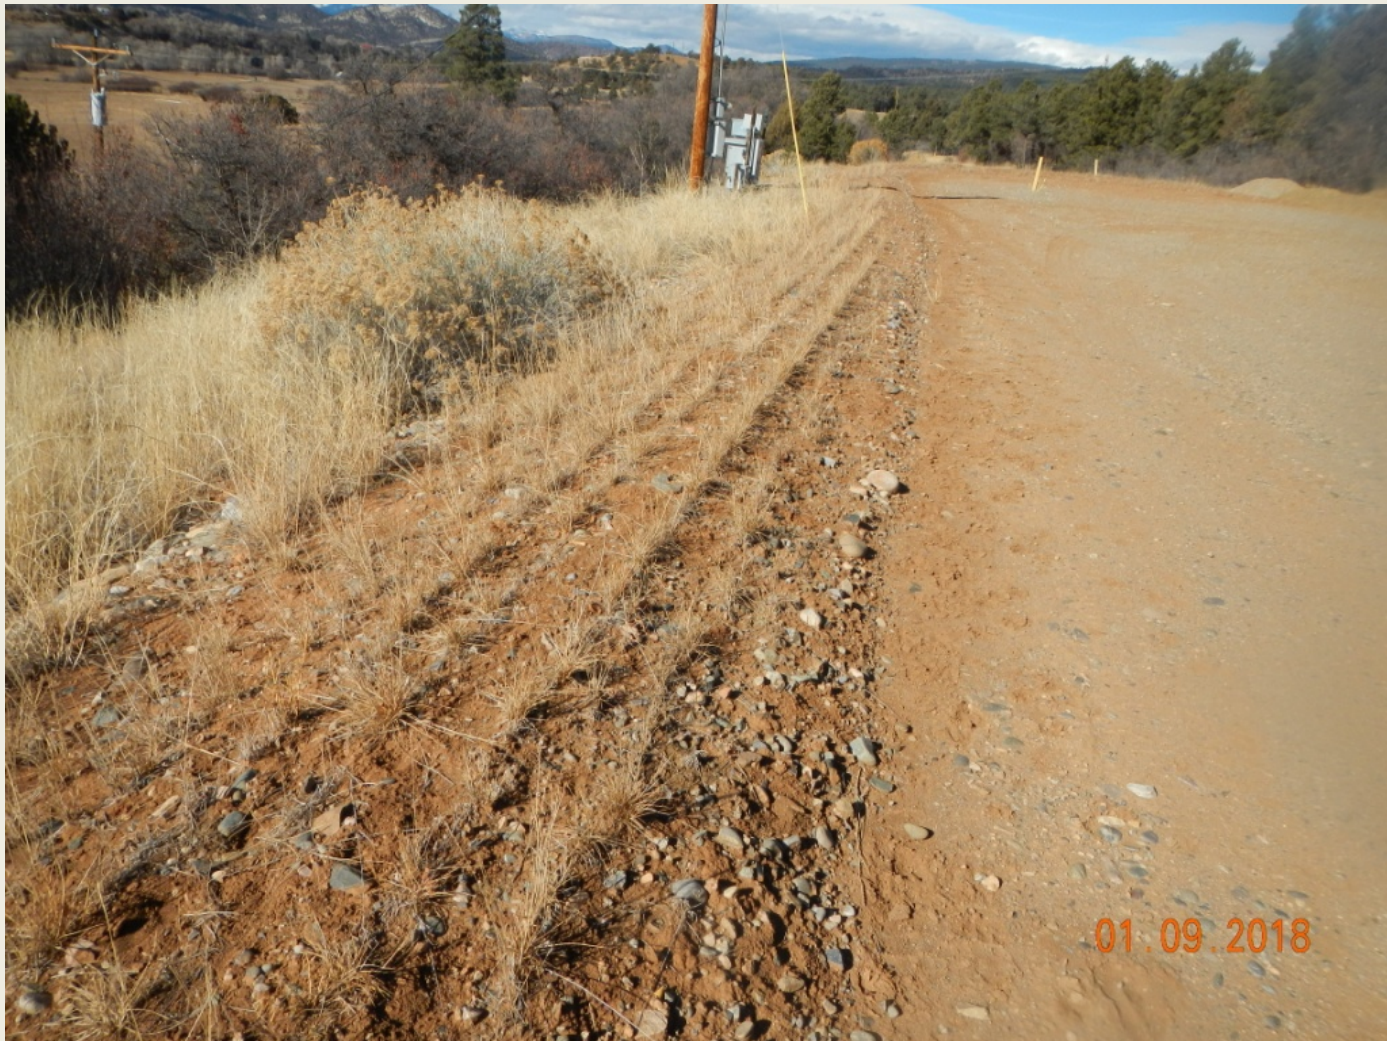
Photo 1. View of the western portion of the project area from the southwestern edge facing northward. Berms are seeded and revegetating.

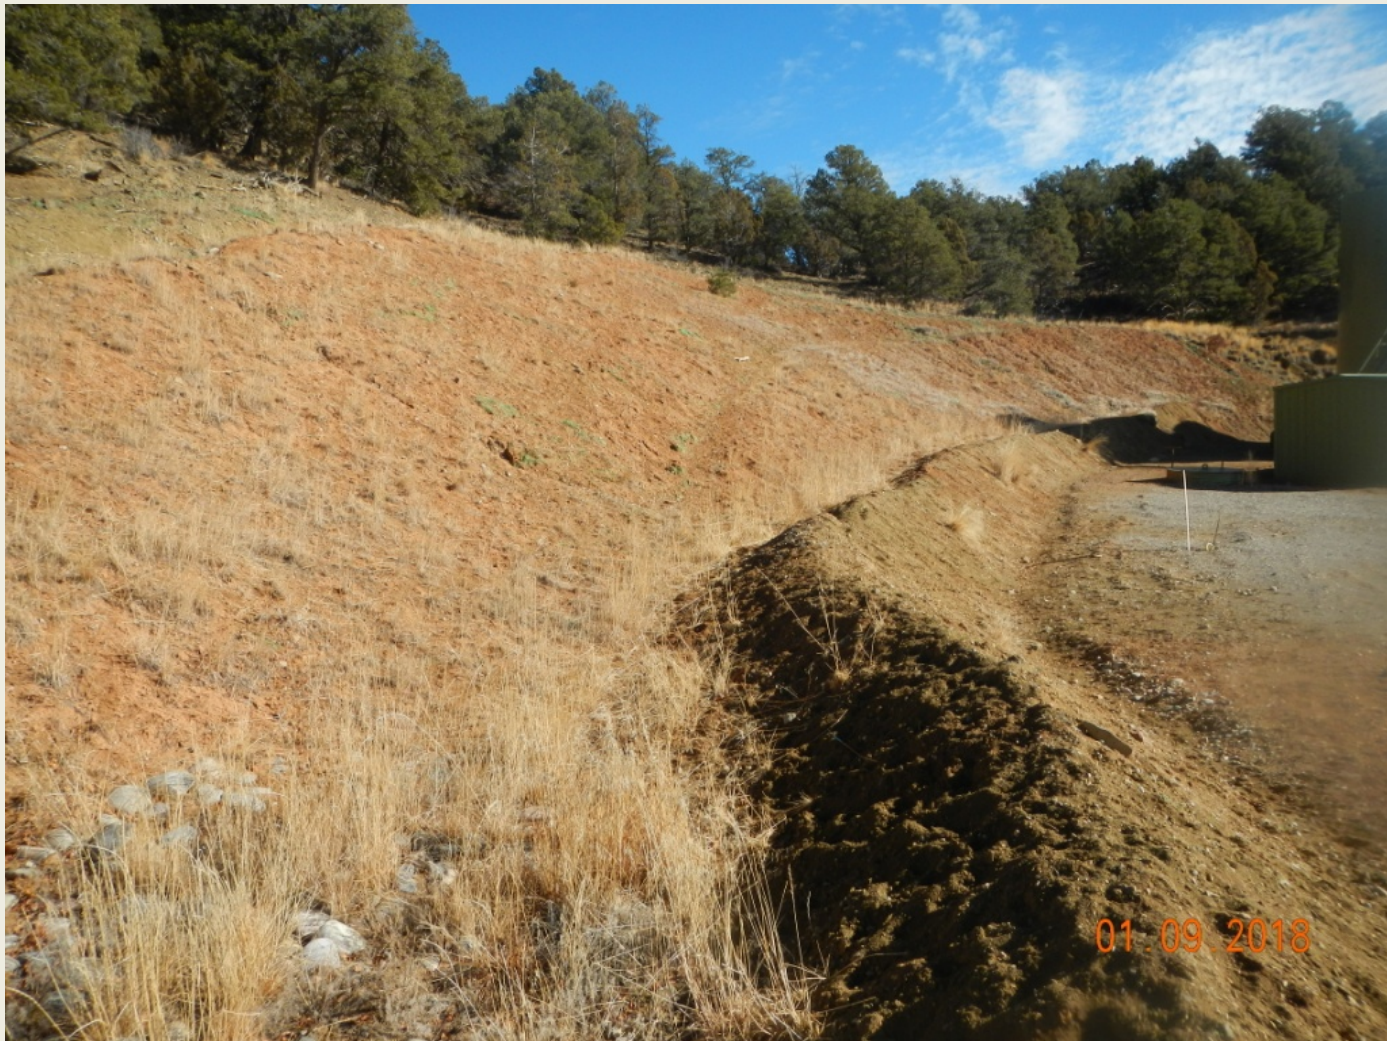
Photo 2. View of the northeastern portion of the project area from the northeastern corner facing southeastward.

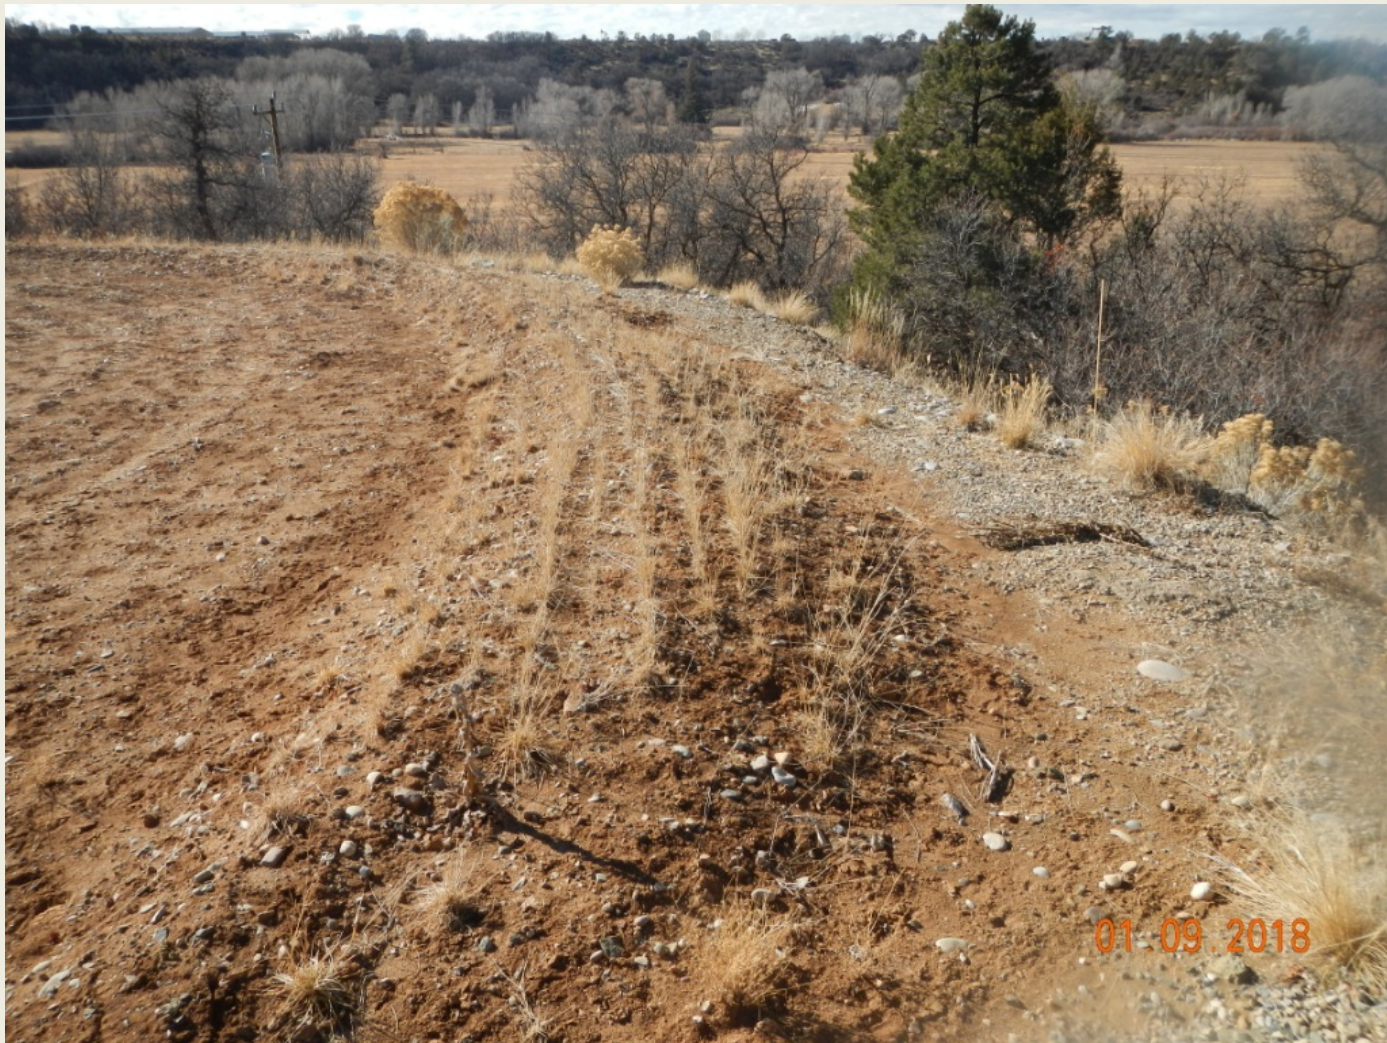
Photo 3. View of the northern portion of the project area from the northern edge facing westward.

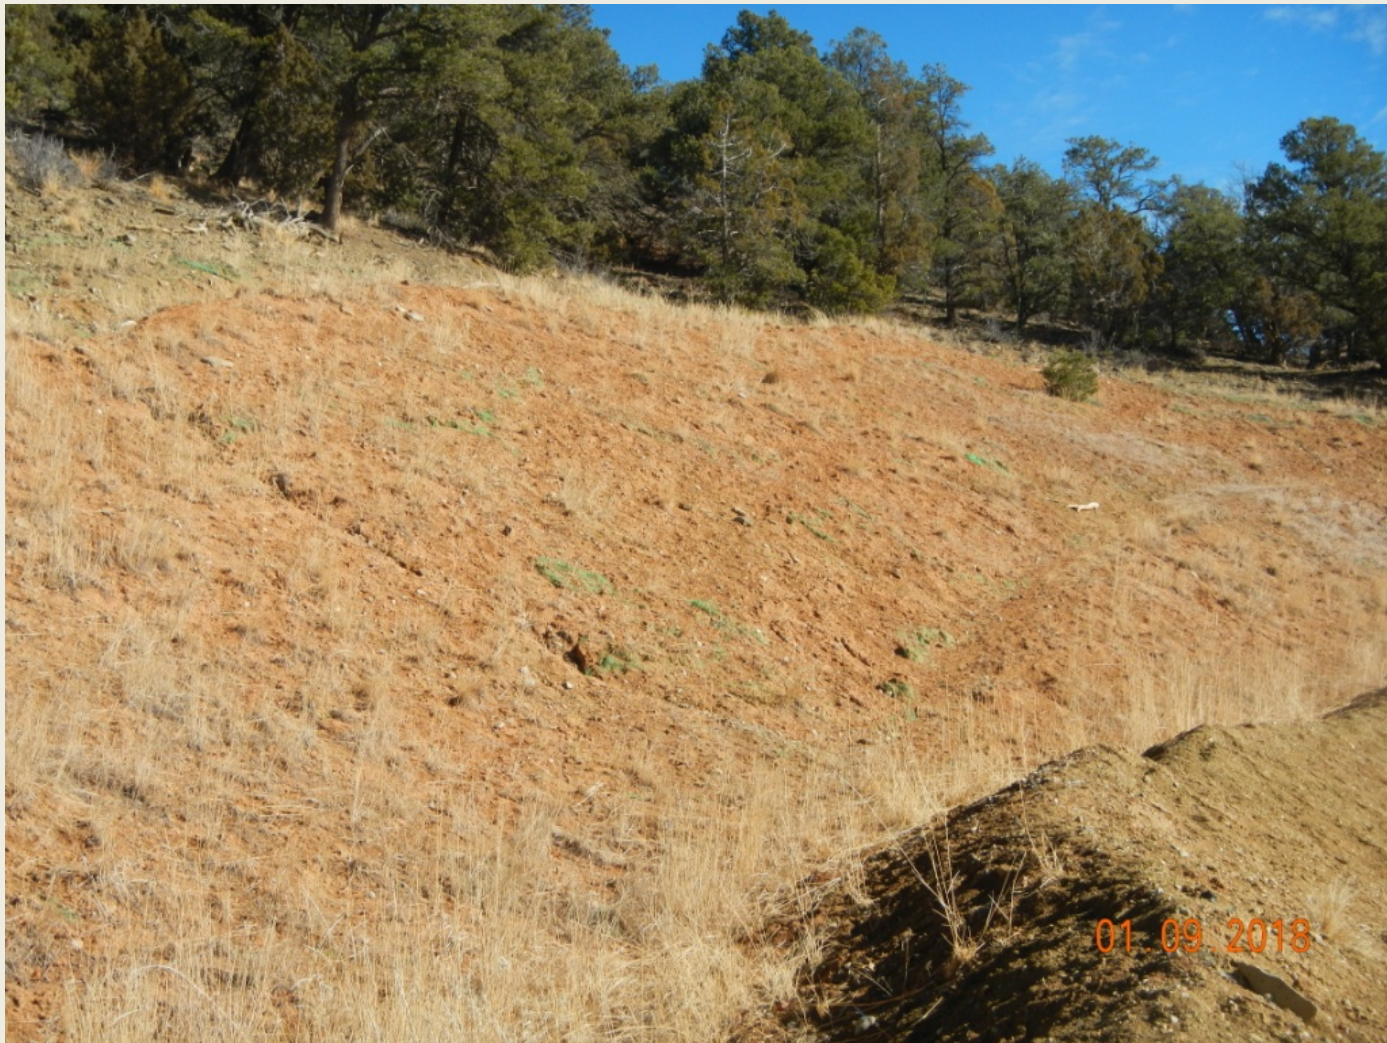
Photo 4. View of green netting debris on cut-slope that needs to be removed and properly disposed of.

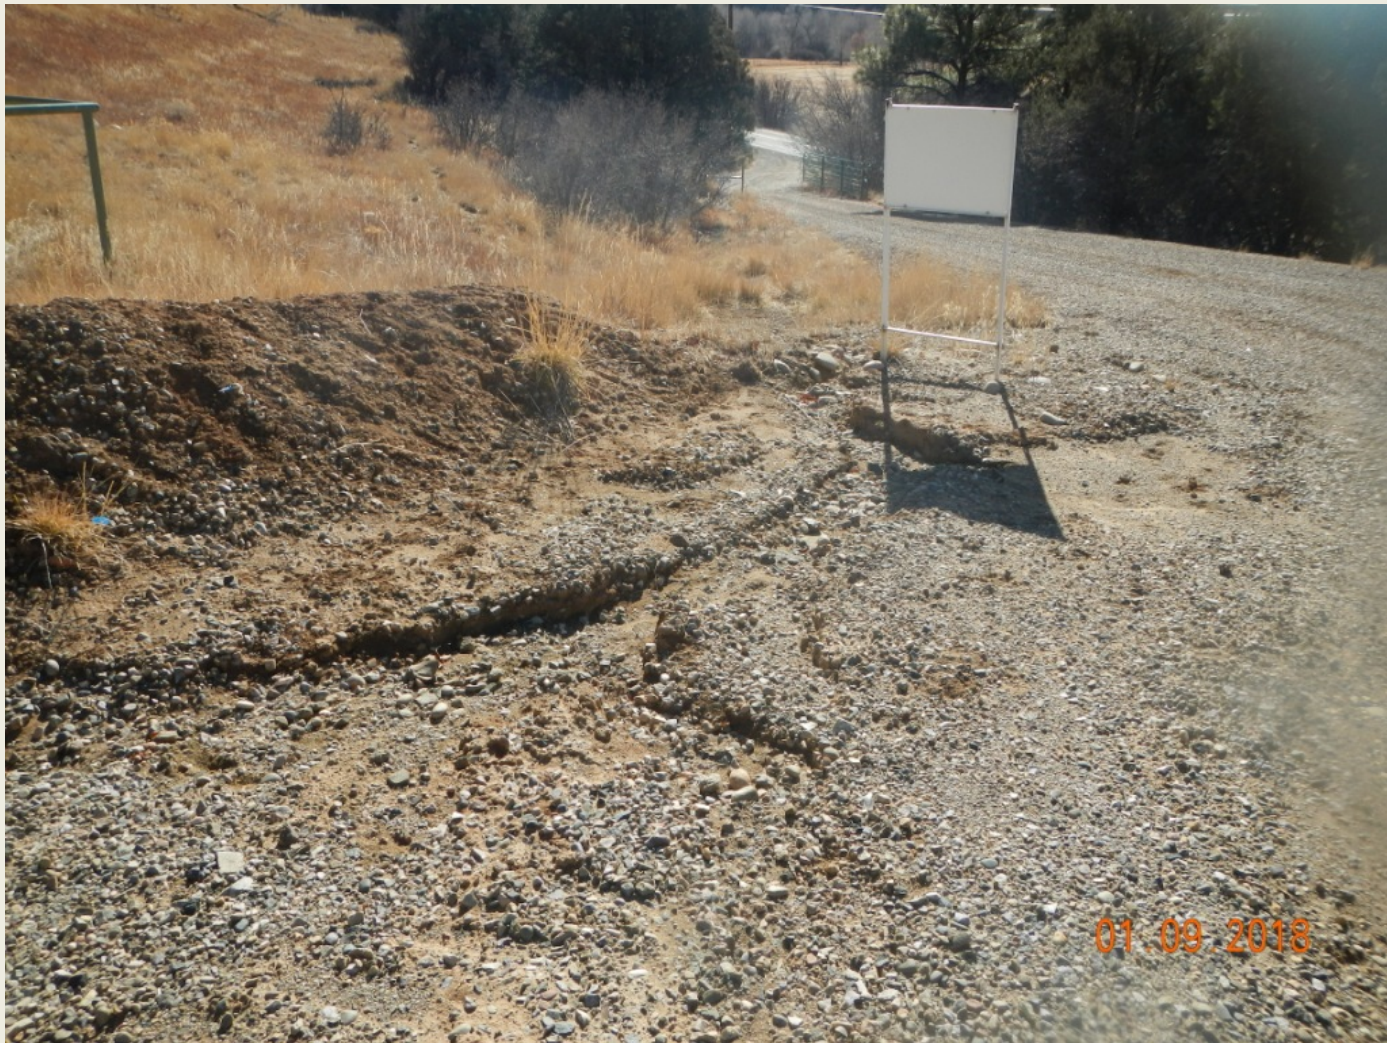
Photo 5. View of erosion occurring at the well pad entrance facing southward.
