Inspection Photos
Location Name: Dyer – USX A #3-17
API: 05-123-24592

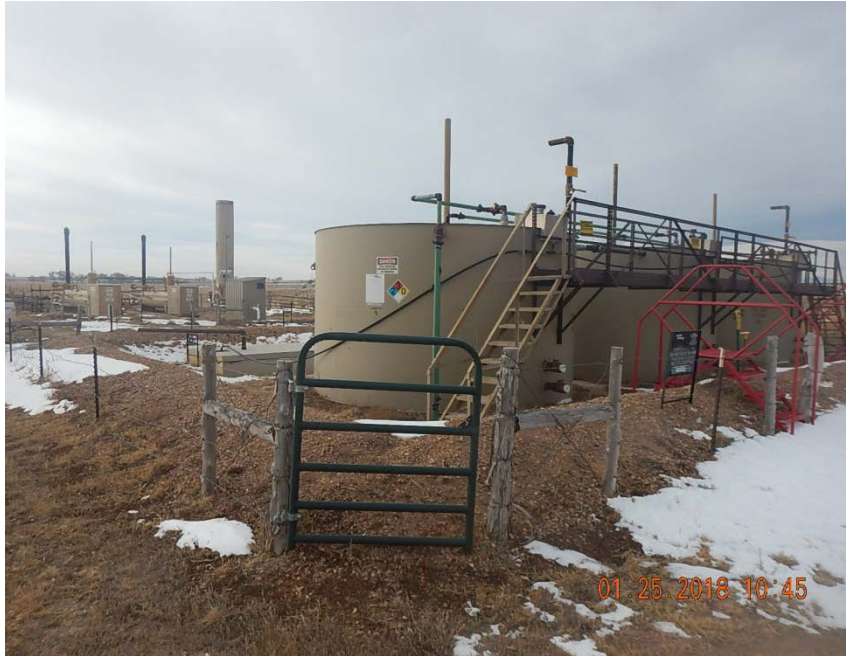
Photo 1: Location, looking SW

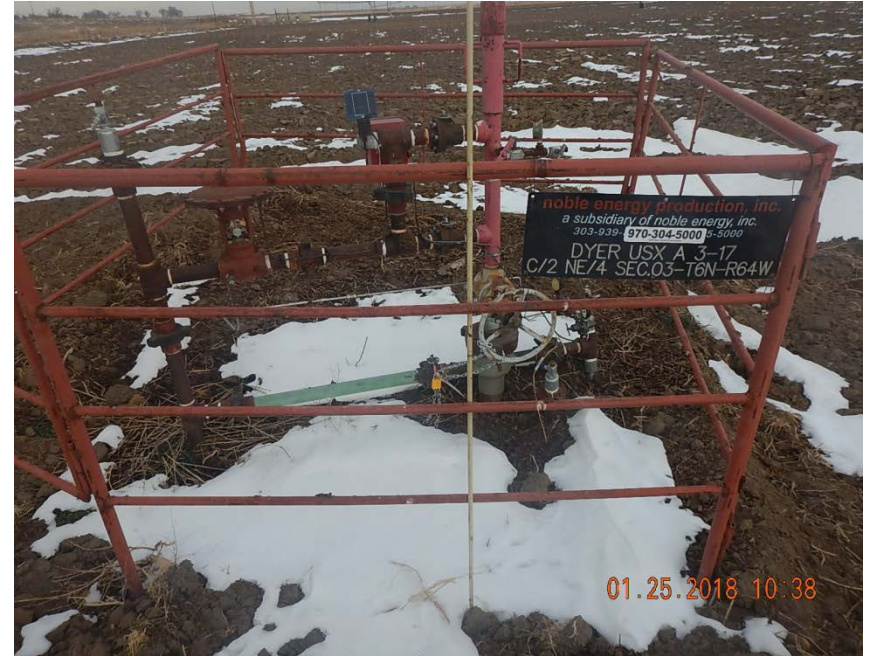
Photo 2: Wellhead, looking N

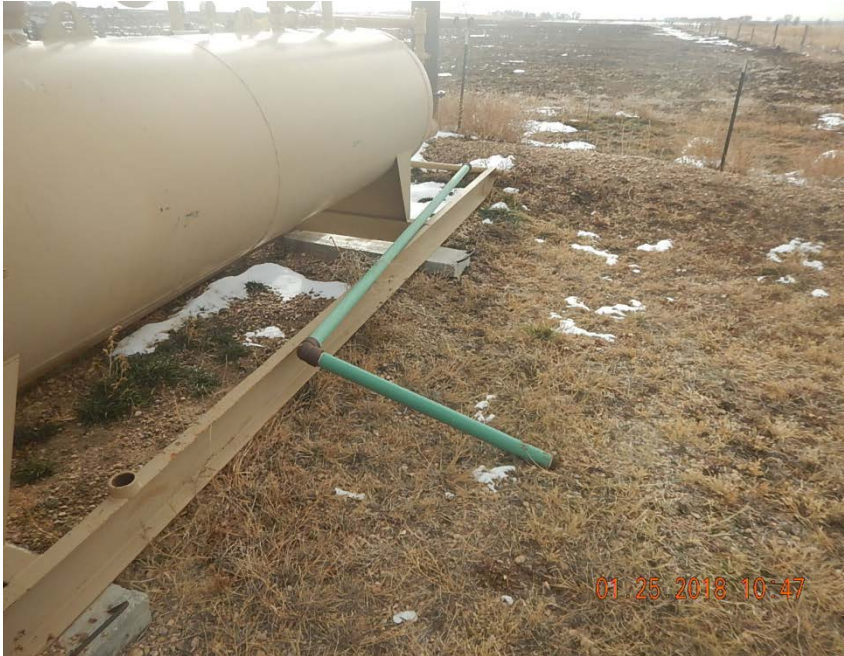
Photo 3: Unused pipe at separator

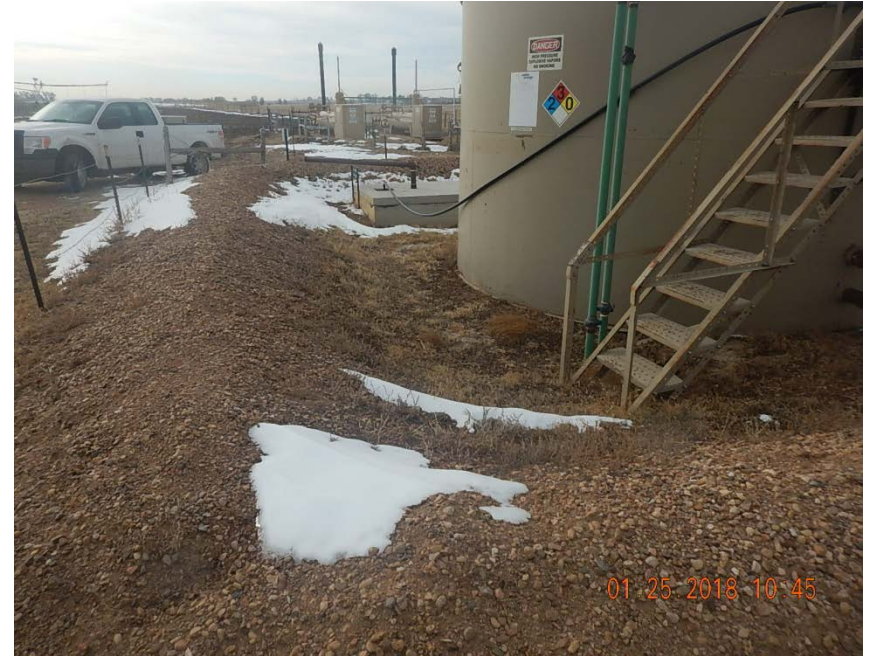
Photo 4: Weeds in tank battery, berm

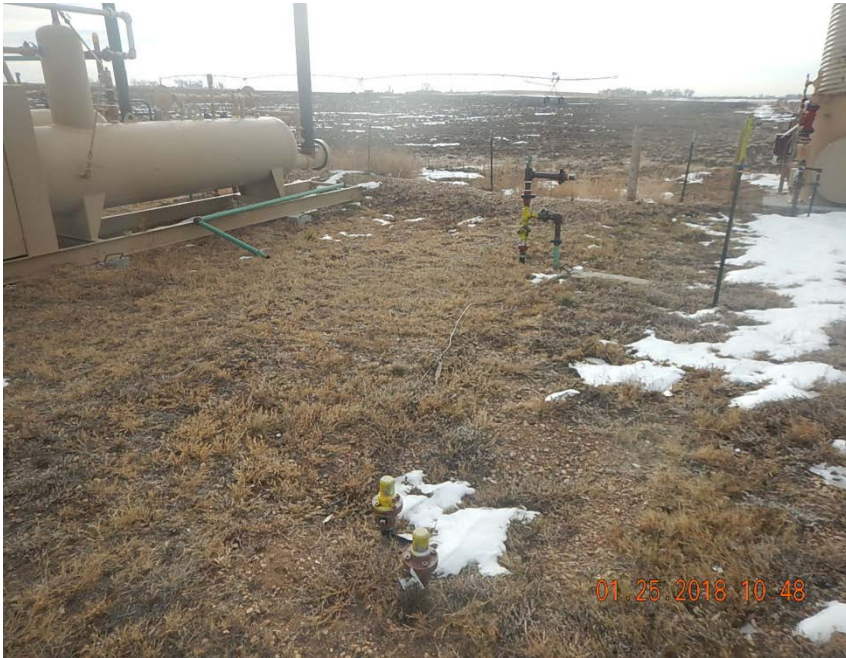
Photo 5: Marked, tagged risers W of separators
