Inspection Photos
Location Name: Rouse USX A #5-17
API: 05-123-24696

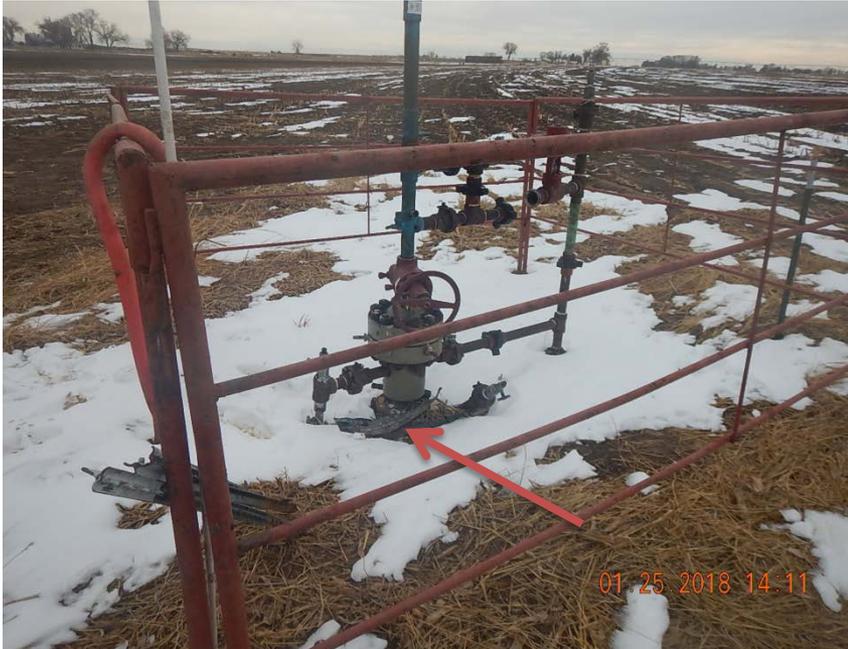
Photo 1: Wellhead, looking SE. Arrow emphasis from inspector is on damaged sign
