Final Reclamation Inspection

Operator: FOUNDATION ENERGY MANAGEMENT LLC- #10112

Location ID: 327445

Inspection Photos
Location Name: ROTH #11-7R
Location ID: 327445

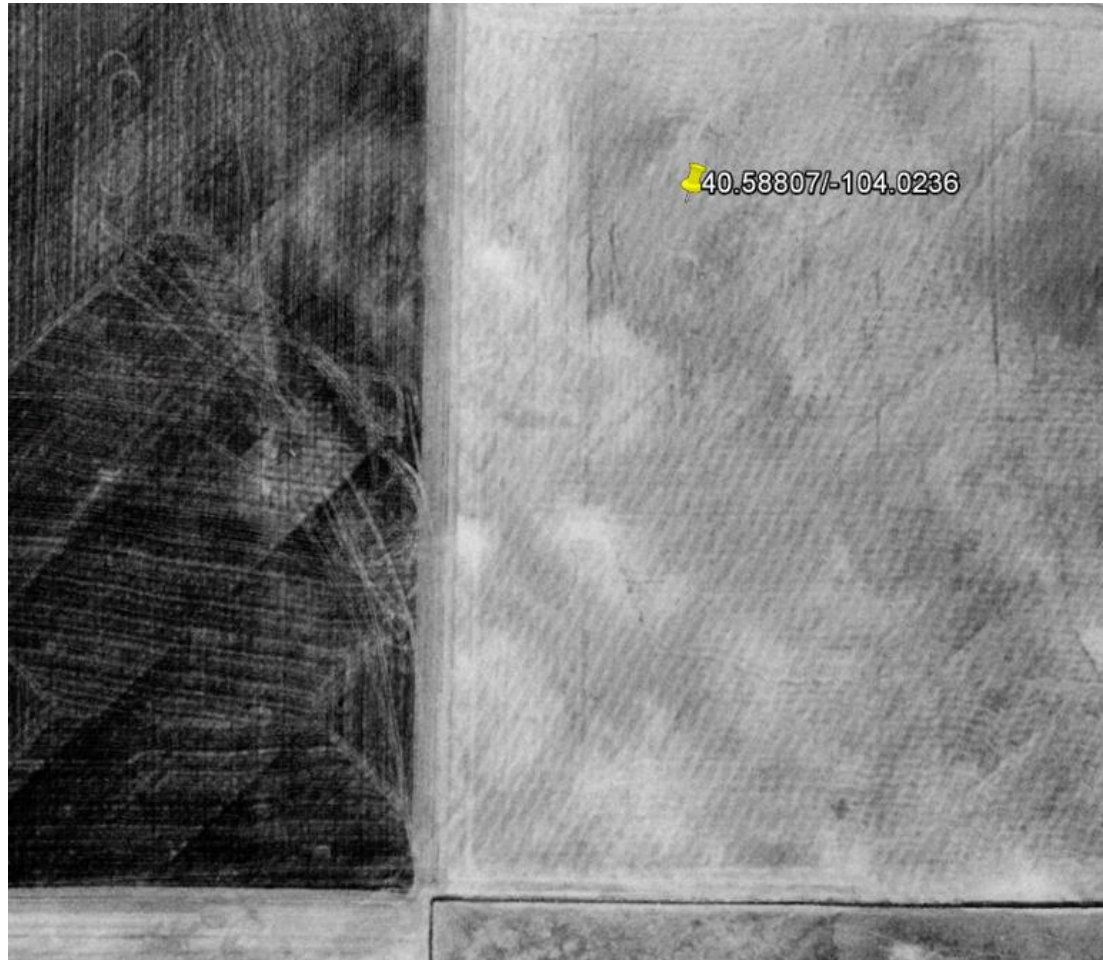
Google Earth aerial imagery taken October 9, 1989 illustrating no access roads were pre-existing prior to oil and gas operations.

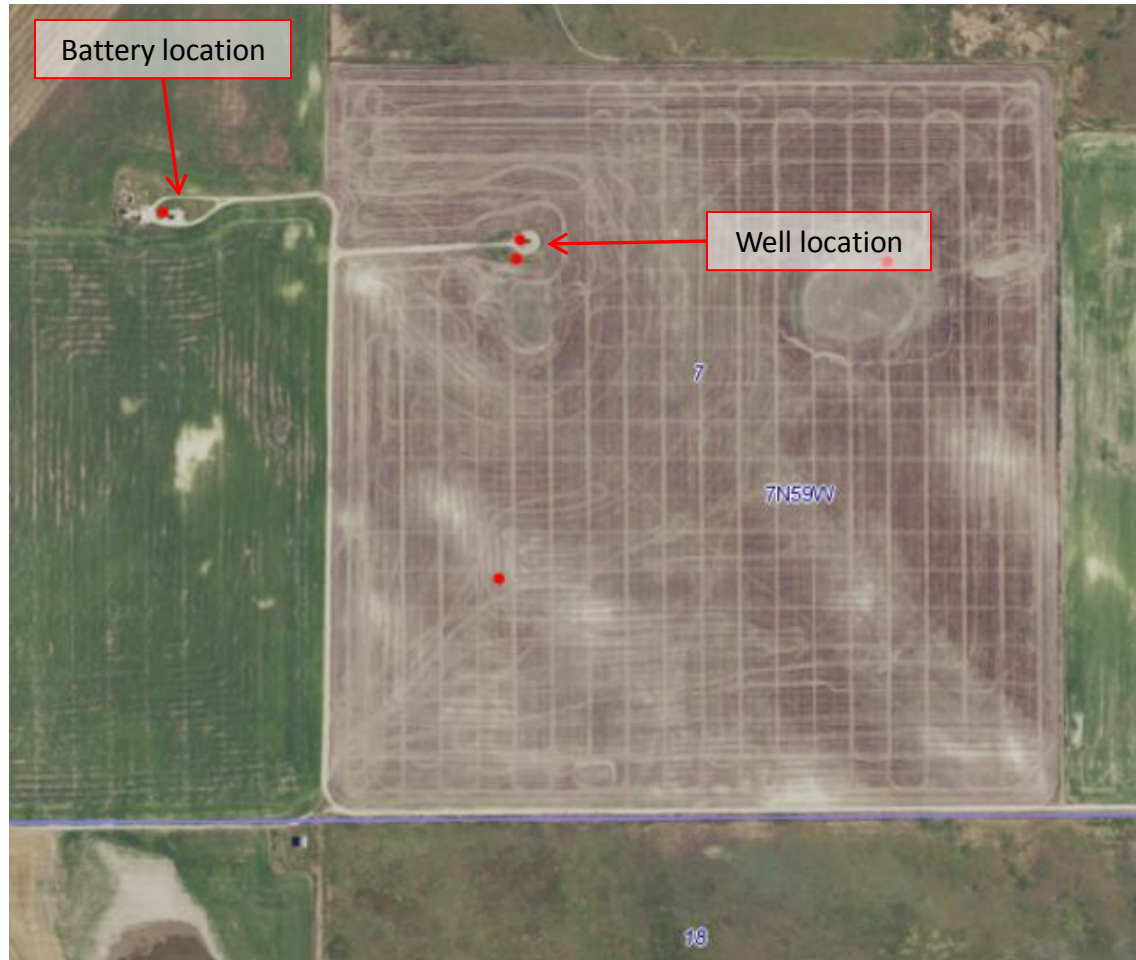
Aerial imagery from COGCC GISOnline database taken in 2015 illustrating the well location and battery location during operations. This is the most recent aerial imagery.

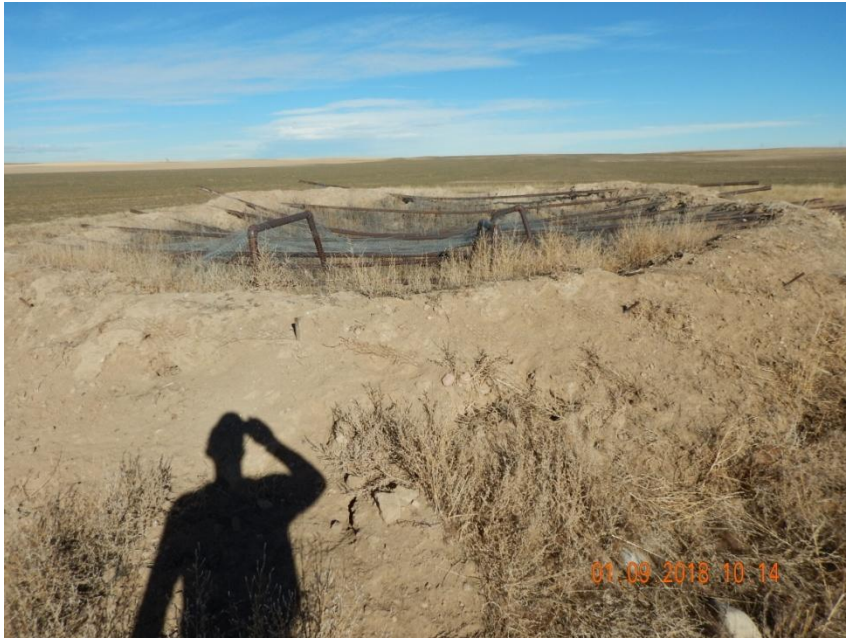
Photo 1. Photo taken from the pit at the battery location, facing North. Operator has failed to backfill pit per Rule 1004.a.

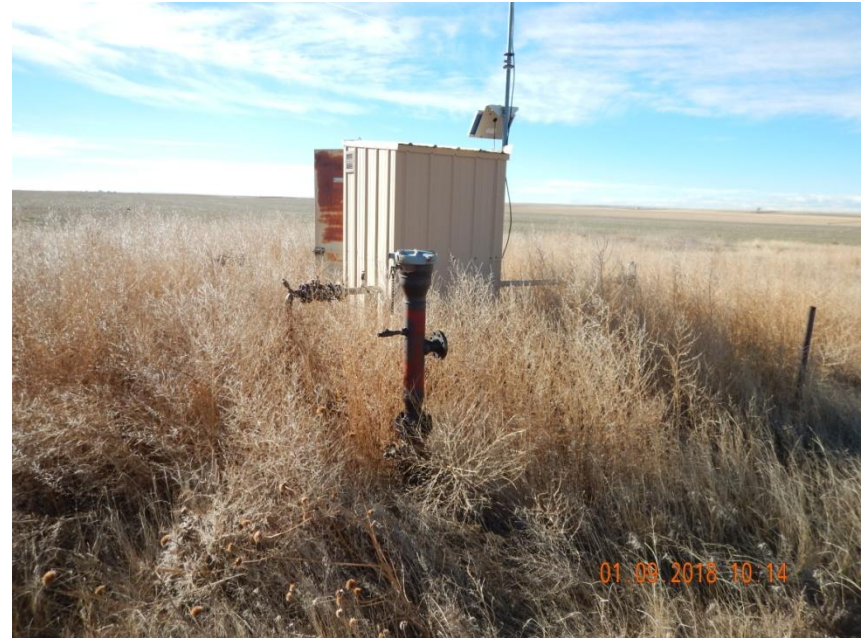
Photo 2. Photo taken from the battery location, facing South. Operator has failed to remove equipment within 3-months of plugging the well, including the meter shed, tank, pig station, and riser.

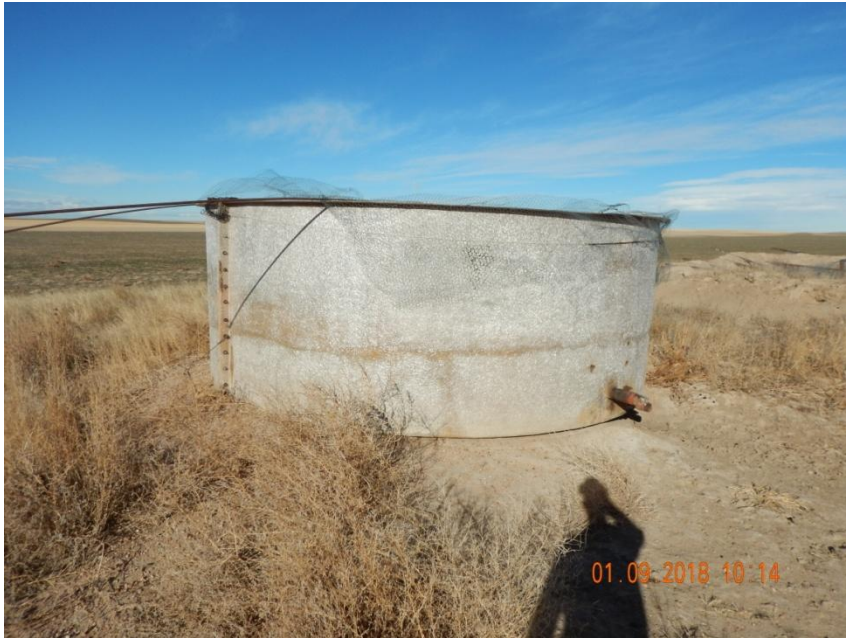
Photo 3. Photo taken from the battery location, facing Northwest. See comments under Photo 2.

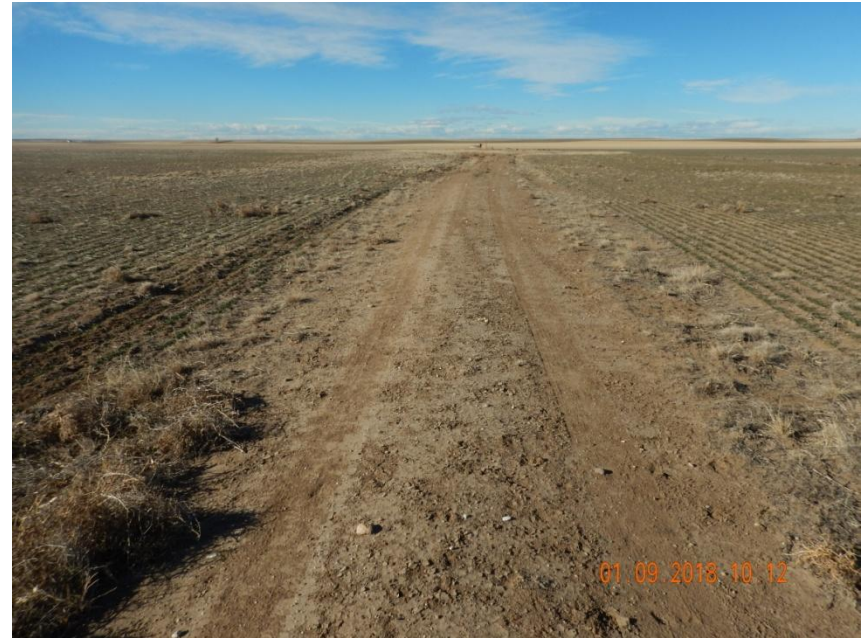
Photo 4. Photo taken from the access road to the battery location, facing West. Operator has failed to perform reclamation activities within 3-months of plugging the well on cropland.

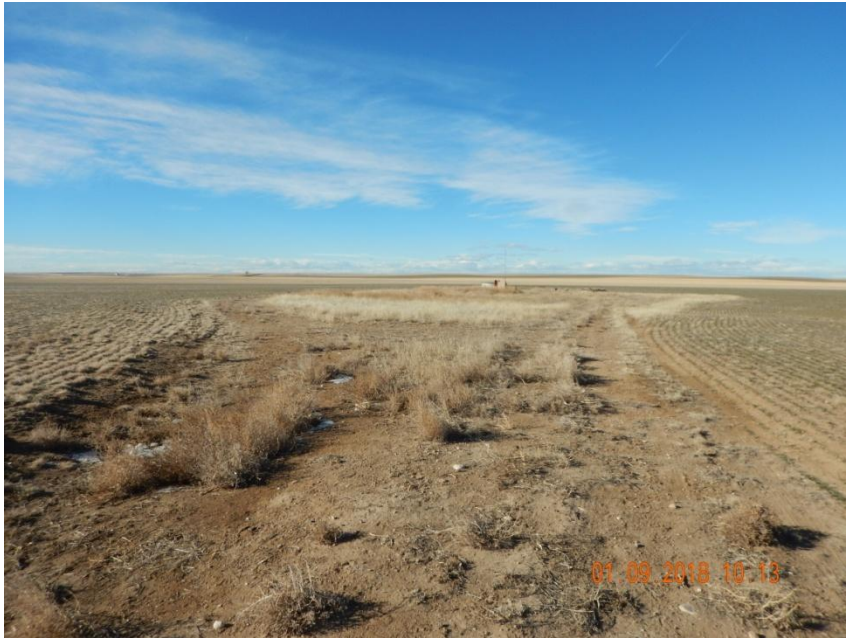
Photo 5. Photo taken from the eastern battery location, facing West. See comments under Photo 4.

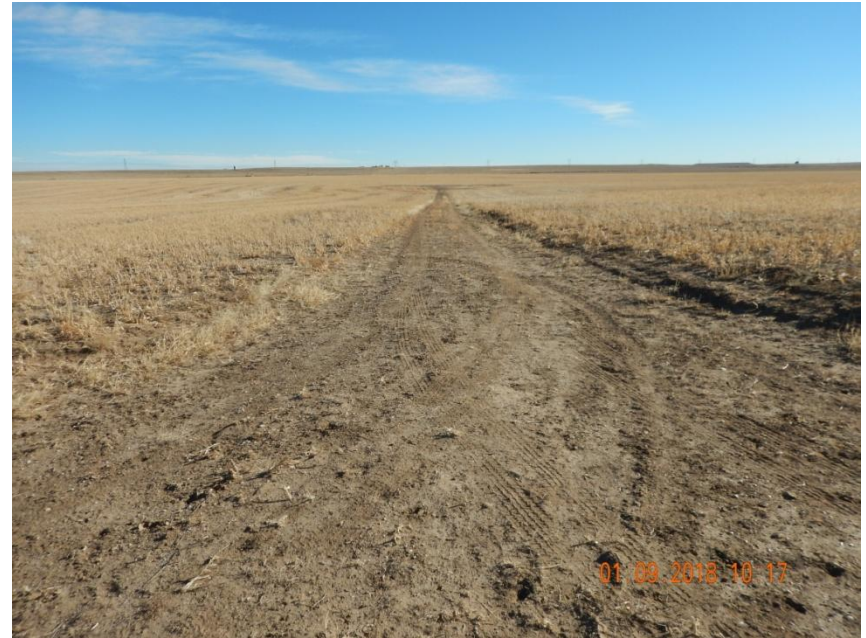
Photo 6. Photo taken from the access road to the well location, facing East. See comments under Photo 4.

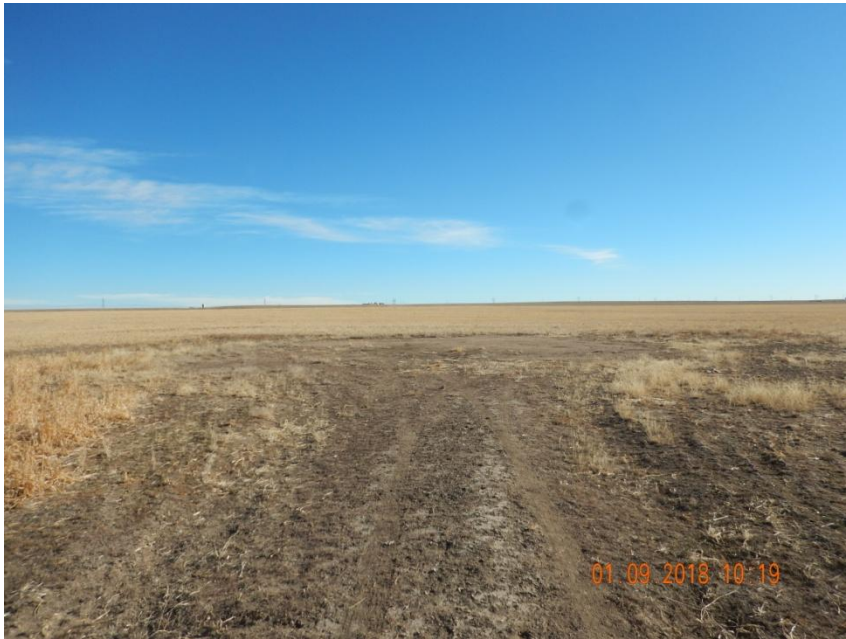
Photo 7. Photo taken from the well location, facing East. See comments under Photo 4.

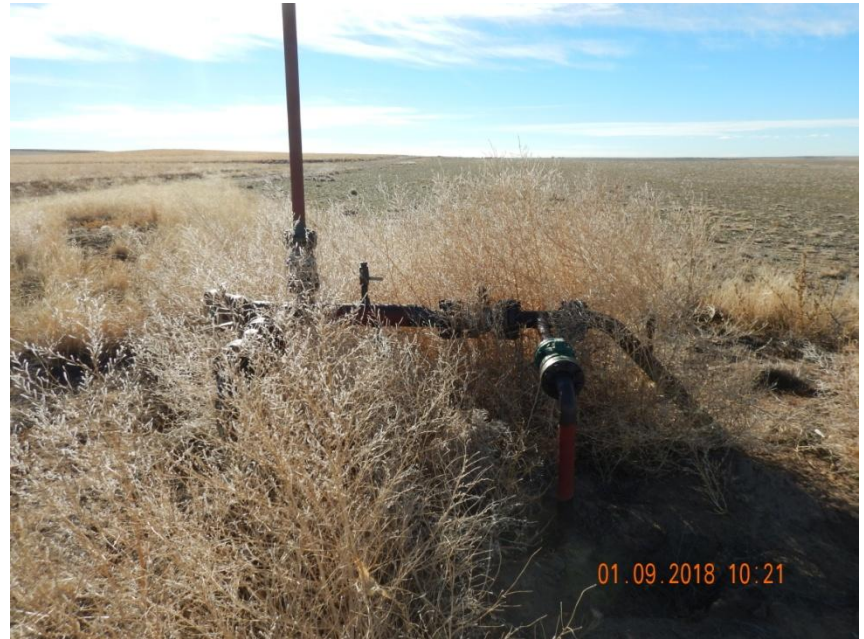
Photo 8. Photo taken between the well location and battery location, facing South. Operator has failed to remove equipment within 3-months of plugging the well.
