Inspection Photos

API: 05-067-09194

Operator: Maralex Disposal LLC

Inspection Number: 680602448

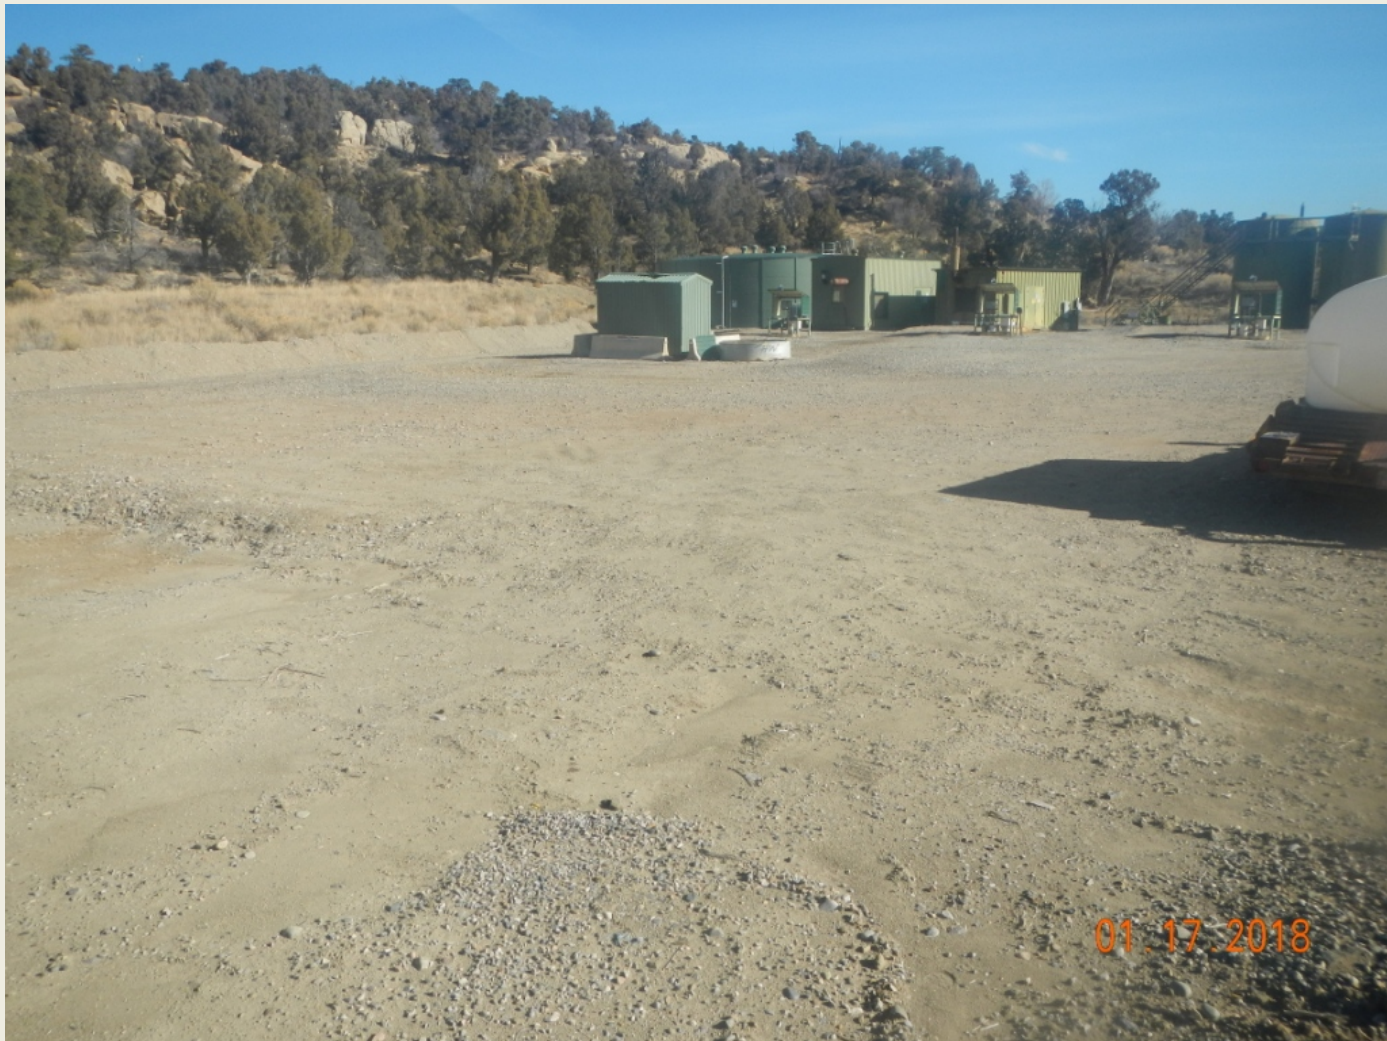
Photo 1. View of the project area from the southwestern corner facing center.

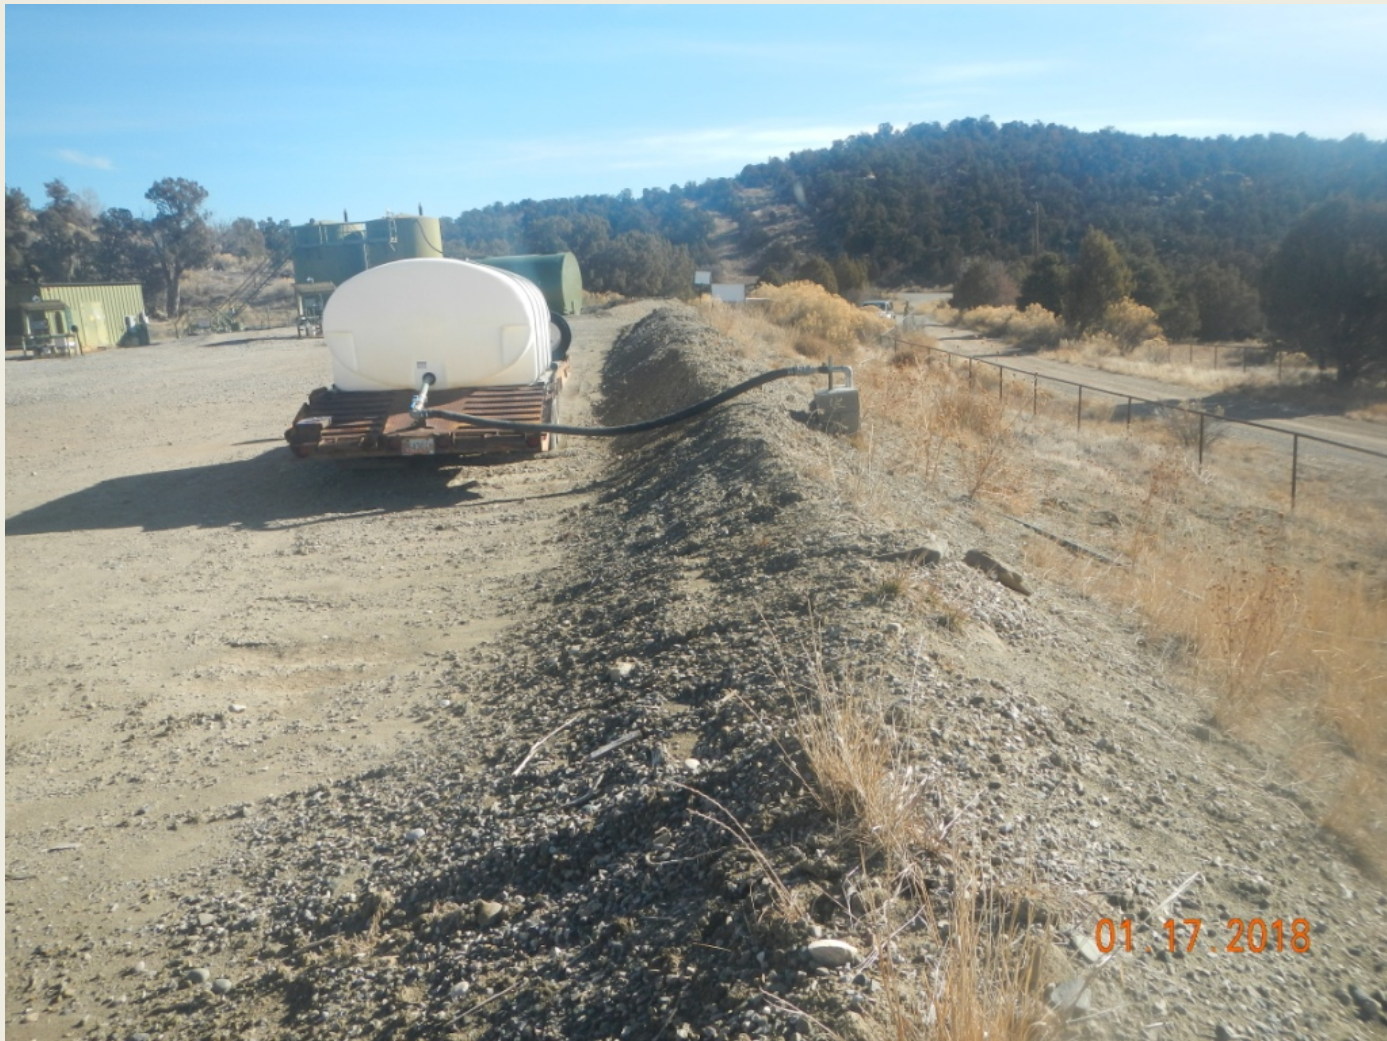
Photo 2. View of the southern portion of the project area from the southwestern corner facing eastward.

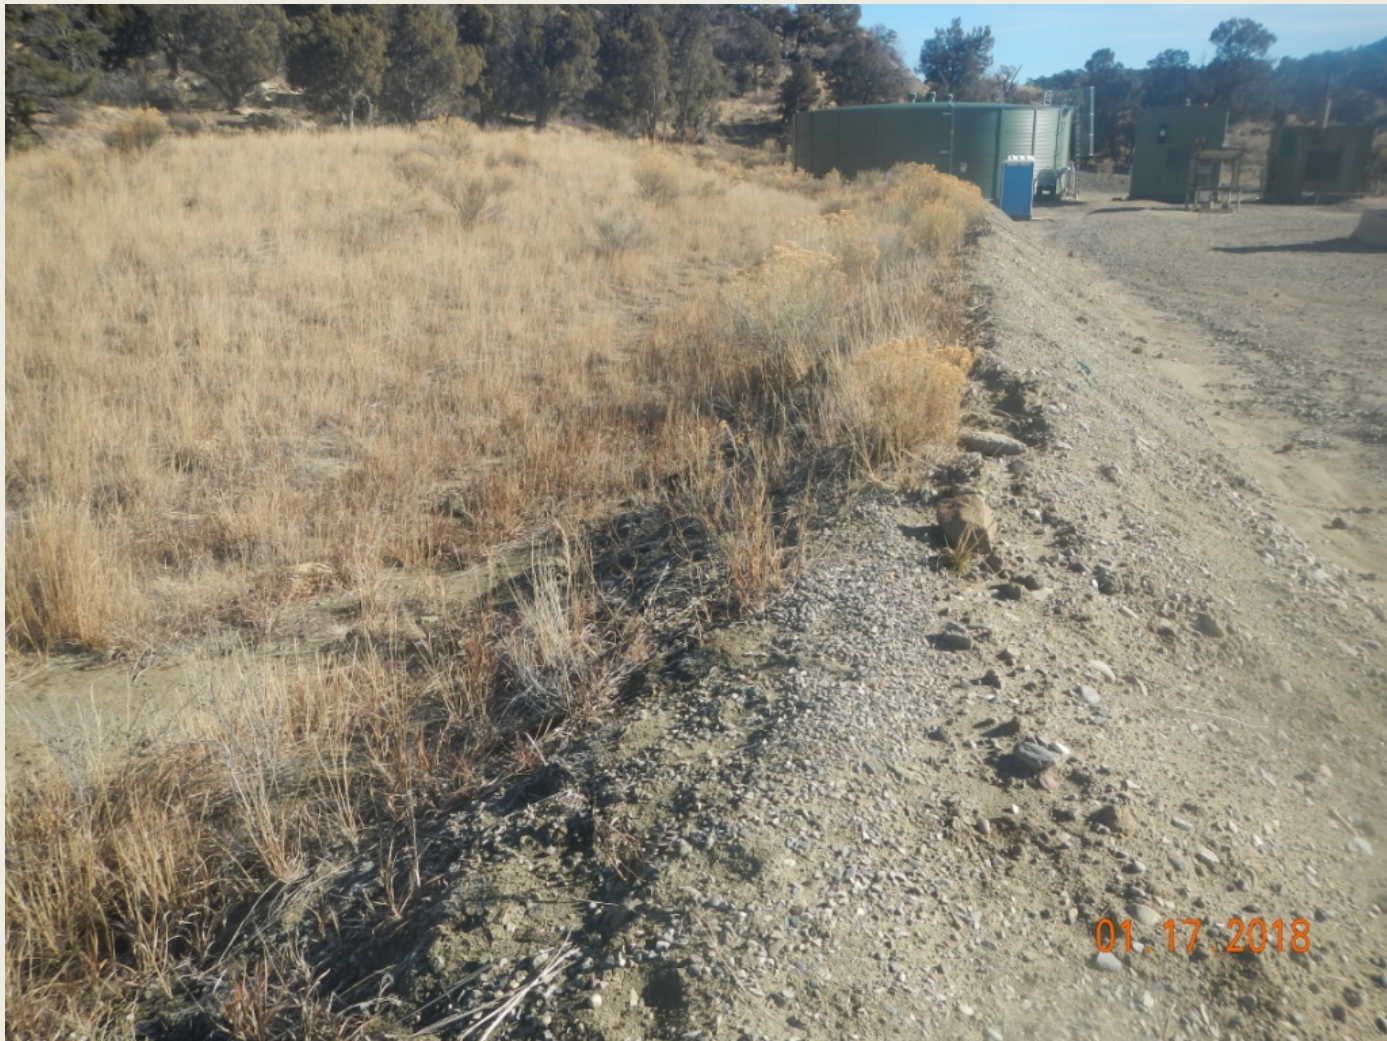
Photo 3. View of the northern portion of the project area from the southwestern edge facing eastward.

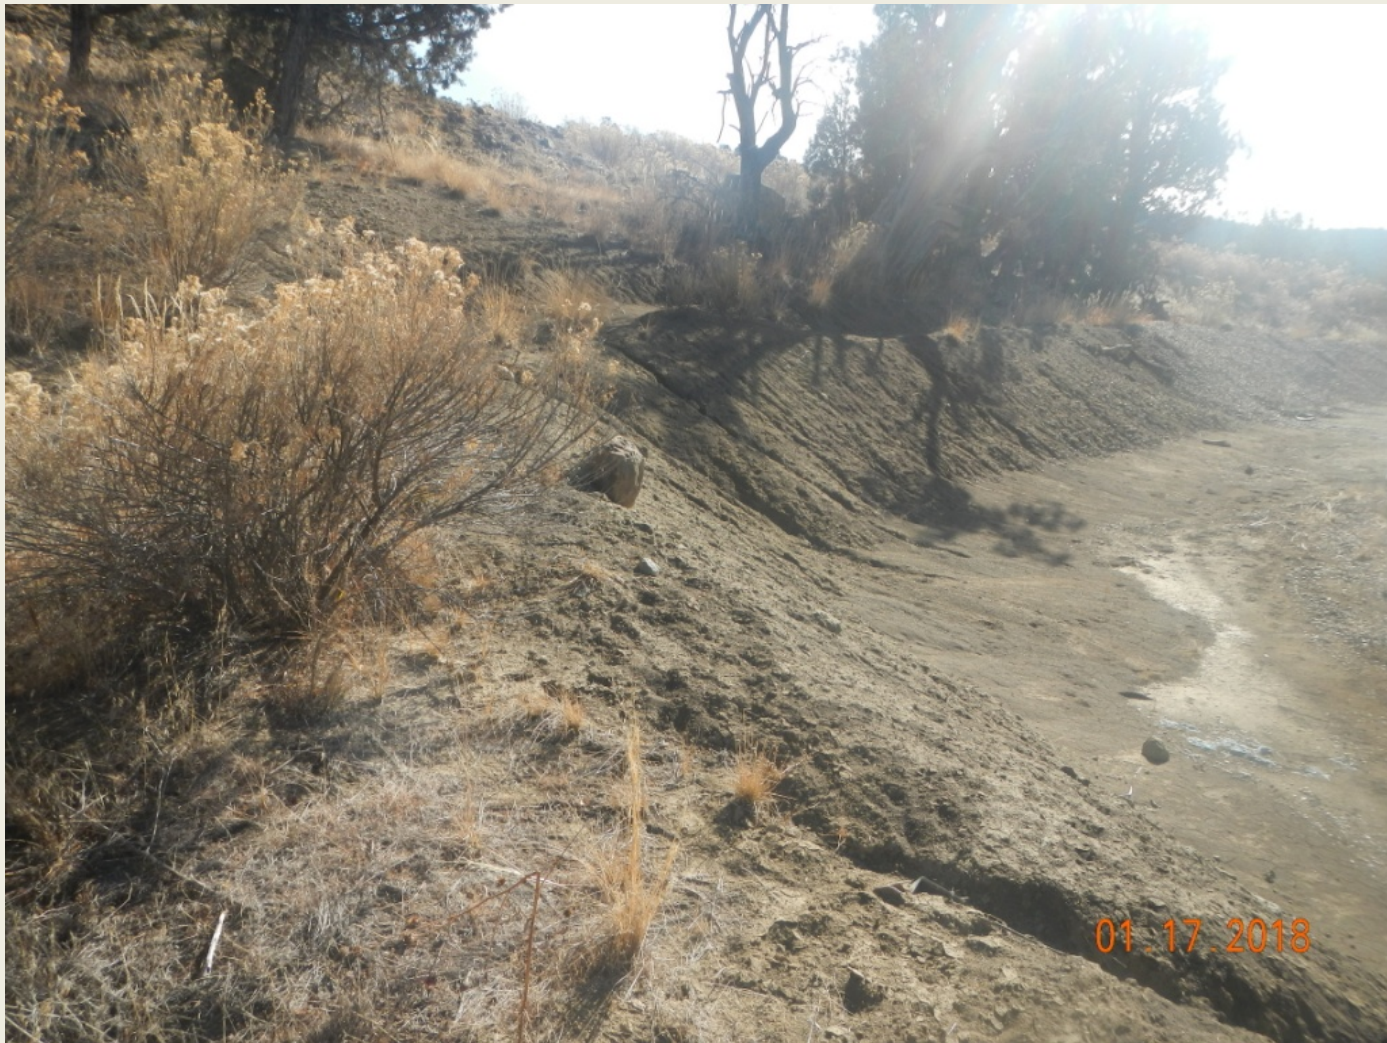
Photo 4. View of area in the northeastern corner of the well pad where stormwater flows run-onto the well pad and are eroding the cut-slope. Diversion ditches are full of sediment.

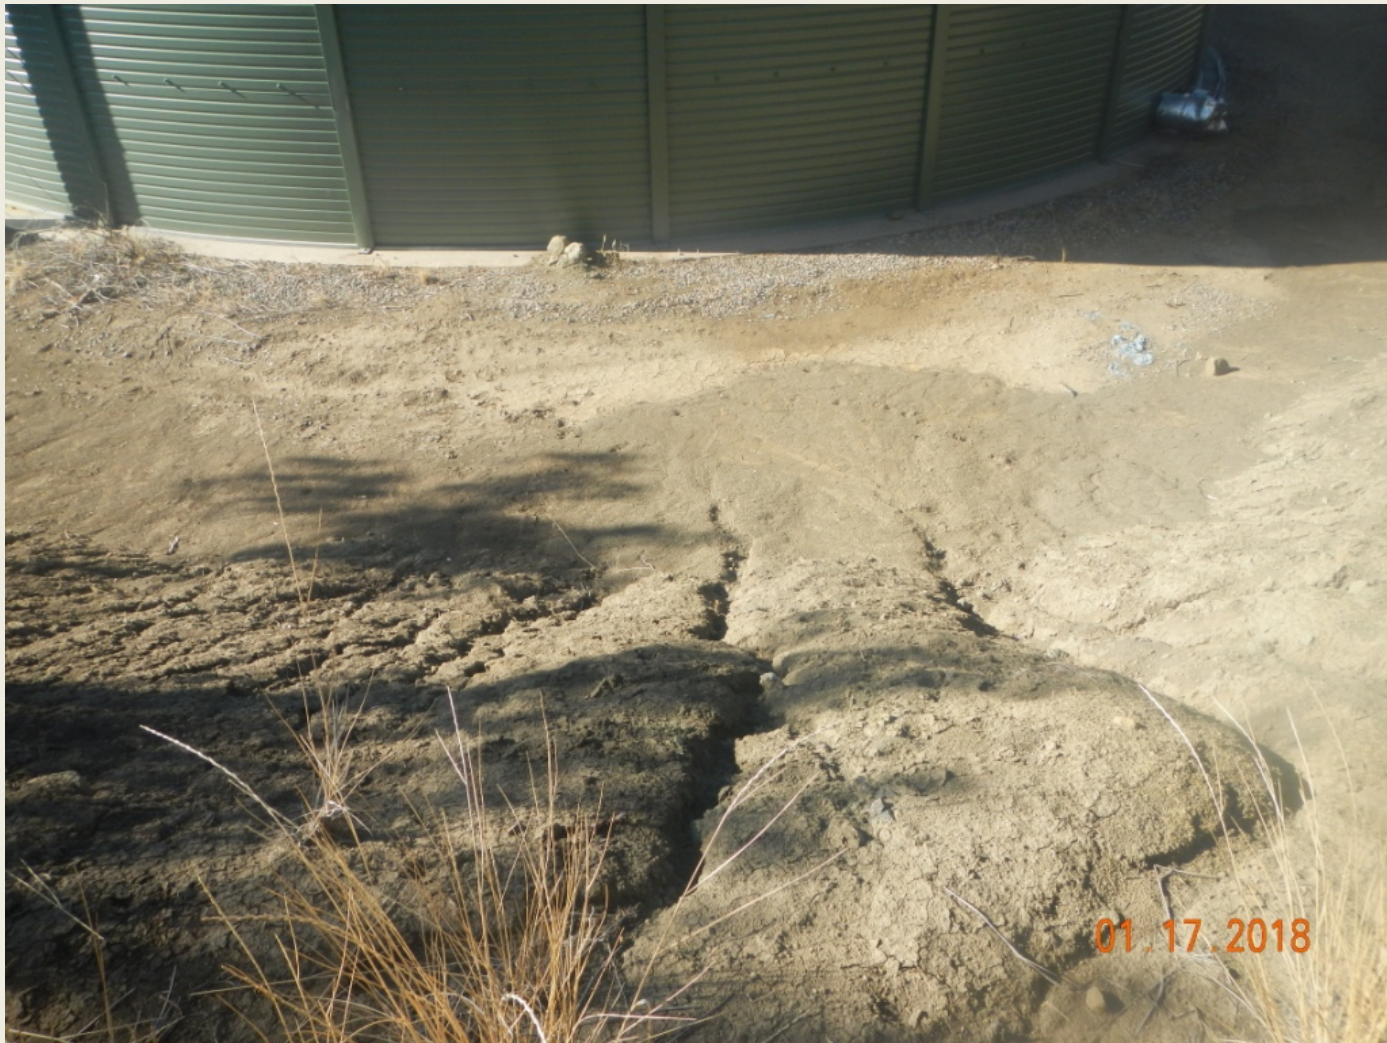
Photo 5. View of sediment deposition and erosional channeling in the northeastern portion of the project area.

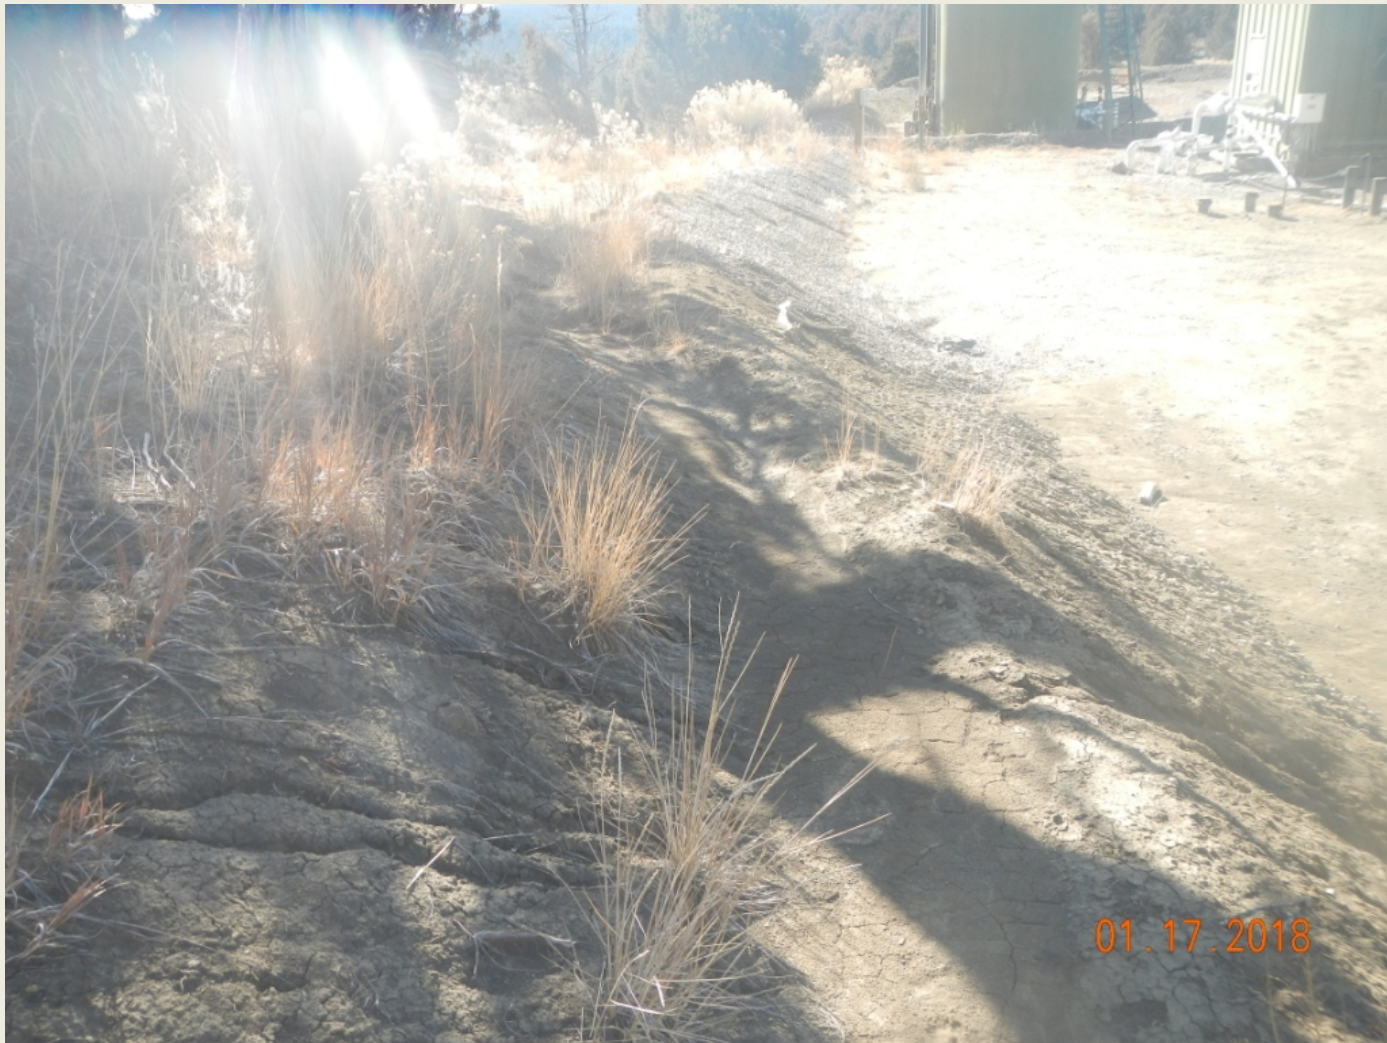
Photo 6. Another view of erosional channeling and diversion full of sediment in the northeastern corner of the project area.
