**COLORADO**  
Oil & Gas Conservation  
Commission  
Department of Natural Resources

**Inspection Photos**  
**Location Name: Sandy Hill Land Application Site**  
**Facility ID: 448950**  
**Inspection Date: 01/25/2018**

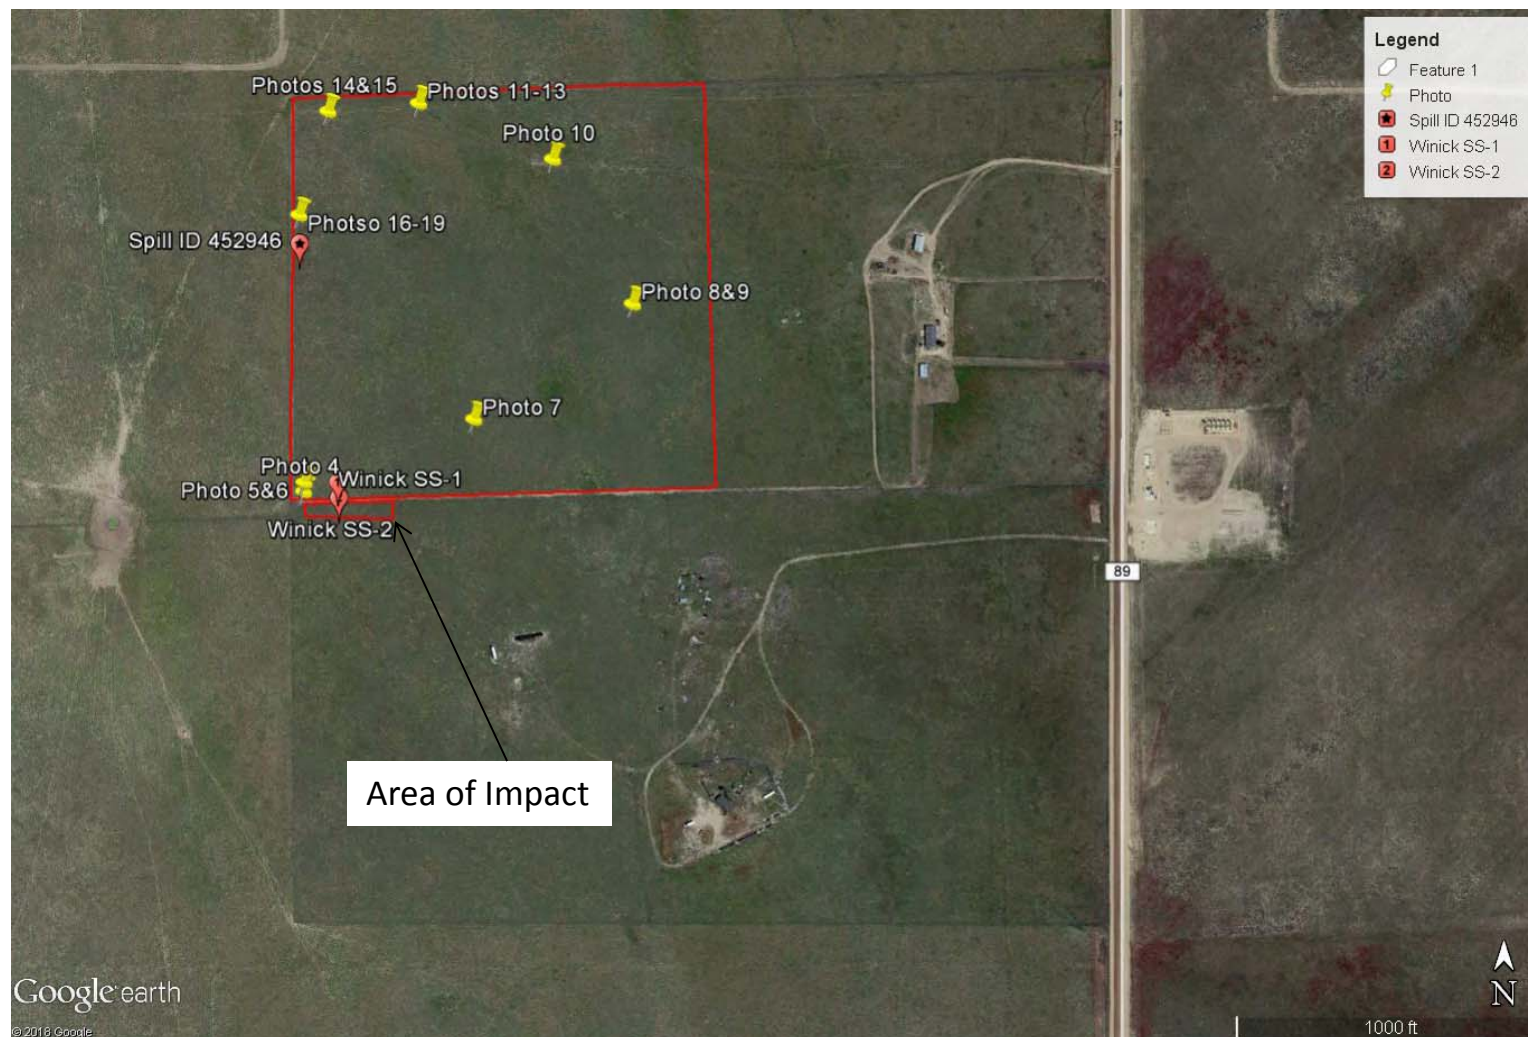
Aerial Image from Google Earth showing Land Application area, soil sample locations, and photograph locations.  
Aerial Image Date = 06/14/2016.

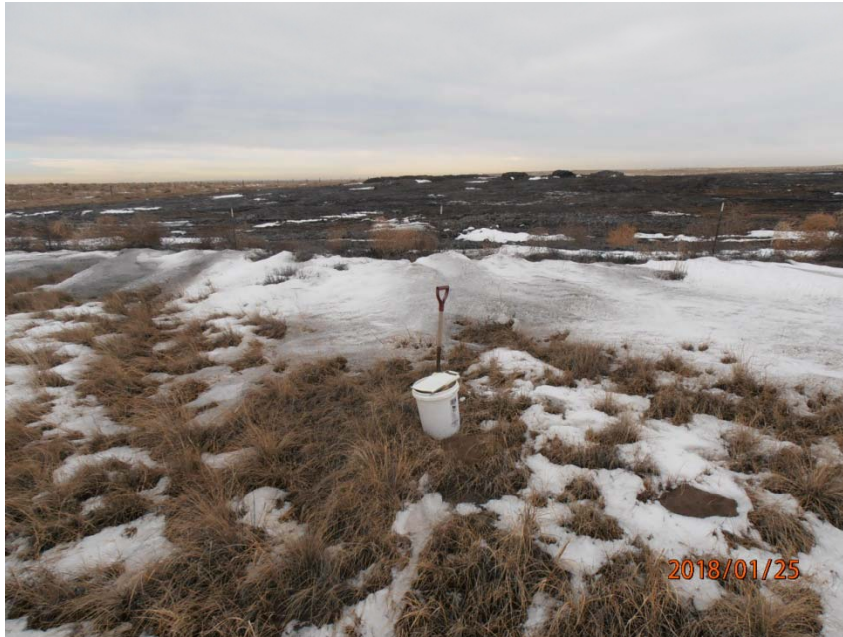
**Photo 1 – Photo of soil sample location SS-1, looking north.**  
**Soil Sample SS-1 location Lat/Lon = 40.37533 / -104.23270**

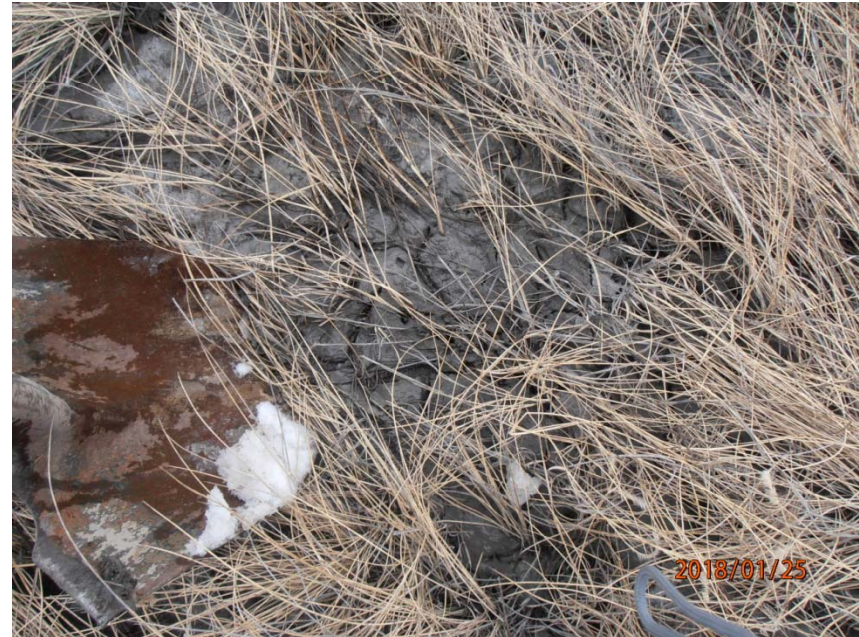
**Photo 2 – Photo of dried drilling fluid at soil sample location SS-1.**

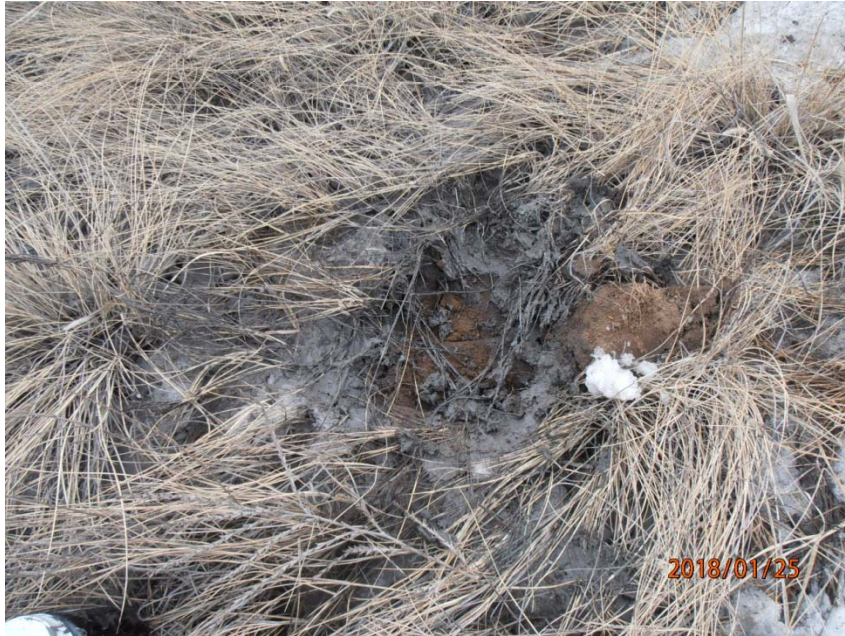
**Photo 3 – Photo of soil sample location SS-1.**

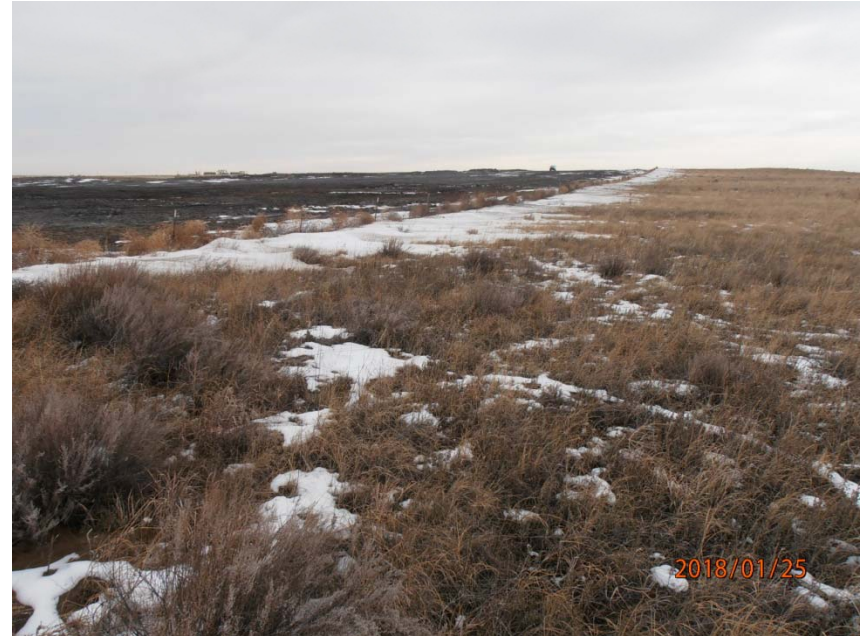
**Photo 4 – Photo from northwest corner of Winick property looking east down property line. Sandy Hill Land Application area is north of property. Area of Winick property beneath snowdrift has been impacted by the migration of drilling fluid.**

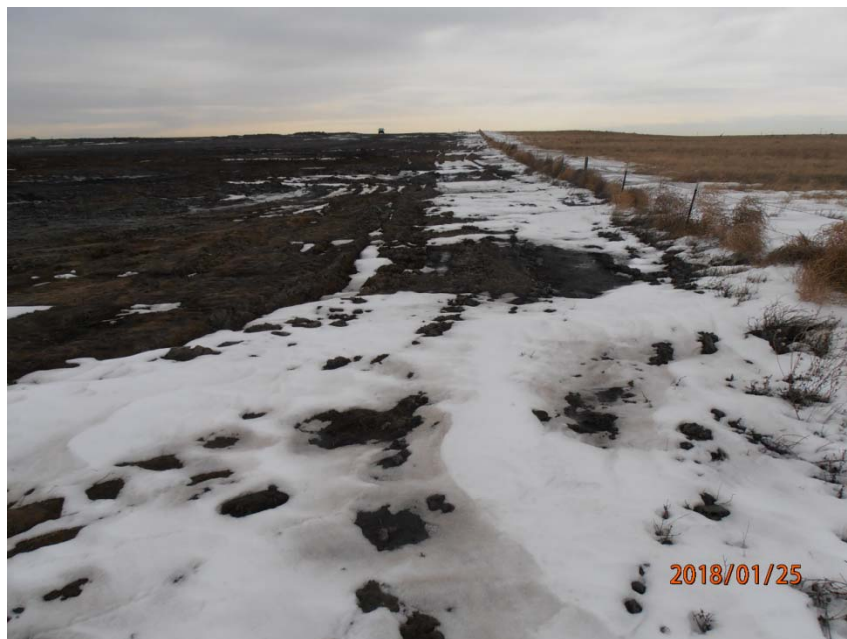
**Photo 5 – Photo from southwest corner of Sandy Hill Land Application area looking east down property line. Winick property is on southside of fence line in the right of the picture.**

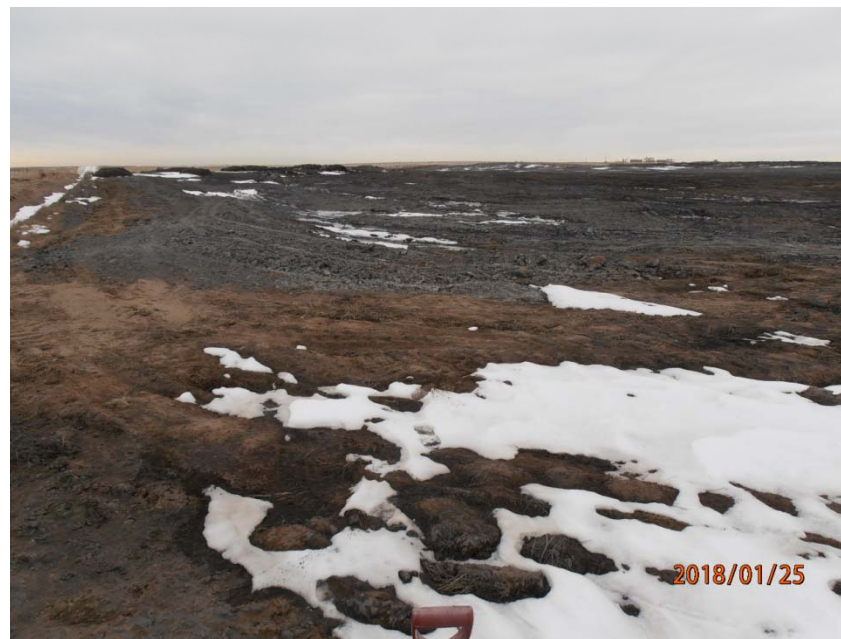
**Photo 6 – Photo from southwest corner of Sand Hill Land Application area looking north down western property line.**

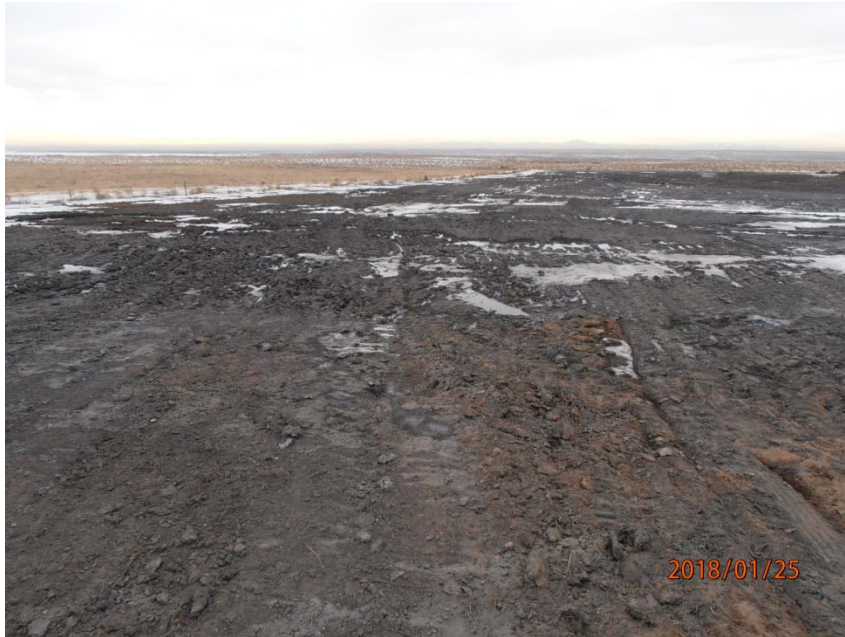
**Photo 7 – Photo from rise on Sandy Hill Land Application area looking west toward southwest corner of land application area.**

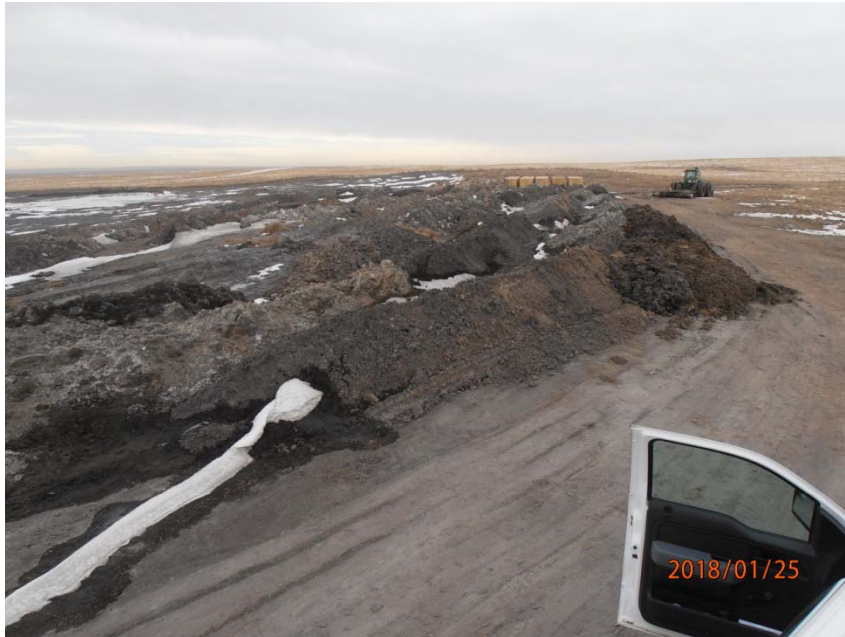
**Photo 8 – One of two areas of staged drill cuttings, looking north.**

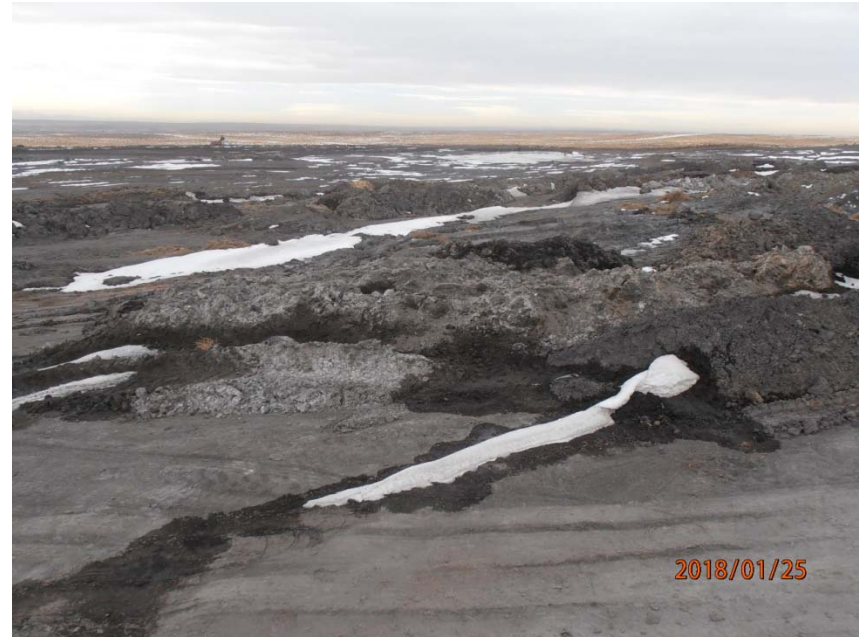
**Photo 9 – One of two areas of staged drill cuttings, looking west.**

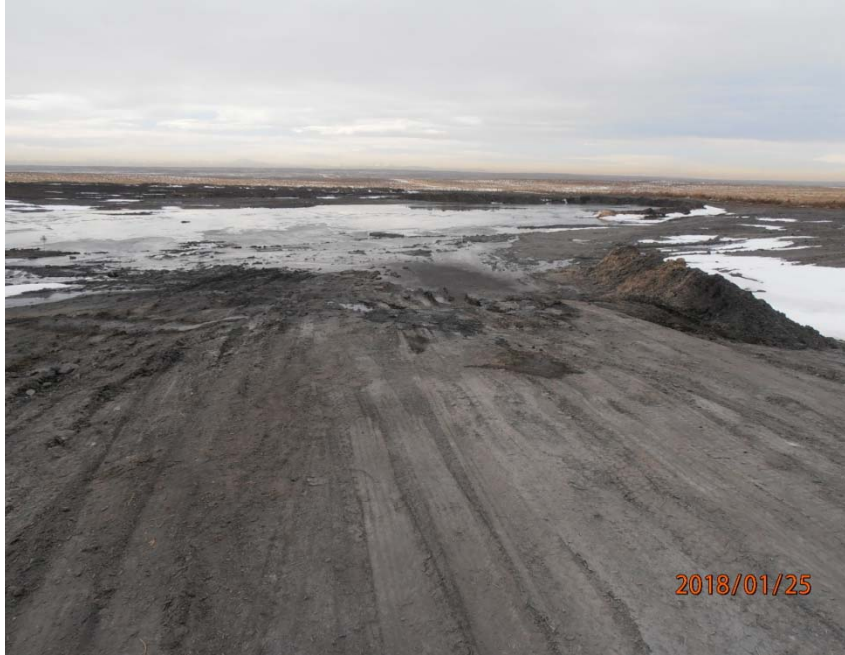
**Photo 10 – Photo of ponded drilling fluid on land application site, taken from Lat/Lon 40.37827,-104.23025 looking west-northwest.**

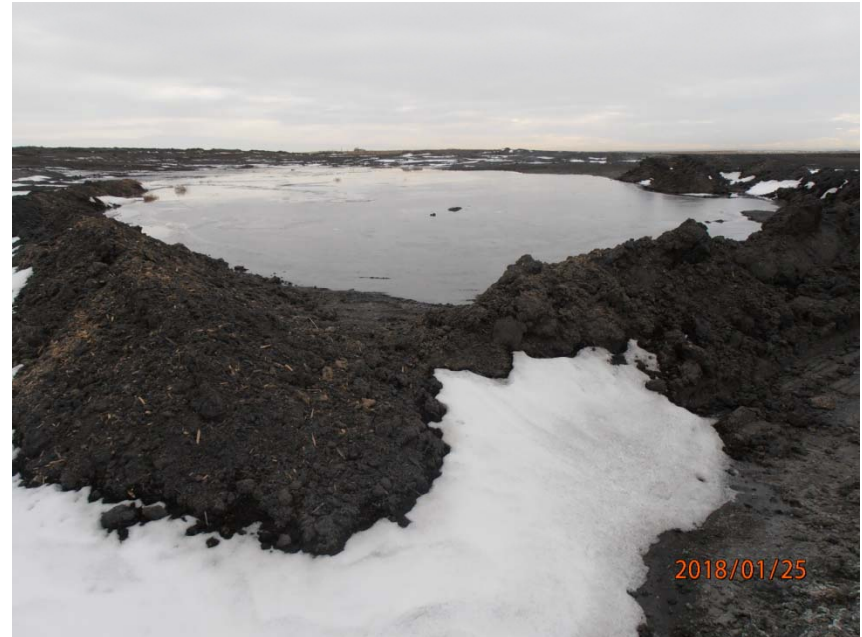
**Photo 11 – Photo of drilling fluids pond looking southeast.**

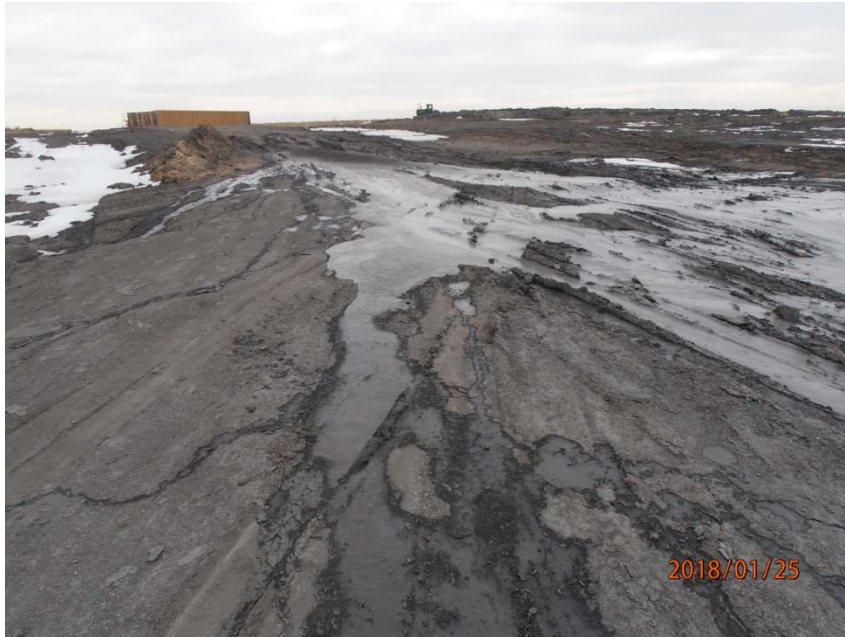
**Photo 12 – Photo of area where drilling fluids are drained to flow into pond.**

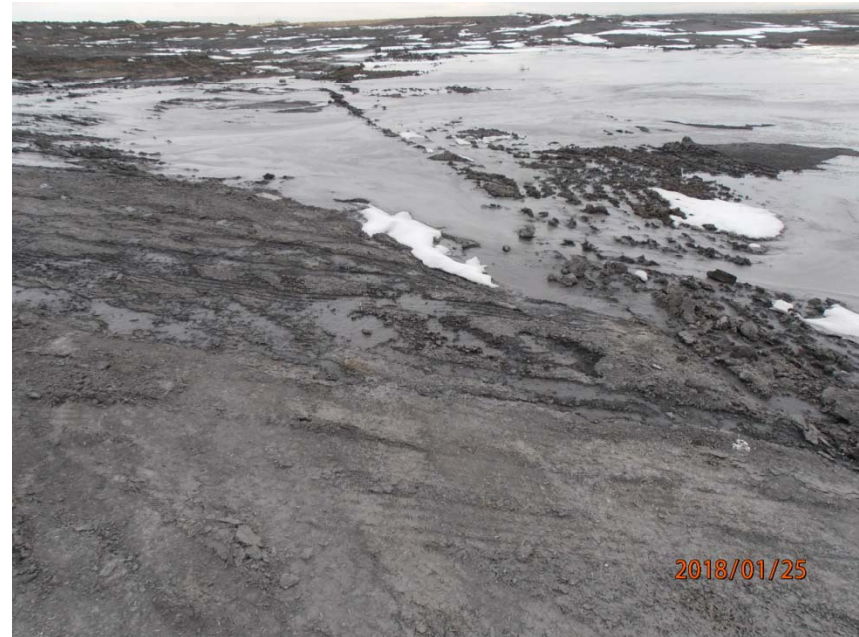
**Photo 13 – Photo near edge of pond where drilling fluids are dumped.**

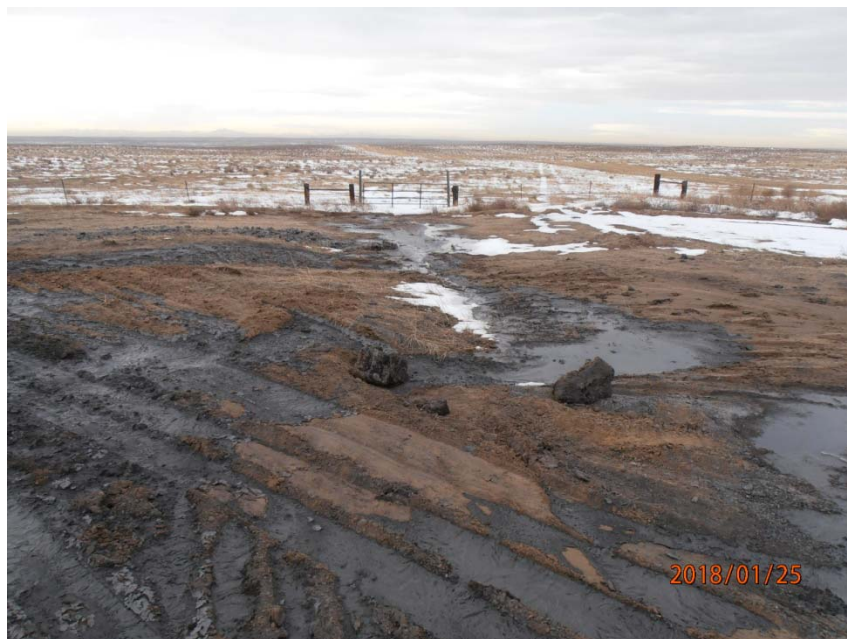
**Photo 14 – Drilling fluids and stormwater mixing with waste runoff in northwest corner of Sandy Hill Land Application area. Gate accesses State Land Board land to the west.**

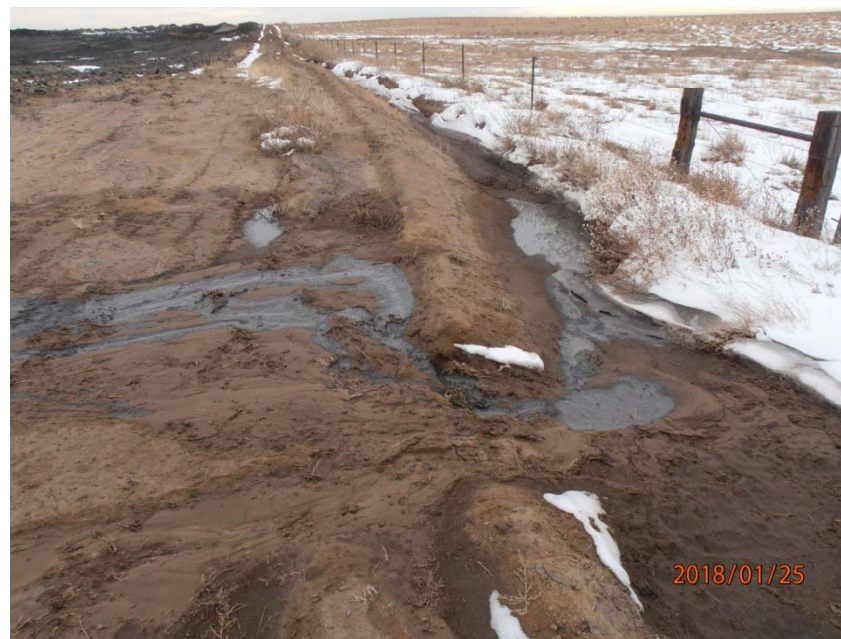
**Photo 15 – Drilling fluids and stormwater mixed with waste runoff into ditch at northwest corner of Sandy Hill Land Application area, looking south. State Land Board land is across the fence to the west.**

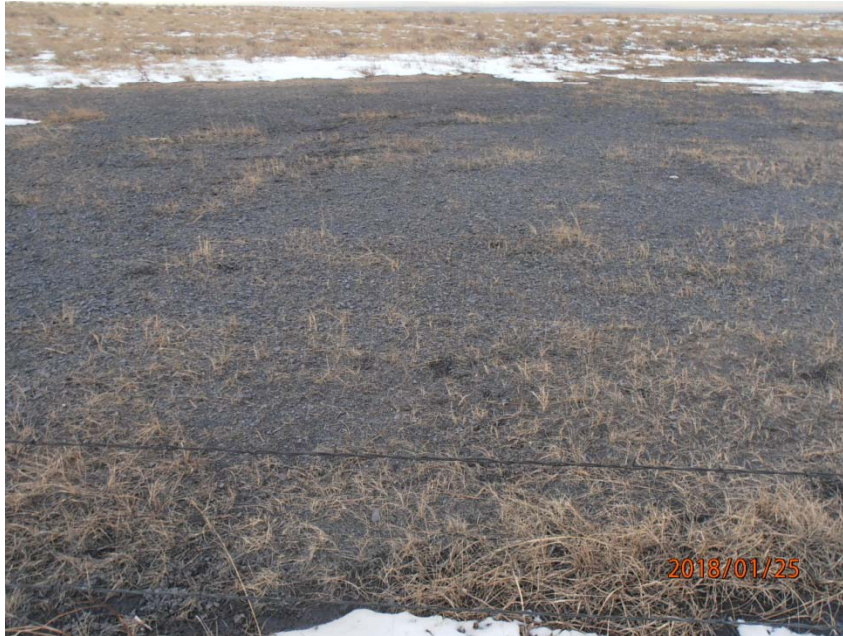
**Photo 16 – Photo looking west across fence at dried drilling mud of spill onto State Land Board land. Spill was reported by Operator and assigned Spill ID #452946.**

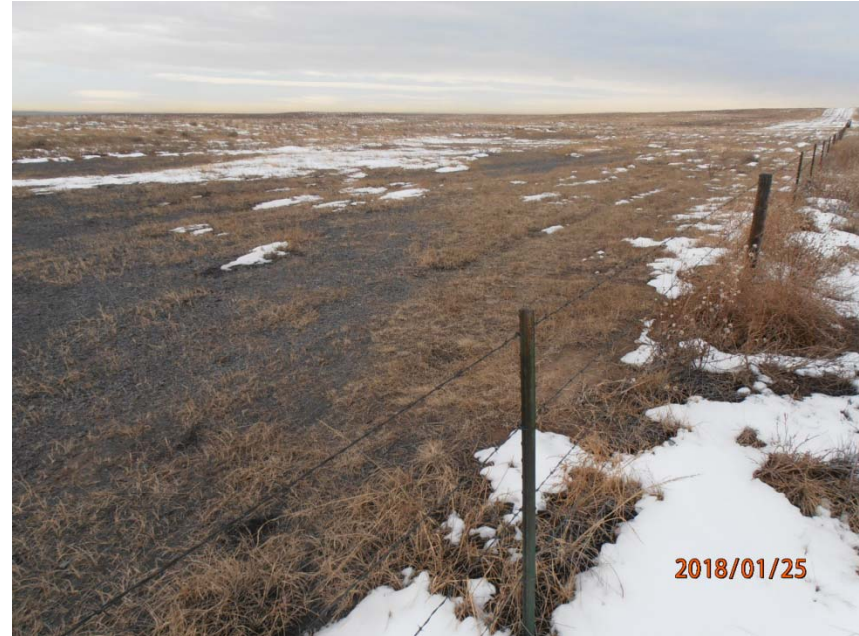
**Photo 17 - Photo looking northwest across fence at dried drilling mud of spill onto State Land Board land. Spill was reported by Operator and assigned Spill ID #452946.**

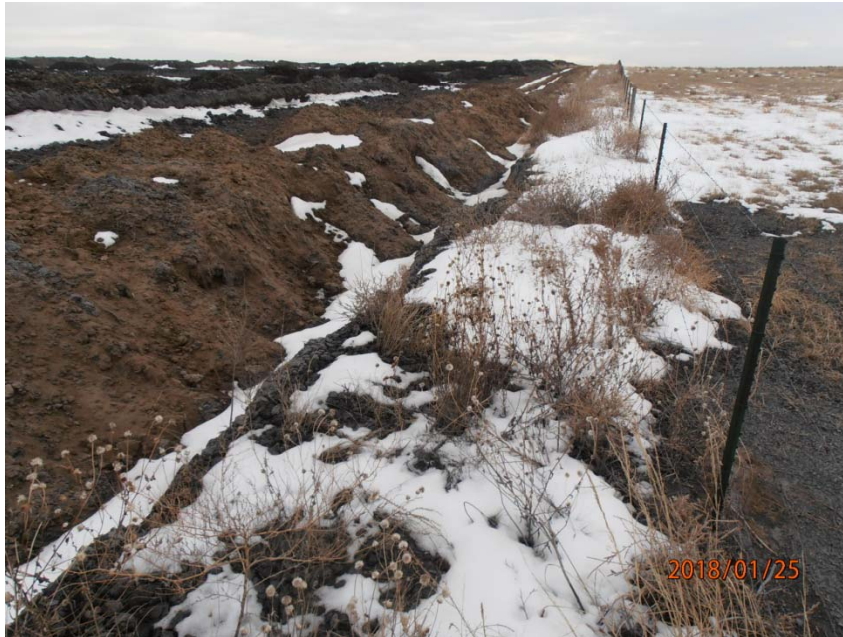
**Photo 18 – Looking south on Sandy Hill Land Application western boundary where spill onto State Land Board land occurred.**

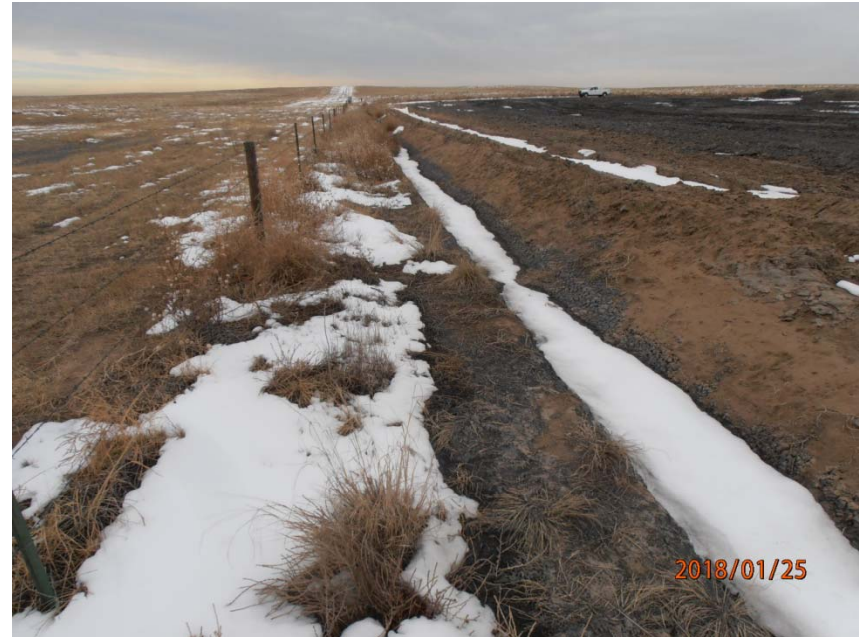
**Photo 19 - Looking north on Sandy Hill Land Application western boundary where spill onto State Land Board land occurred.**
