Inspection Photos

API: 05-067-08089

Operator: WPX

Inspection Number: 680602456

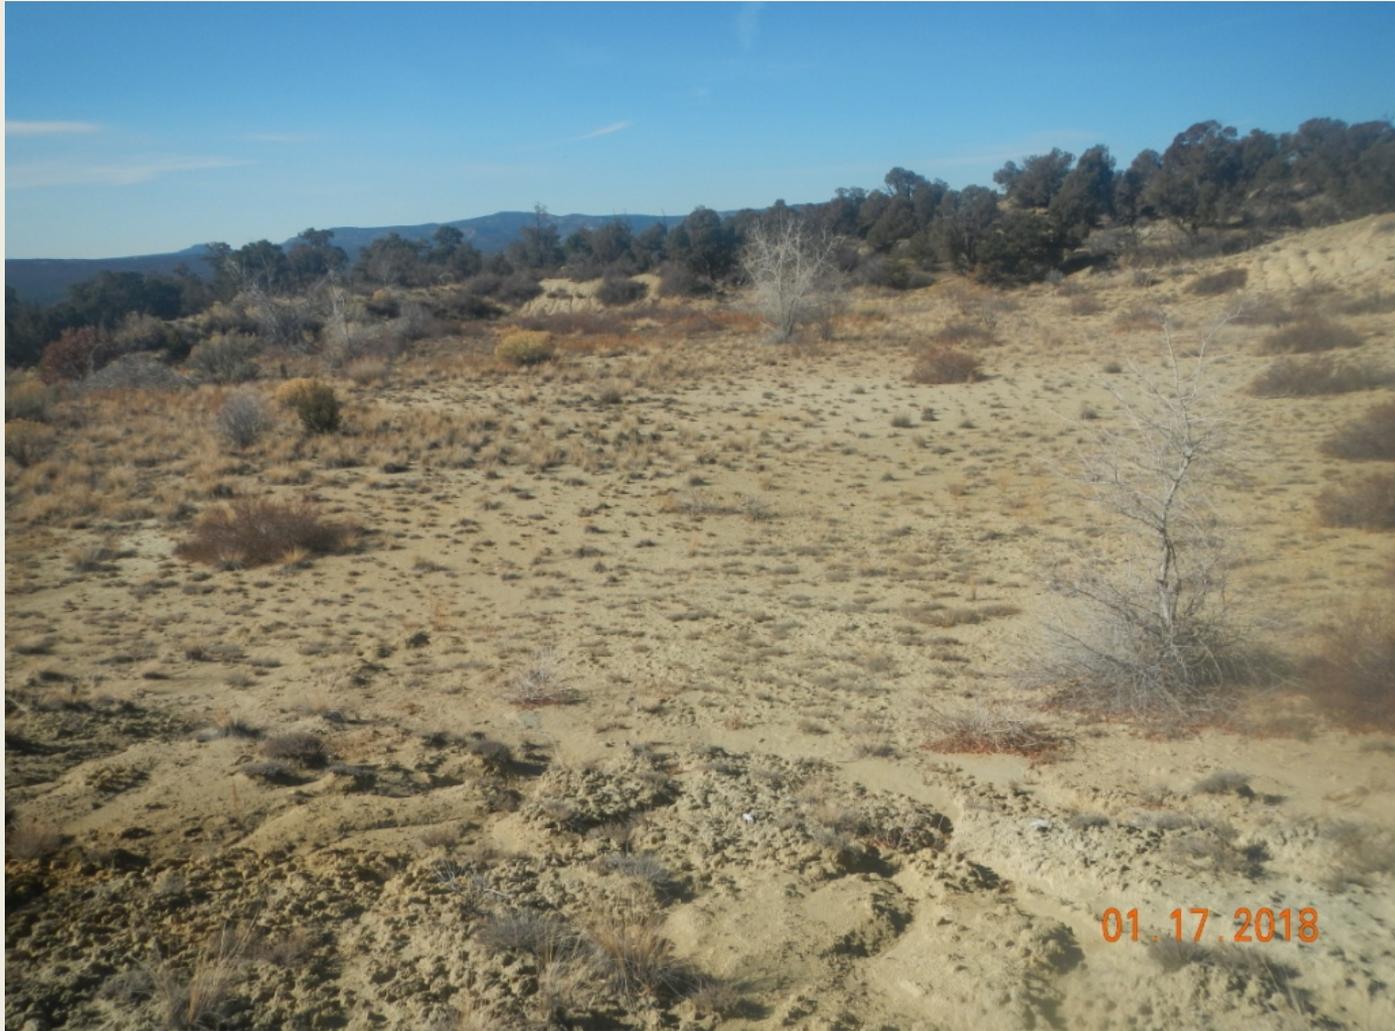
Photo 1. View of the project area from the northeastern edge facing center. Project area is not reclaimed.

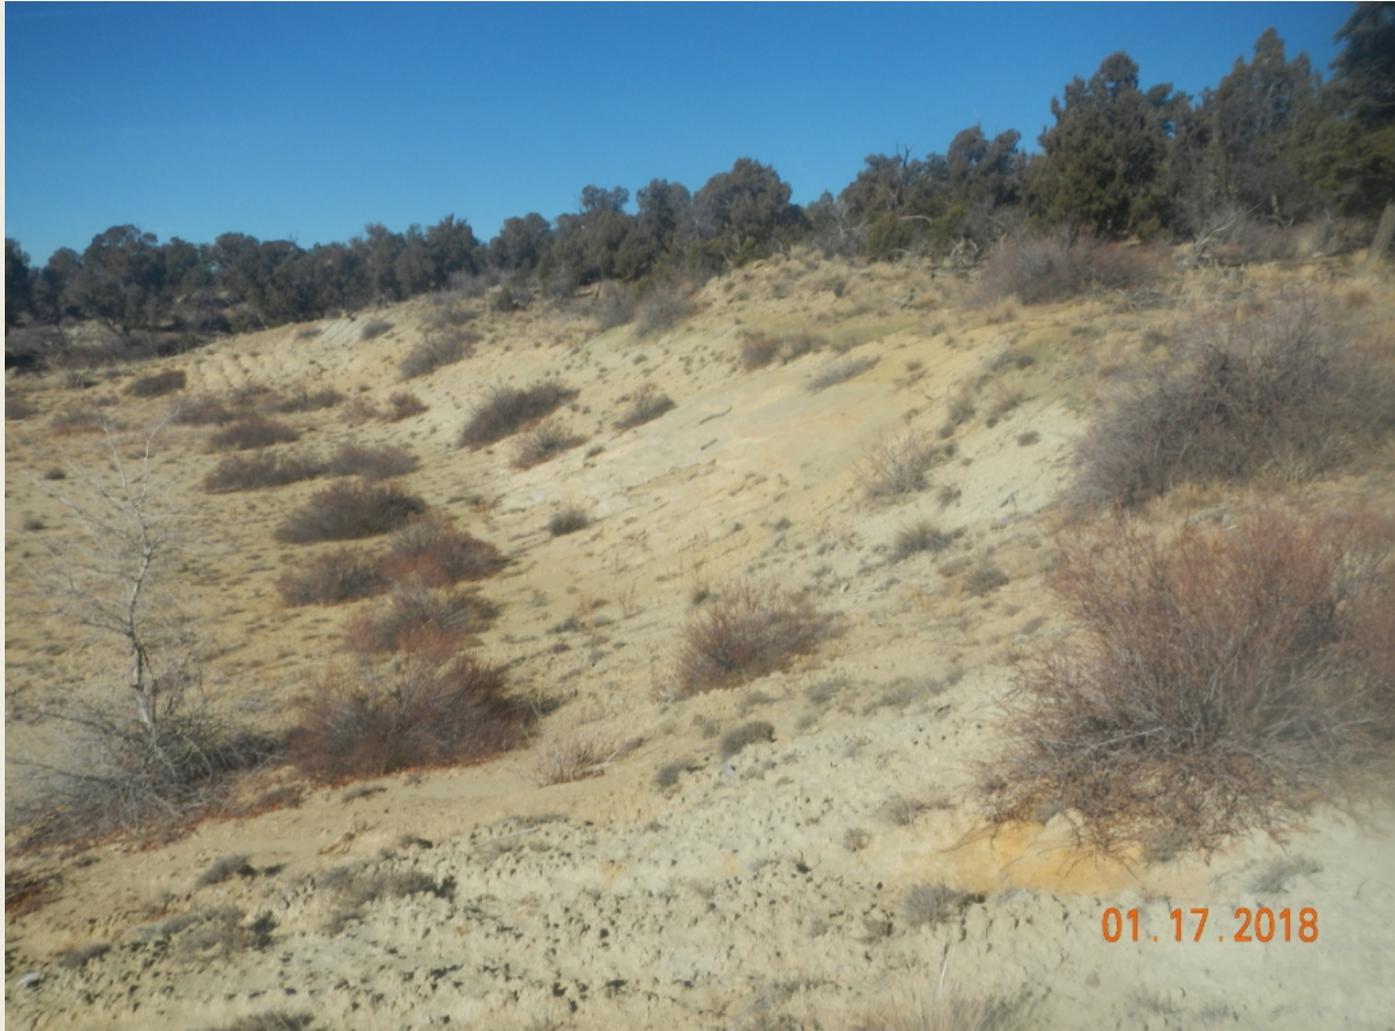
Photo 2. View of the northern portion of the project area from the northeastern edge facing westward.

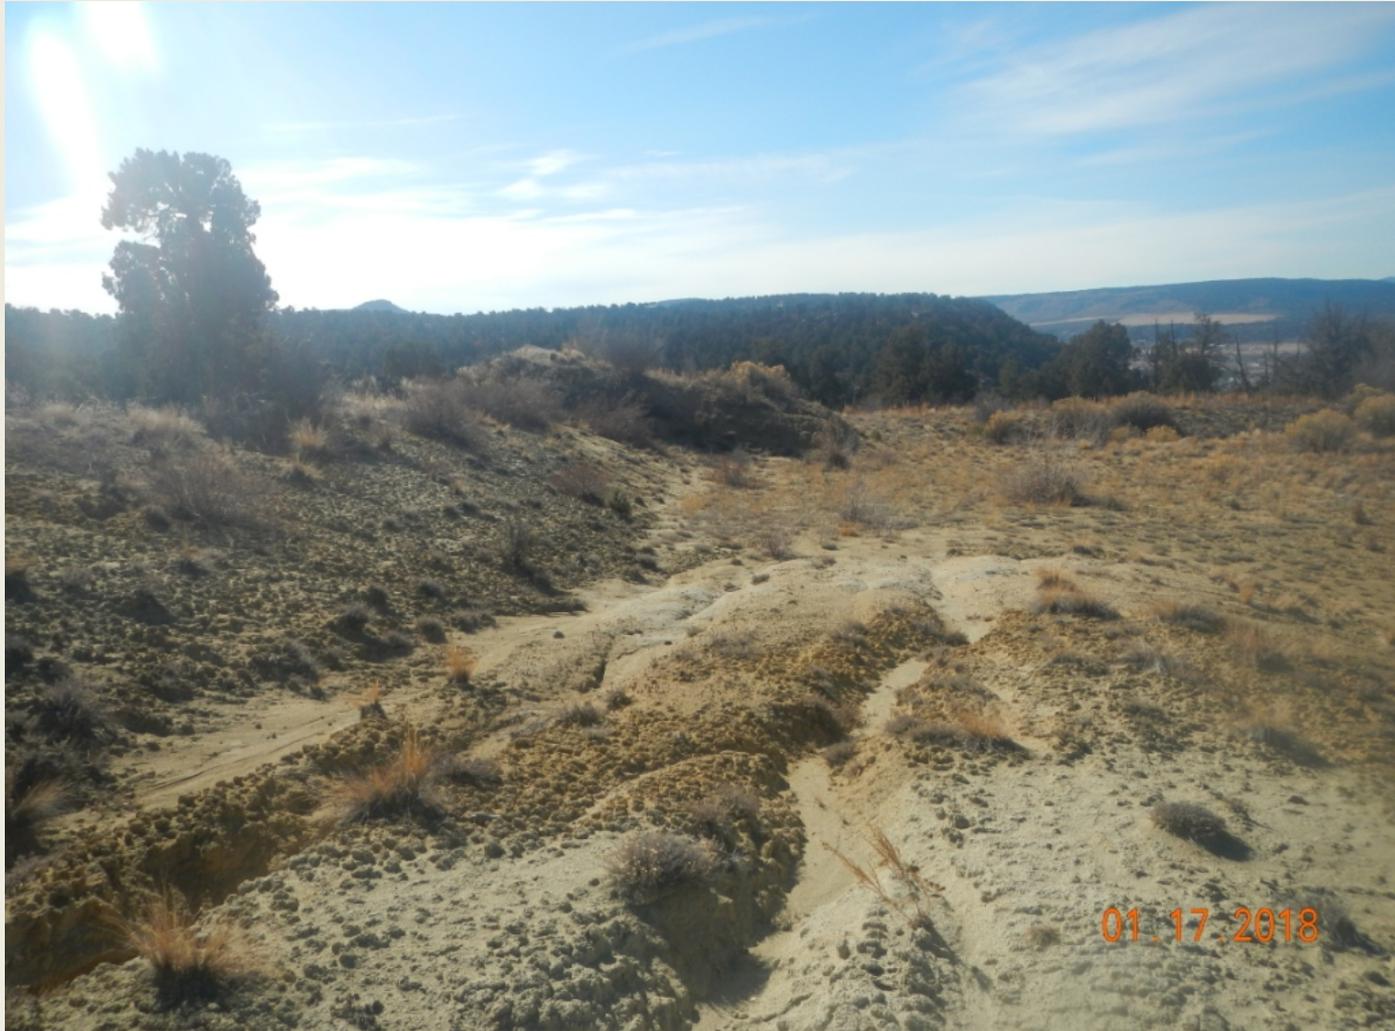
Photo 3. View of the eastern portion of the project area from the access road facing southward.

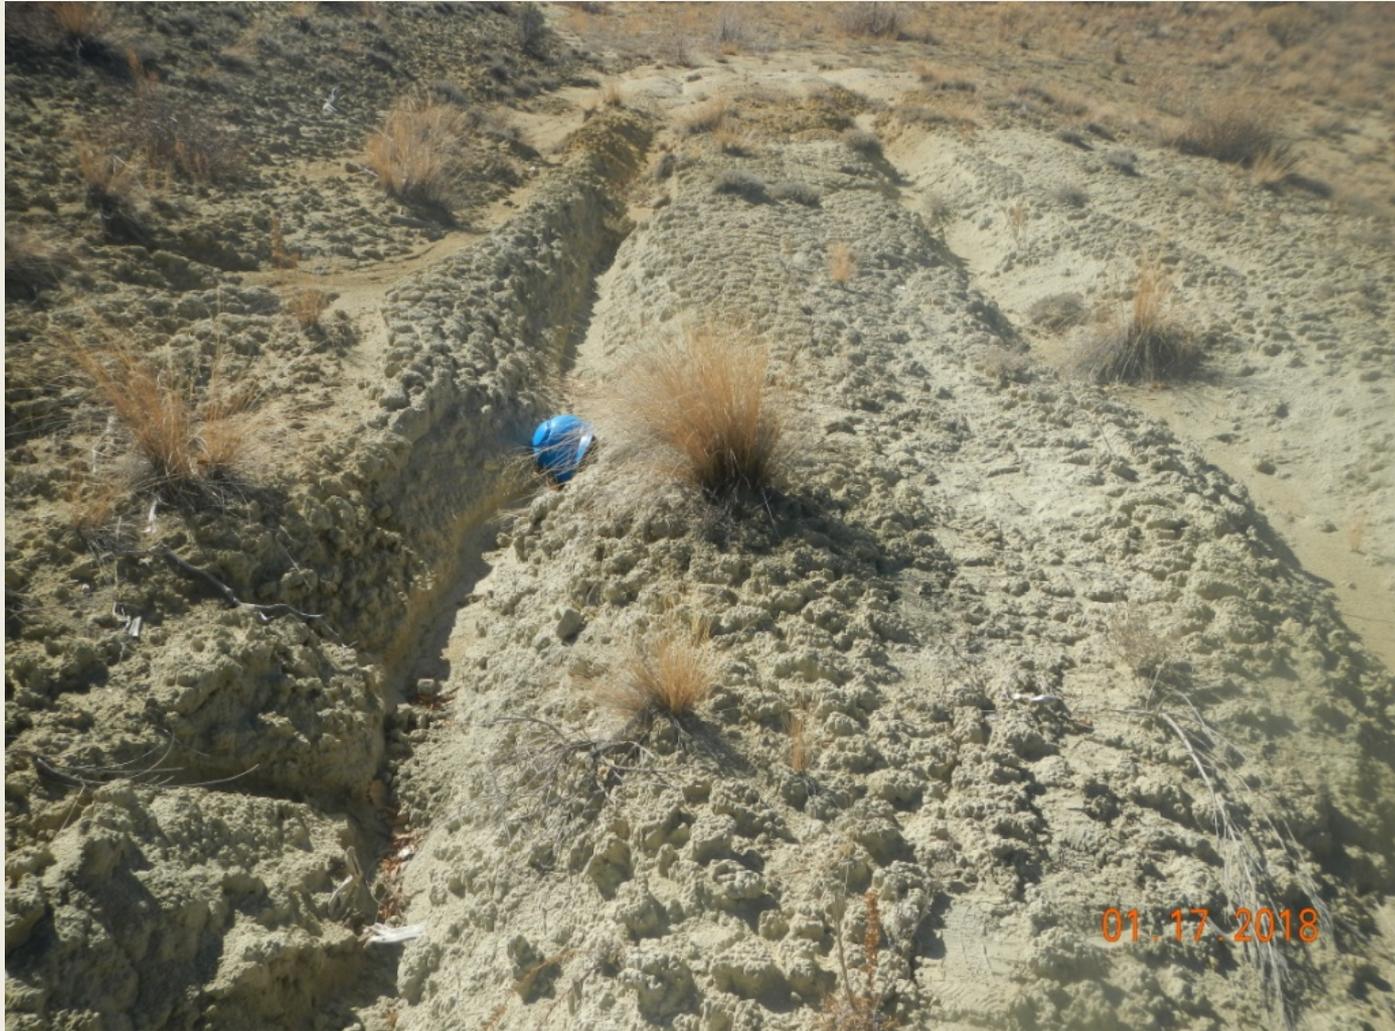
Photo 4. View of erosional pedestaling and channeling (approximately 1.5 feet wide and deep) within the access road.

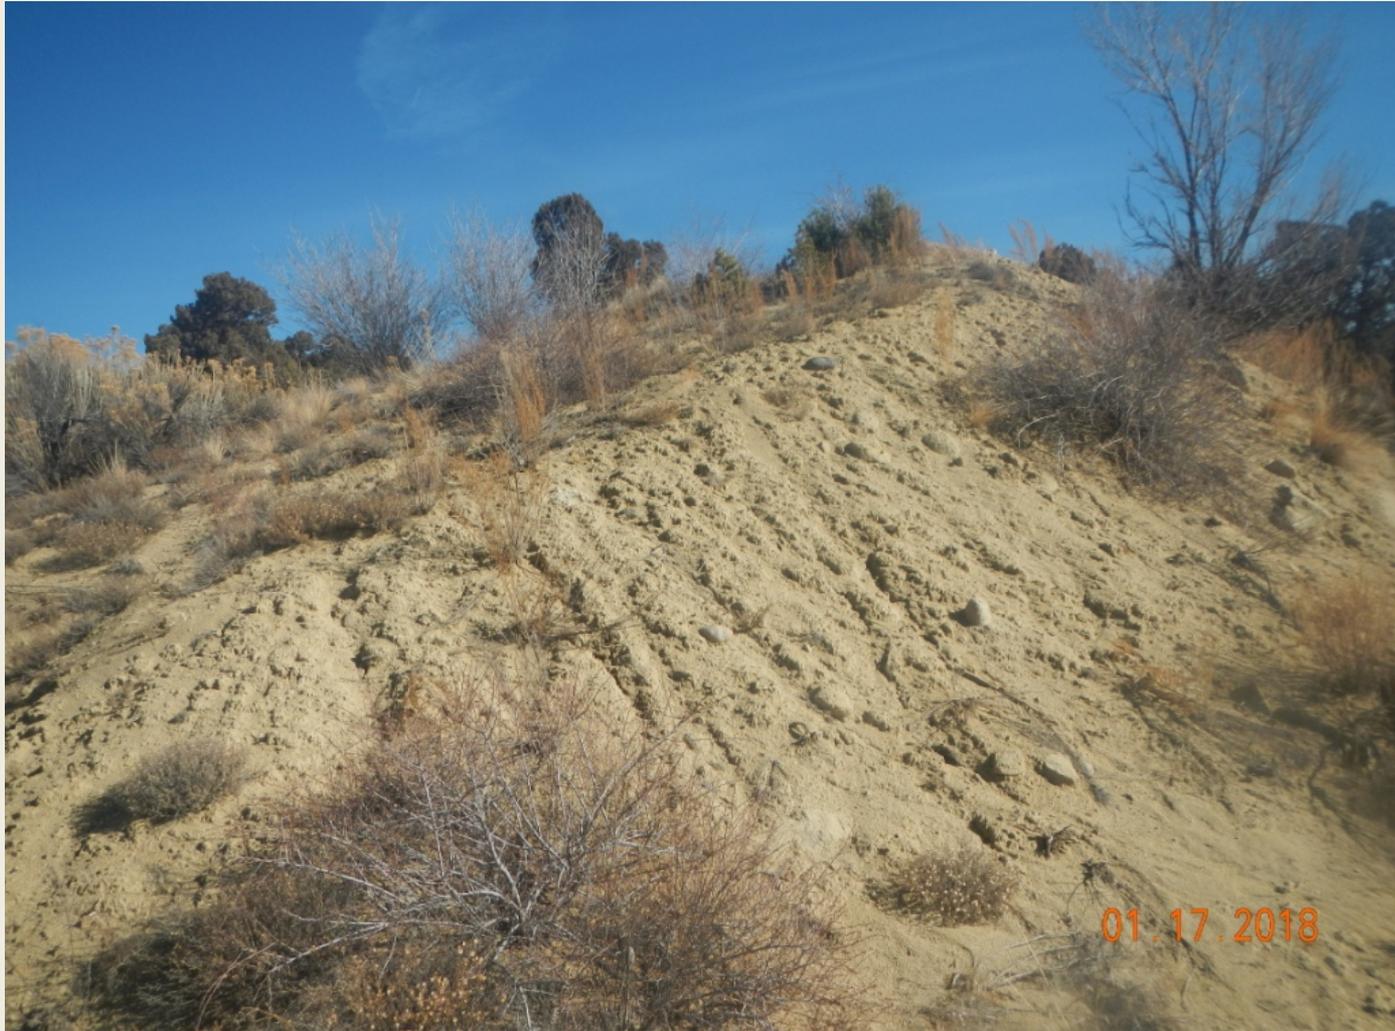
Photo 5. View of soil stockpile approximately 15 feet high in the southeastern portion of the project area.

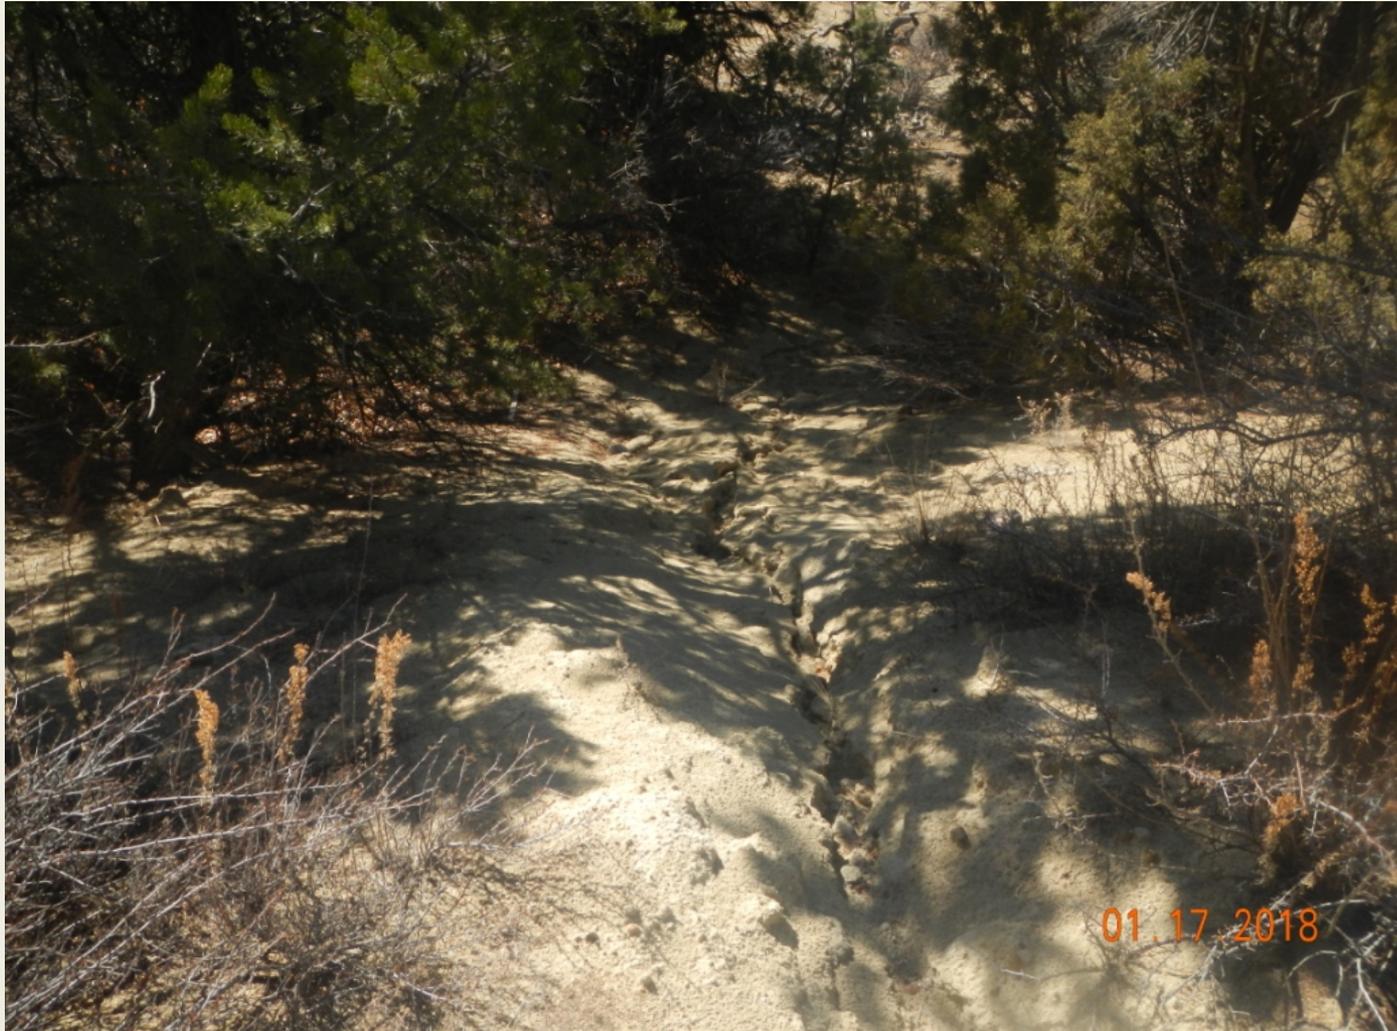
Photo 6. View of erosional channeling in the southern portion of the project area.

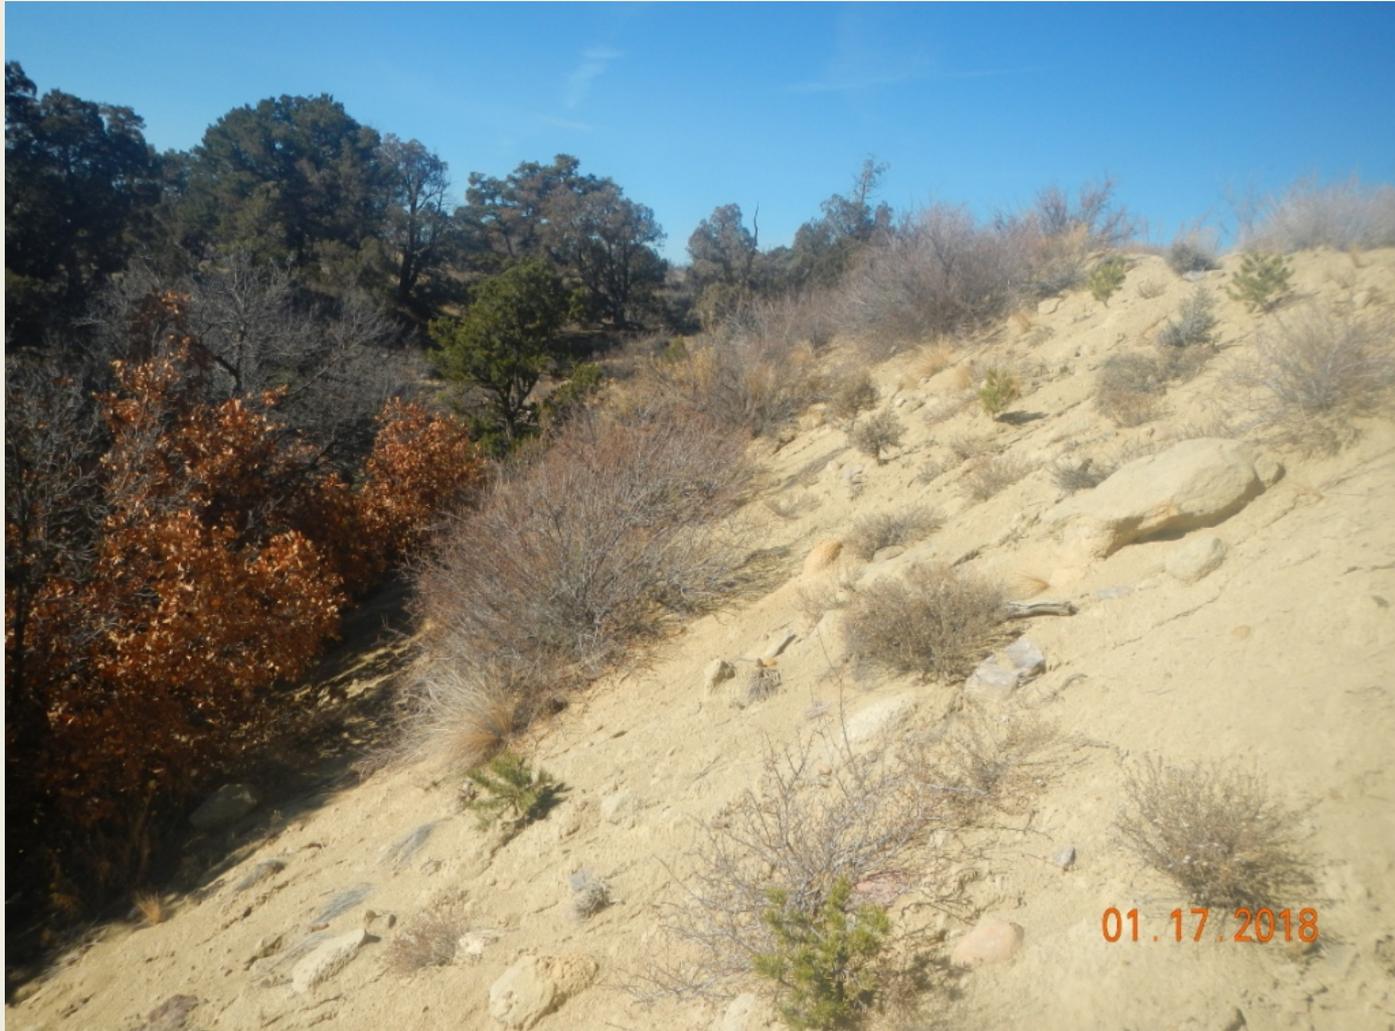
Photo 7. View of fill slope in the southwestern portion of the project area.

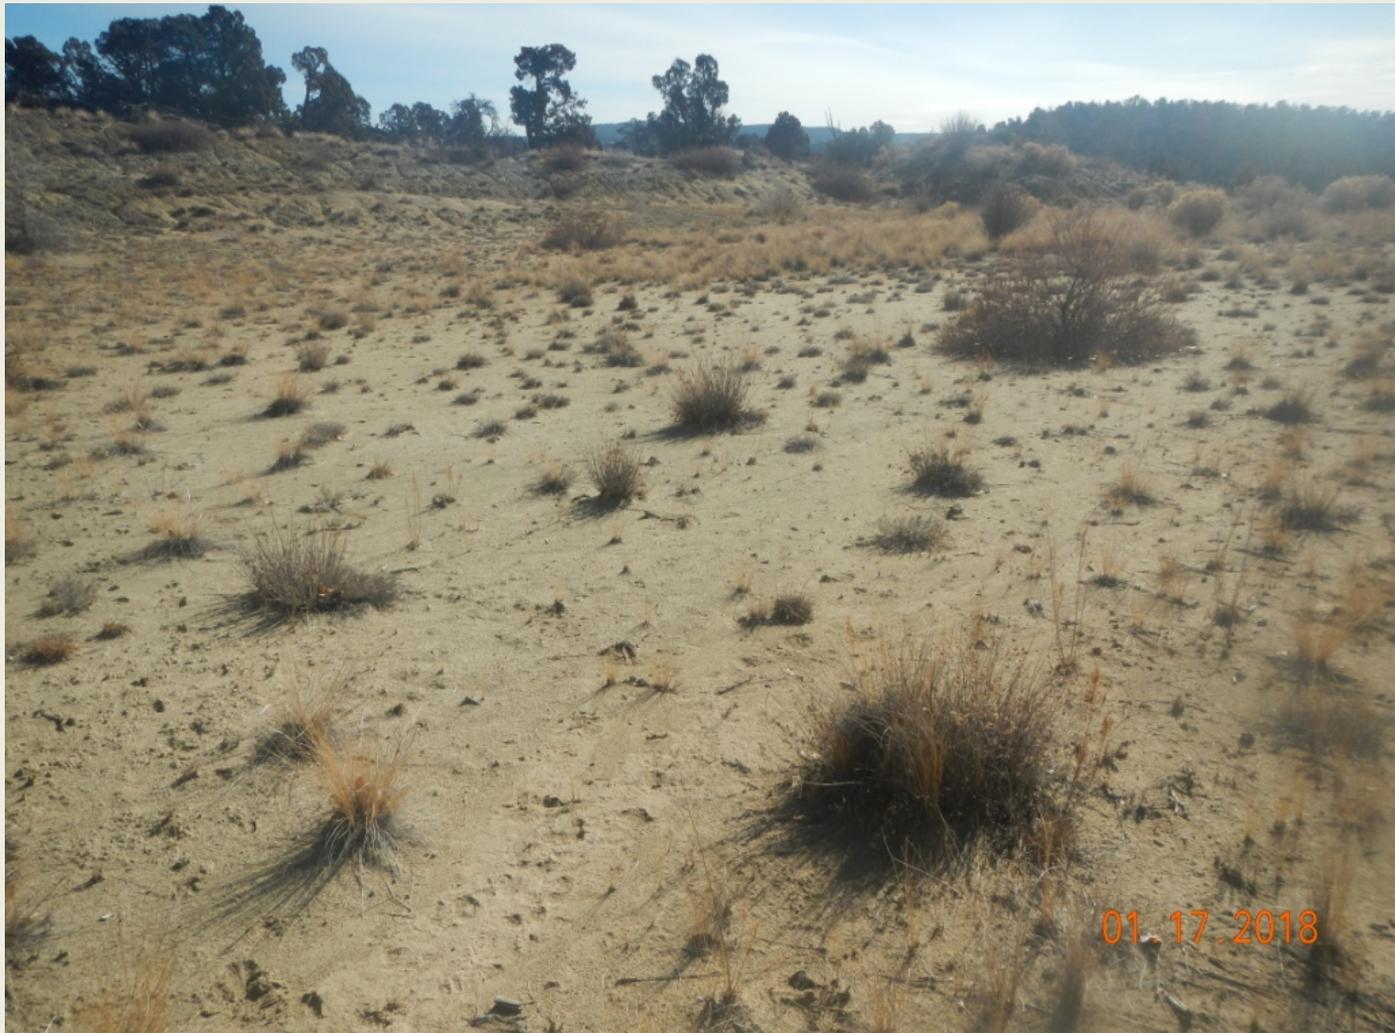
Photo 8. View of flat well pad from the northwestern corner facing center.

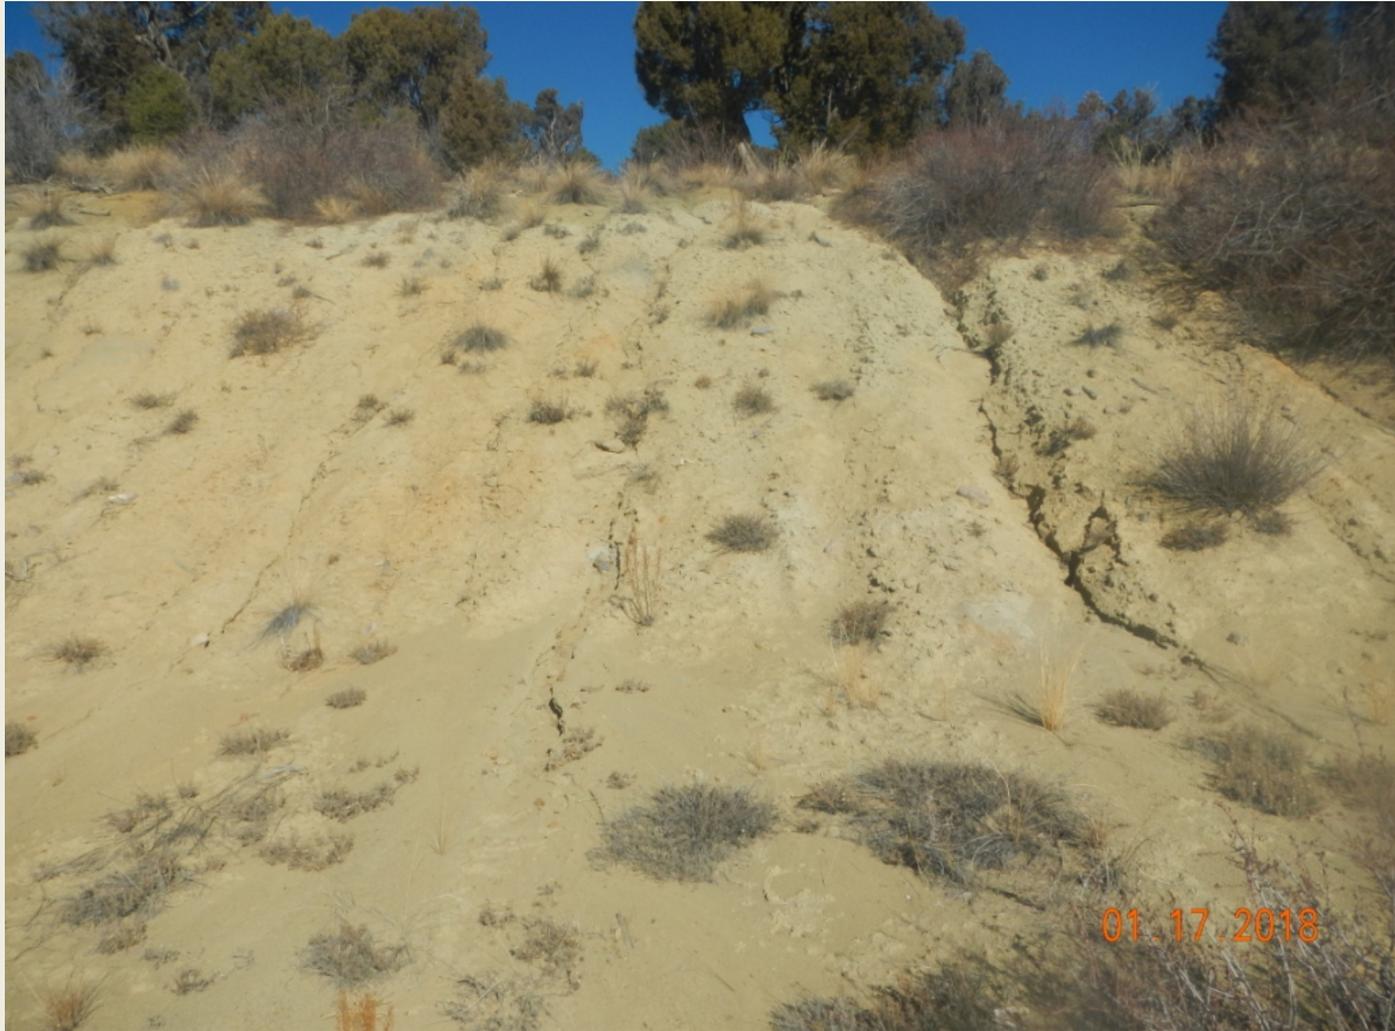
Photo 9. View of erosional channels forming within the northern cut-slope.

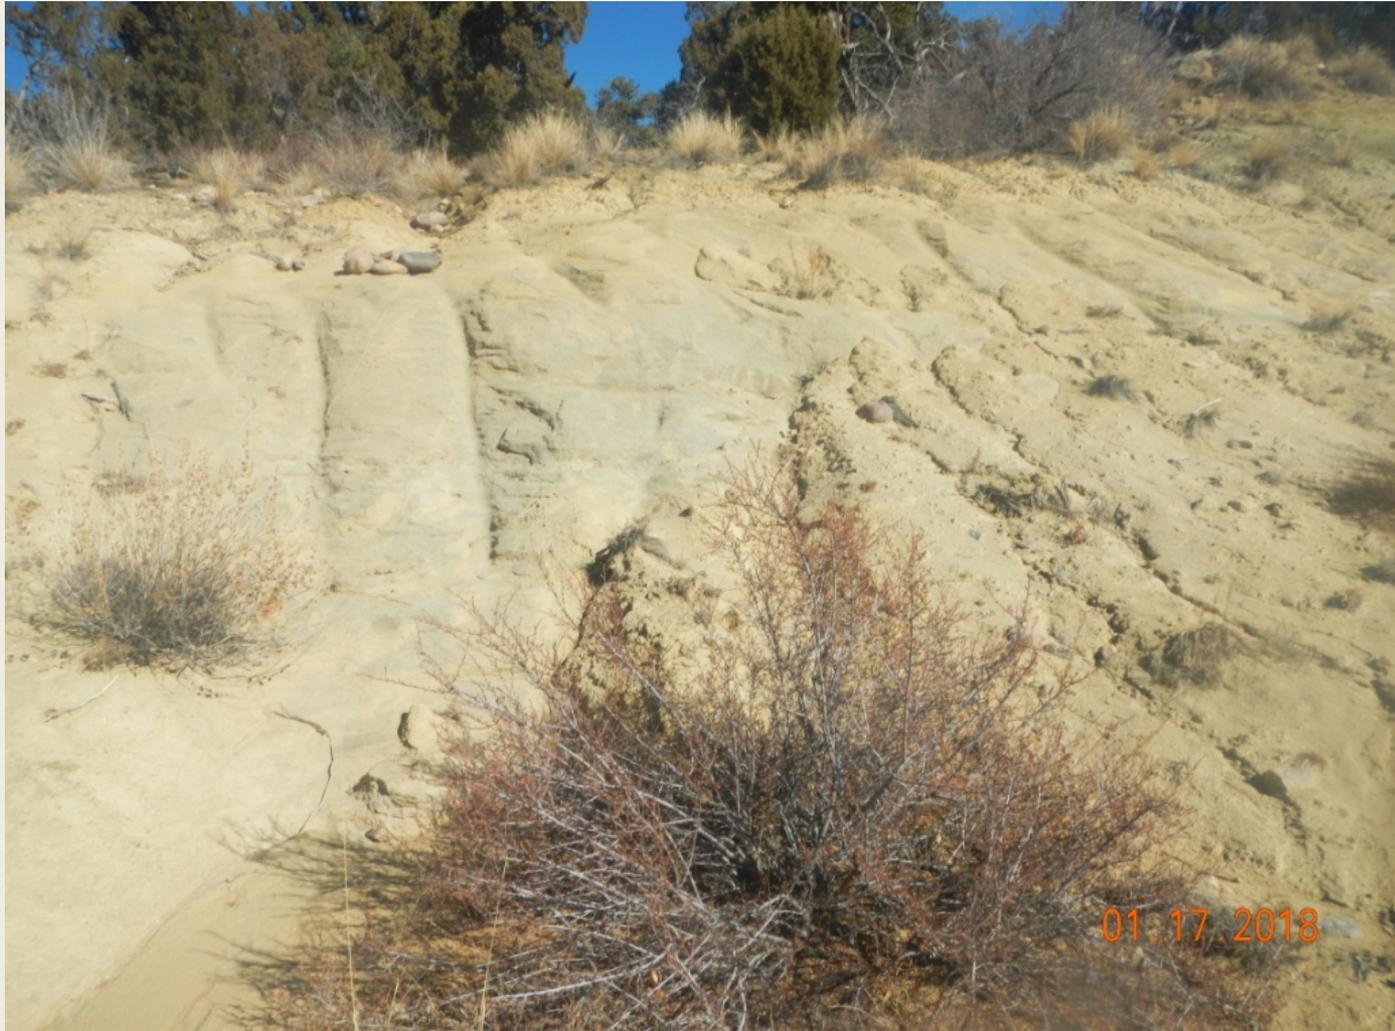
Photo 10. Another view erosional channeling within the northern portion of the project area. Soils have eroded to bedrock in areas.

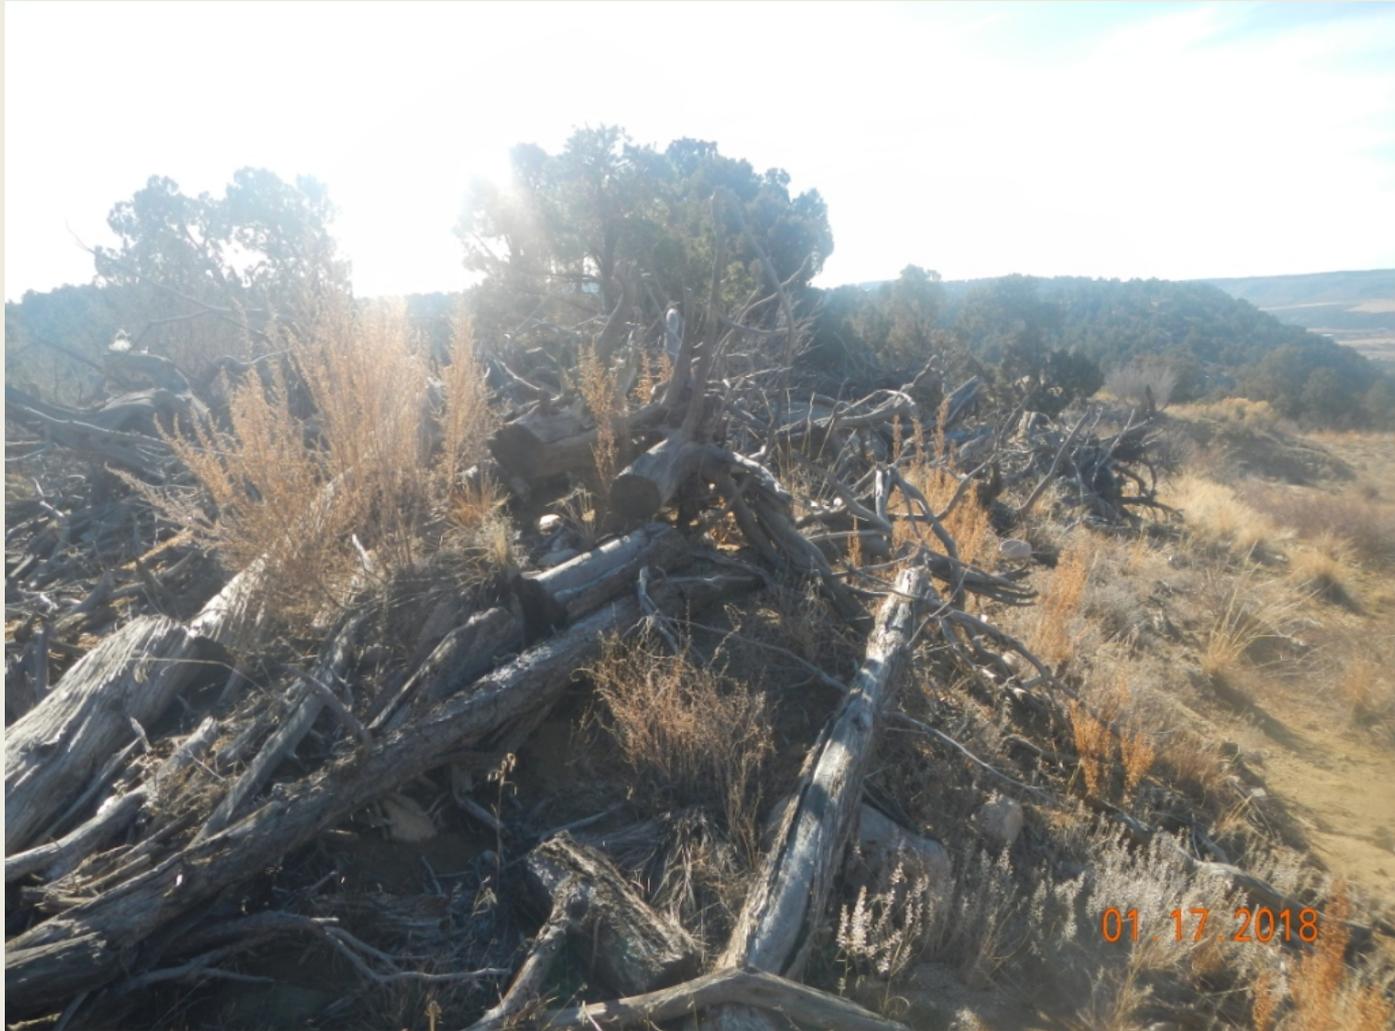
Photo 11. View of wood debris stockpiled along the eastern edge of the project area.
