Inspection Photos

API: 05-067-08485

Operator: HILCORP ENERGY COMPANY

Inspection Number: 680602458

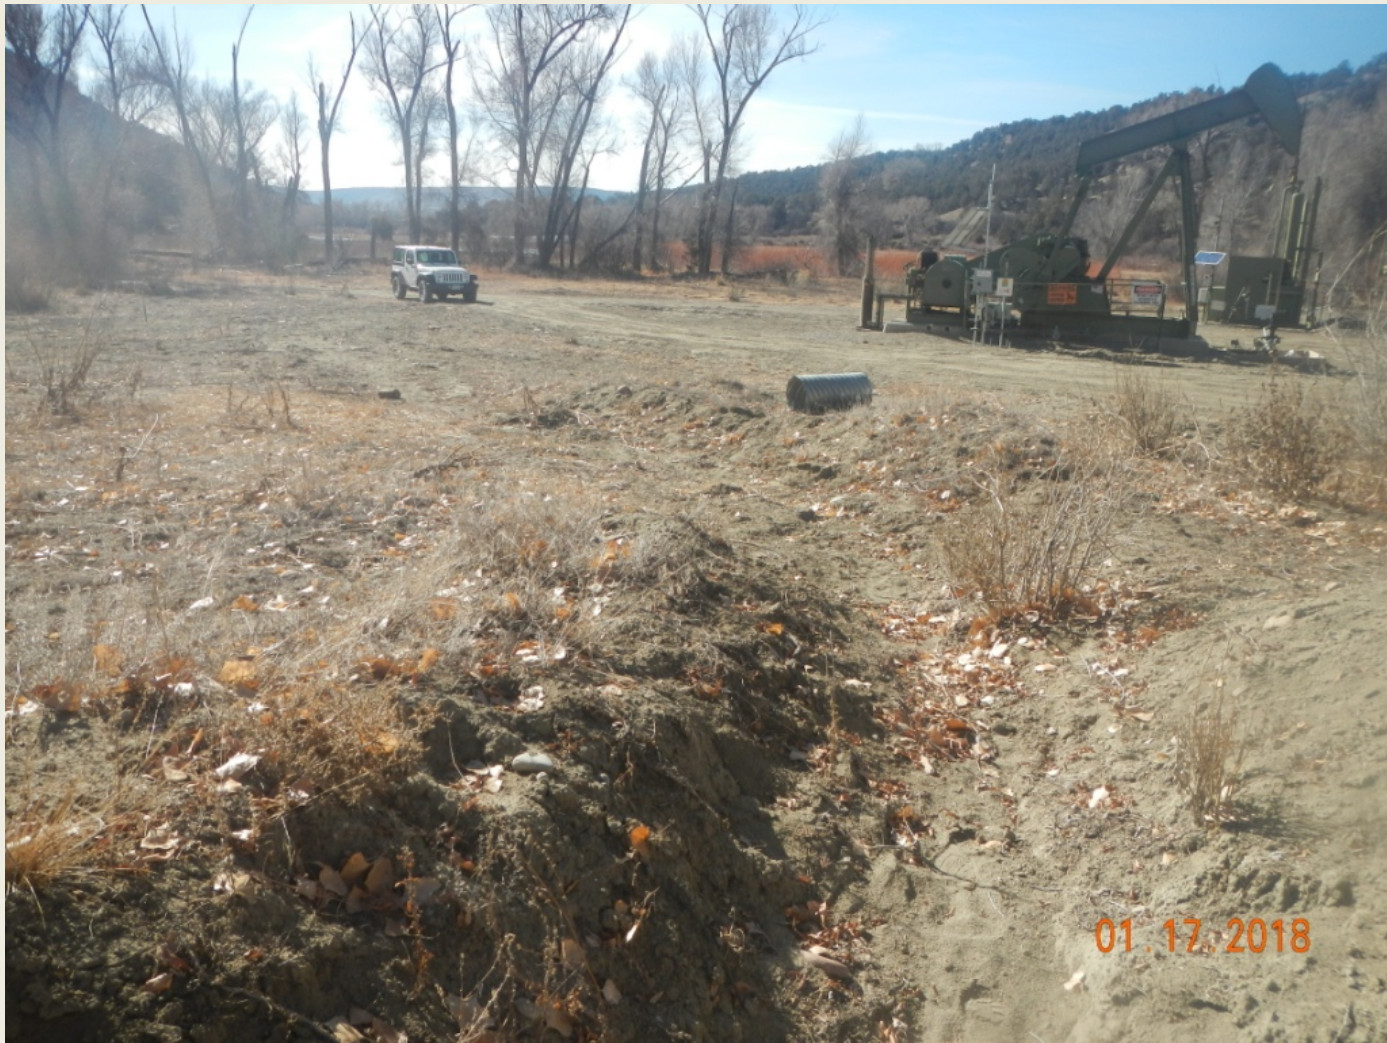
Photo 1. View of the project area from the northern corner facing center.

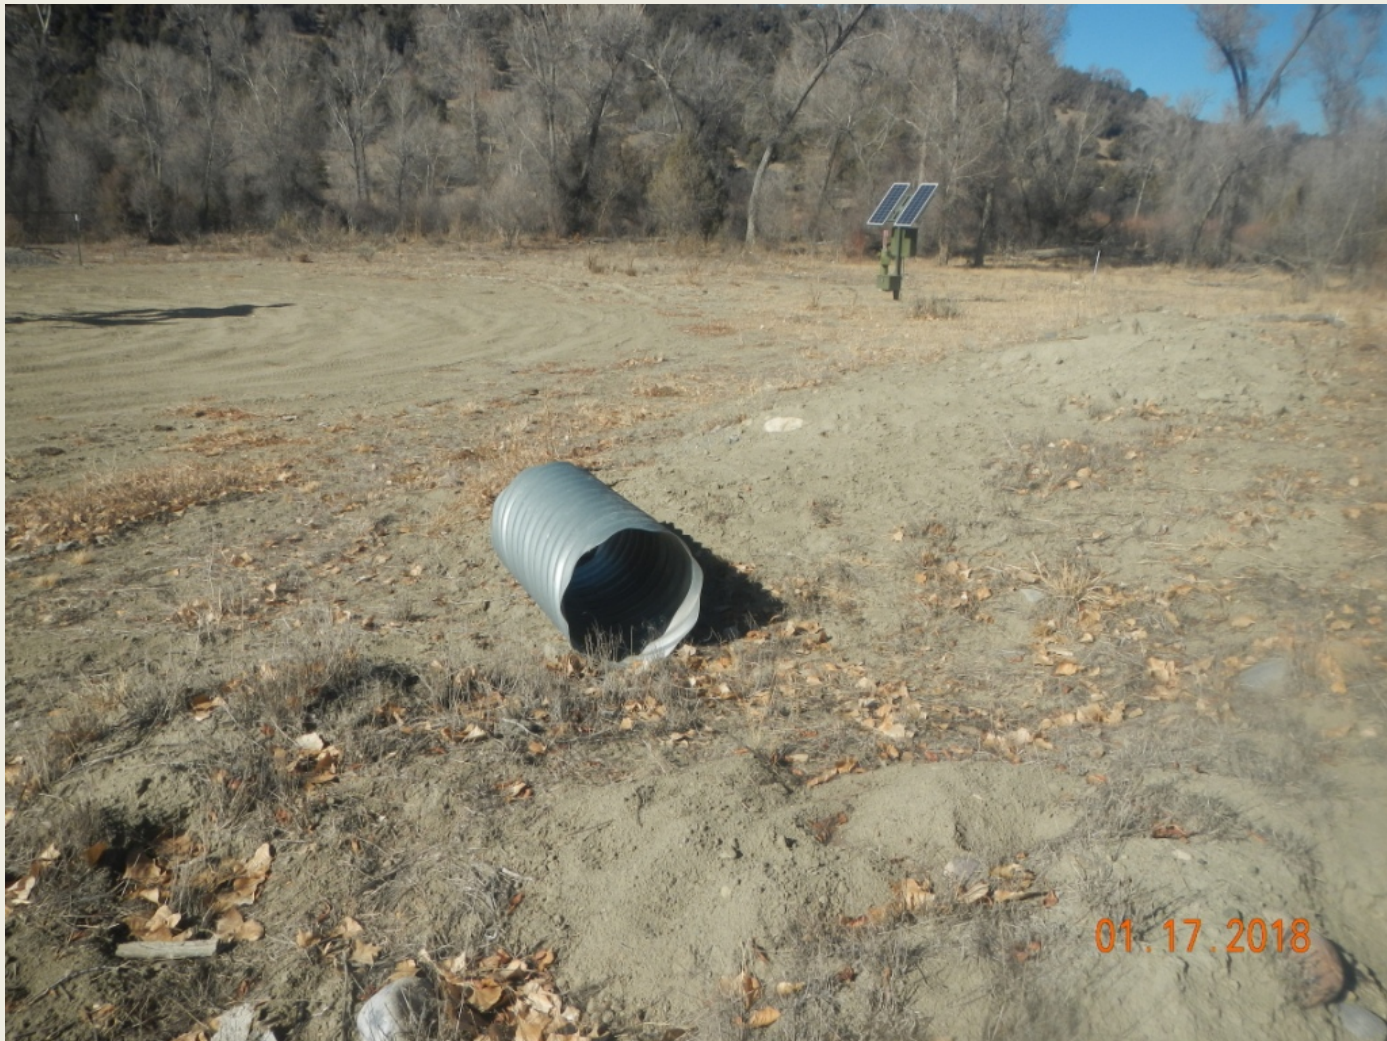
Photo 2. View of the northern portion of the project area from the northeastern edge facing westward. Culvert needs to be removed.

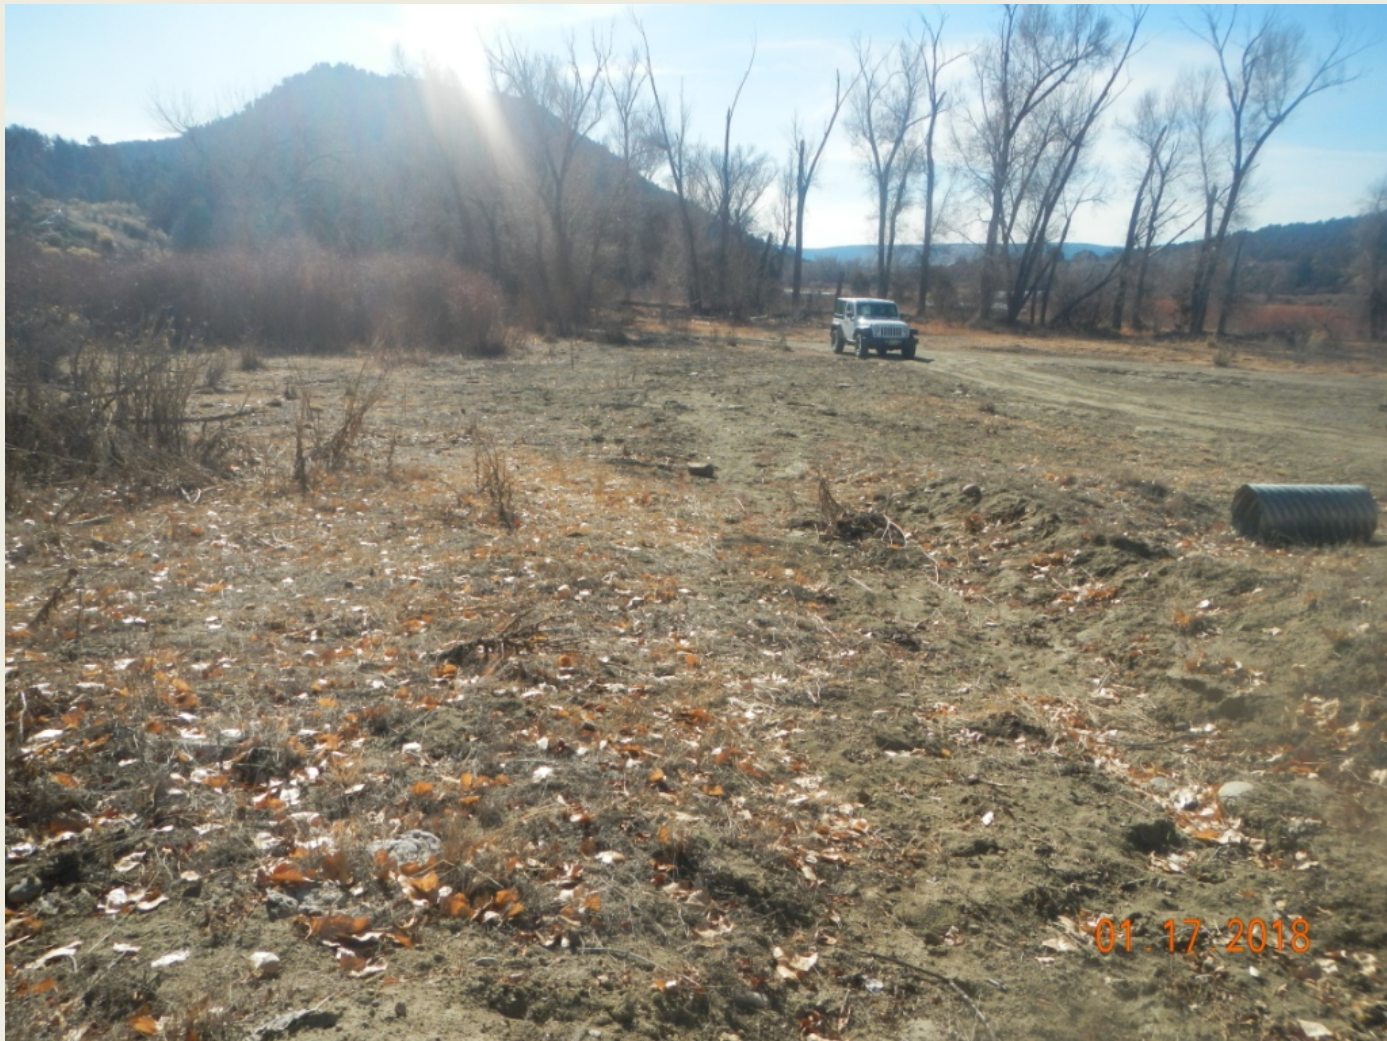
Photo 3. View of the northeastern portion of the project area from northern corner facing southward.

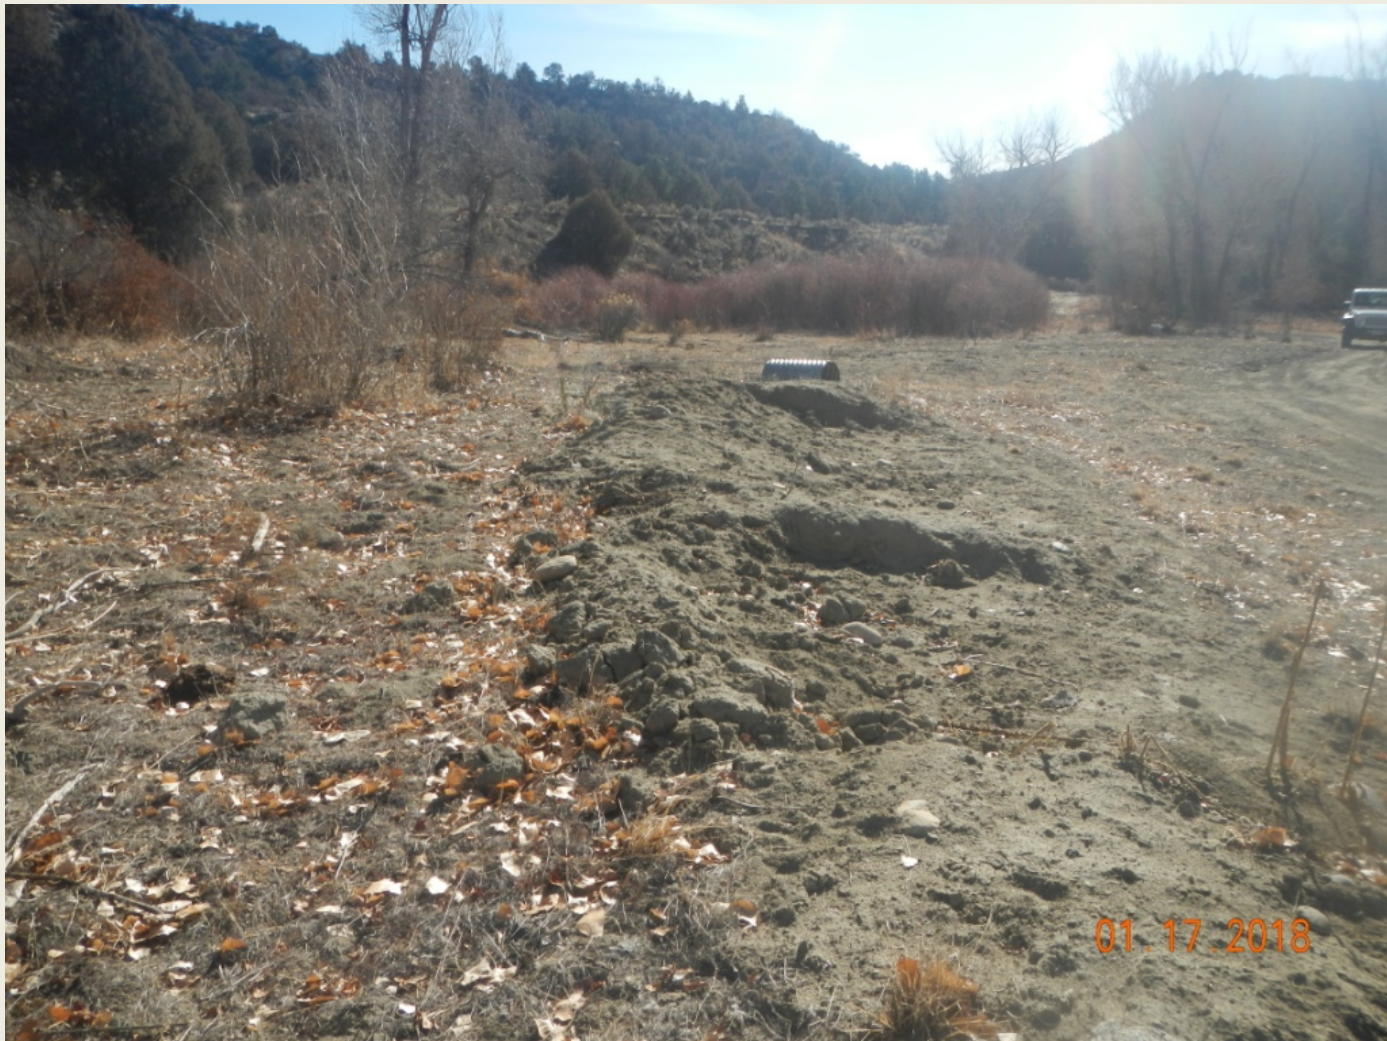
Photo 4. View sediment piles in the eastern portion of the project area. Sediment needs to be contained to prevent run-off and run-on.

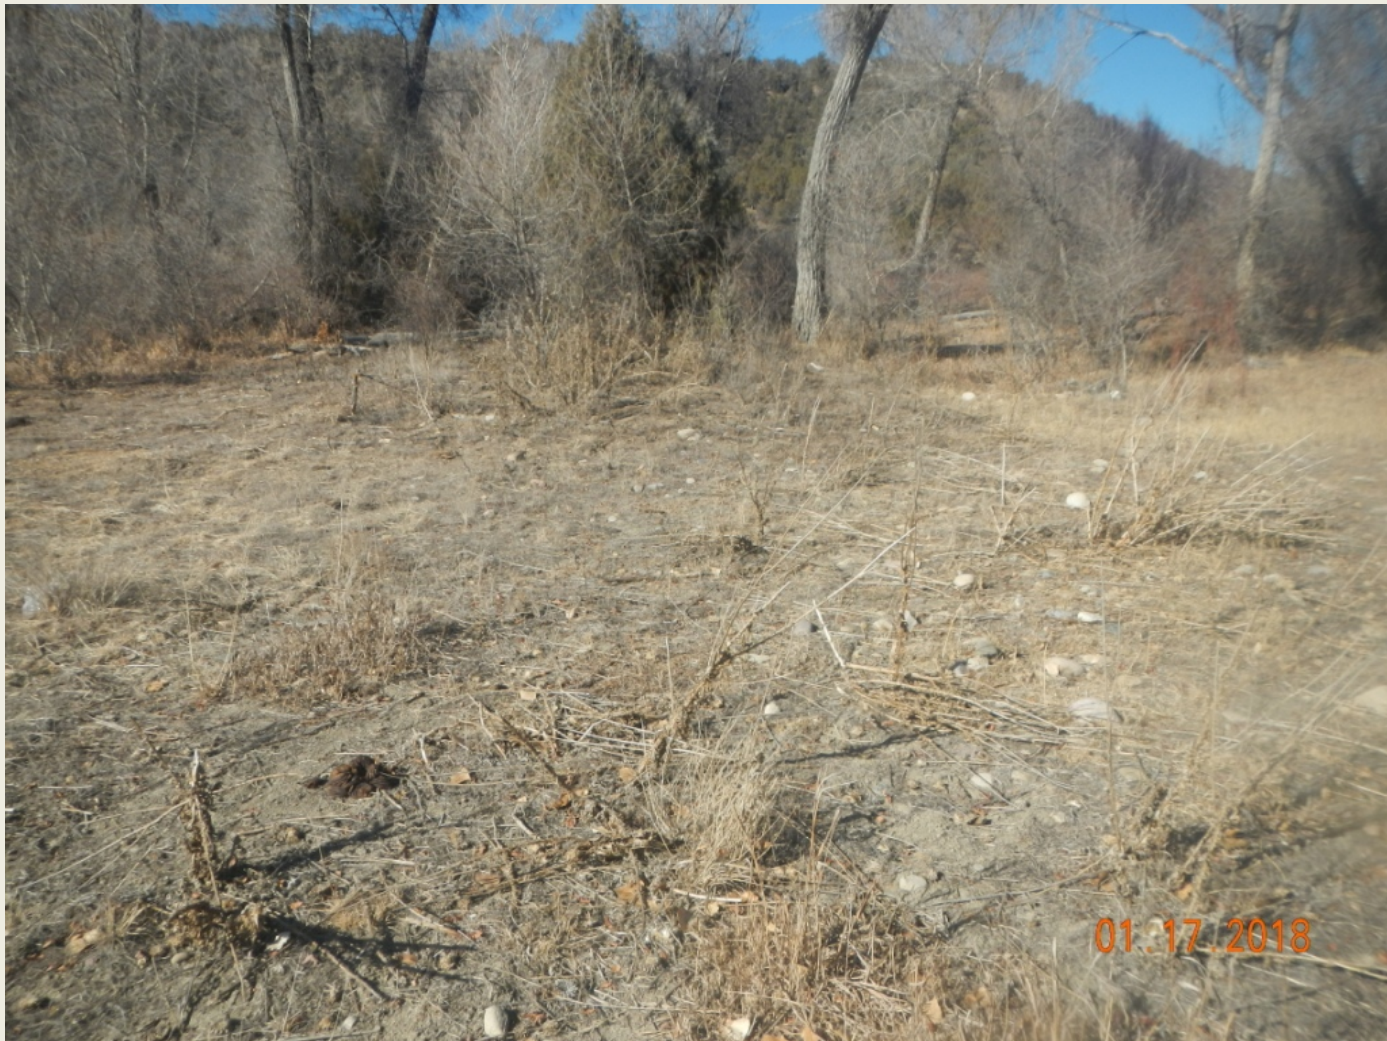
Photo 5. View of musk thistles (*Carduus nutans*) in the northern portion of the project area. Approximately 200 individuals identified on location.

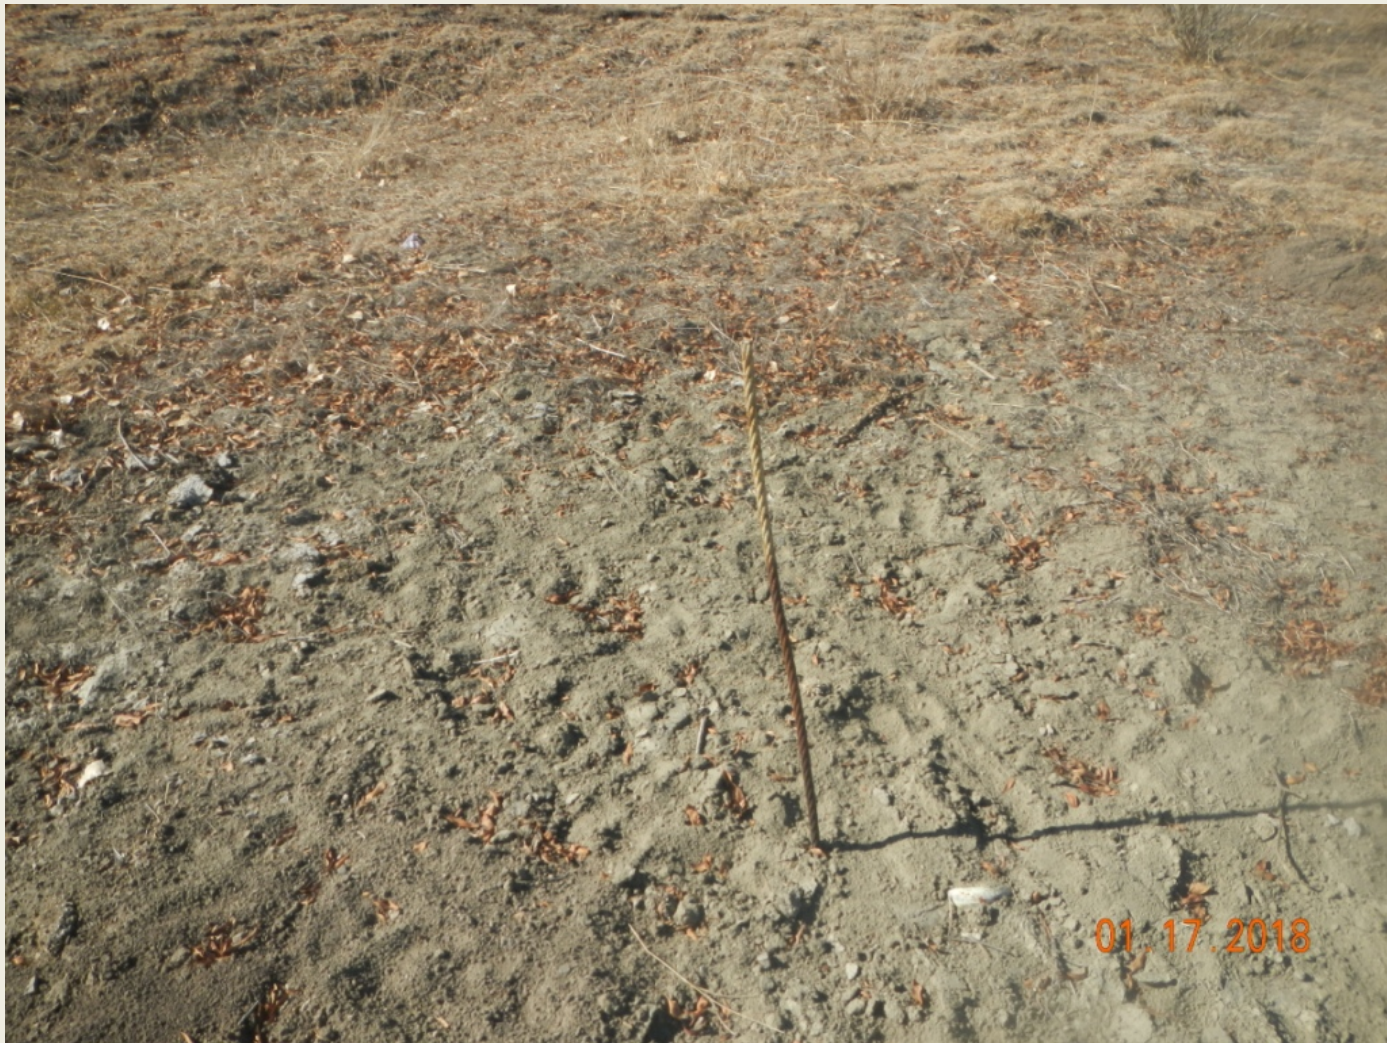
Photo 6. View of anchor cable in the southern portion of the project area.
