# Inspection Photos

Operator: CASCADE PETROLEUM LLC - 10414

Location ID: 439341

Inspection Doc. Number: 682503104

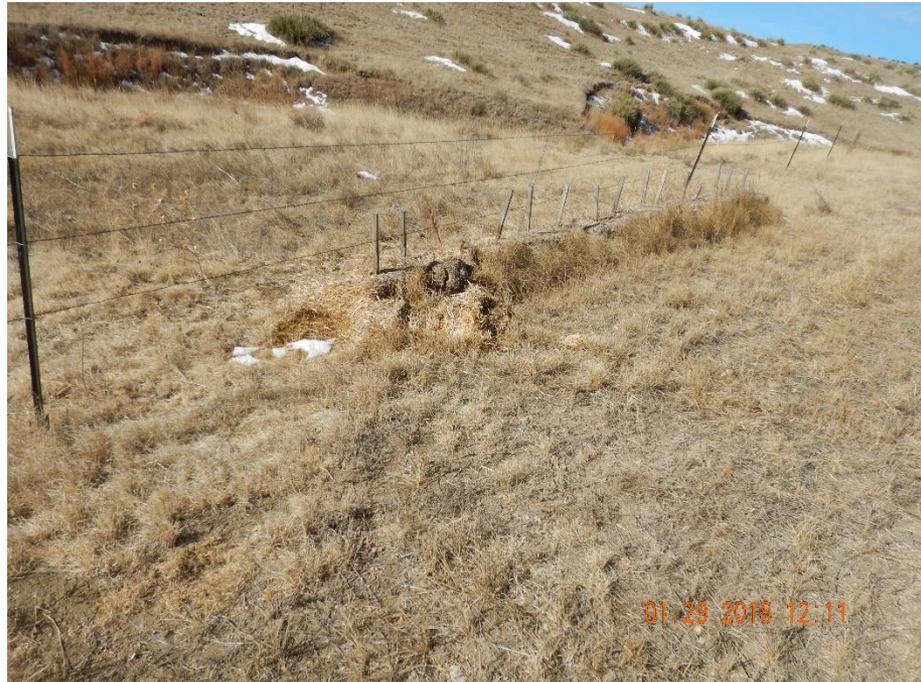
**Photo 1:** Photo taken from the south end of the location, facing west. Inspection #682502556 required operator to install or repair stormwater and sediment control BMP's on location. Photo shows hay-bale ponding BMP that has not been maintained or repaired, and is not in proper functioning condition. In accordance to good engineering practices, bale and straw wattle BMPs need to be trenched with ends tightly abutted, and backfilled on the up-gradient side and compact. Bales seen here have not been trenched.

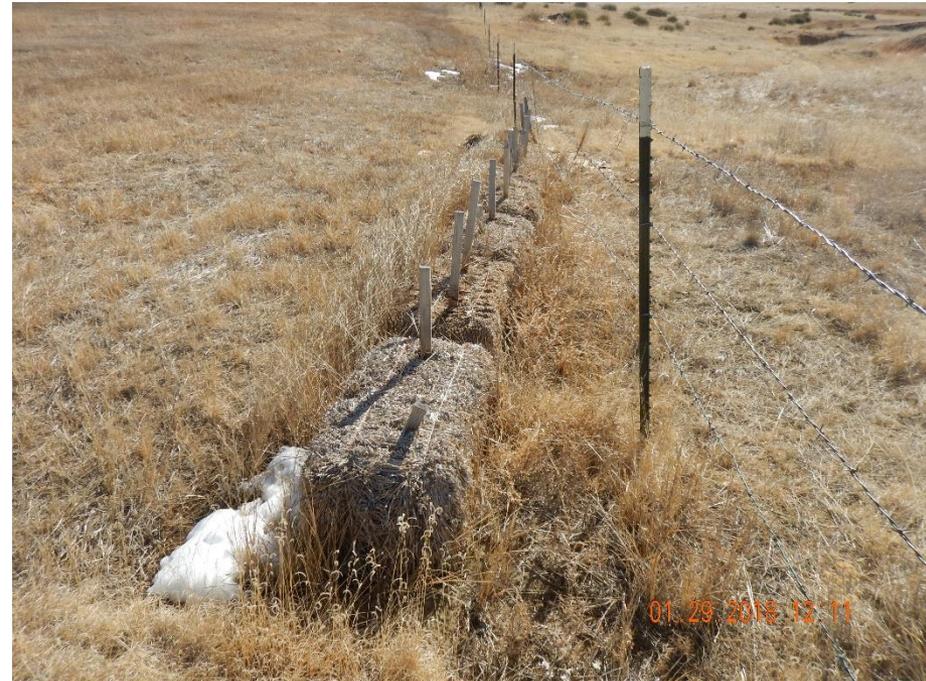
**Photo 2:** Photo taken from the west end of the hay-bale ponding BMP seen in photo 1. See comments under photo 1.

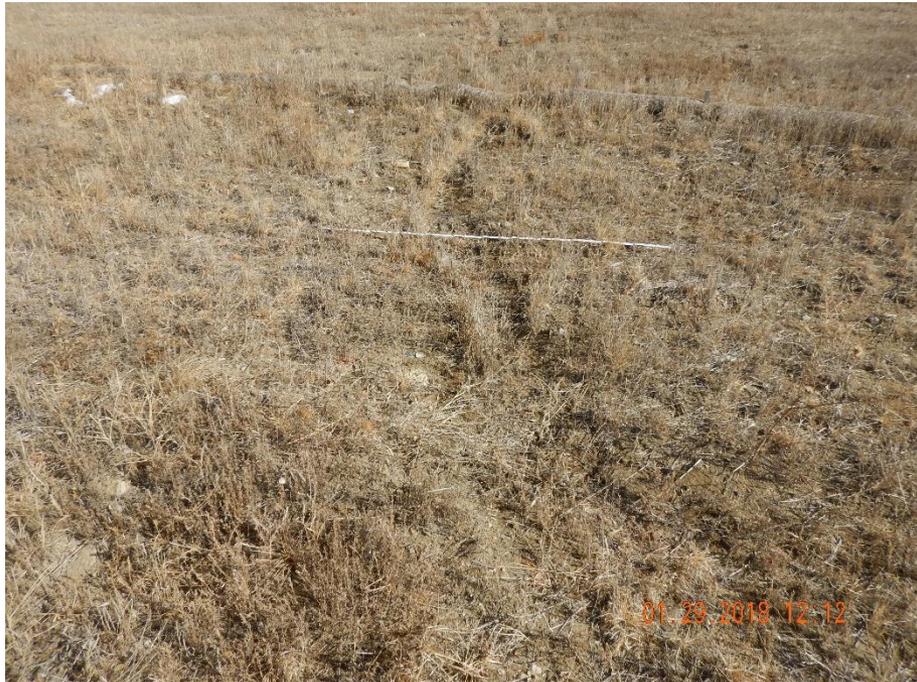
**Photo 3:** Photo taken from the southwest end of the location, facing north. Previous inspections required operator to repair erosion and Install or repair required BMPs Photo shows areas where erosion degradation has not been repaired. Additional stormwater degradation since previous inspection is evident. 6 foot measuring stick for reference.

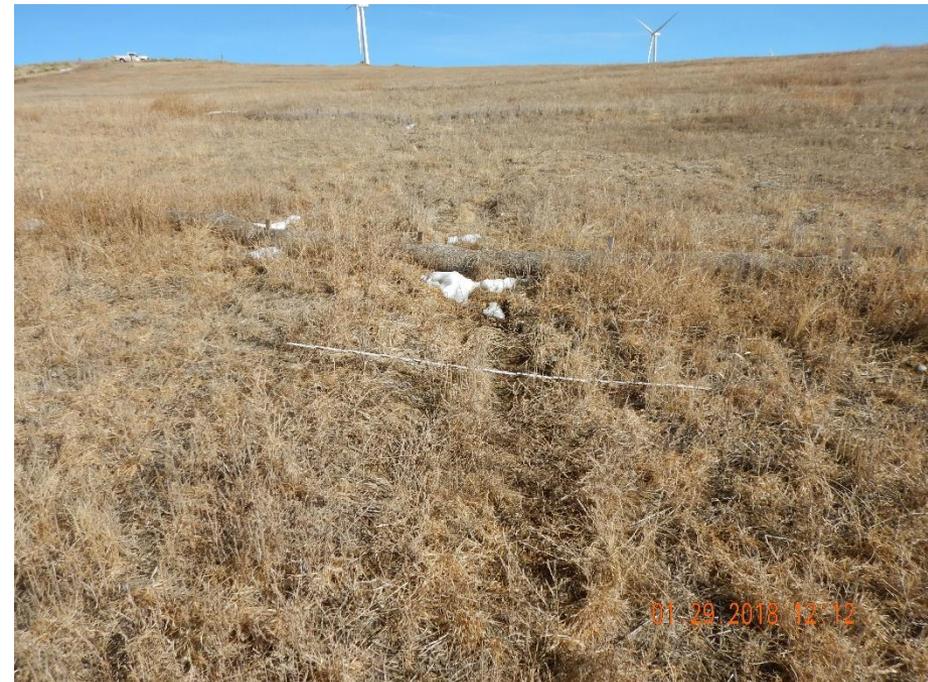
**Photo 4:** Photo taken from the southwest end of the location, facing north. Photo shows erosion remains evident, and stormwater and sediment control BMP has not been maintained per corrective actions. Stormwater has continued to cut under the wattle with additional degradation since previous inspection evident. 6 foot measuring stick for reference.

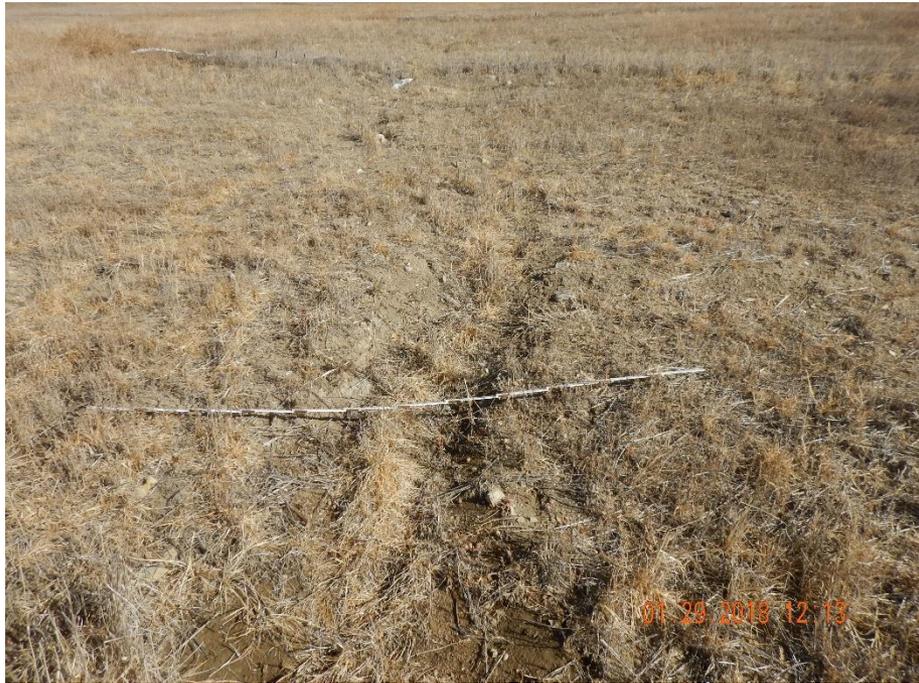
**Photo 5:** Photo of gully formation and erosion degradation. 6 foot measuring stick for reference.

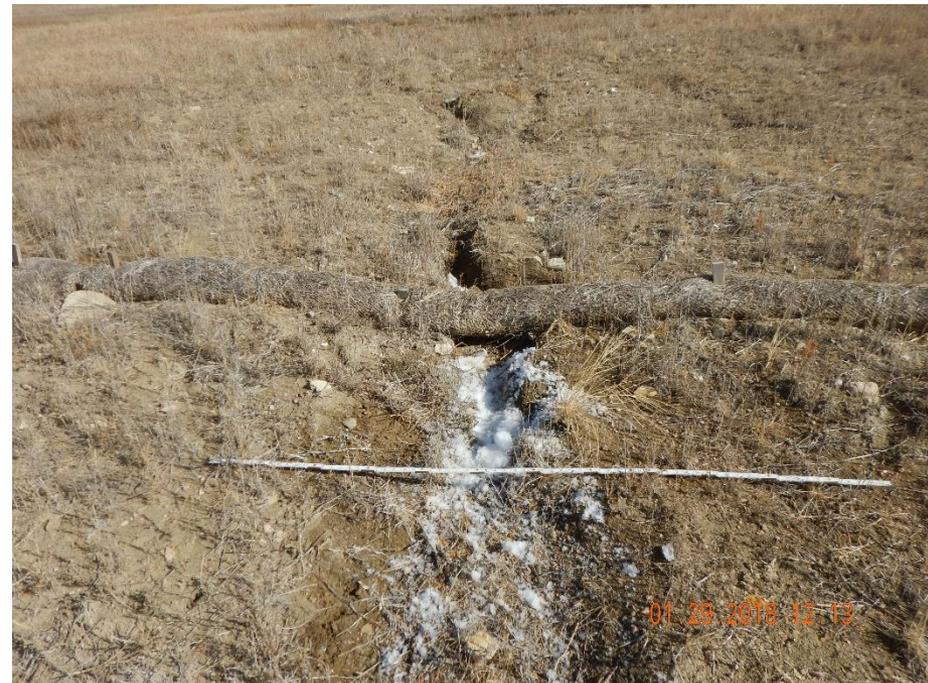
**Photo 6:** Photo taken from the southwest end of the location. Photo shows straw wattle BMP in not in proper functioning conduction and has not been maintained per corrective actions. Erosion degradation has also not been repaired and stabilized, and has continued to erode since previous inspection. 6 foot measuring stick for reference.

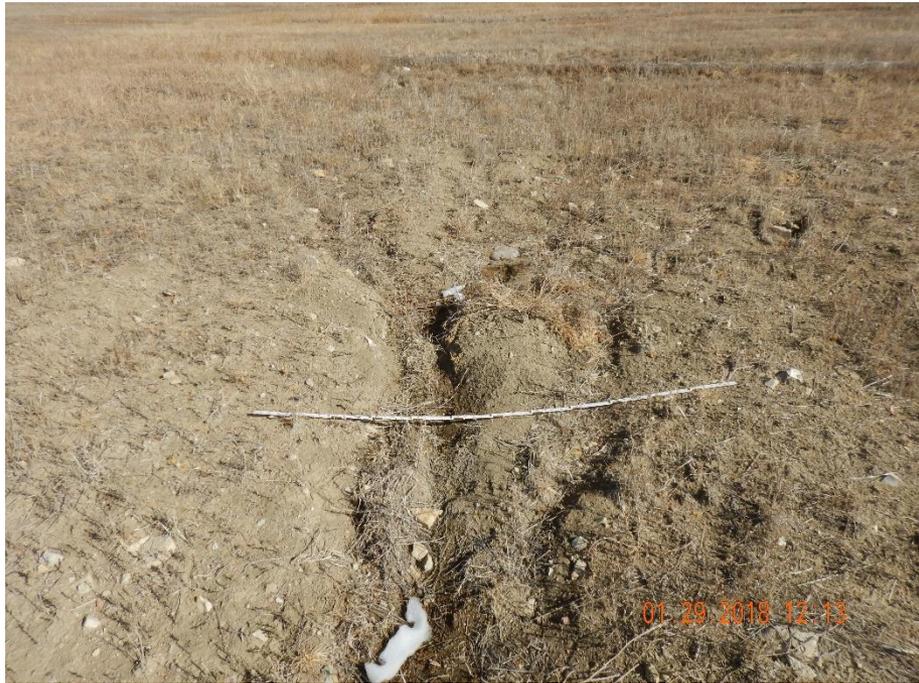
**Photo 7:** Photo taken from the southwest end of the location, facing north. Photo shows that erosion degradation has not been repaired and stabilized per corrective actions, and has continued to erode since the previous inspection. 6 foot measuring stick for reference.

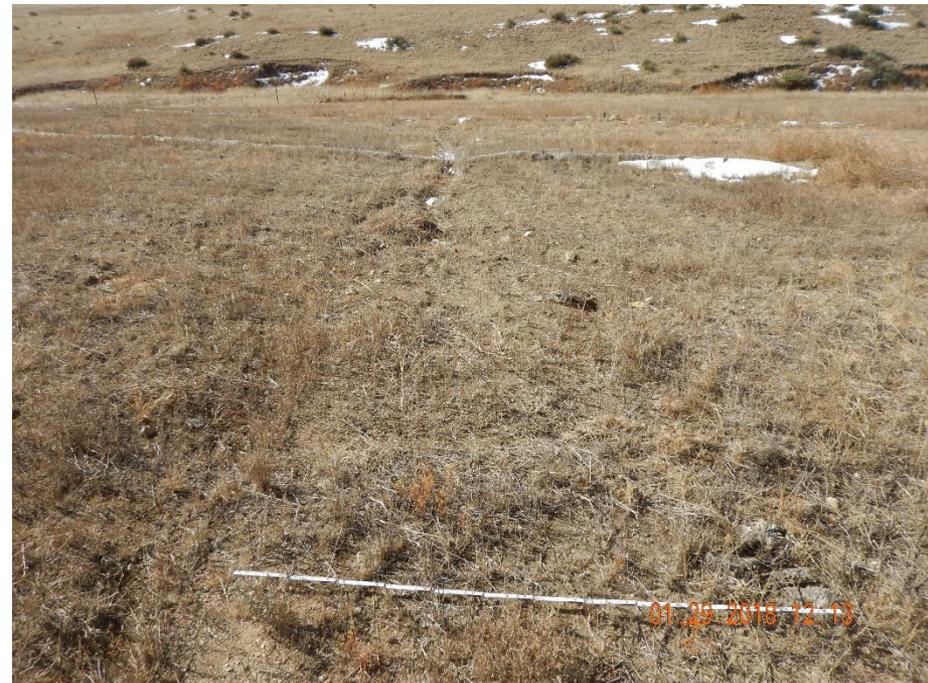
**Photo 8:** : Photo taken from the southwest end of the location, facing southwest. Photo shows water movement patterns and erosion evident on location.

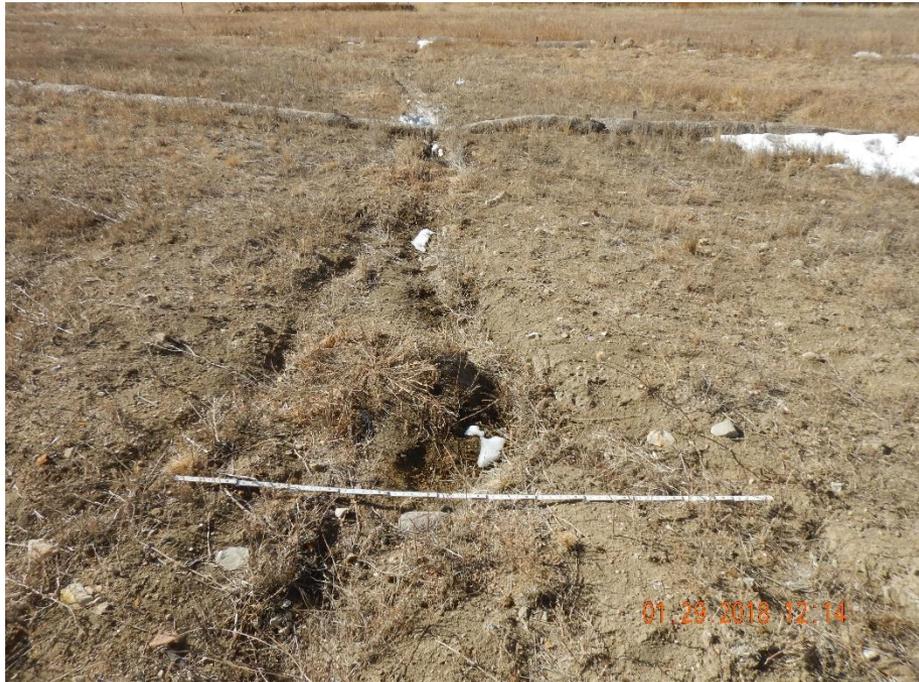
**Photo 9:** Photo taken from the southwest end of the location, facing southwest. Photo shows that erosion degradation has not been repaired and stabilized per corrective actions, and has continued to erode since the previous inspection. 6 foot measuring stick for reference.

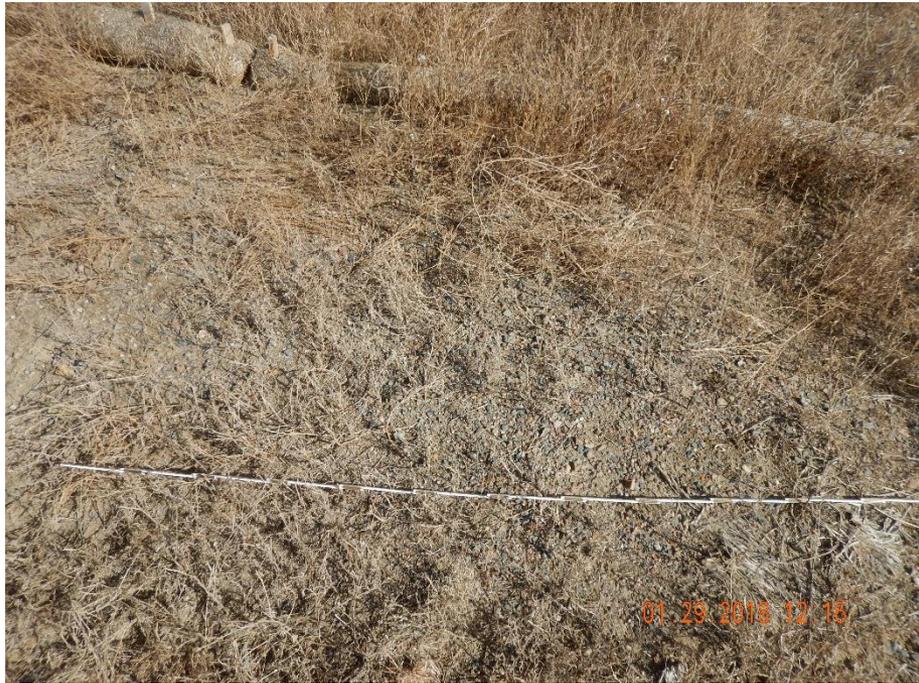
**Photo 11:** Photo taken from the west end of the location. Photo shows areas of the access road where road-base and gravel remains. Previous inspections required operator to perform reclamation on the access road. 6 foot measuring stick for reference.

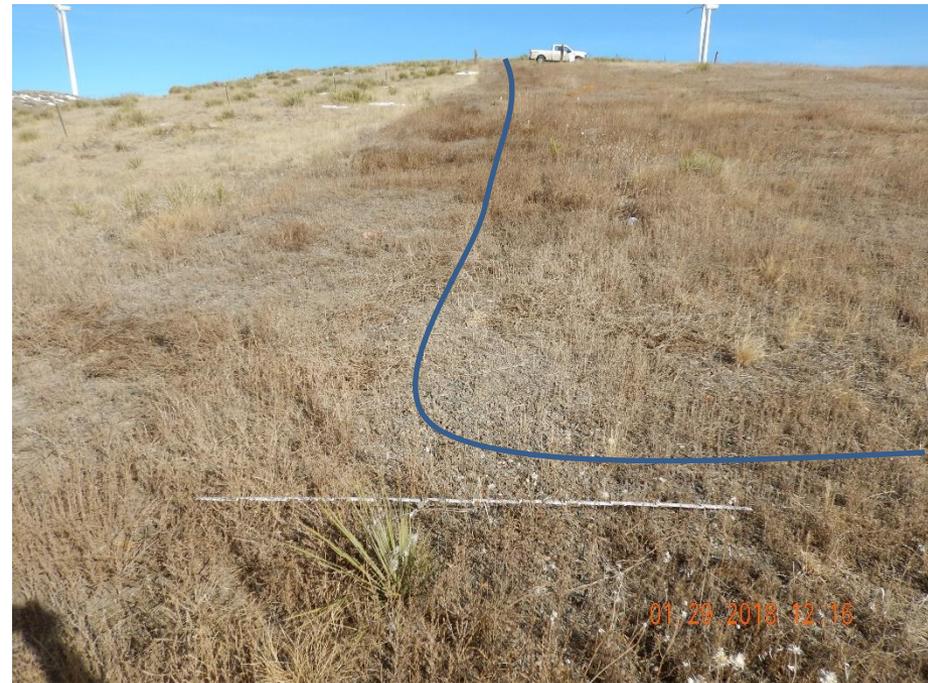
**Photo 12:** Photo taken from the west end of the location, facing north. Photo shows areas of the access road where road-base and gravel remains. 6 foot measuring stick for reference.

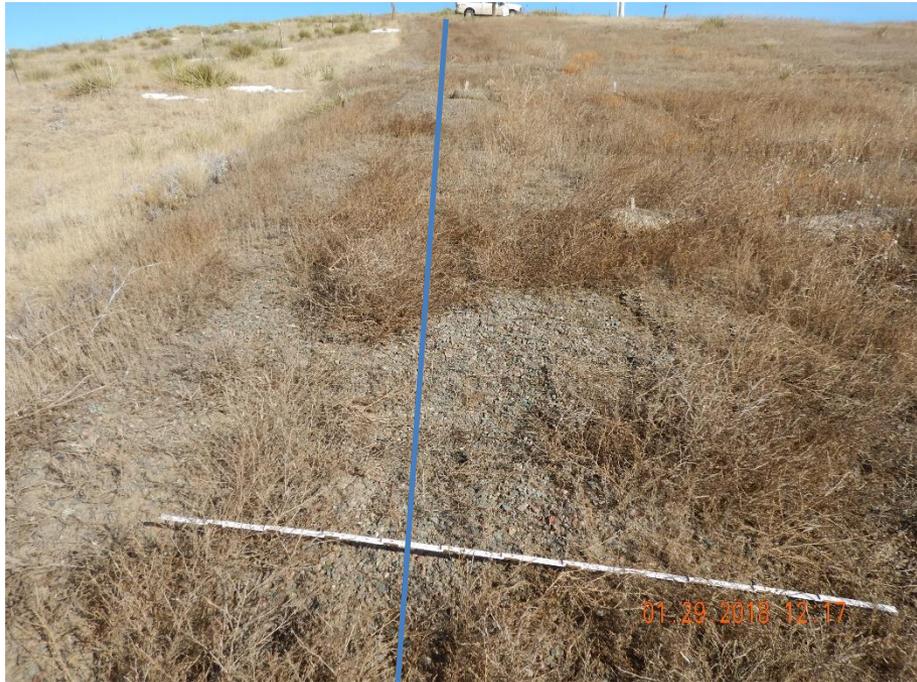
**Photo 13:** Photo taken from the west end of the location, facing north. Photo shows areas of the access road where road-base and gravel remains. 6 foot measuring stick for reference.

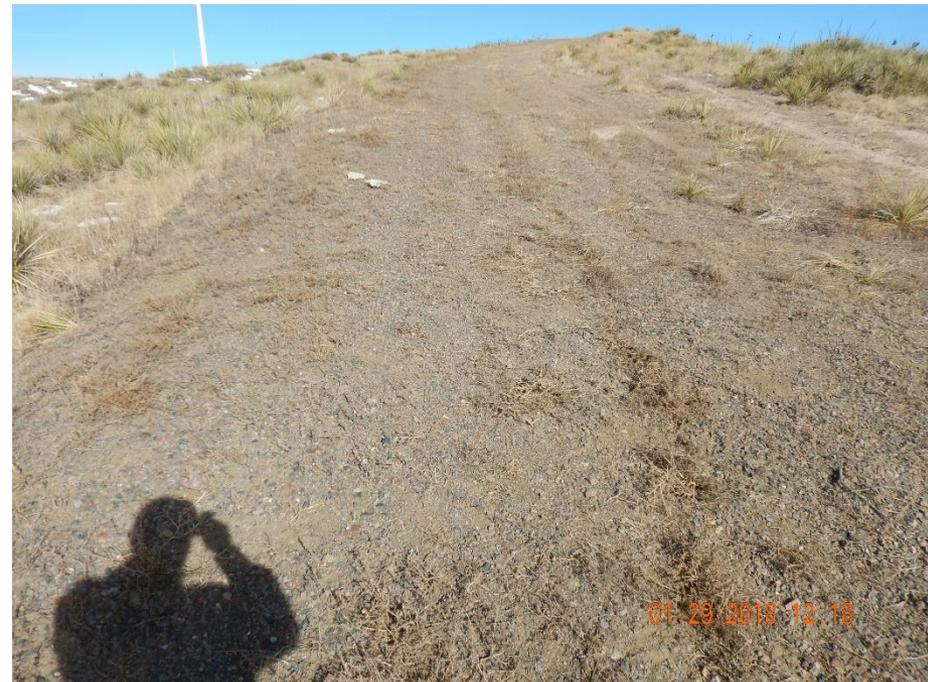
**Photo 14:** Photo taken from the access road north of the location, facing north. Previous inspections required operator to perform reclamation on the access road. Photo shows access road has not been reclaimed. 6 foot measuring stick for reference.

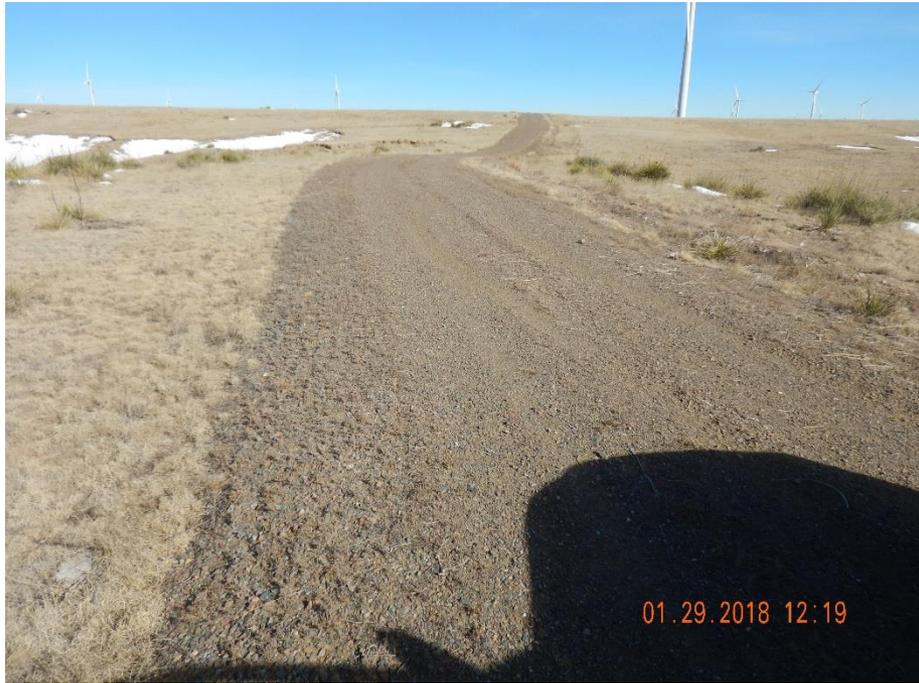
**Photo 15:** Photo taken from the access road north of the location, facing north. Previous inspections required operator to perform reclamation on the access road. Photo shows access road has not been reclaimed.

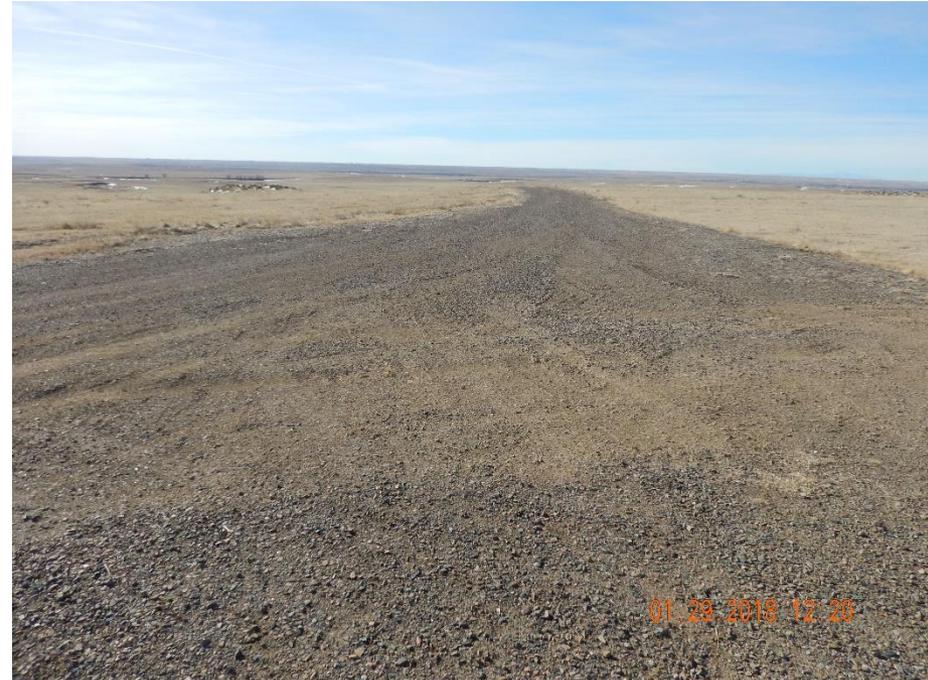
**Photo 16:** Photo taken from the access road north of the location, facing south. Previous inspections required operator to perform reclamation on the access road. Photo shows access road has not been reclaimed. 6 foot measuring stick for reference.

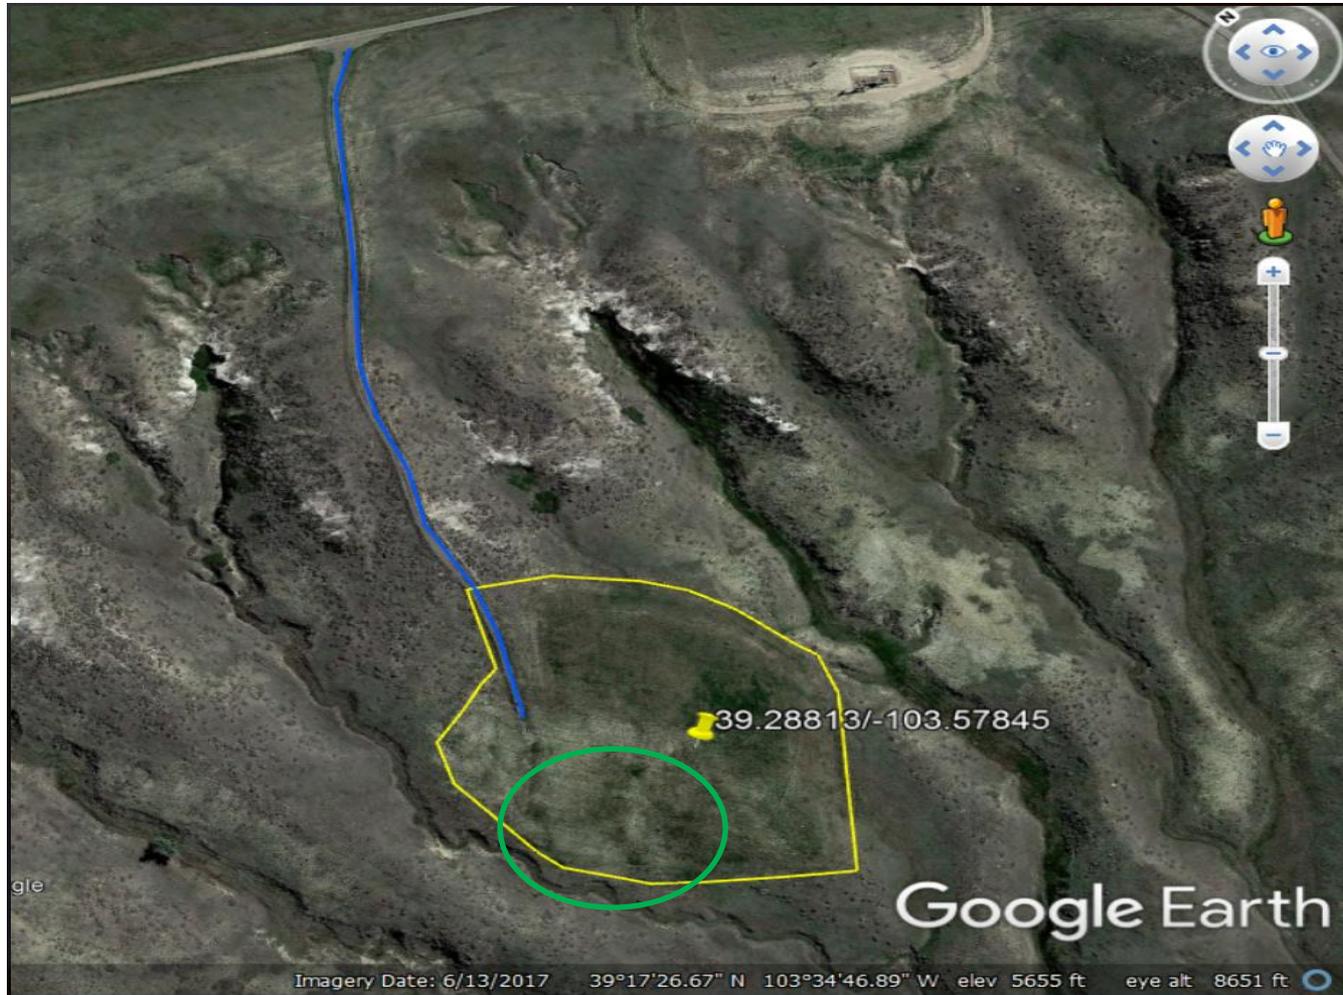
**Photo 17:** Aerial imagery (2017). Photo shows the location (yellow), areas of access road requiring reclamation (blue) and areas where erosion degradation is occurring (green).
