# Interim Reclamation and Stormwater Inspection

January 30, 2018

Operator: EXTRACTION OIL & GAS LLC- #10459

Location ID: 439027

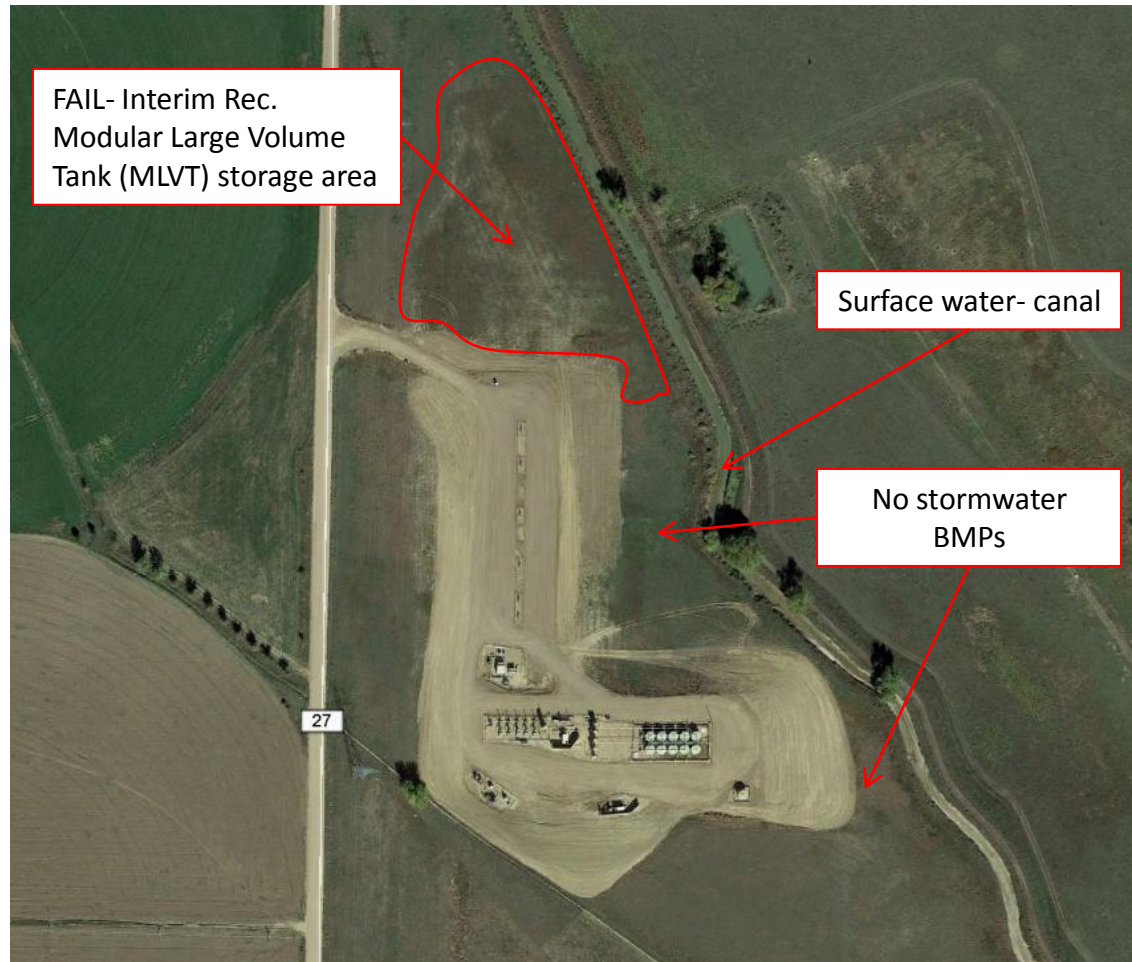
Aerial imagery taken October 14, 2017 post drilling operations of the Thornton 8-P Pad. Appears the western, southern and eastern interim reclamation areas have been redone by the evidence of seedbed prep. The northern interim area used for the MLVT storage area does not appear to meet Rule 1003 standards, as much of the vegetation is dominated by weedy, annual vegetation (Kochia and Russian thistle). There are no down gradient stormwater BMPs to prevent and control stormwater runoff in a manner that minimizes erosion, transport of sediment offsite, and site degradation. Surface water (canal) is less than 25' from the disturbance area.

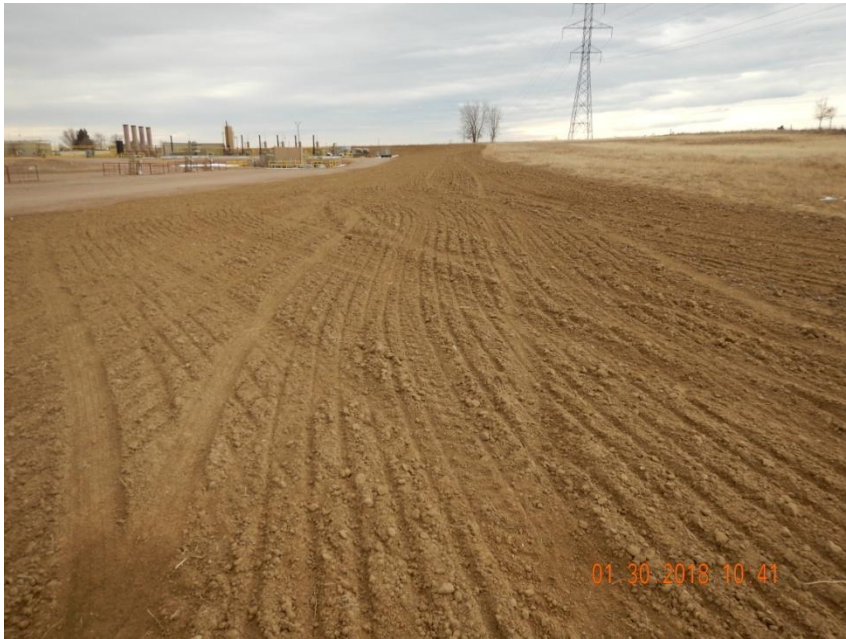
**Photo 1.** Photo taken from the entrance of the location, facing South. Seedbed prep has been performed but has not been seeded or stabilized.

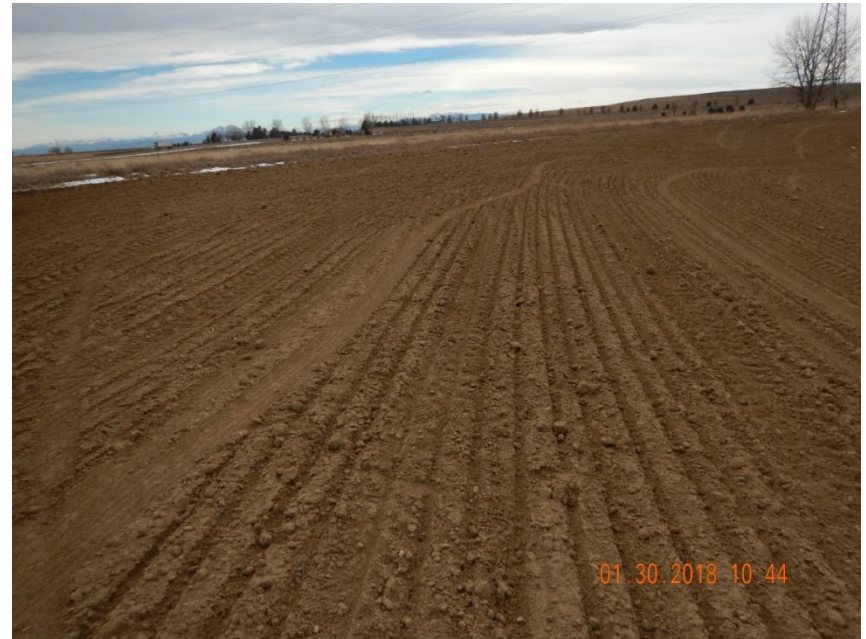
**Photo 2.** Photo taken from the southern location, facing West. See comments under Photo 1.

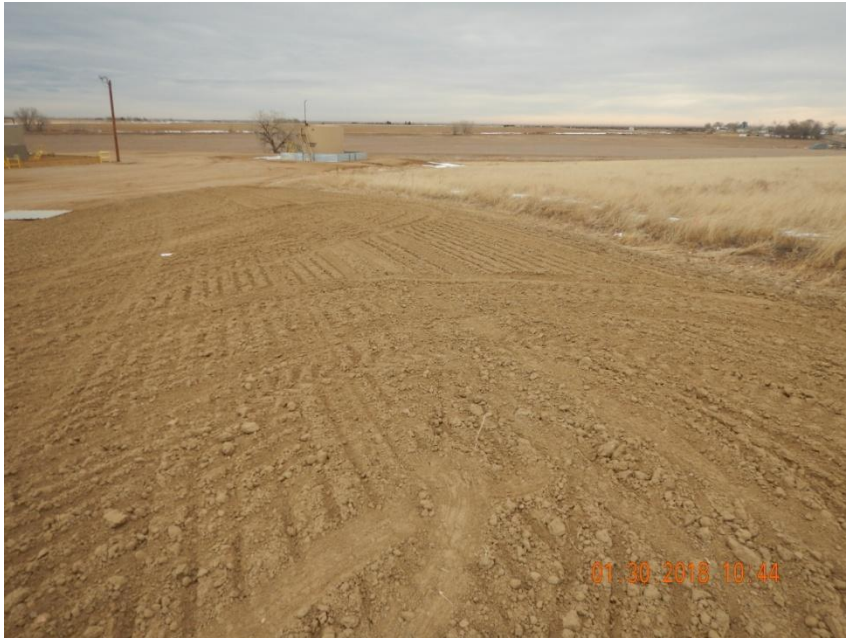
**Photo 3.** Photo taken from the southern location, facing East. See comments under Photo 1.

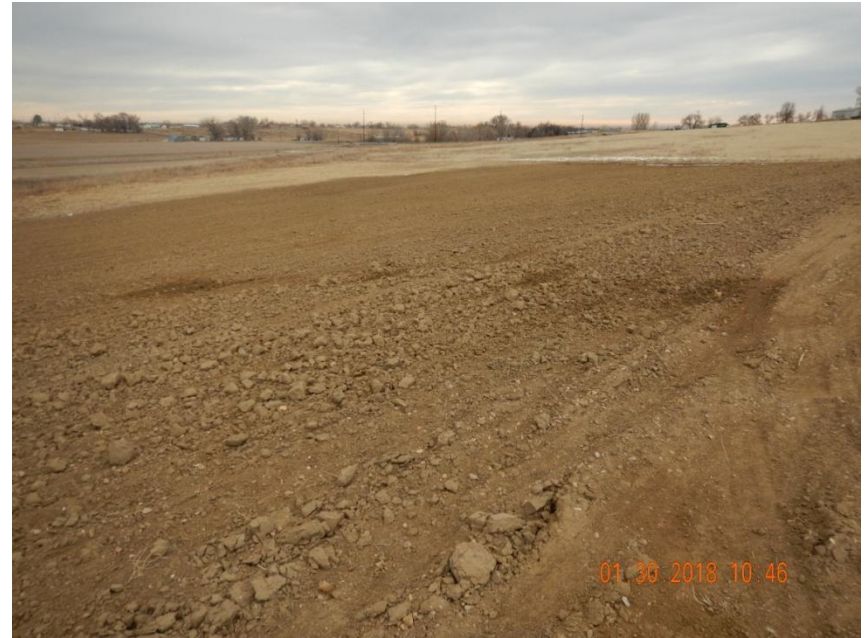
**Photo 4.** Photo taken from the southeastern location, facing South. See comments under Photo 1. No stormwater BMPs were observed down gradient of the disturbance areas (interim area).

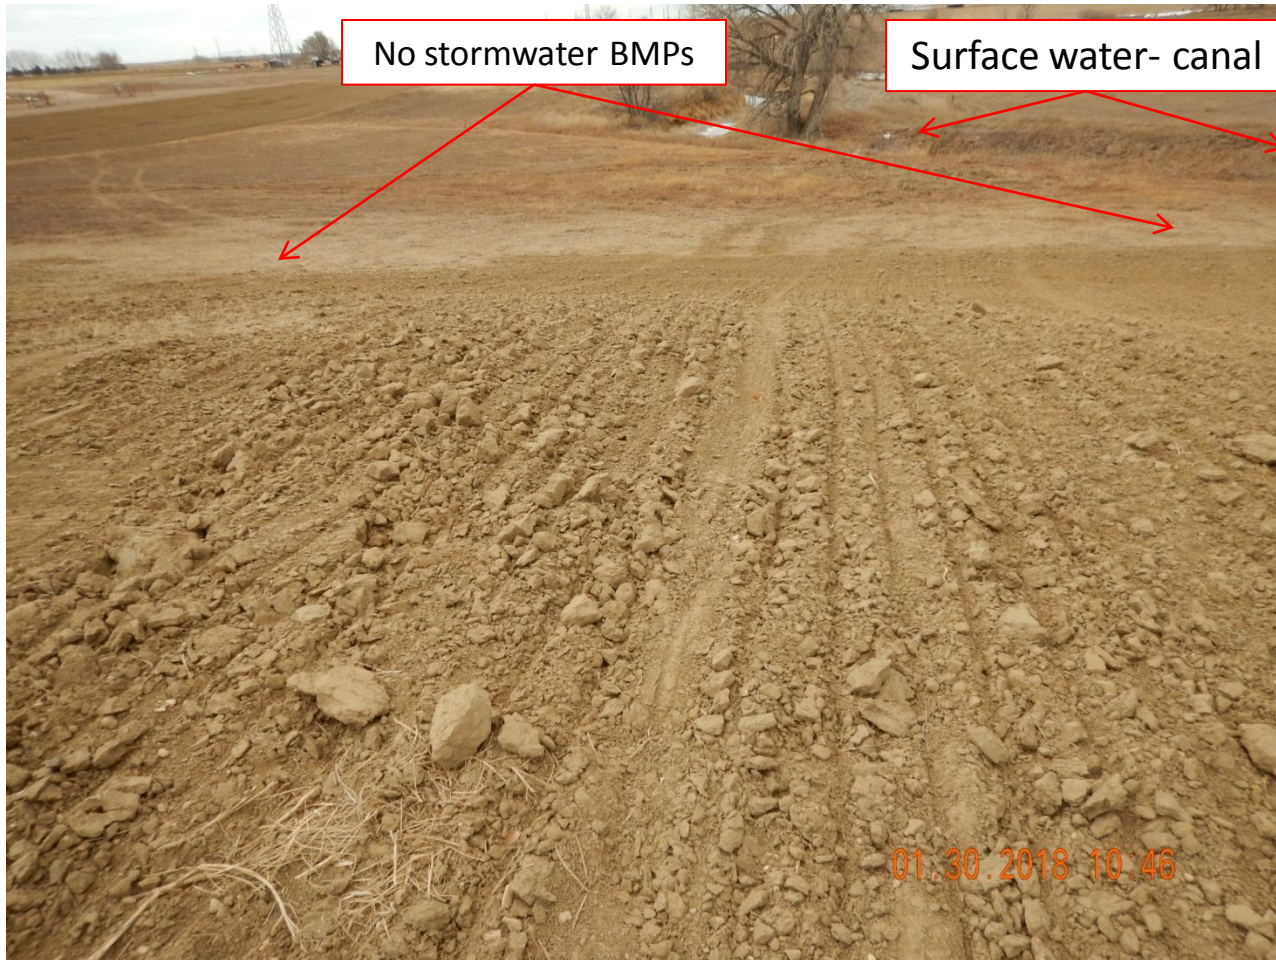
**Photo 5.** Photo taken from the southeastern location, facing North. See comments under Photo 4. The surface roughening BMP has not been installed in the correct direction. The surface roughening BMP should be installed perpendicular to the slope to help reduce runoff velocity, increases infiltration, and reduces erosion. In this current state, this would aid erosion in a stormwater event.

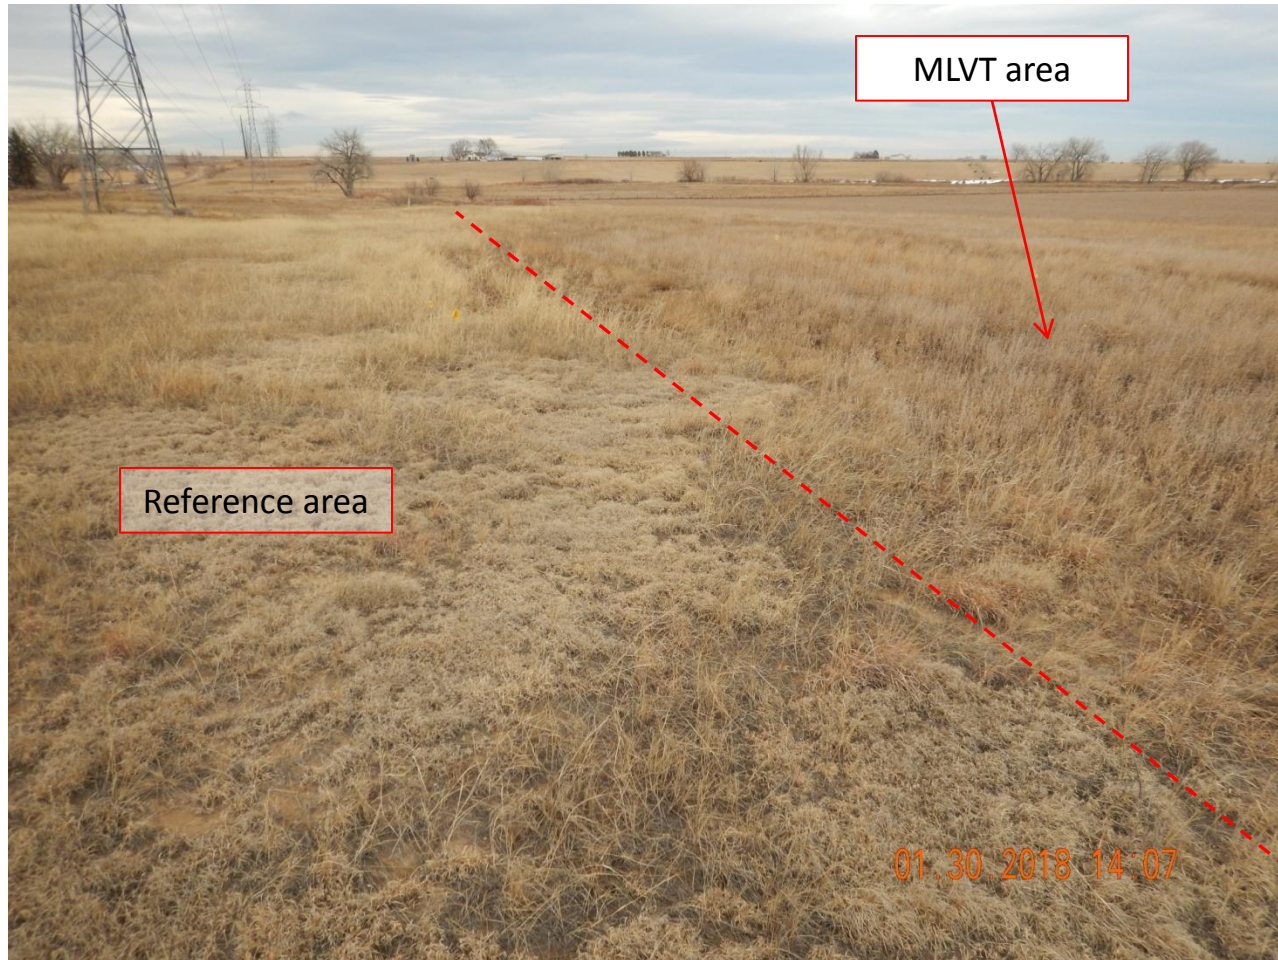
**Photo 6.** Photo taken from the northern location, facing North. This area was used for the Modular Large Volume Tank storage area. This area consists mainly of Kochia and Russian thistle which is not reflective of reference vegetative levels. Reference area vegetation mainly consists of Sand dropseed (*Sporobolus cryptandrus*) and Blue grama (*Bouteloua gracilis*).

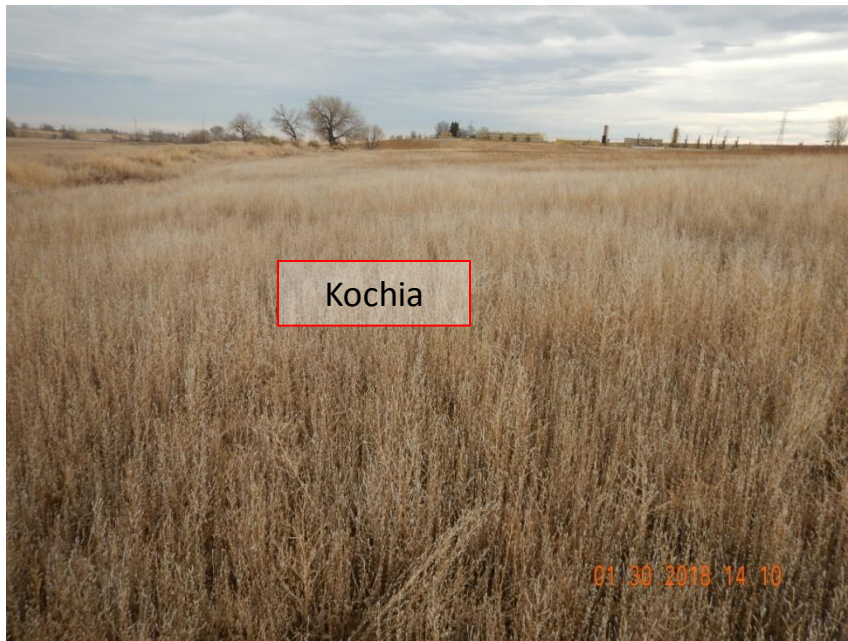
**Photo 7.** Photo taken from the eastern MLVT area, facing South. See comments under Photo 6.

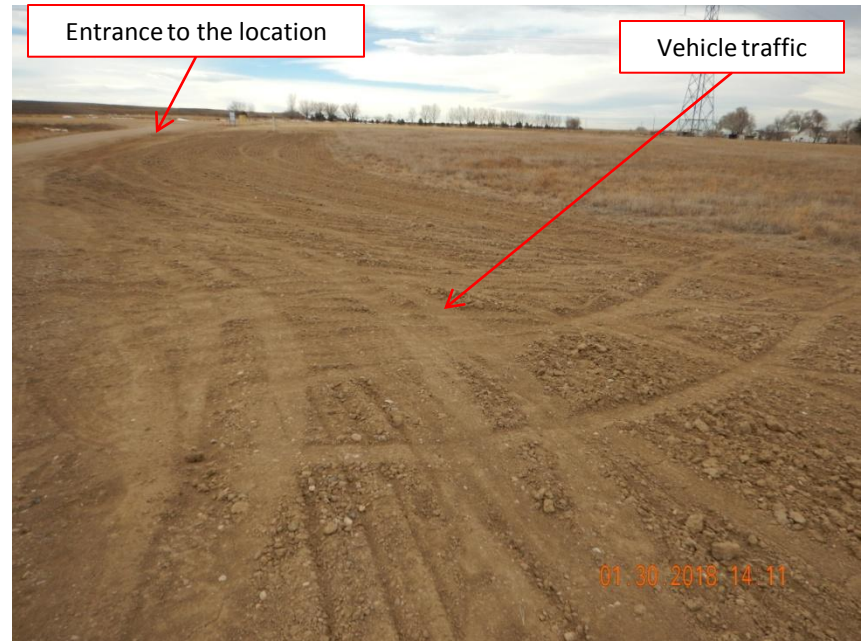
**Photo 8.** Photo taken from a portion of the northern interim area, facing West. Operator should ensure vehicle traffic remains off interim areas.
