# Inspection Photos

API: 05-067-06443

Operator: WPX ENERGY PRODUCTION LLC

Inspection Number: 680602460

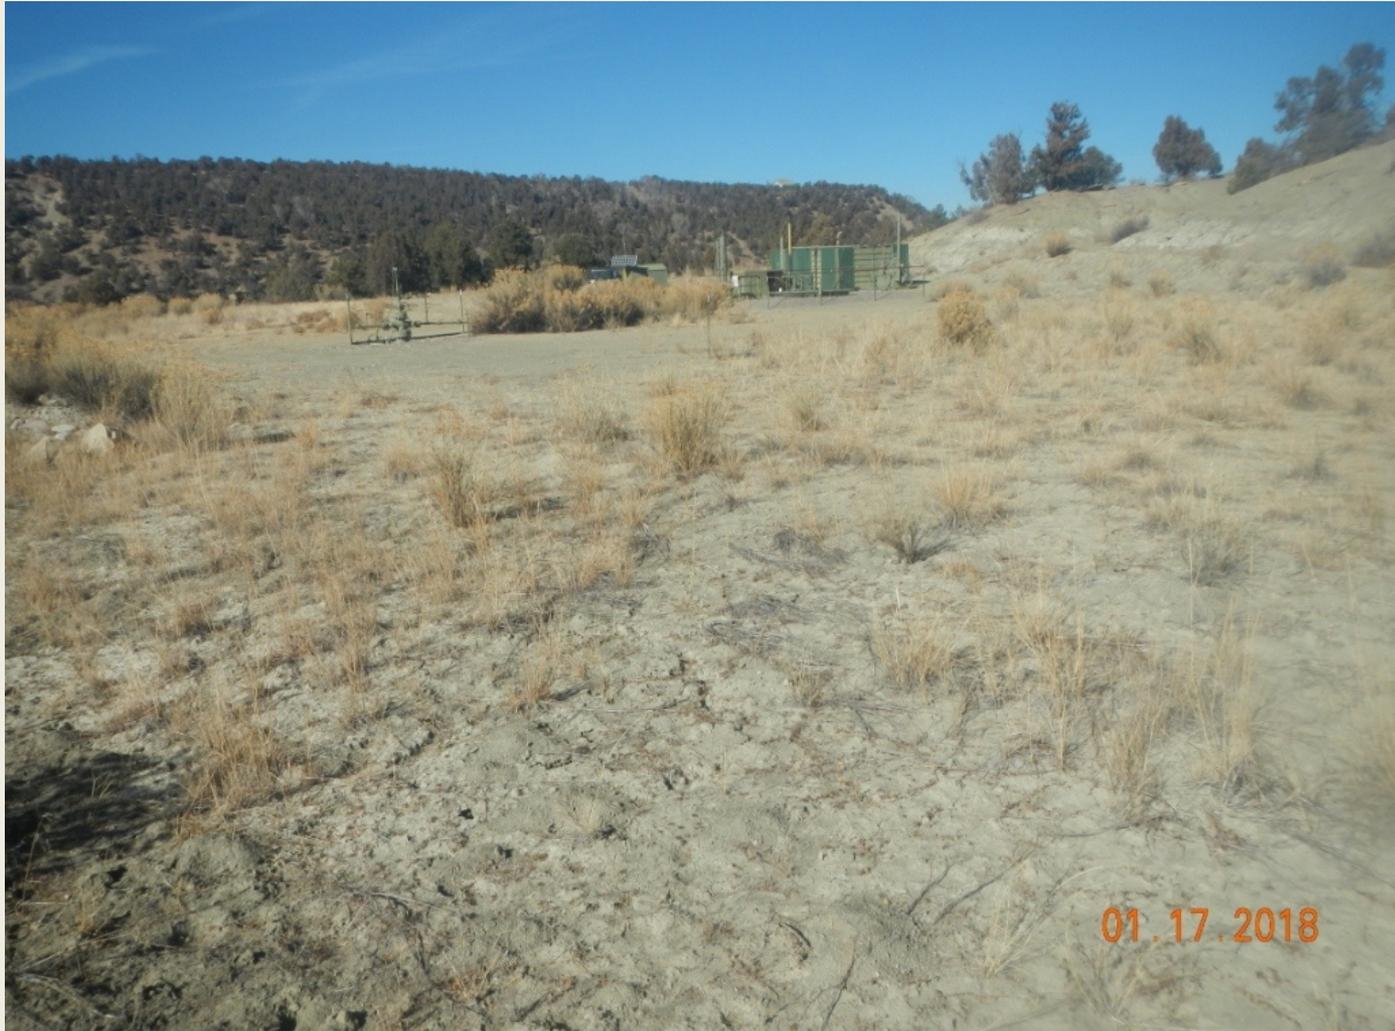
**Photo 1. View of the project area from the southeastern corner facing center.**

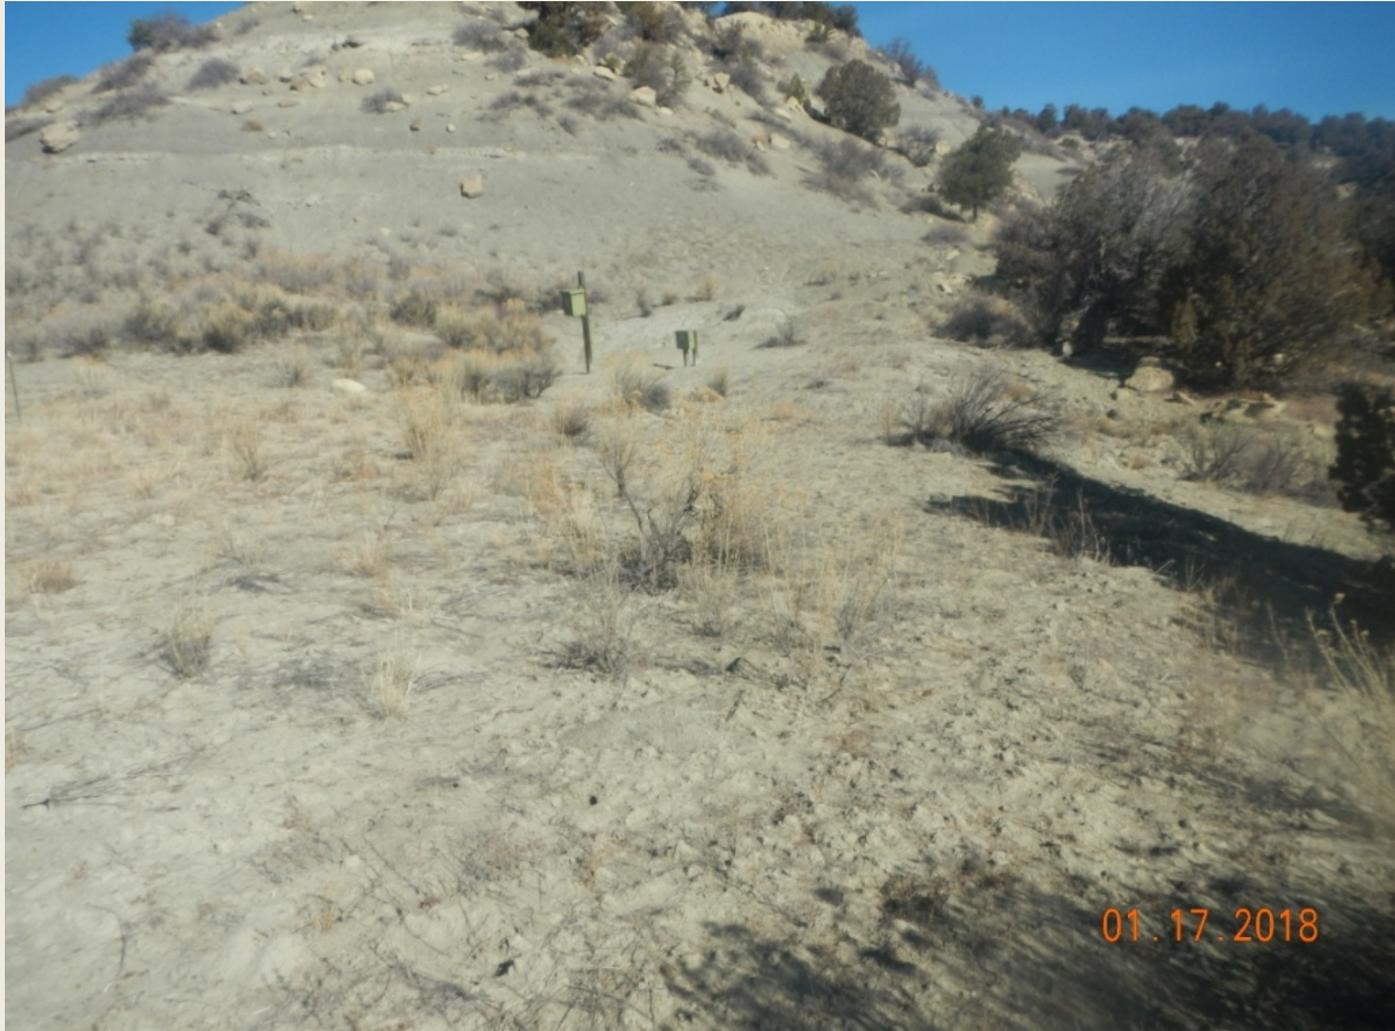
**Photo 2. View of the eastern portion of the project area from the southeastern edge facing northward.**

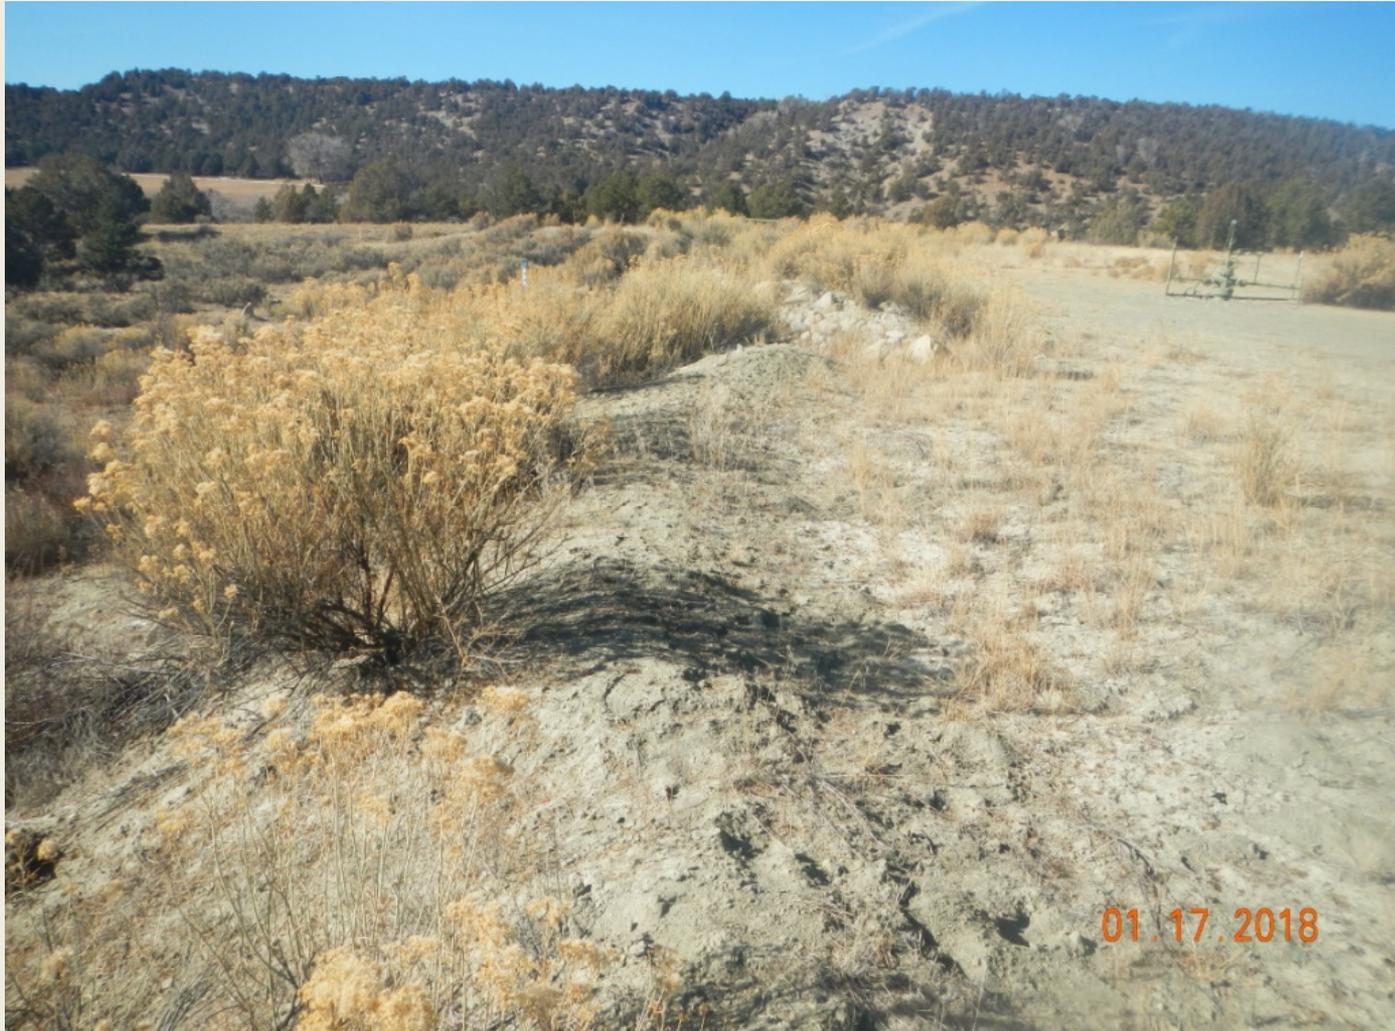
**Photo 3. View of the southern portion of the project area from northern corner facing westward. Stormwater controls with cobble run-downs in this portion of the project area appear to be functioning.**

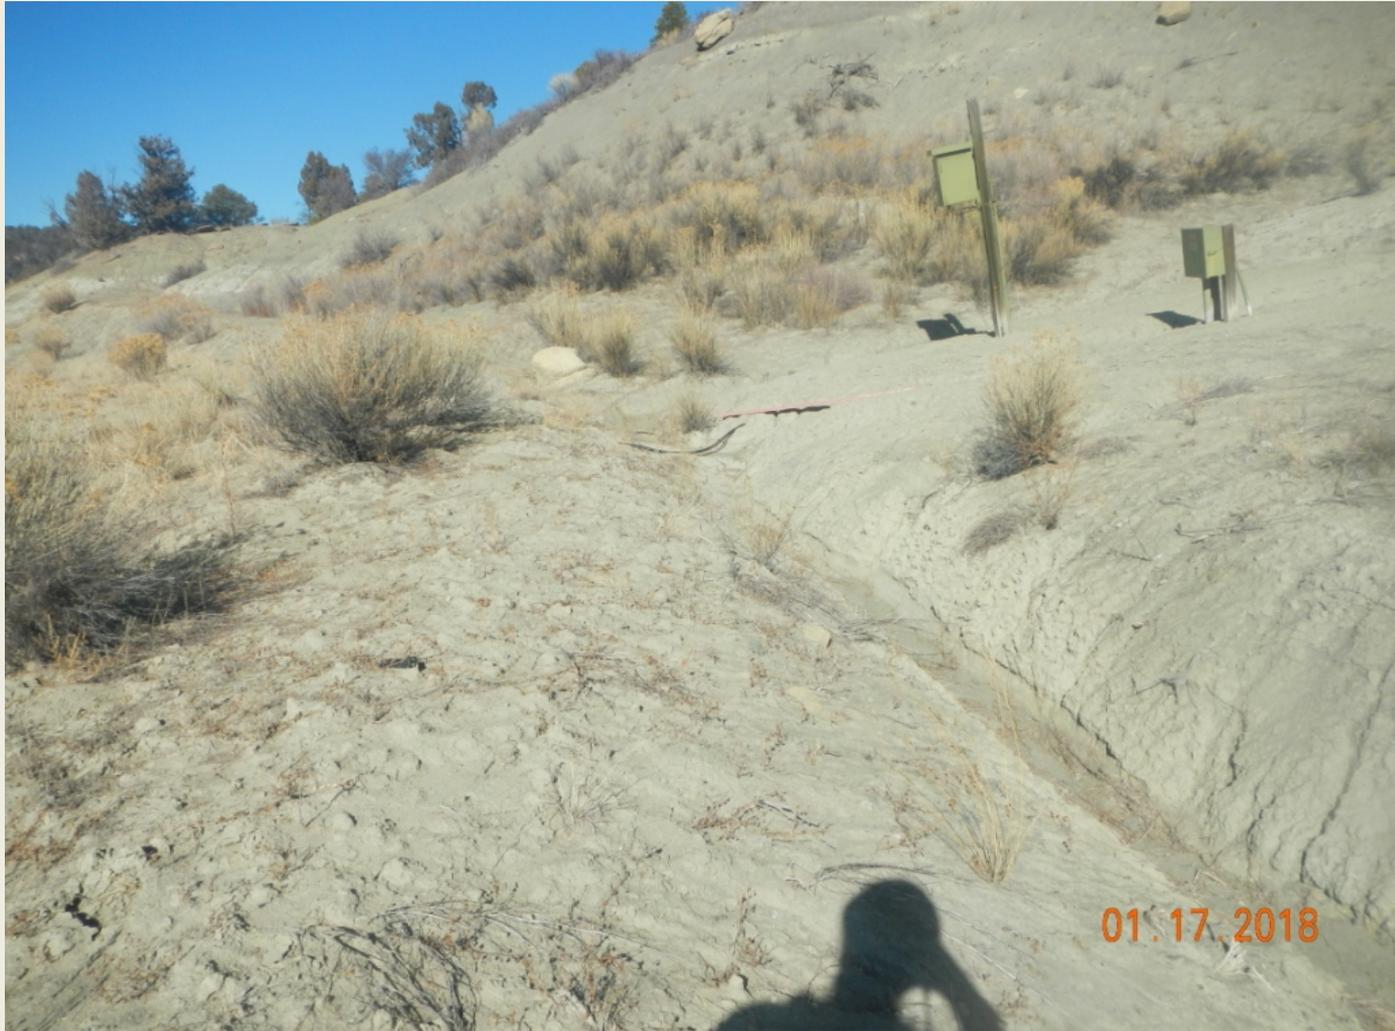
**Photo 4. View of diversion channel, approximately 3.5 feet wide and deep, in the northeastern portion of the project area (facing upstream) that is eroding and needs stormwater controls.**

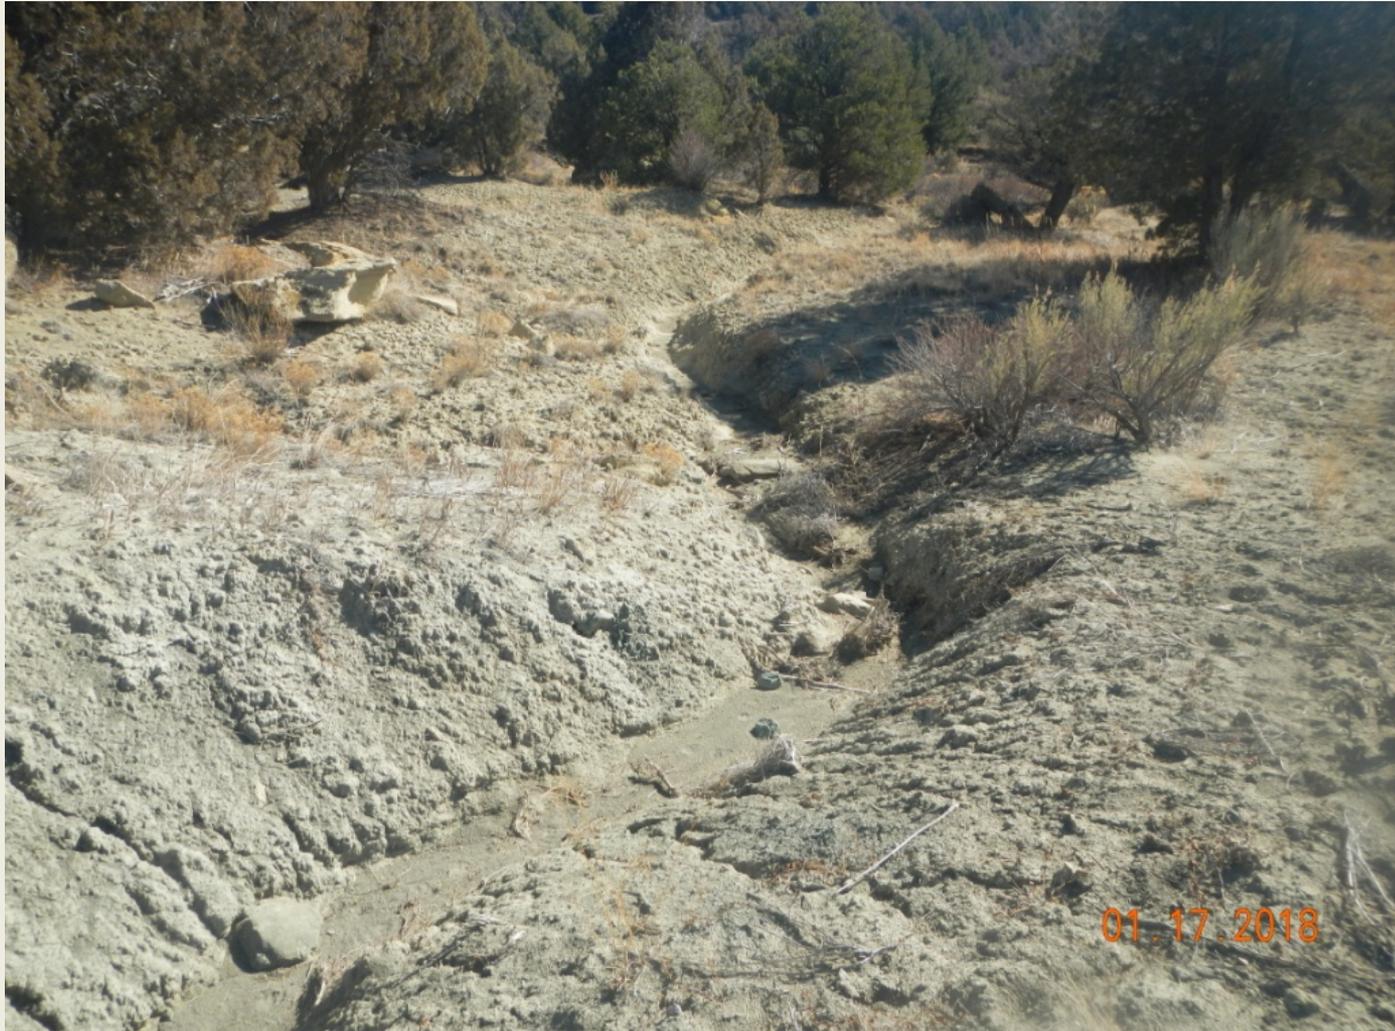
**Photo 5. Downstream view of diversion channel draining from the northeastern portion of the project area. Stormwater controls need to be installed to de-energize flows coming off of the well pad.**

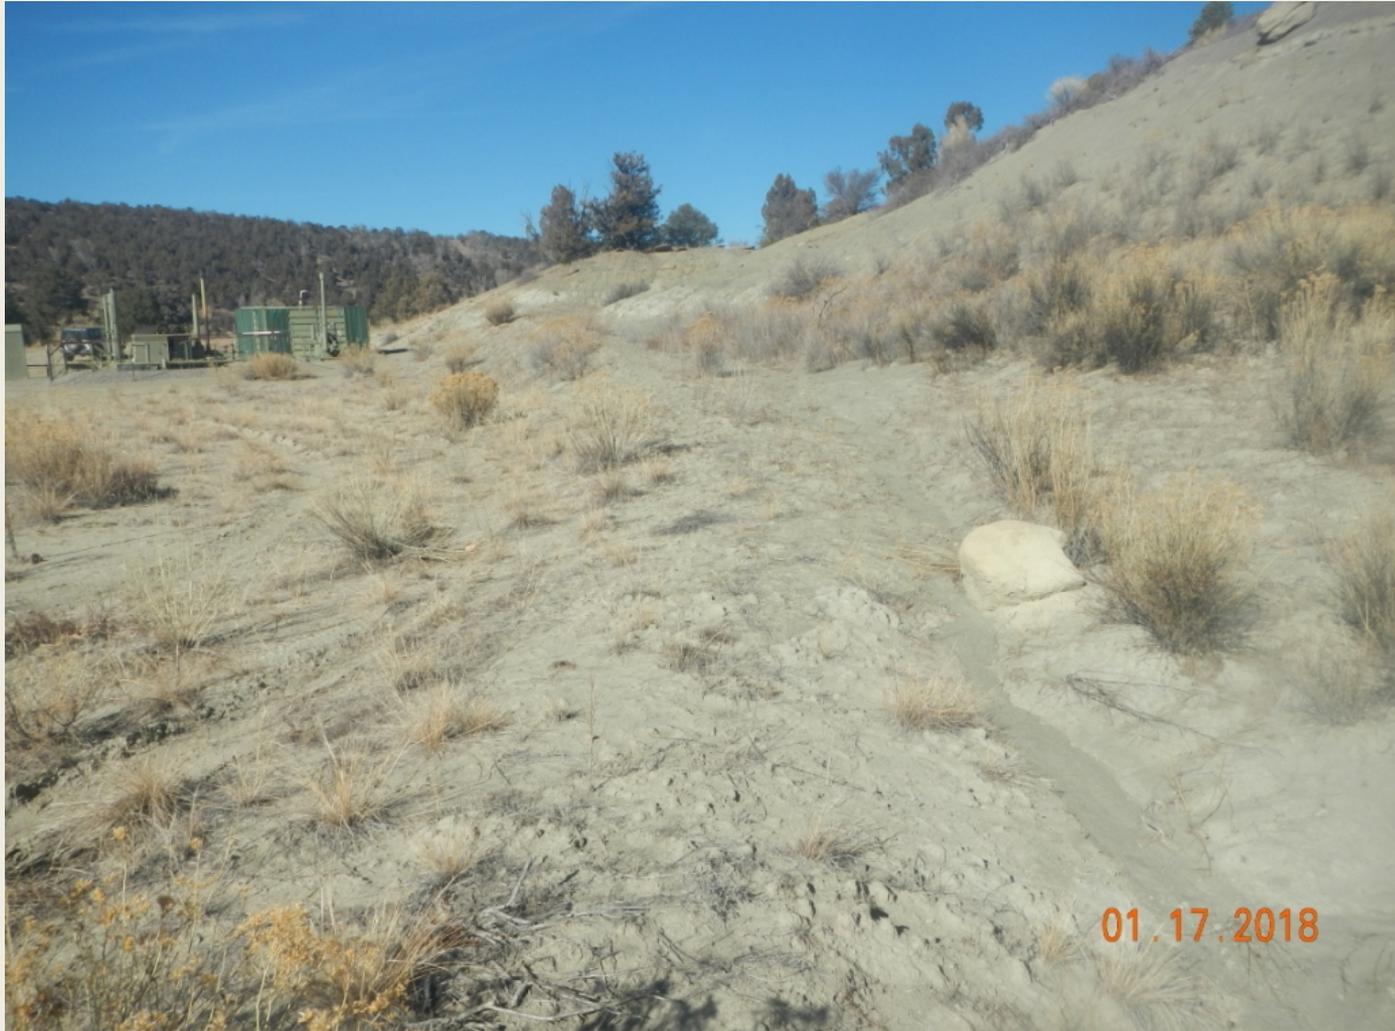
**Photo 6. View of diversion channel in northern project area (upstream from photos 5 and 6) that is full of sediment and needs maintenance.**
