Inspection Photos

01/29/2018

Operator: WIEPKING-FULLERTON ENERGY LLC -
96340

Inspection Doc. Number: 682503108
Lincoln County, CO

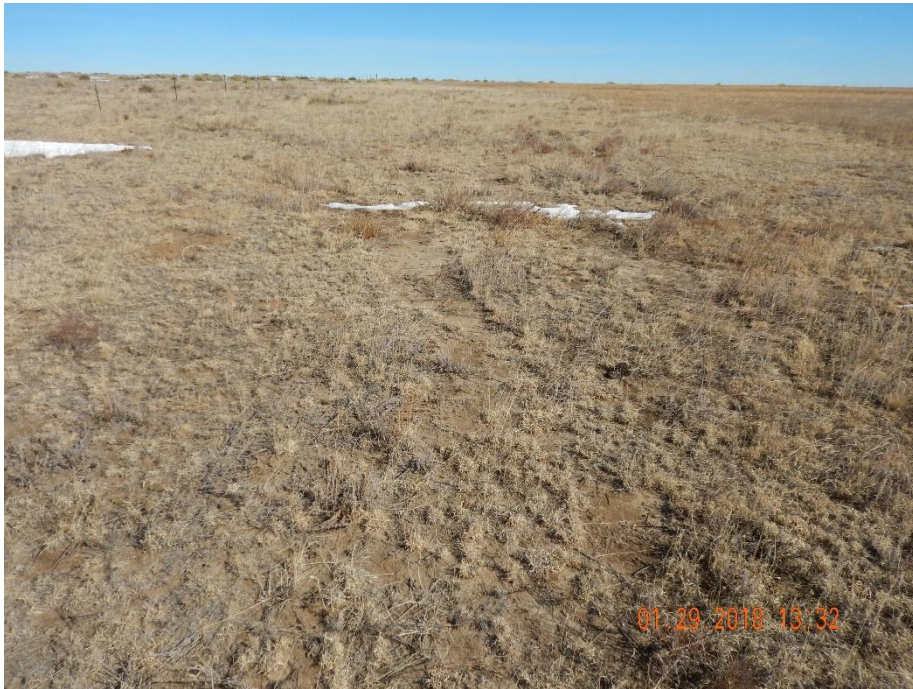
Photo 1: Photo taken from the northwest corner of the location, facing east. Photo shows overview of the location.

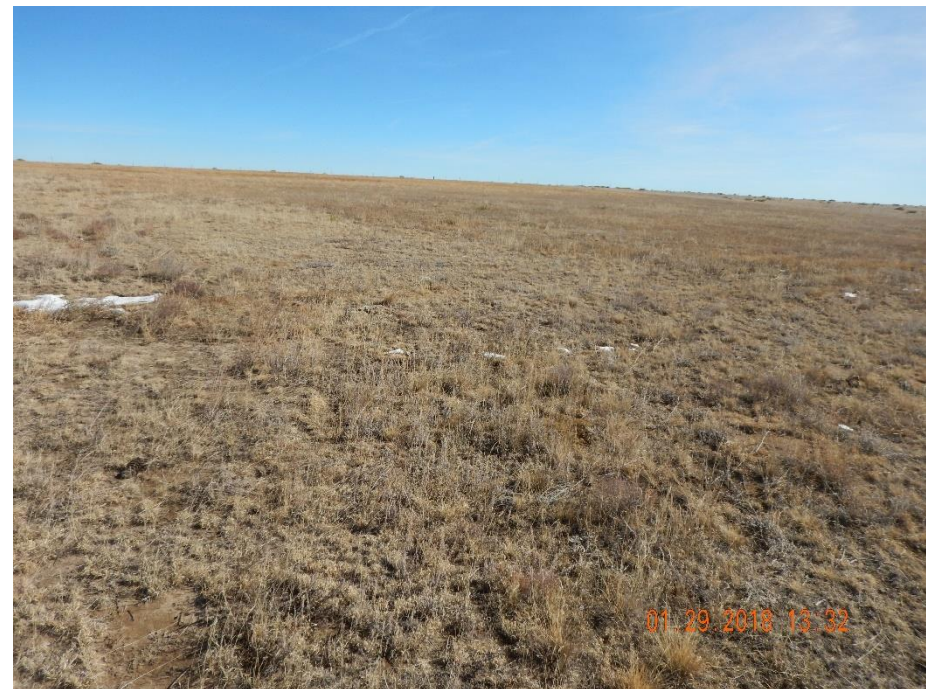
Photo 2: Photo taken from the northwest corner of the location, facing southeast. Photo shows overview of the location.

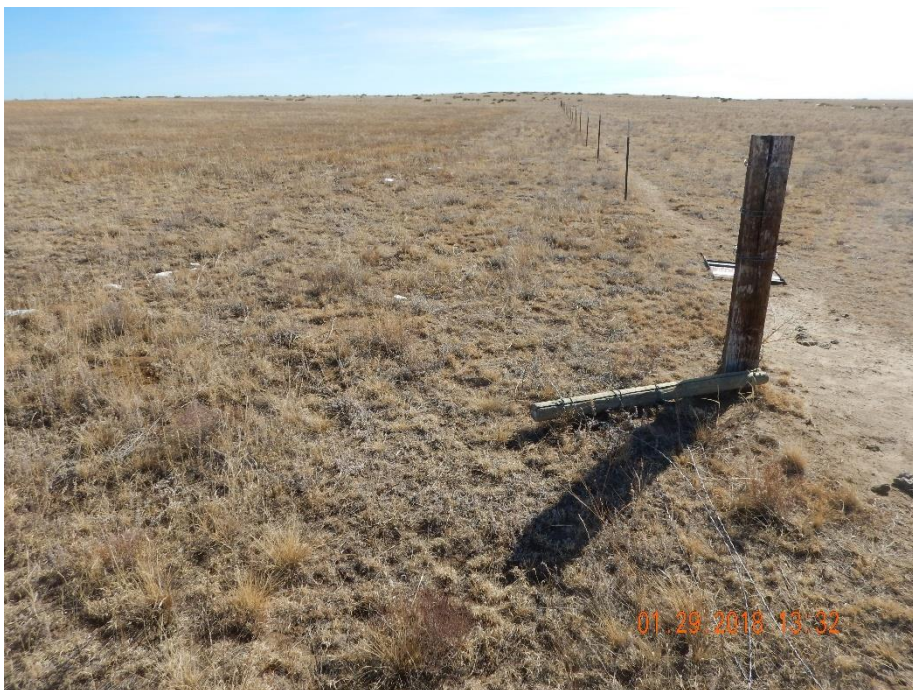
Photo 3: Photo taken from the northwest corner of the location, facing south. Photo shows overview of the location.

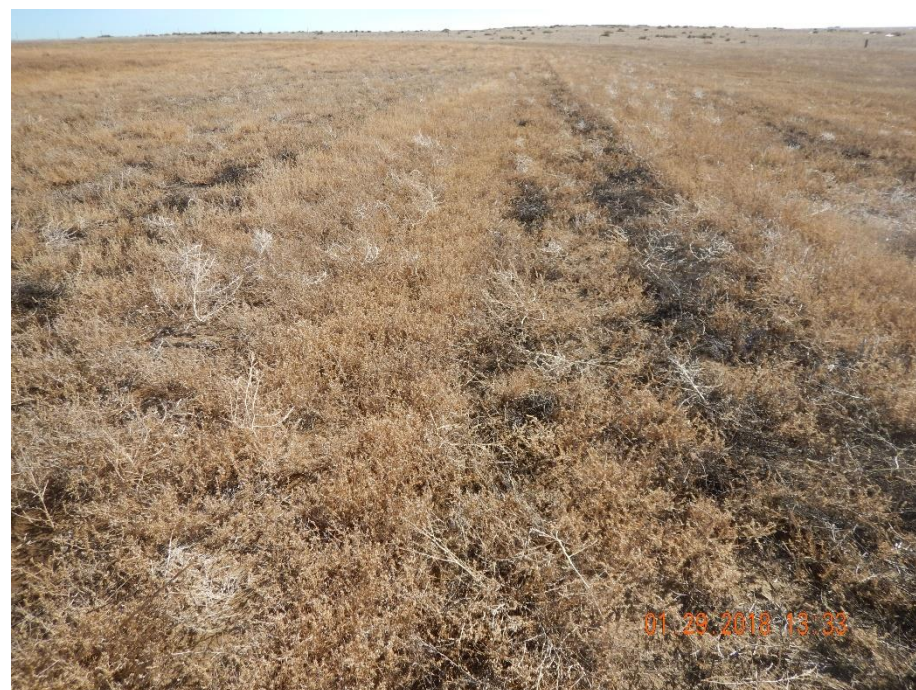
Photo 4: Photo taken from the north end of the location, facing south. Photo shows the vegetation over the reclamation area. Photo shows vegetation appears to be a monoculture of undesirable weedy plant species such as kochia and Russian thistle.

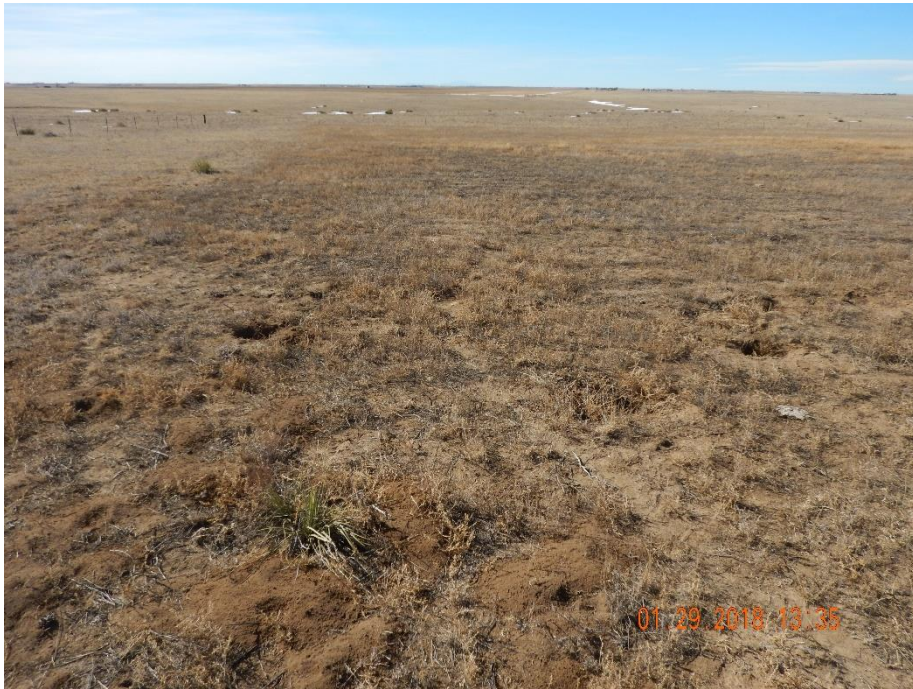
Photo 5: Photo taken from the southeast corner of the location, facing west. Photo shows vegetation over the reclamation areas appears to be progressing along the perimeter edges of the location, however, the large majority of the location is predominantly undesirable weedy plant species.

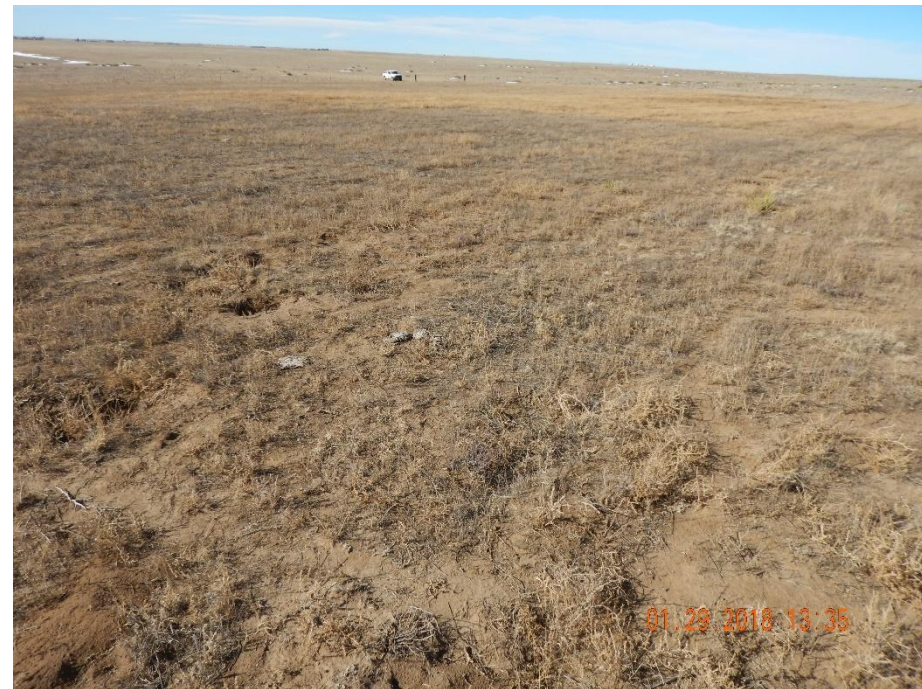
Photo 6: Photo taken from the southeast corner of the location, facing northwest. Photo shows vegetation over the reclamation areas appears to be progressing along the perimeter edges of the location, however, the large majority of the location is predominantly undesirable weedy plant species.

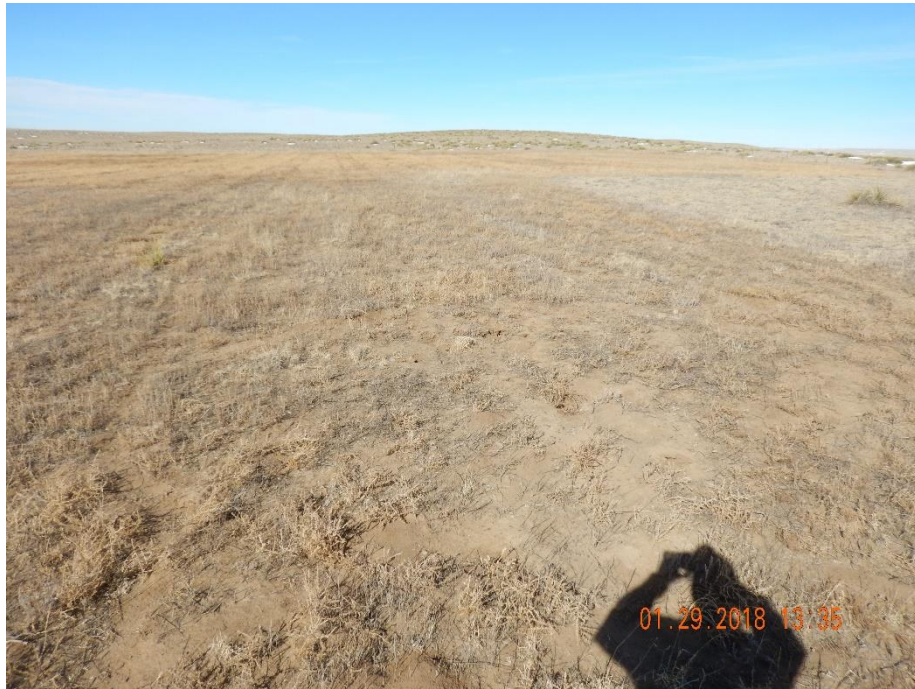
Photo 7: Photo taken from the southeast corner of the location, facing north. Photo shows vegetation over the reclamation areas appears to be progressing along the perimeter edges of the location, however, the large majority of the location is predominantly undesirable weedy plant species.

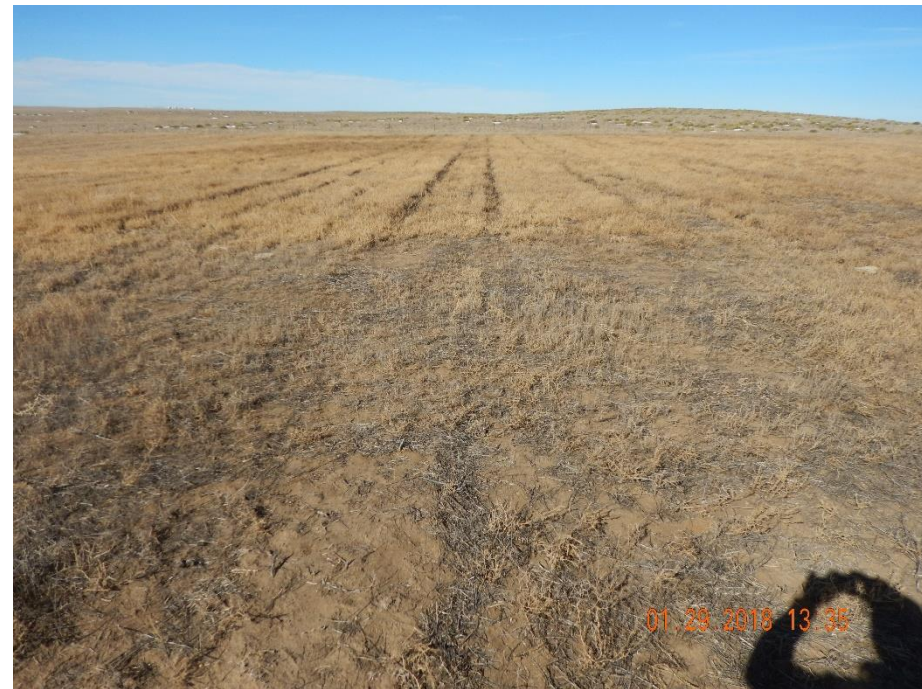
Photo 8: Photo taken from the south end of the location, facing north. Photo shows the vegetation over the reclamation area. Photo shows vegetation appears to be a monoculture of undesirable weedy plant species such as kochia and Russian thistle.

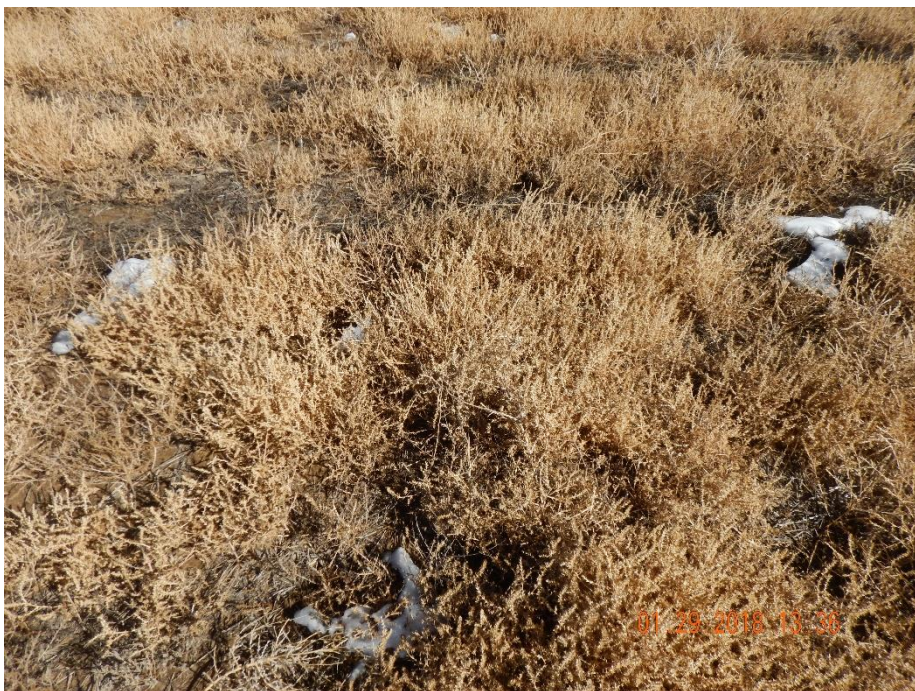
Photo 9: Photo taken from the central area of the location. Photo shows vegetation over the reclamation area is predominantly undesirable weedy plant species.

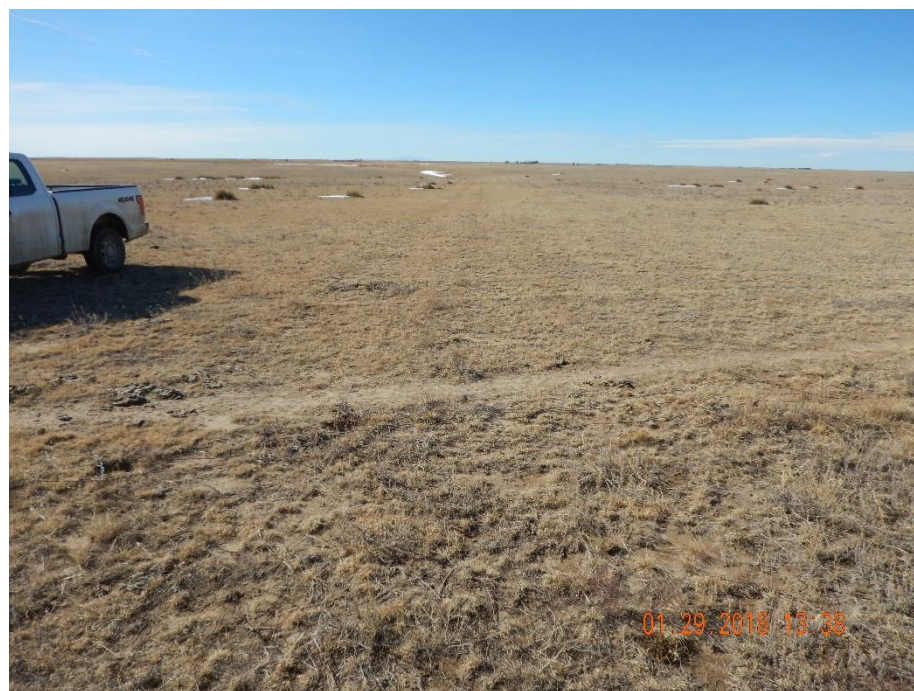
Photo 10: Photo taken from the northwest corner of the location, facing west. Photo shows access road reclamation appears to be progressing.

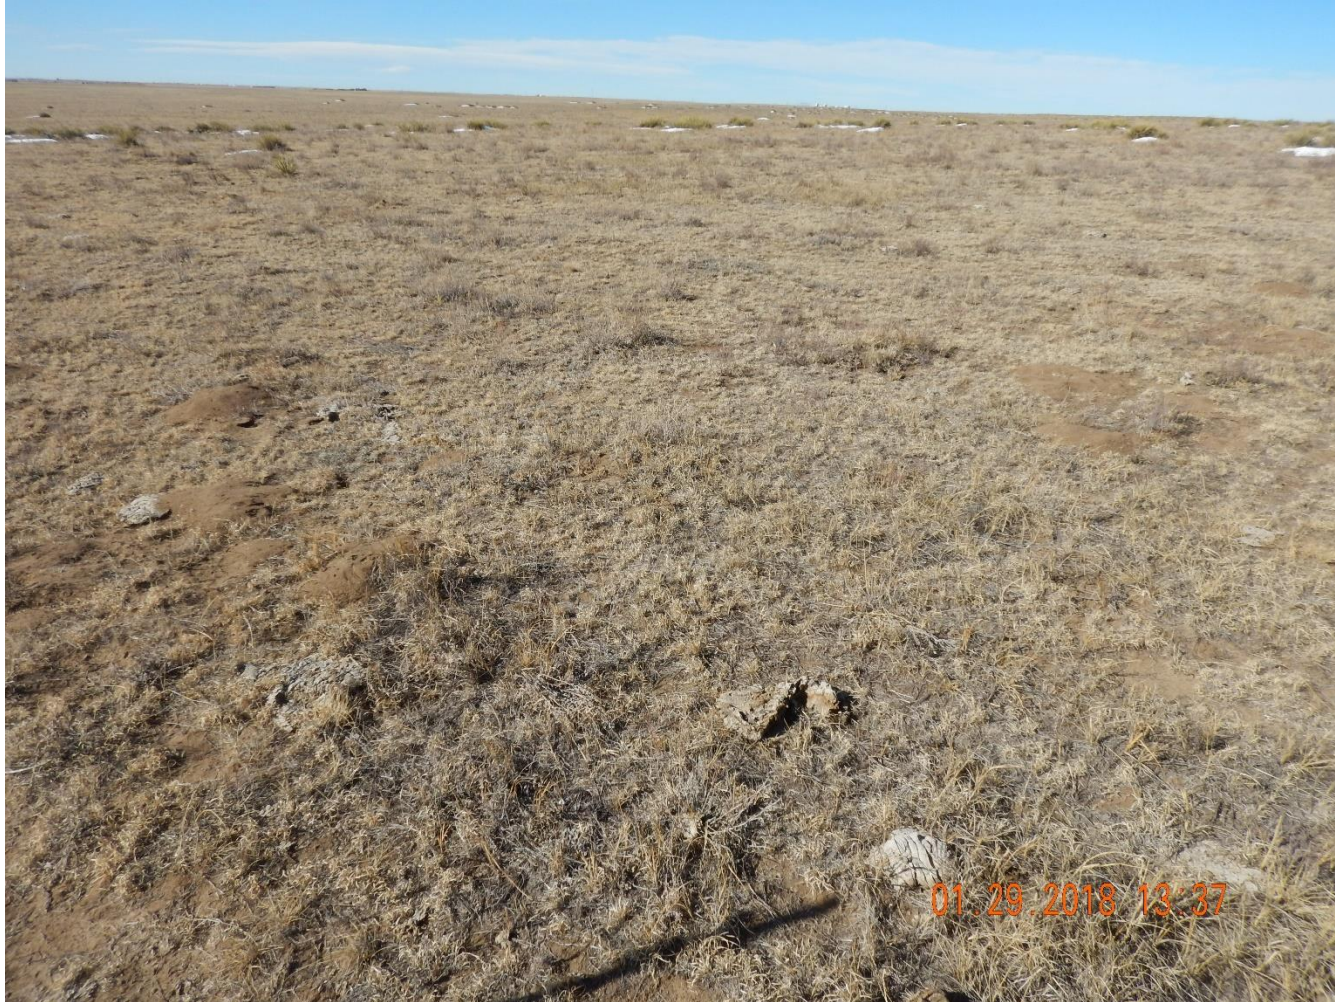
Photo 11: Photo taken from the adjacent reference area. Photo shows vegetation over the reference area. Vegetation seen in photo predominantly Blue grama, Buffalo grass, threeawn, sand dropseed, western wheatgrass and yucca.
