# Inspection Photos

API: 05-067-08201

Operator: Hilcorp Energy Company

Inspection Number: 680602462

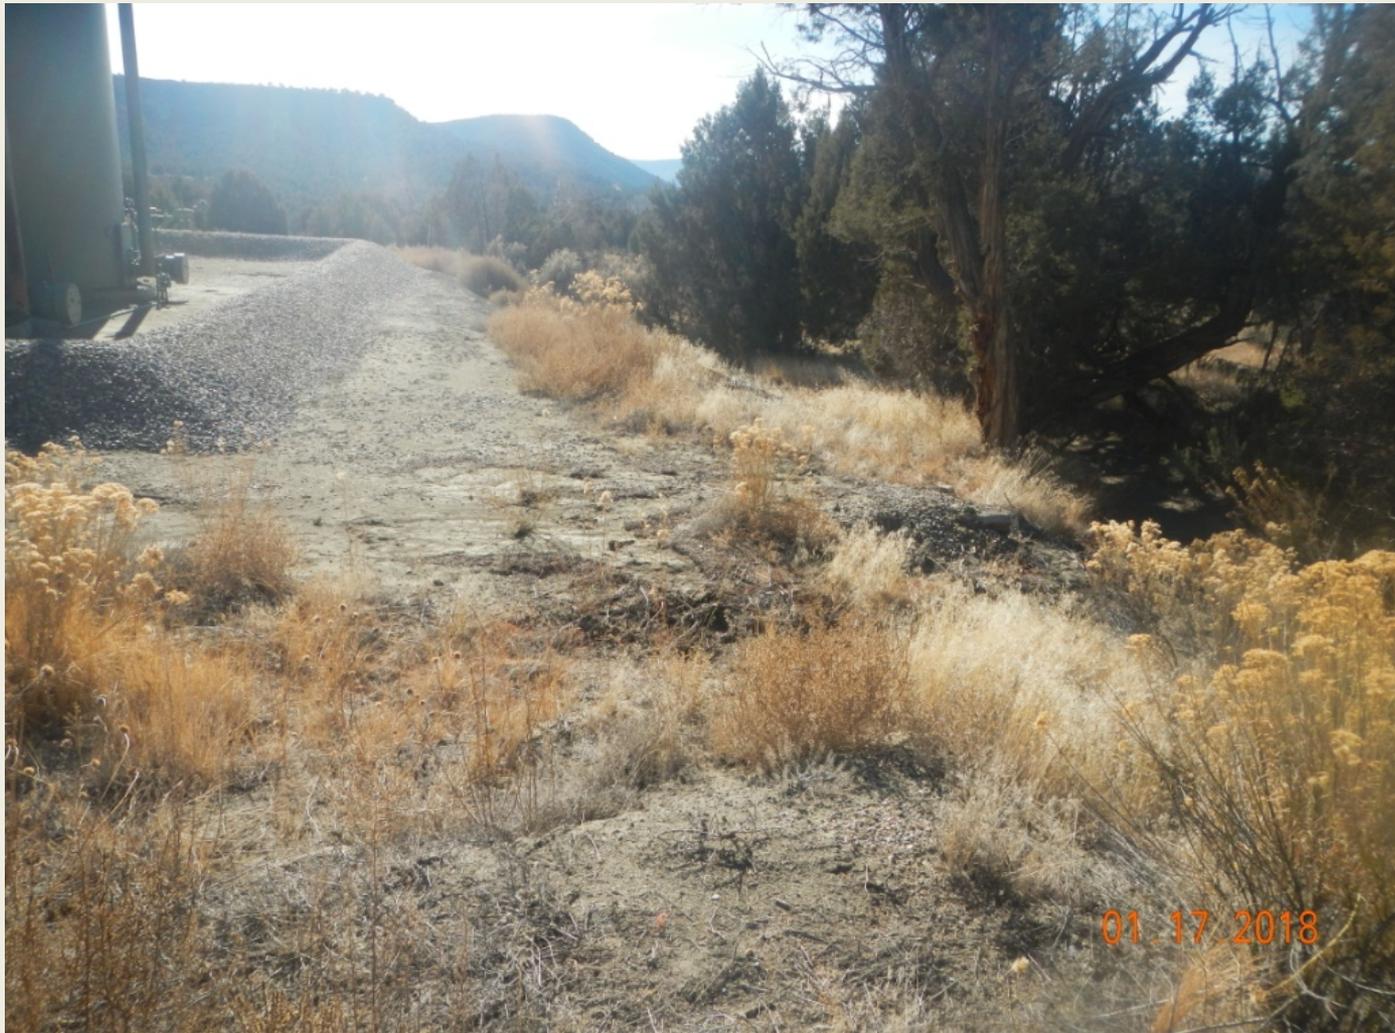
**Photo 3. View of the western portion of the project area from northwestern corner facing southward. Erosion is occurring off of the northwestern edge of the well pad.**

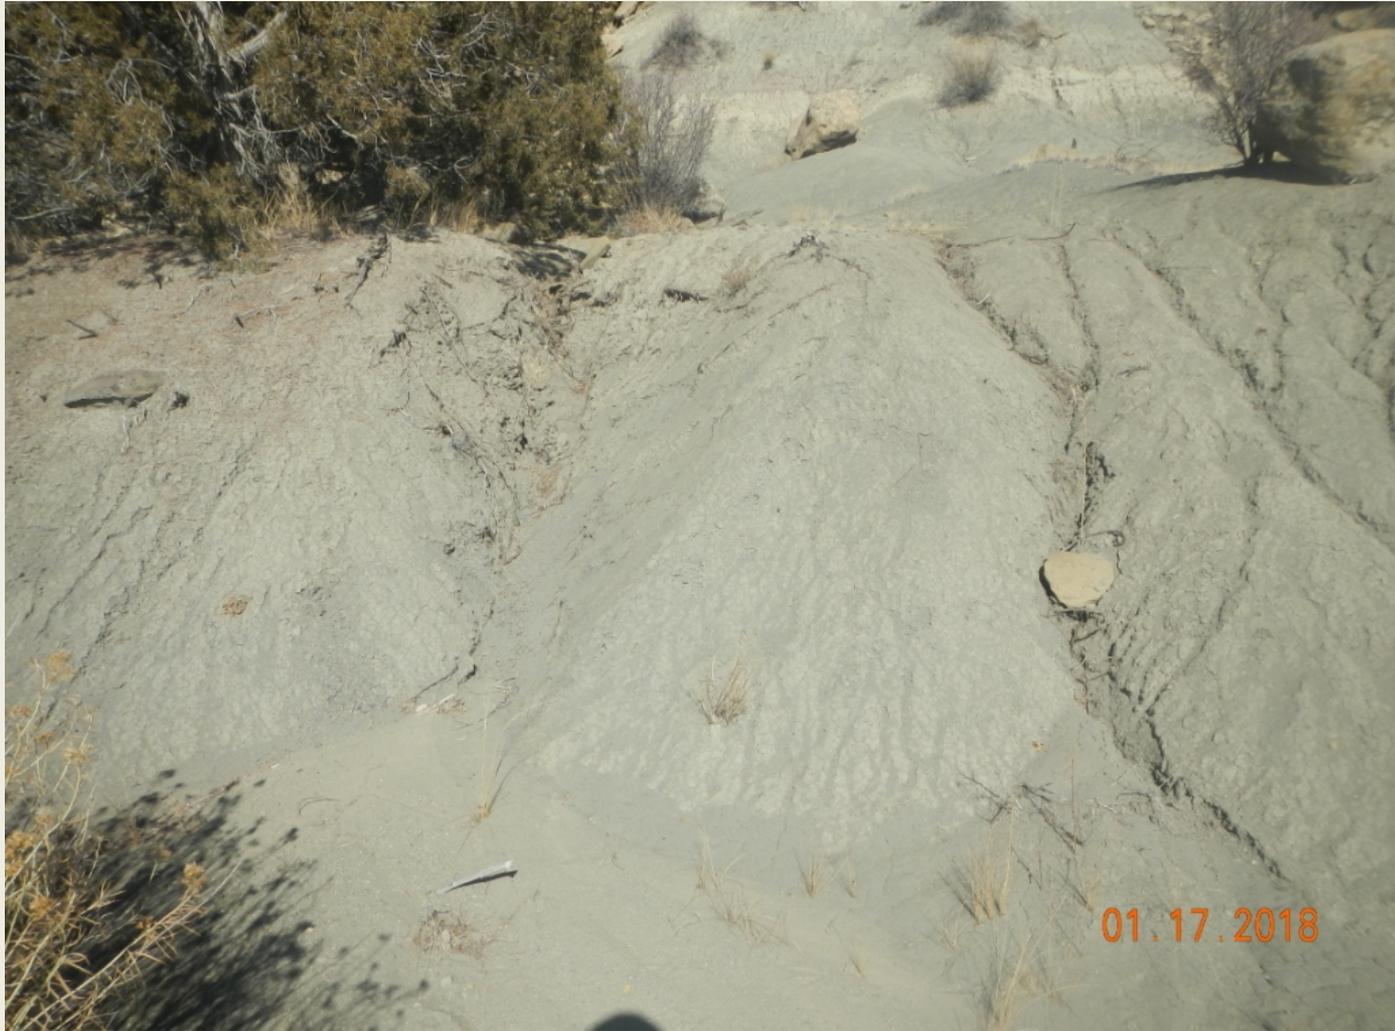
**Photo 4. View of erosion occurring within the northern portion of the project area.**

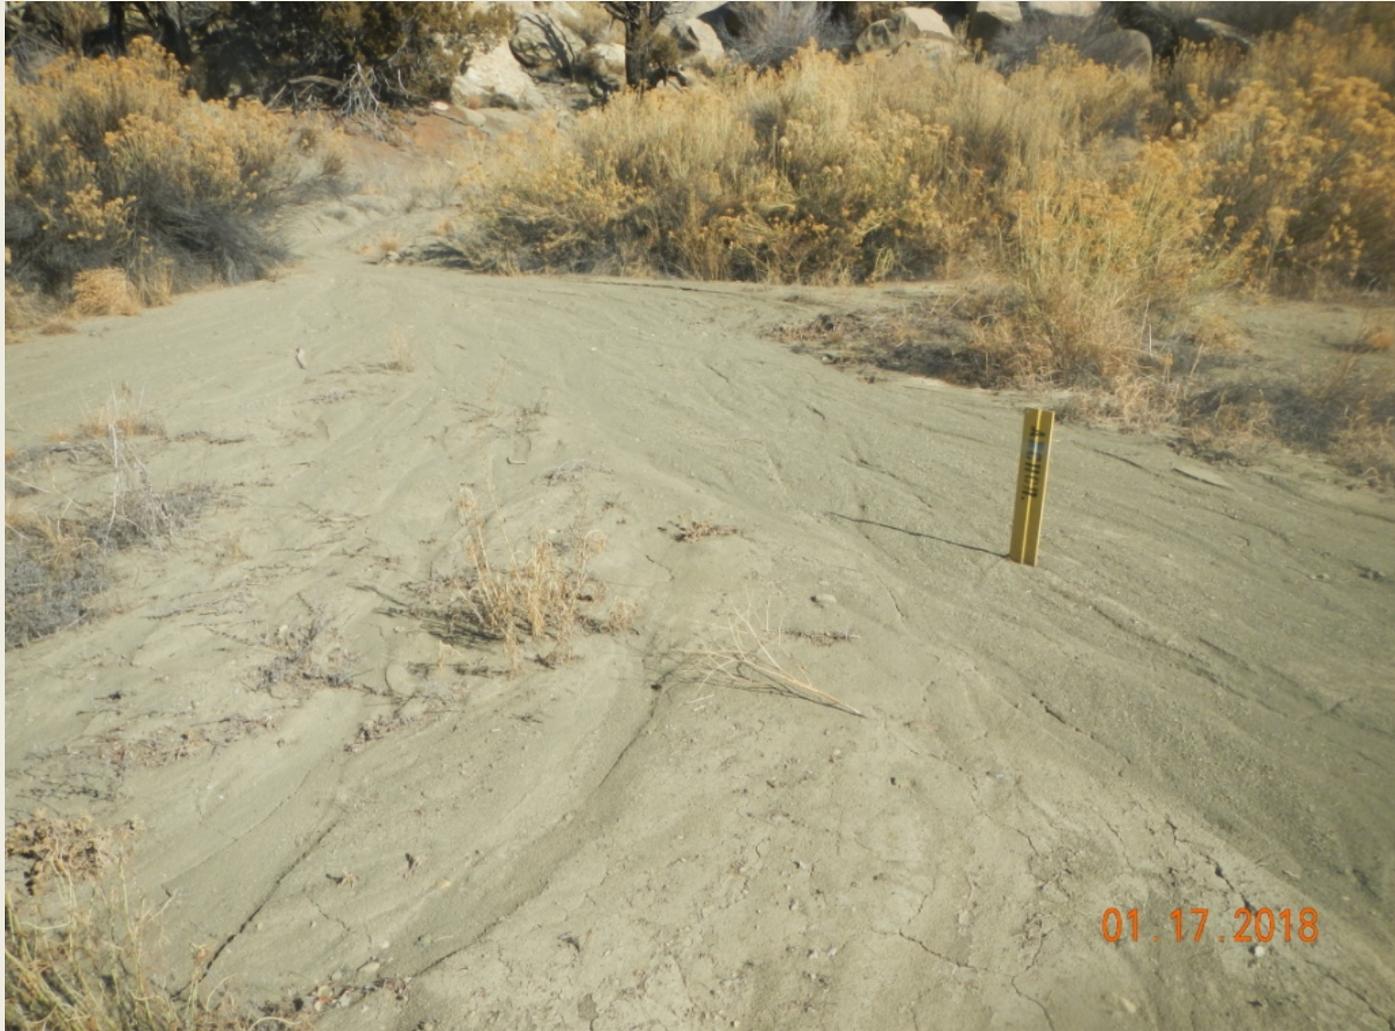
**Photo 5. View of area in the eastern portion of the project area where significant quantities of sediment run onto the well pad. Anchor marker is largely buried.**

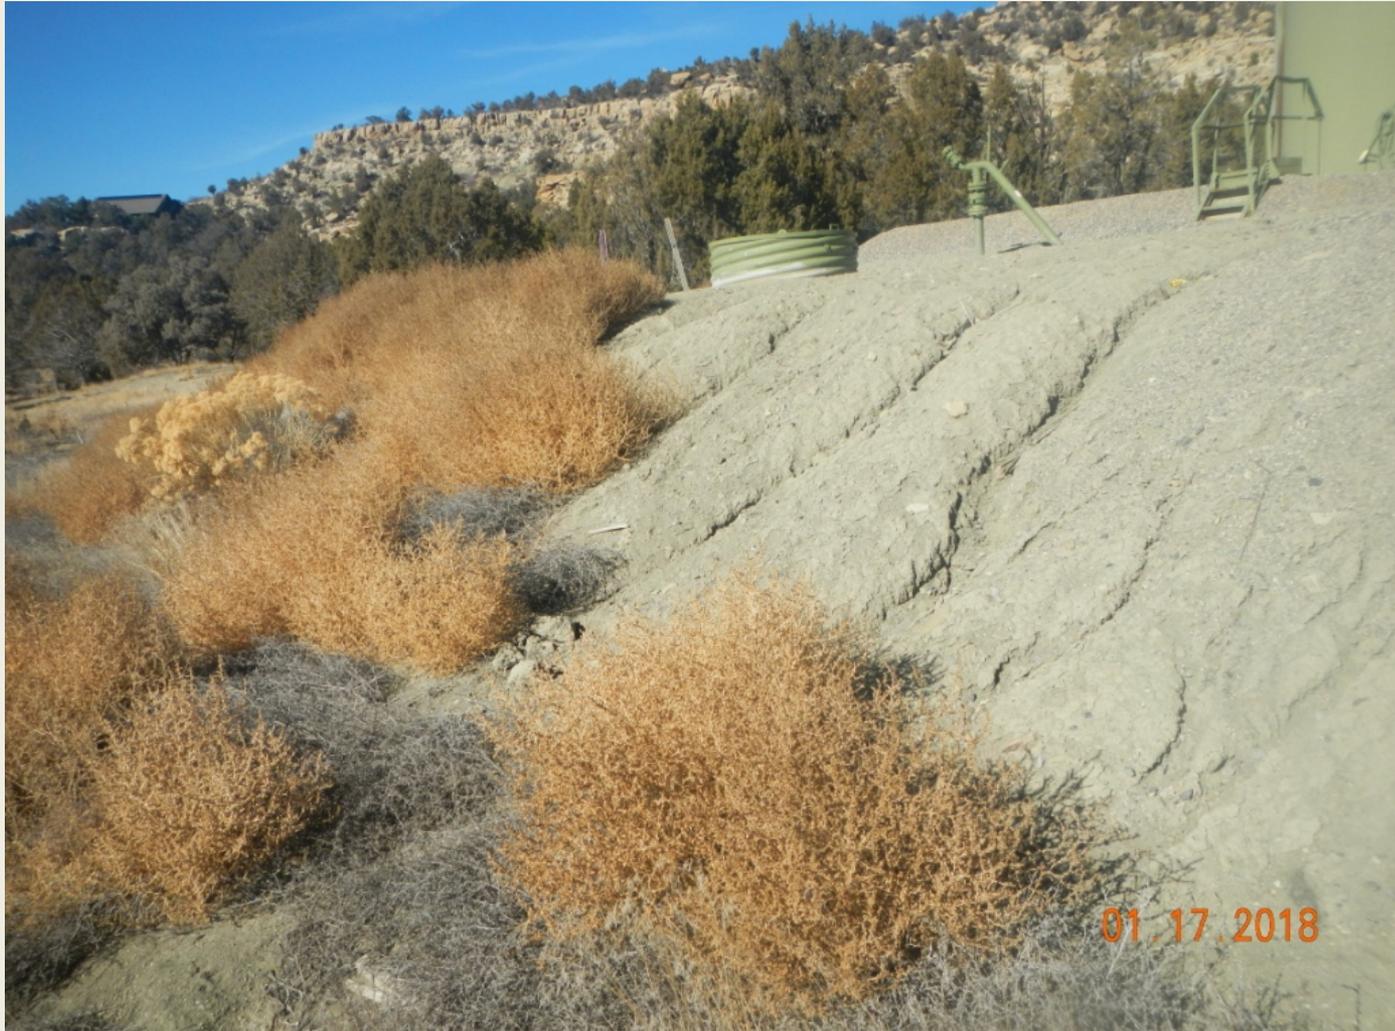
**Photo 6. View of erosion channels and Russian thistle (*Salsola tragus*) debris within the southern portion of the project area. This slope needs stabilization, and seeding. R. thistle needs to be removed and properly disposed of.**

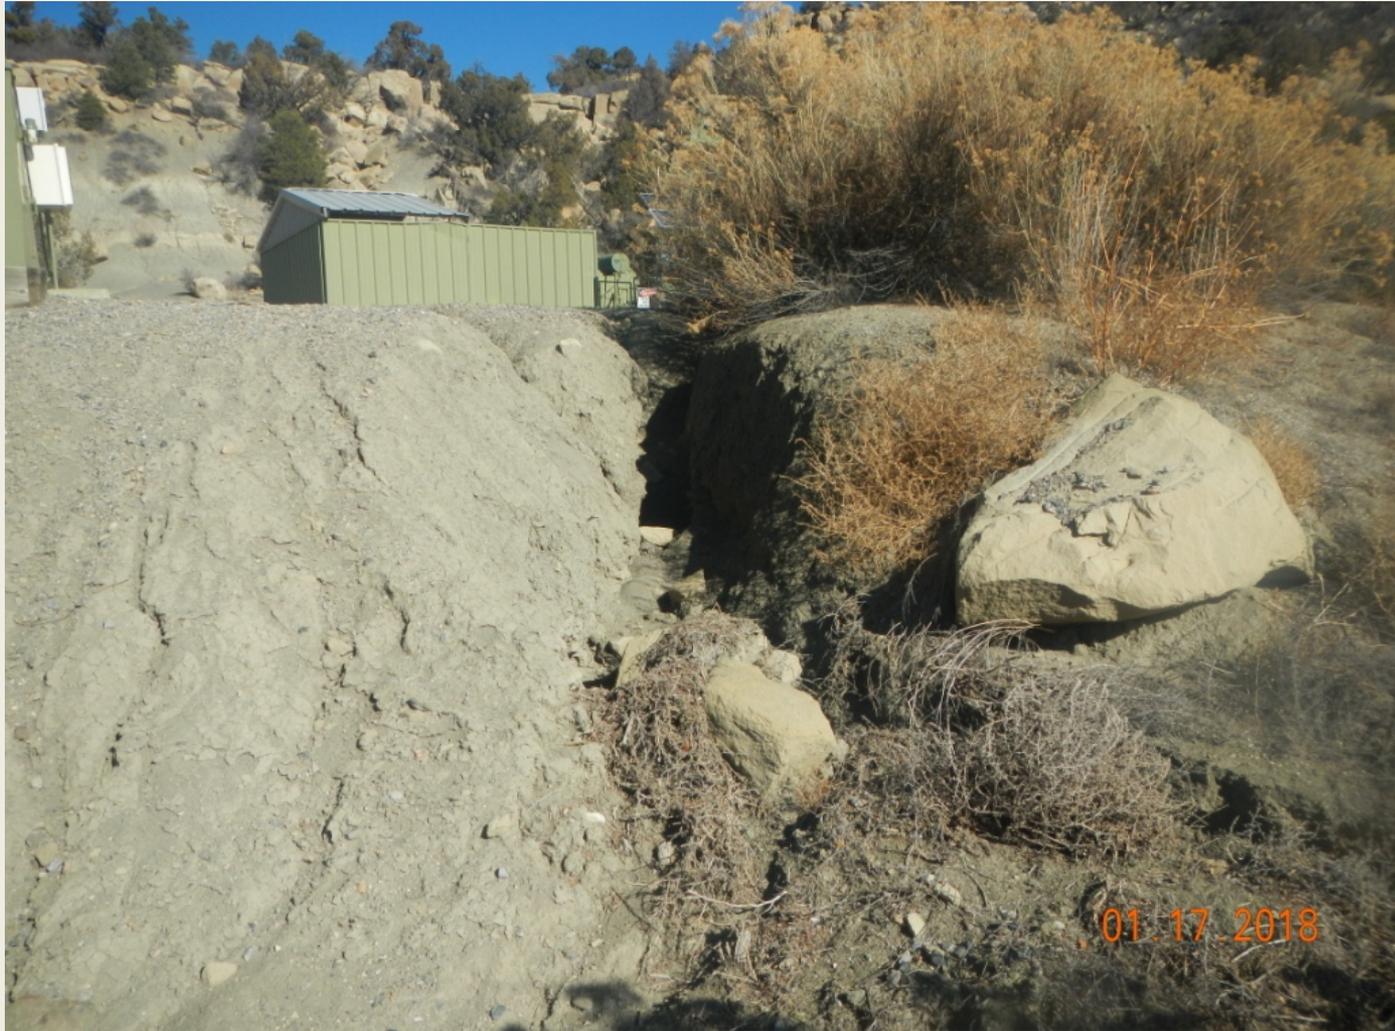
**Photo 7. View of erosional channel approximately 3 feet wide and deep in the southern portion of the project area.**

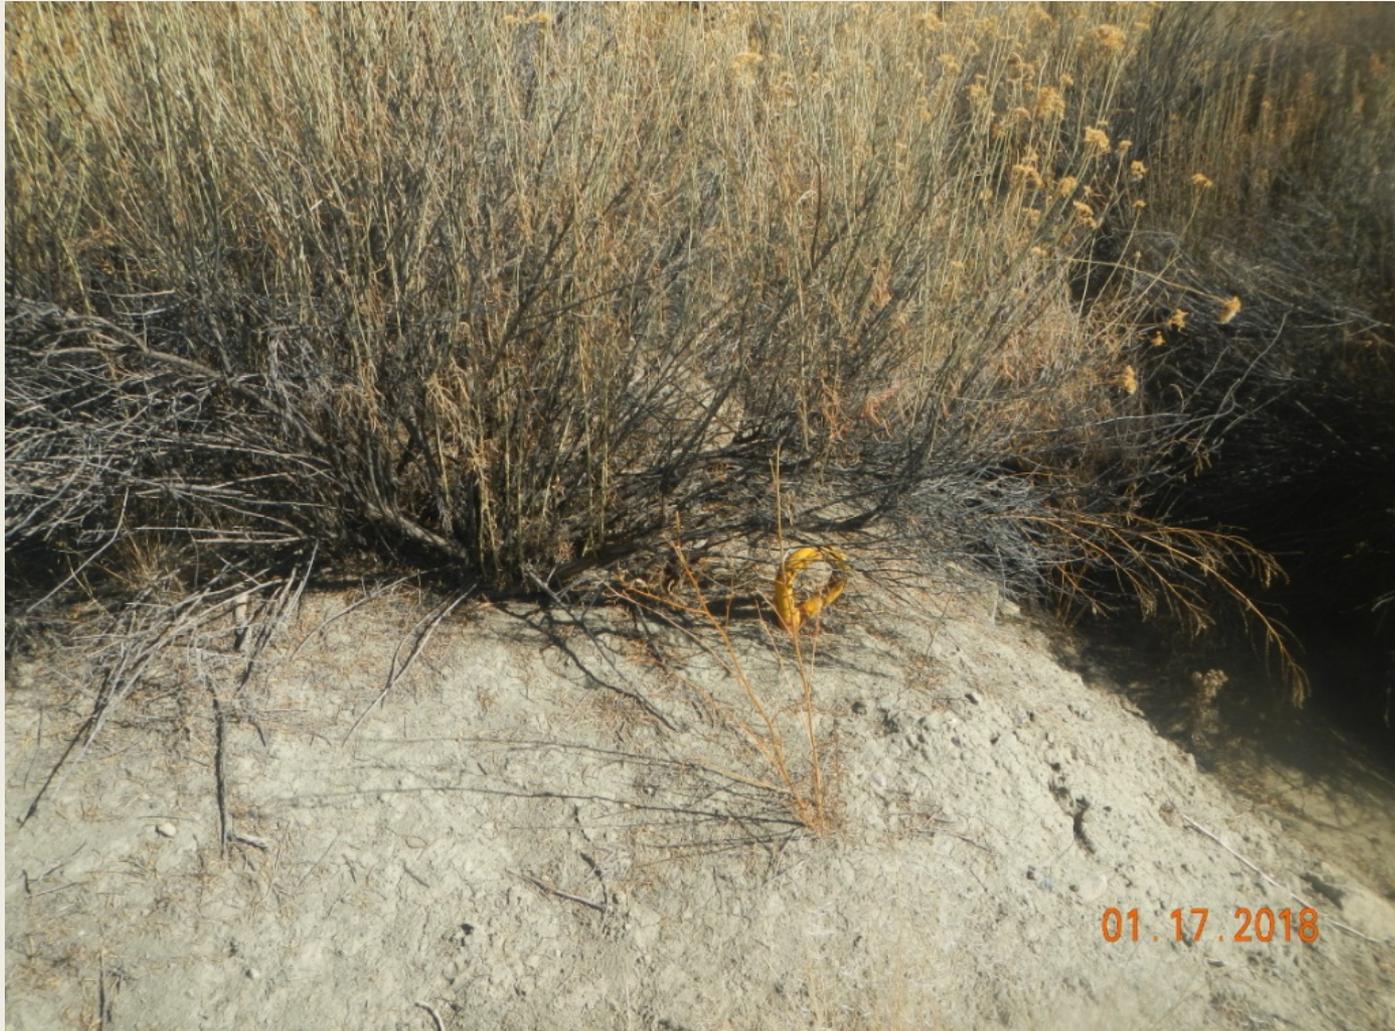
**Photo 8. View of unmarked rig anchor in the southern portion of the project area.**

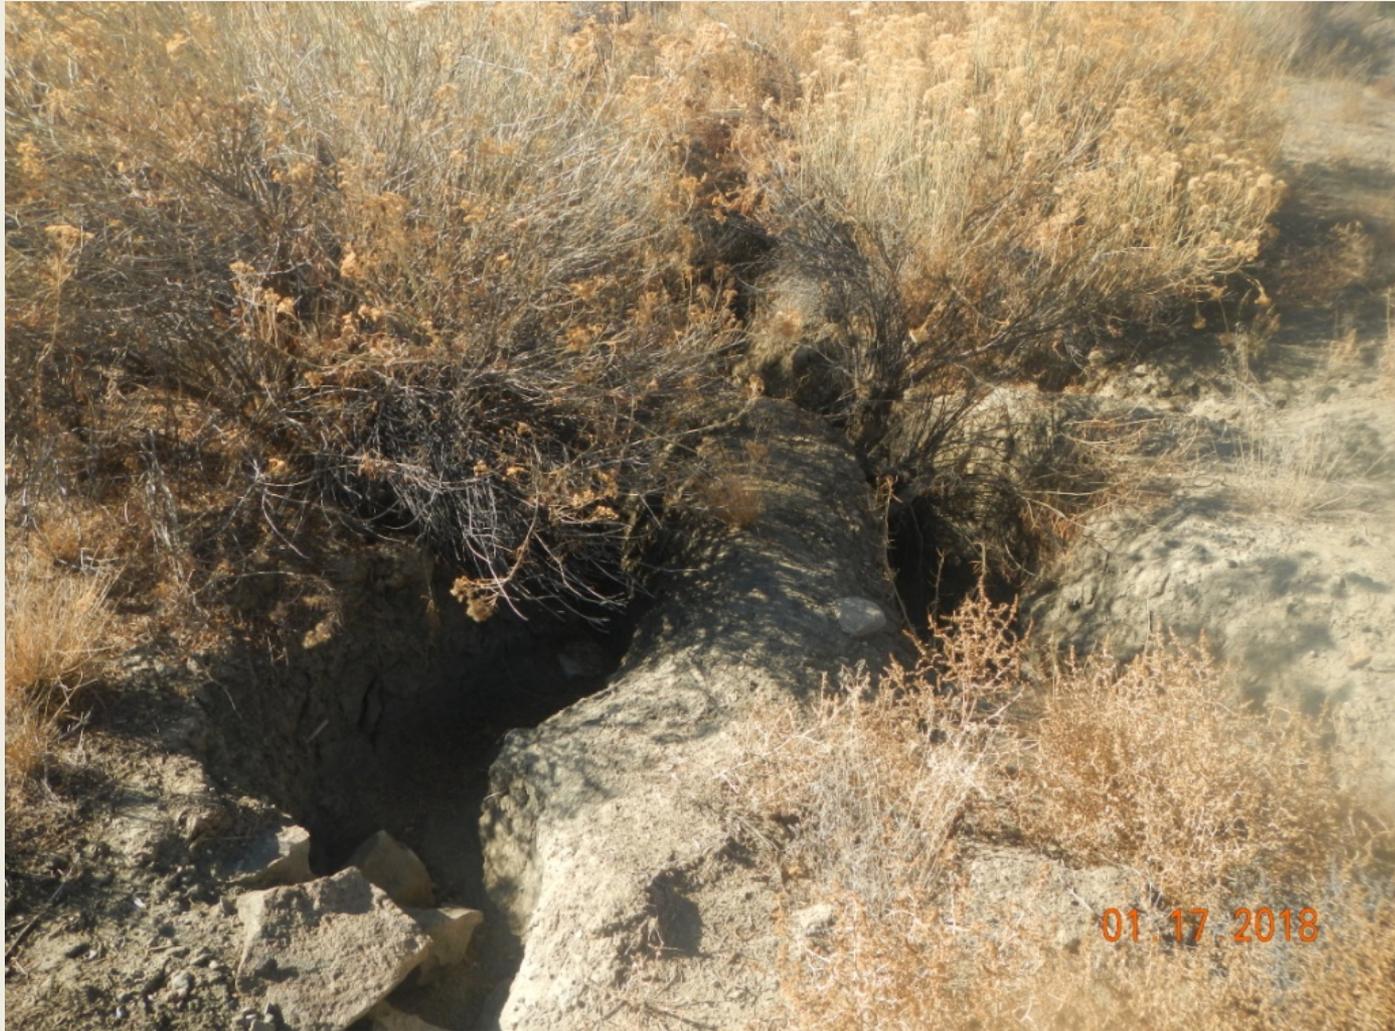
**Photo 9. View of erosional channels up to 3 feet wide and deep in the southern portion of the project area.**

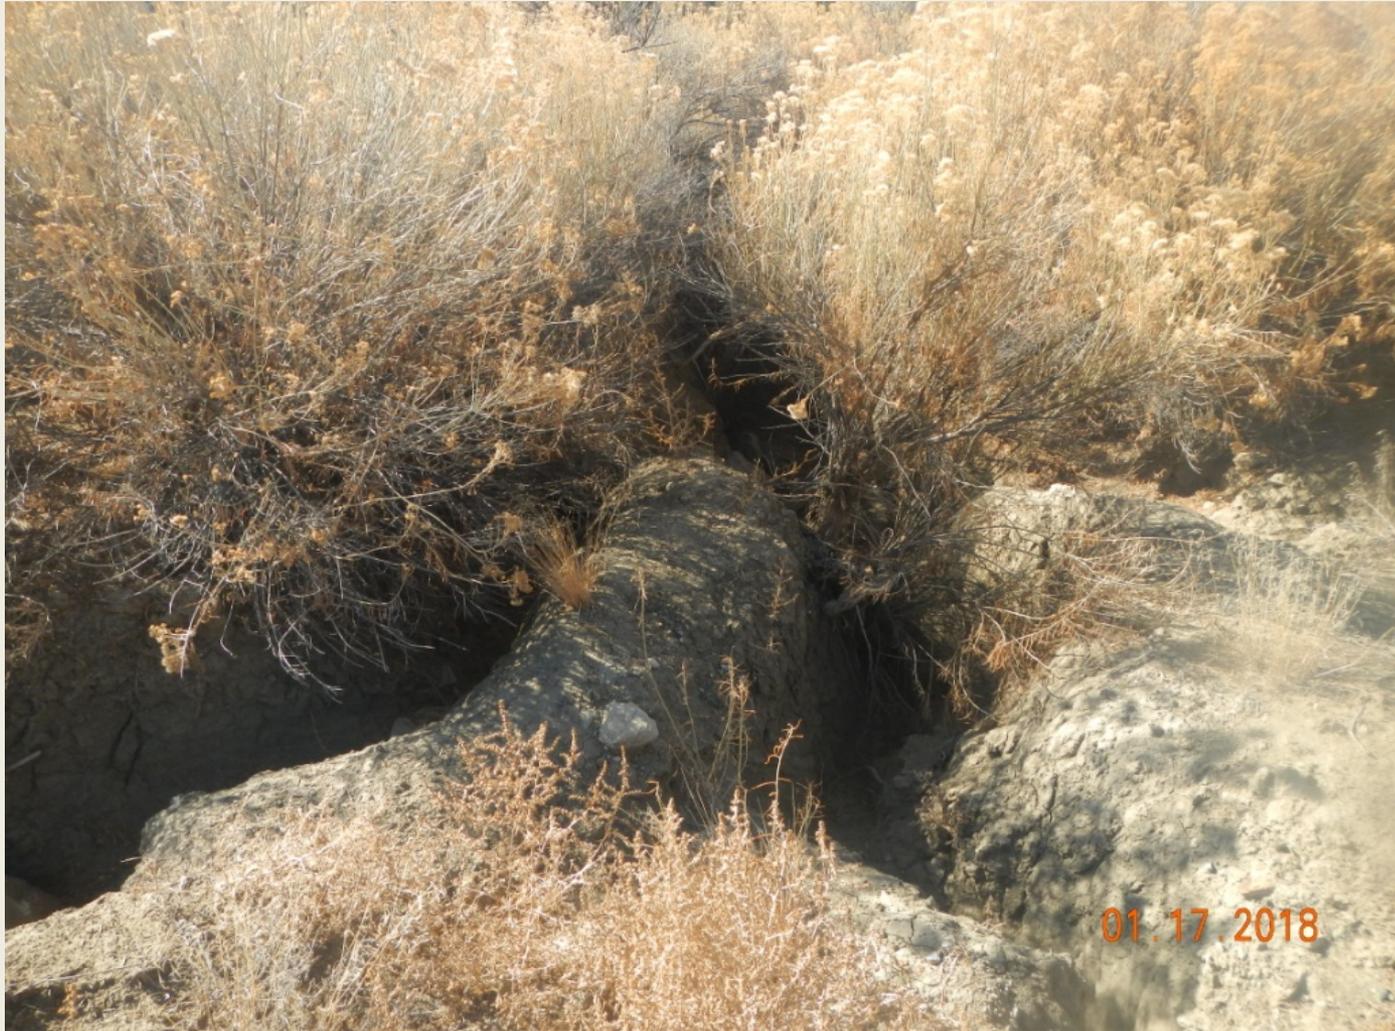
**Photo 10. View of another erosional channel up to 3 feet deep in the southern portion of the project area.**
