- Tyner – Lunt (EPA) 1
- 05-067-06140

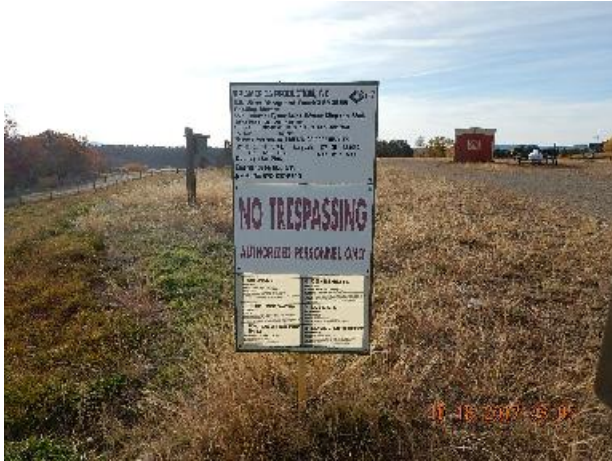
Photo 1: Wellhead sign. Previous inspection.

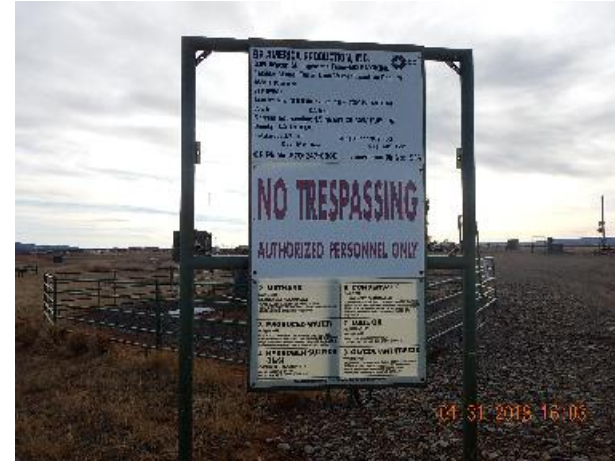
Photo 2: Wellhead sign.

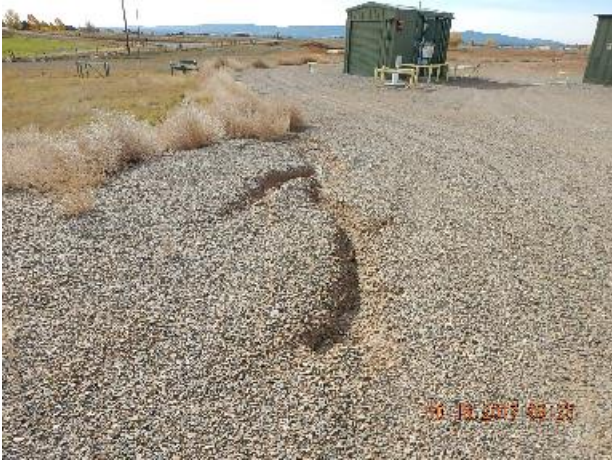
**Photo 3: Erosion channel at E side of tank battery. Previous inspection.**

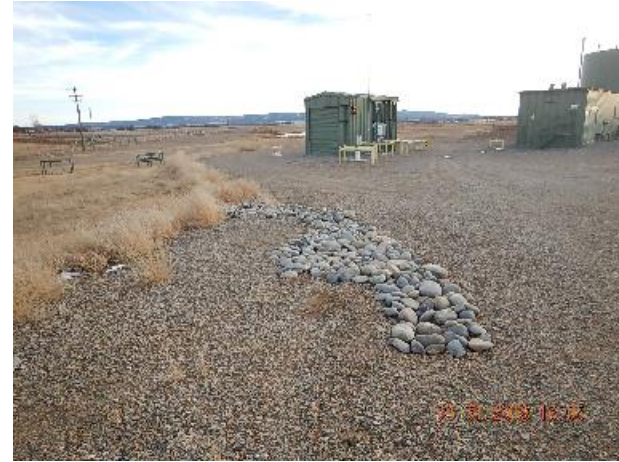
**Photo 4: Repaired erosion channel on E side of tank battery.**

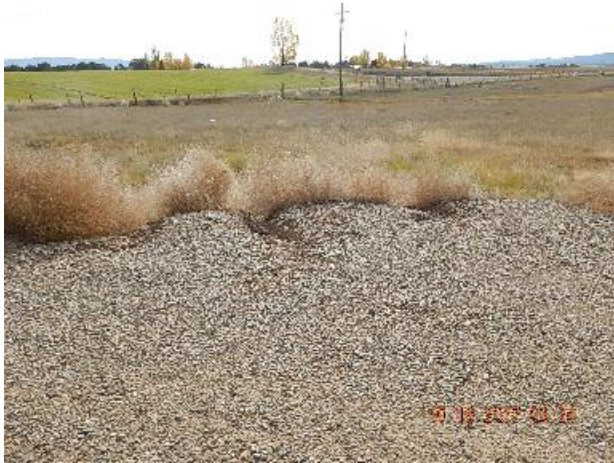
**Photo 5: Erosion channels along S perimeter. Previous inspection.**

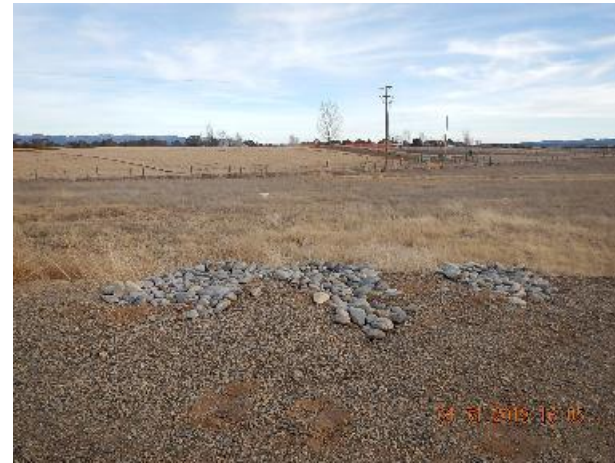
**Photo 6: Repaired erosion channels along S perimeter.**

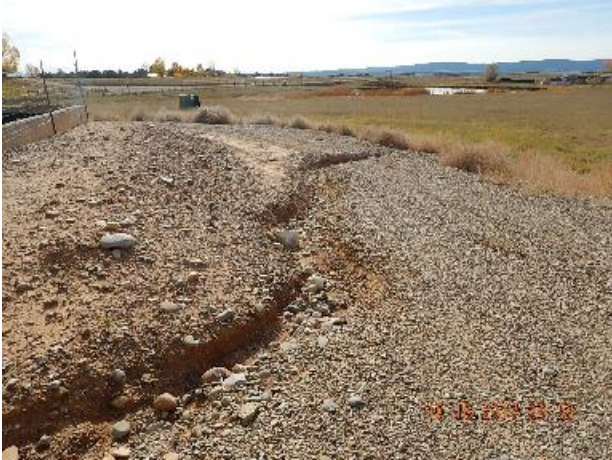
**Photo 7: Erosion channel on W side of tank battery. Previous inspection.**

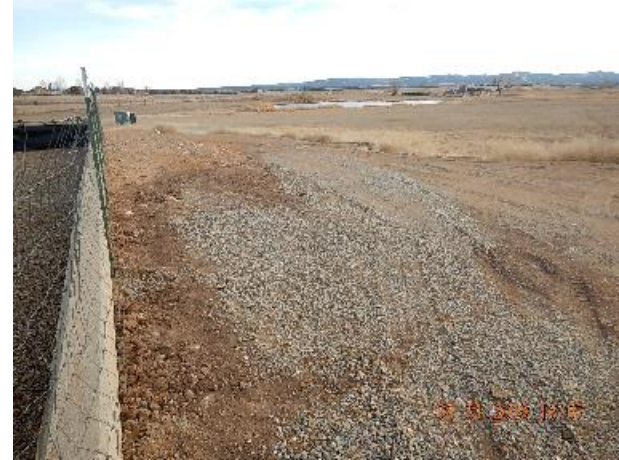
**Photo 8: Repaired erosion channel on W side of tank battery.**

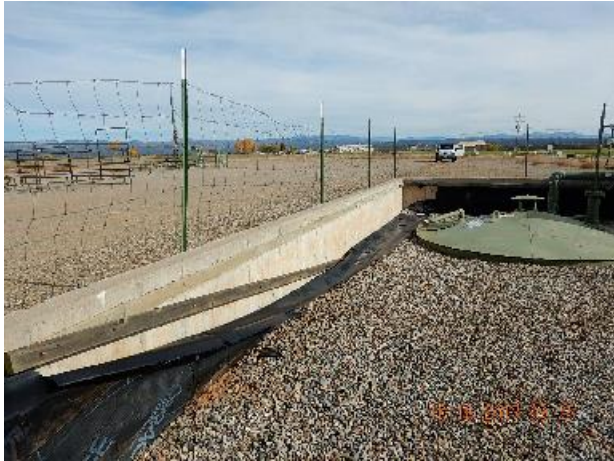
**Photo 9: Liner detached from wall. Previous inspection.**

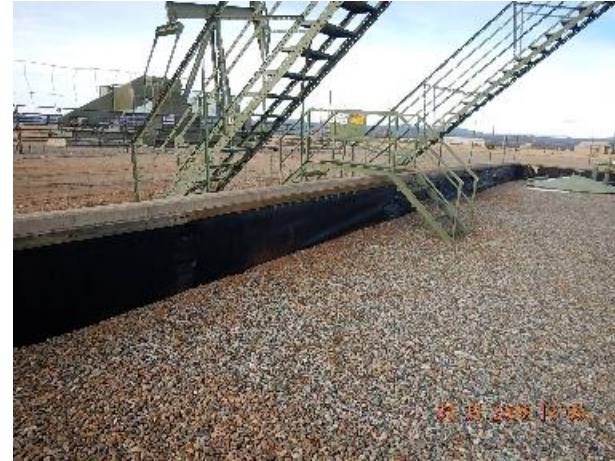
**Photo 10: Repaired liner.**

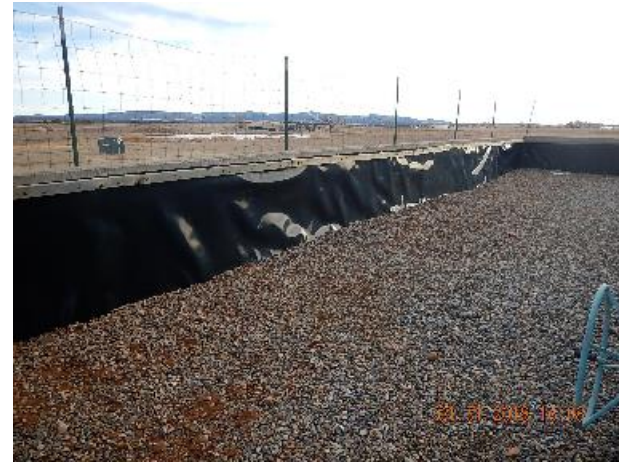
**Photo 12: Replaced/repared liner.**
