Well Name : Bullseye 2

API # : 067-09286

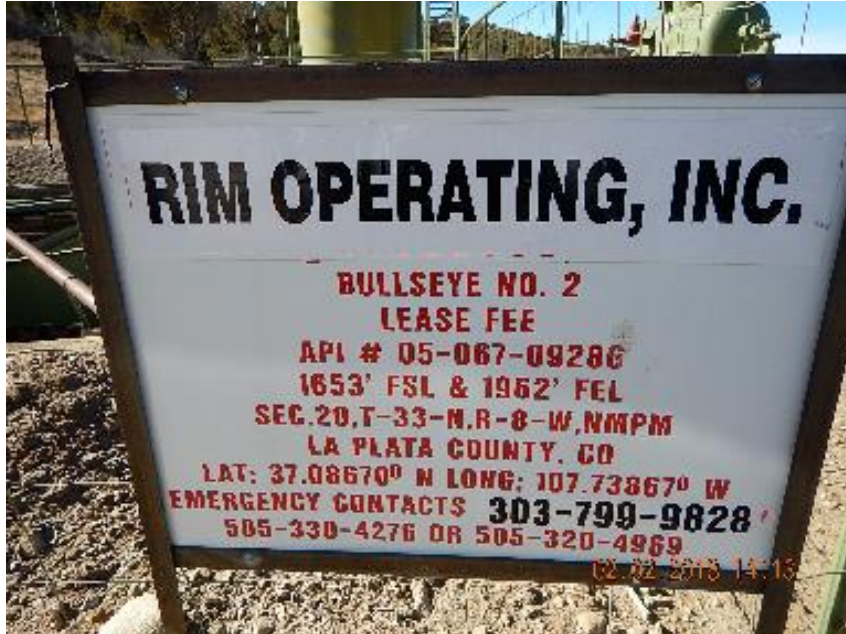
Photo 1: Wellhead sign.

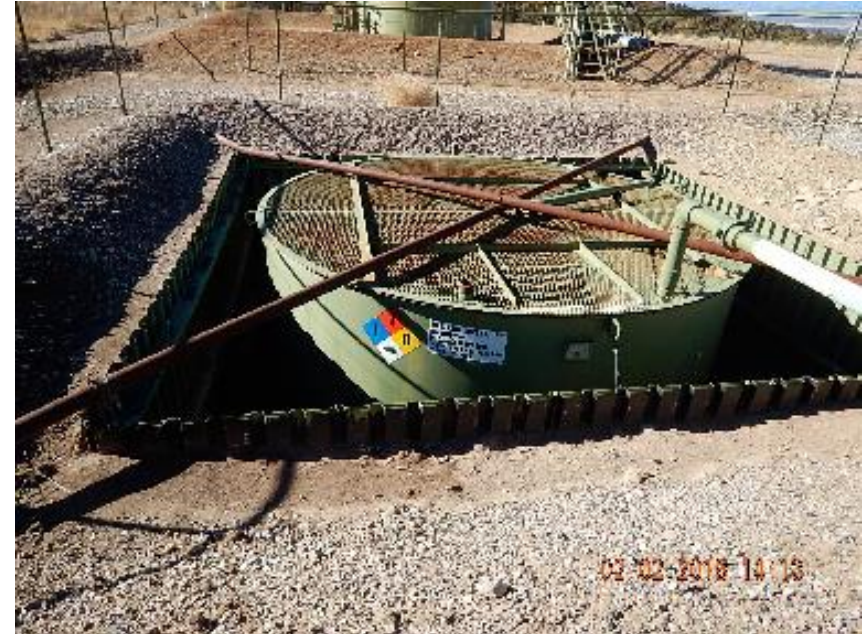
Photo 2: Open top tank with below grade labels.

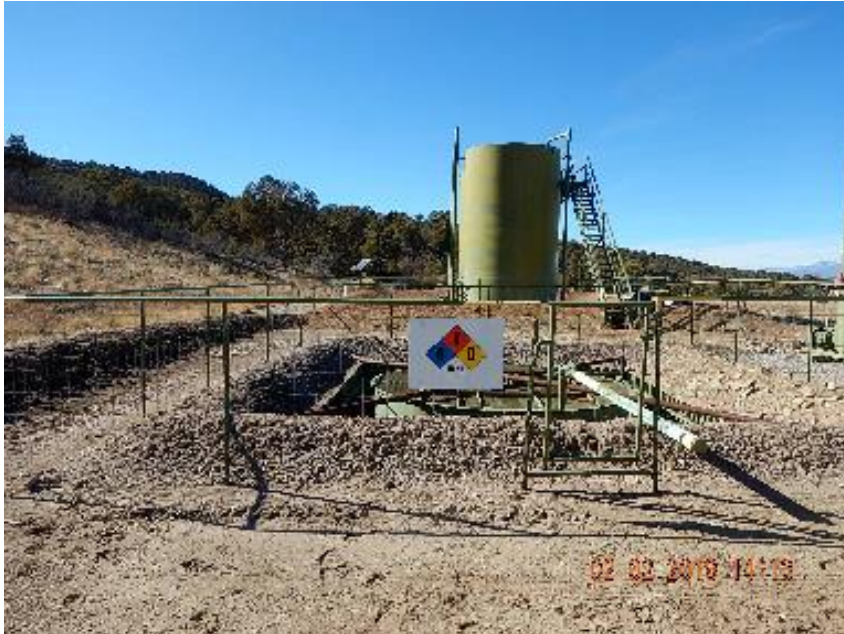
Photo 3: Tank labels below grade and not visible. NFPA label on fencing does not match label on tank.

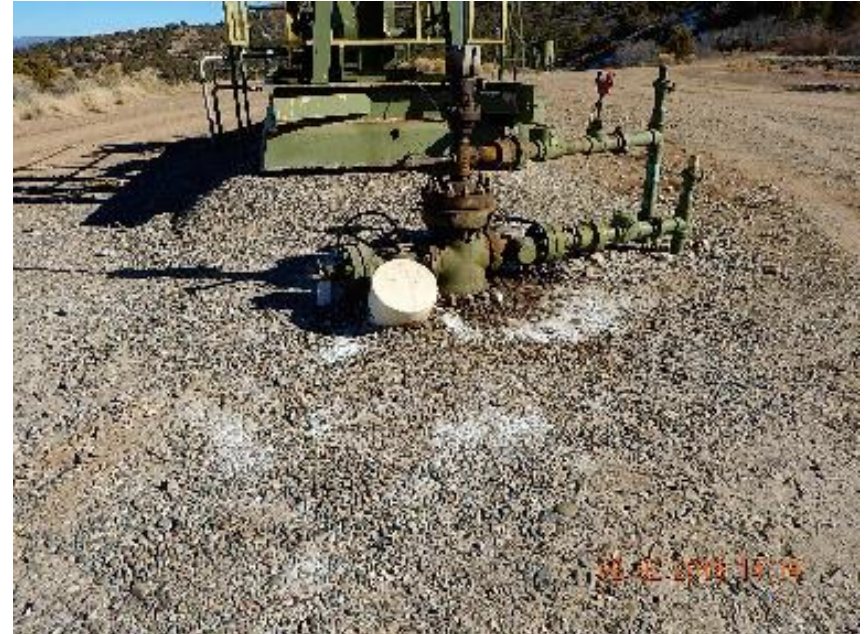
Photo 4: Impacted soil around wellhead.

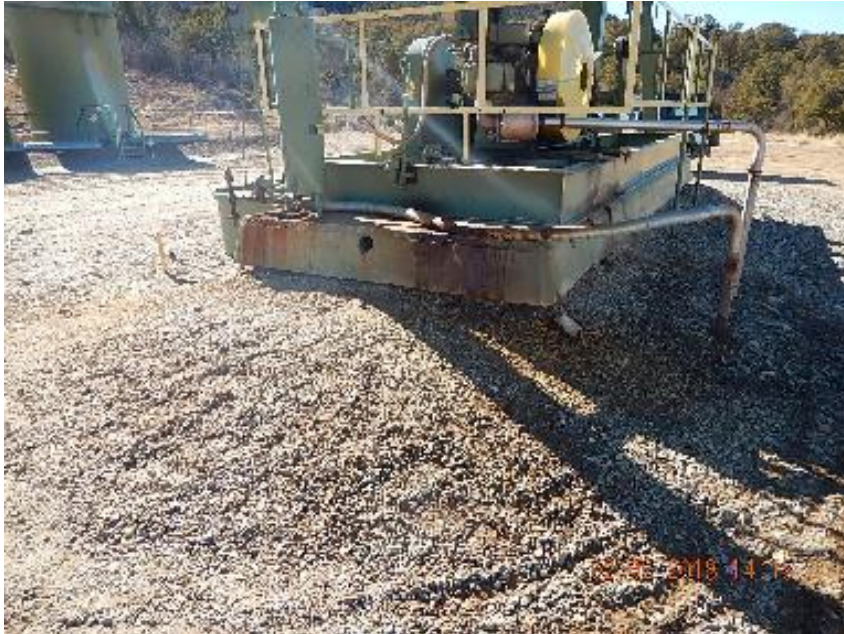
Photo 5: Impacted soil at rear of pump jack.

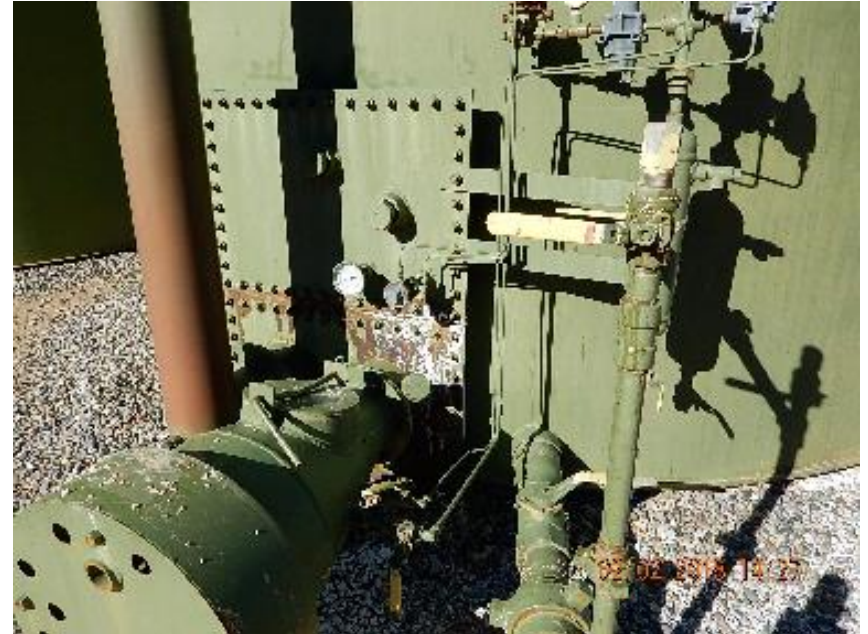
Photo 6: Mineral deposits on tank heater tube hatch.

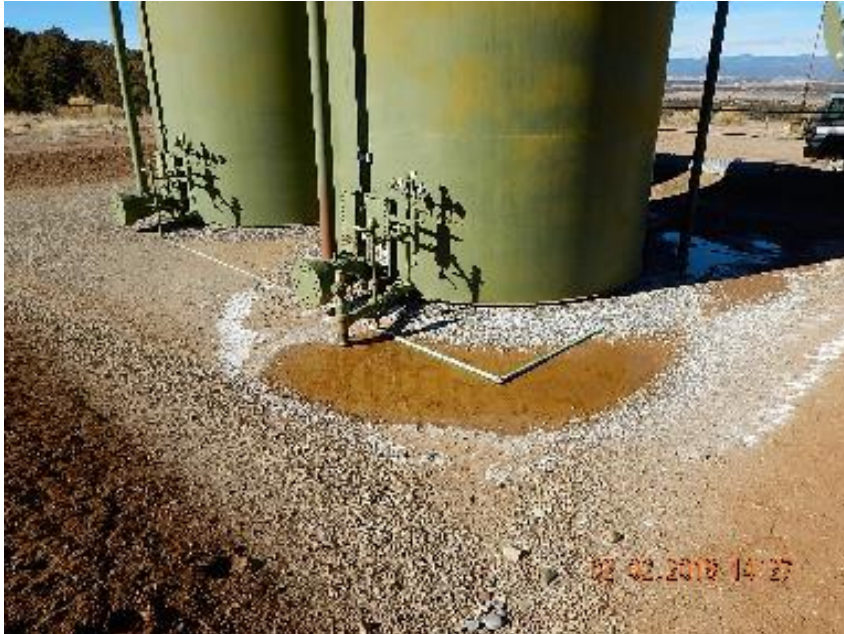
Photo 7: Mineral ring around base of tank. Inside berms.

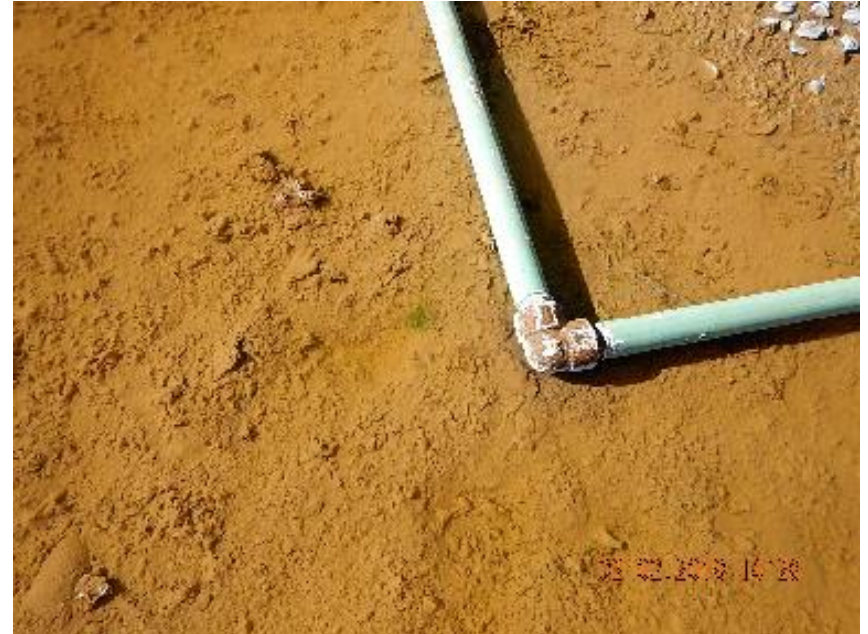
Photo 8: Algae in standing water.

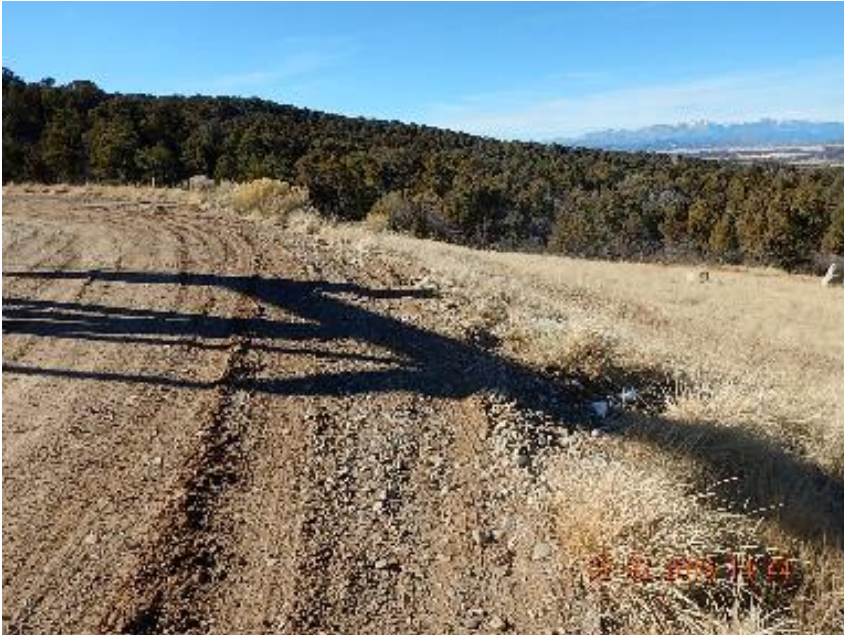
Photo 9: Vehicle tracking on edge of disturbed area N side of pump jack.

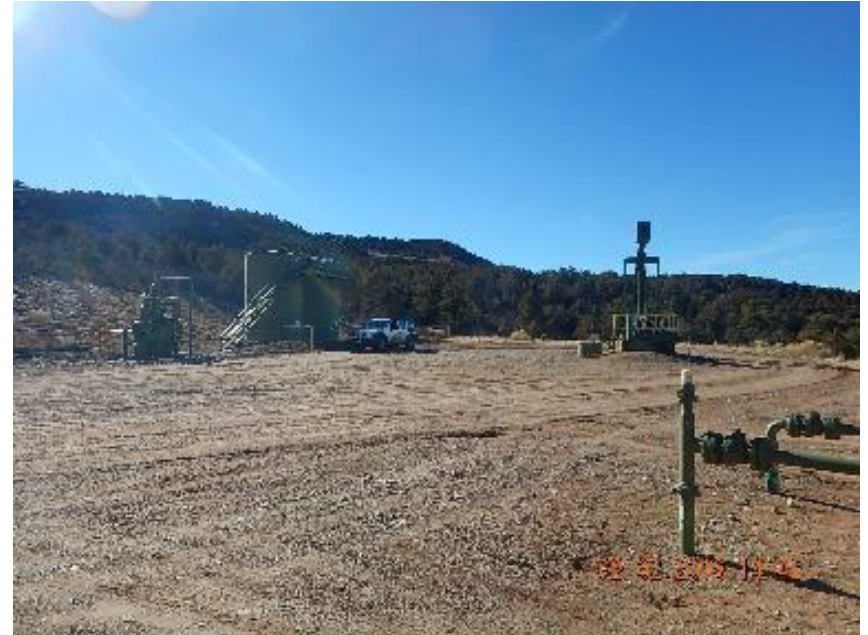
Photo 10: Location overview.
