Inspection Photos
Location Name: Snooks A #2
API: 05-067-08870

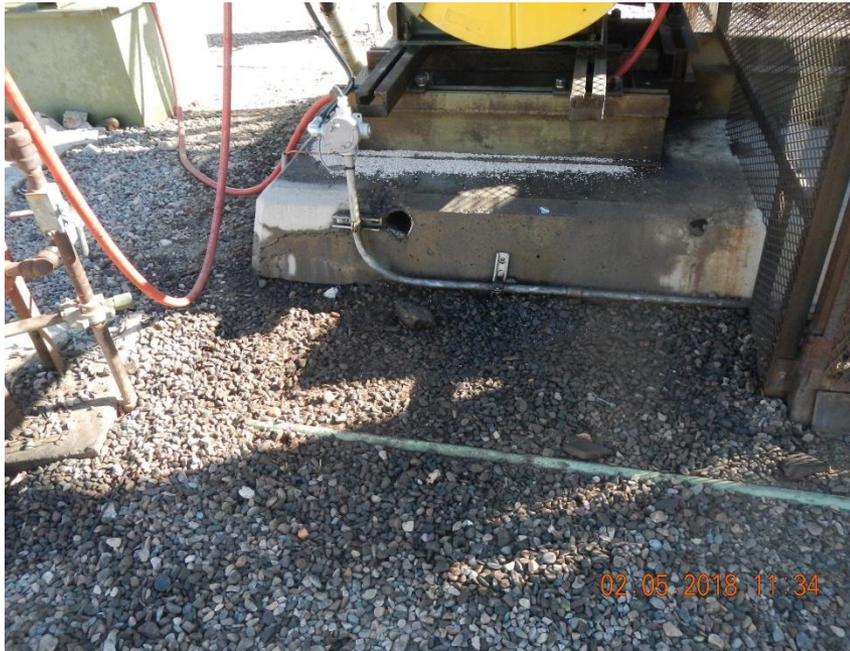
Stained concrete pad and surrounding gravel around prime mover.

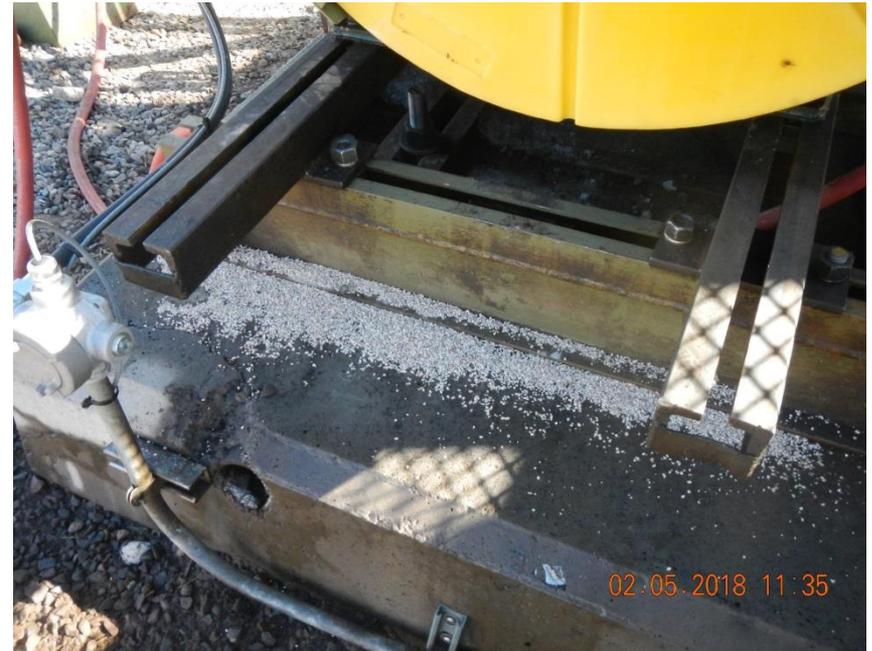
Absorbent granules on concrete pad.

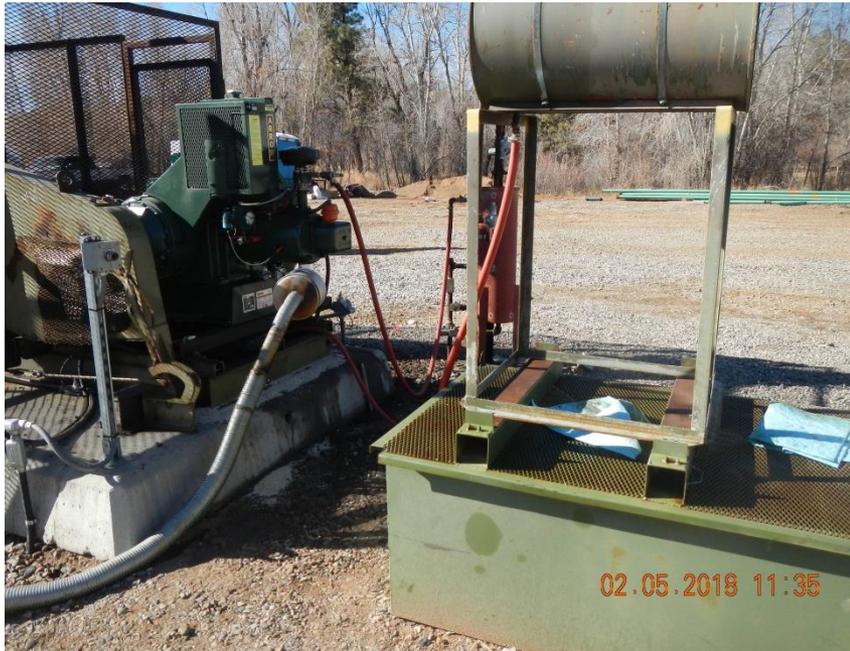
Secondary containment for lube oil container.

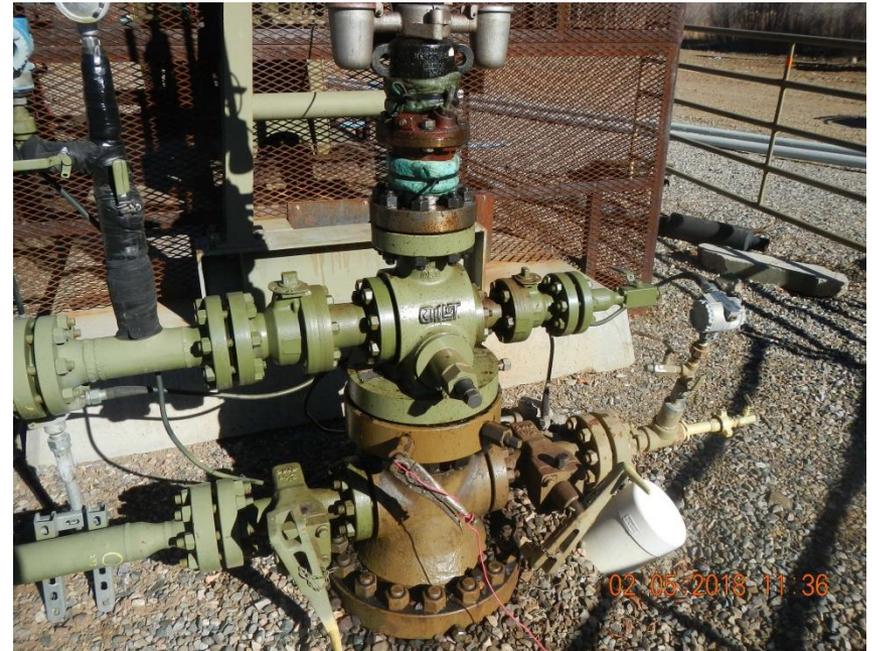
Absorbent rags on well head are saturated.

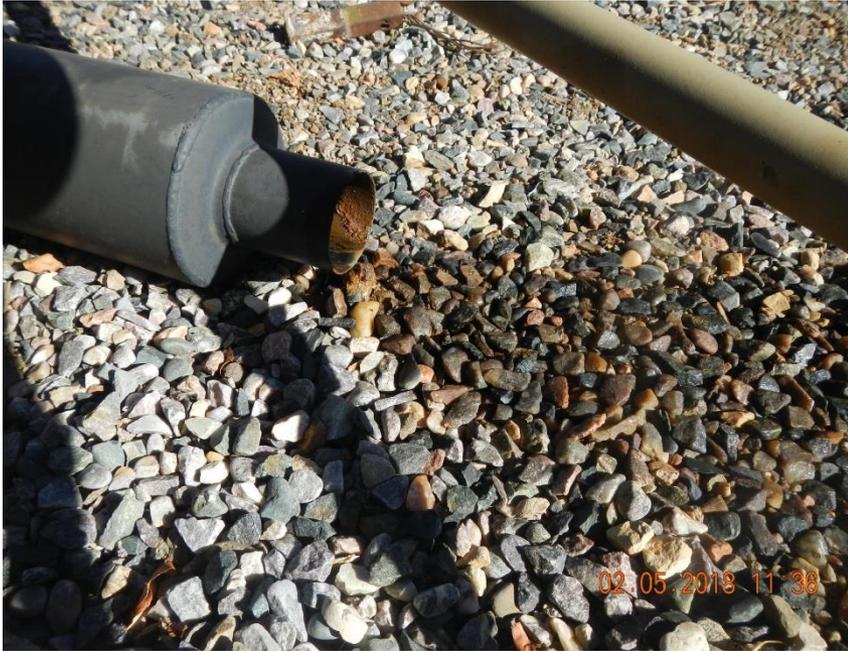
Stained gravel at muffler exhaust.

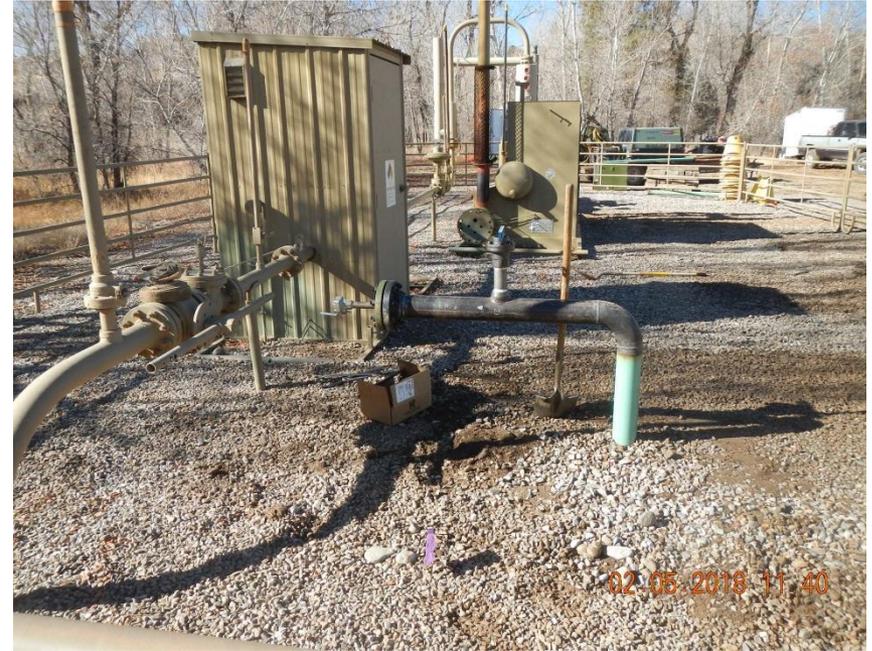
Tie in for Le Platt B #2.

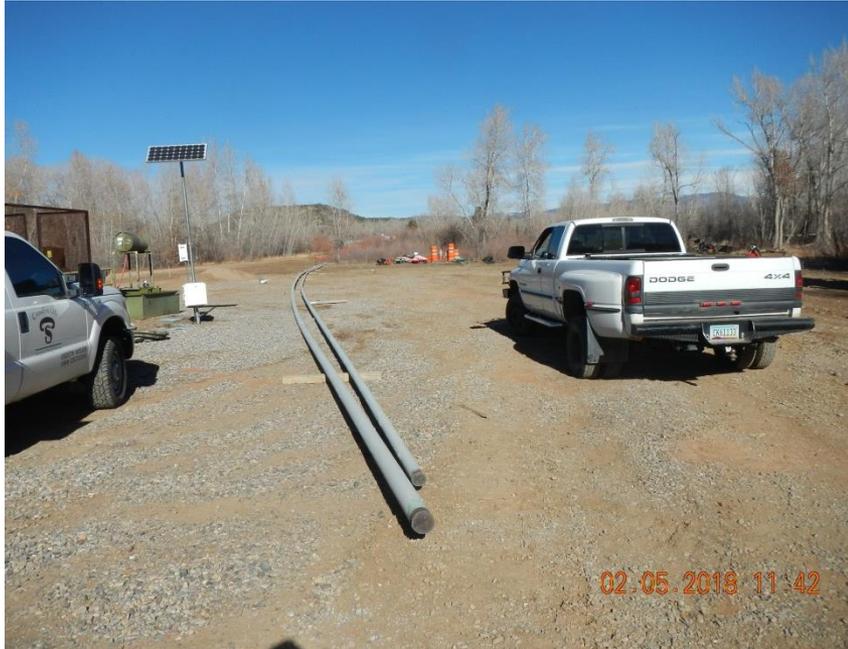
Preparations for tie in.

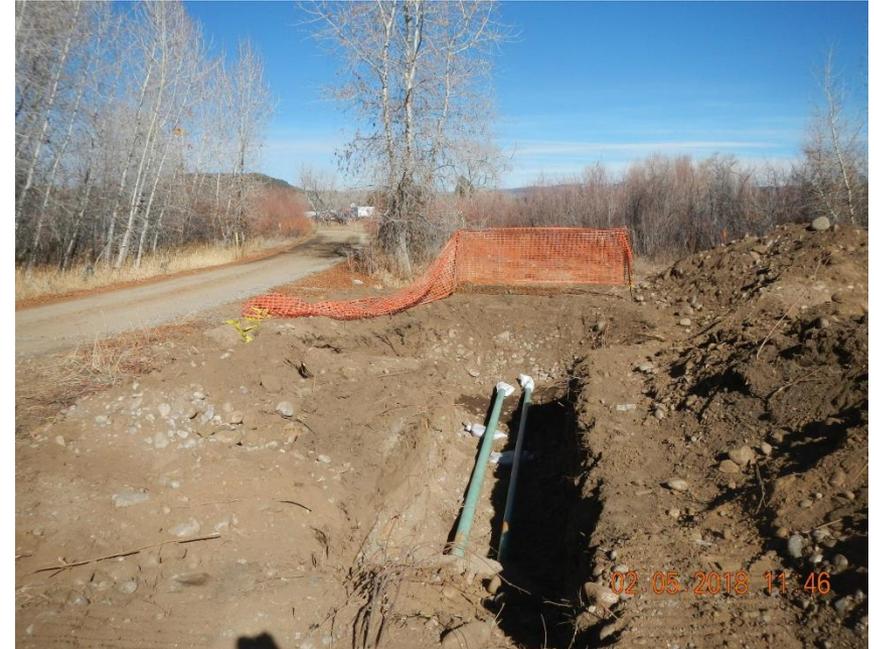
Gathering line excavation. Le Platt B #2 in background.
