# Inspection Photos

Operator: NIOBRARA ILLUMINATING GAS  
ASSOCIATES LLC - 63380

Location ID: 403658

Inspection Doc. Number: 682503114  
Washington County, CO

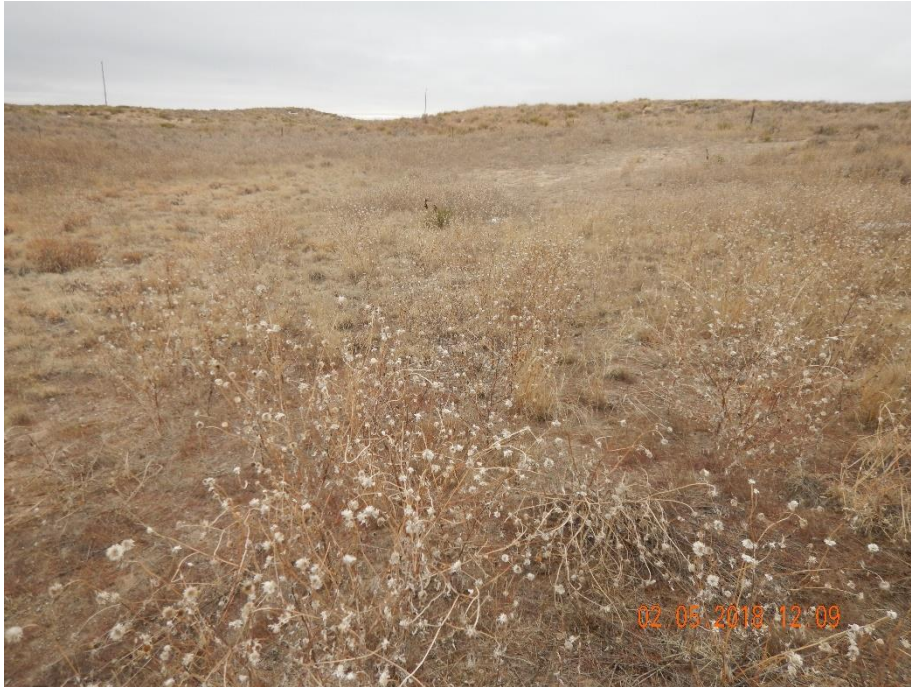
**Photo 1:** Photo taken from the well, facing north. Photo shows vegetation over the western portion of the location. Vegetation seen here is predominantly annual aster species.

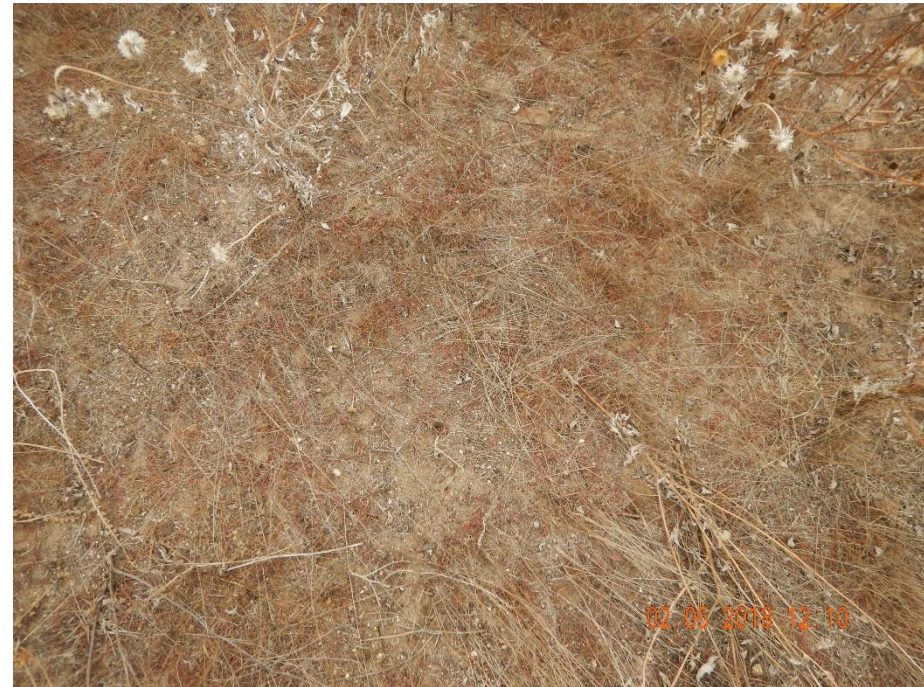
**Photo 2:** Continued from photo 1: soils on location remains predominantly bare and exposed.

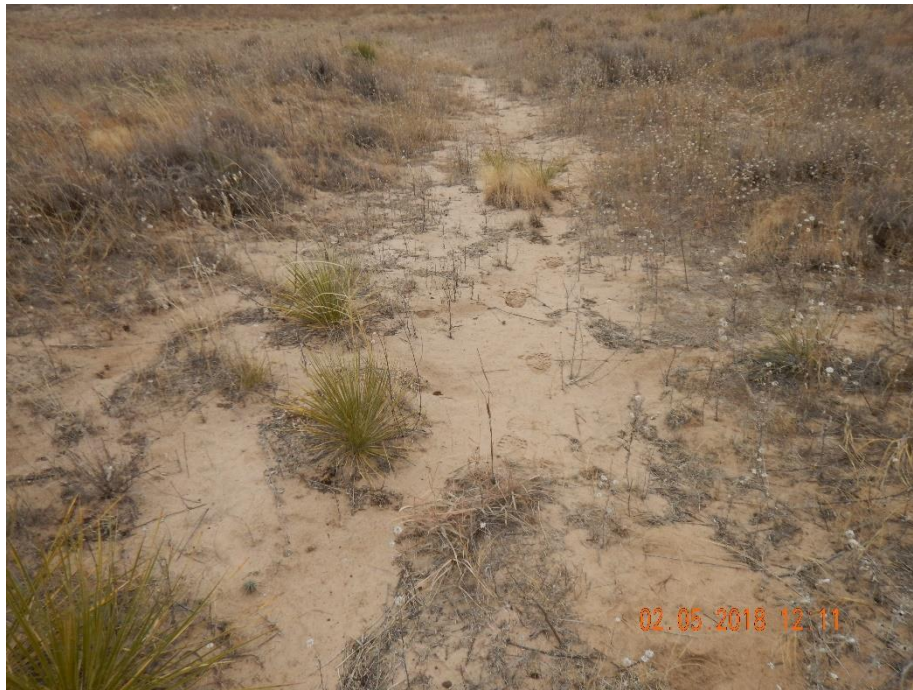
**Photo 3:** Photo taken from the north end of the location, facing east. Photo shows areas of the location and access road that remain unstabilized, and soils remain bare and exposed. Unable to find evidence that additional reclamation activities have been conducted.

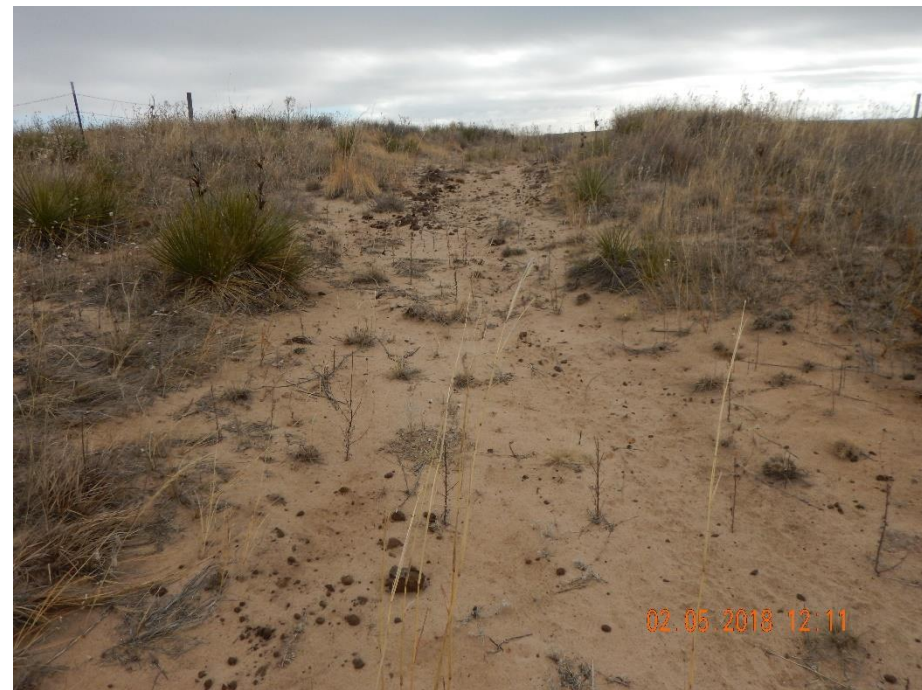
**Photo 4:** Photo taken the east end of the location, facing south. Photo shows portions of the access road on location have not been reclaimed per reclamation rules. Erosion evident. Dark, stained/contaminated soils have not been removed.

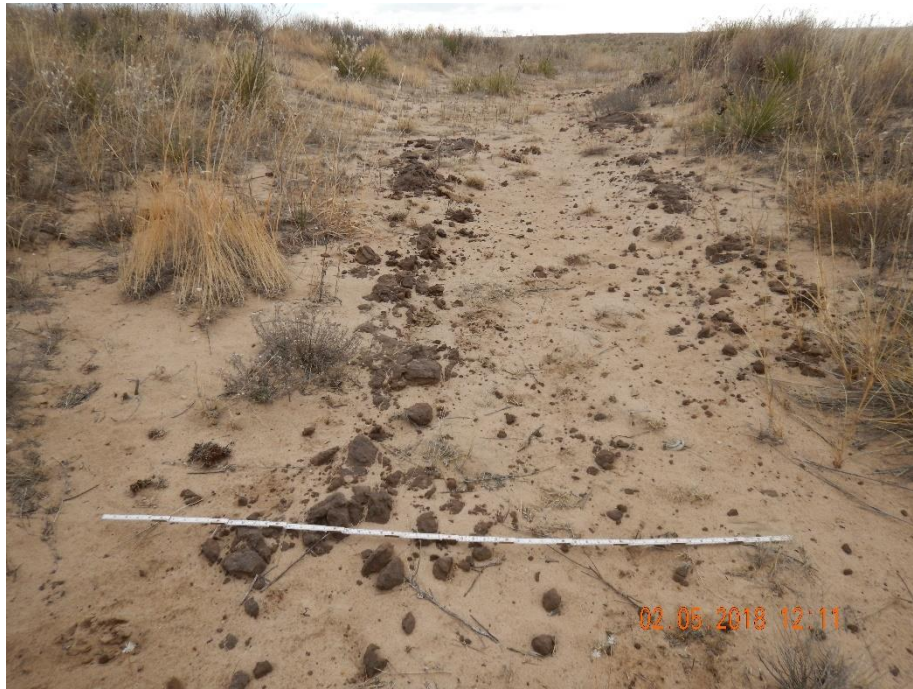
**Photo 5:** Photo taken from the east end of the location, facing south. Photo shows contaminants have not been removed. 6 foot measuring stick for reference.

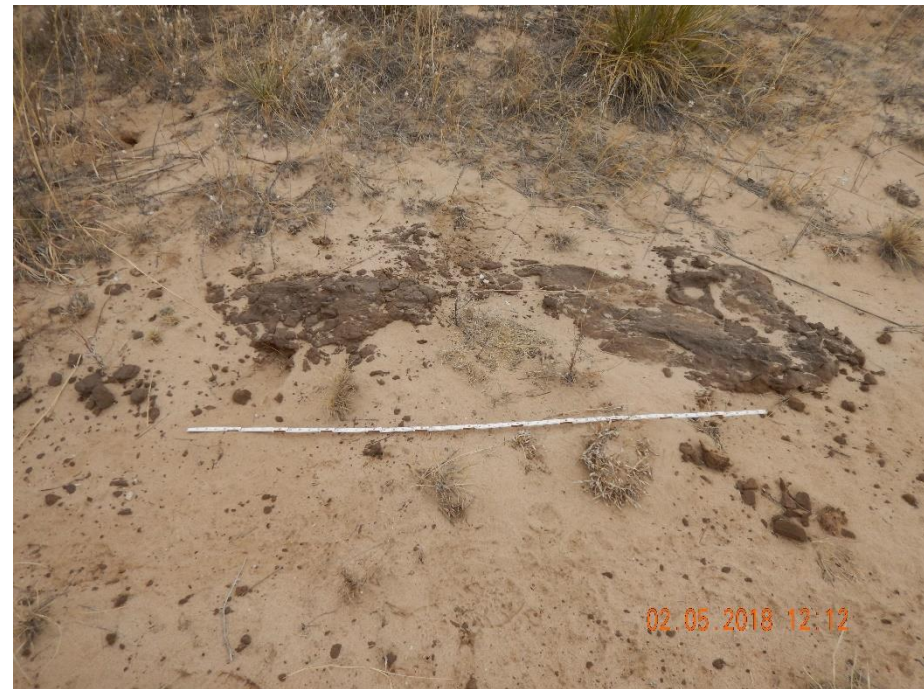
**Photo 6:** Photo taken from the east end of the location. Photo shows contaminants have not been removed. 6 foot measuring stick for reference.

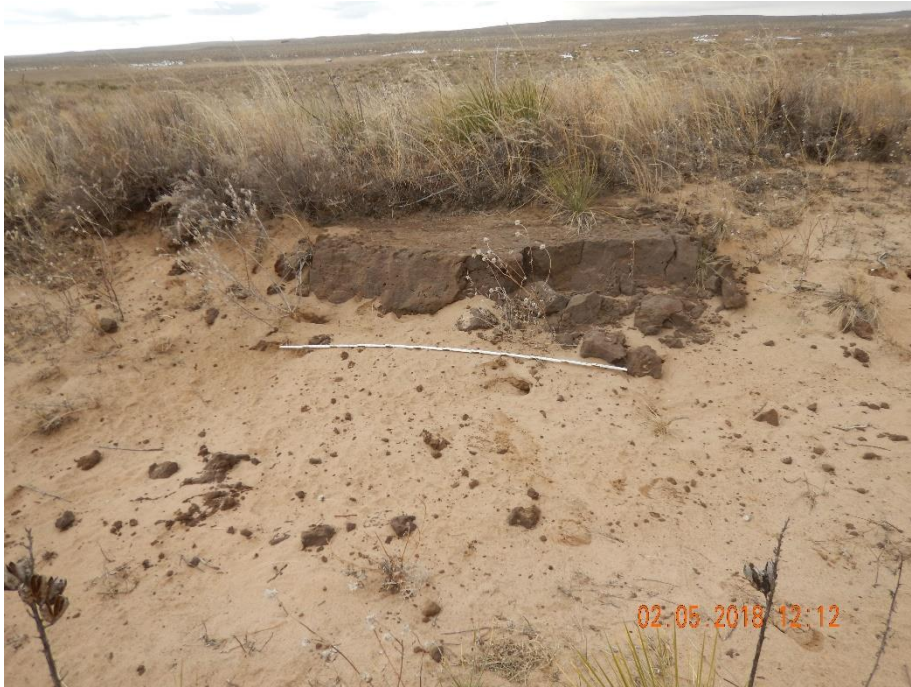
**Photo 7:** Photo taken from the east end of the location, facing south. Photo shows contaminants have not been removed. 6 foot measuring stick for reference.

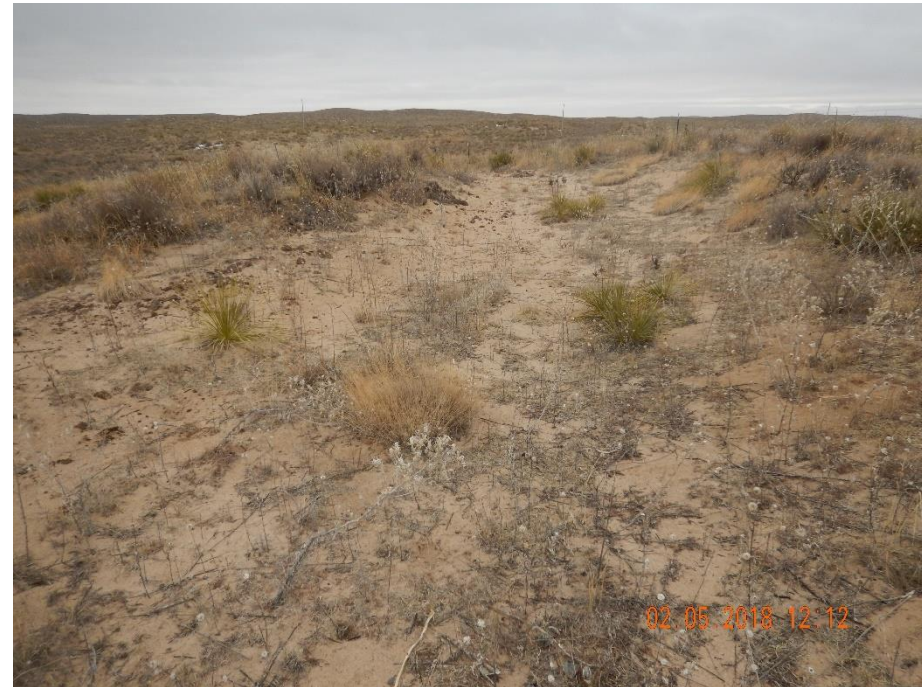
**Photo 8:** Photo taken from the east end of the location, facing north. Photo shows no additional reclamation activities have been conducted on location and access road.

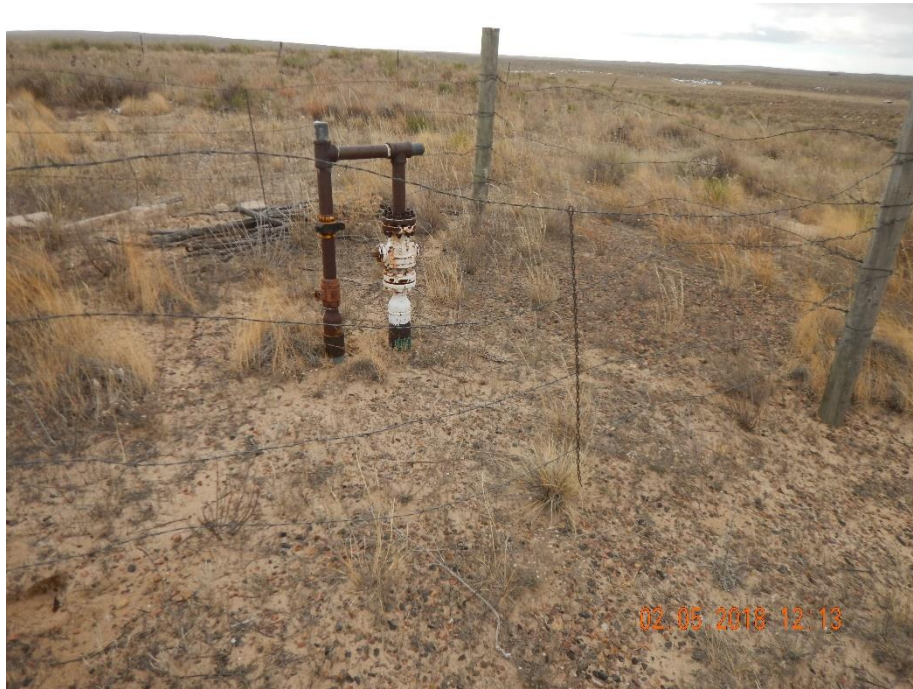
**Photo 9:** Photo taken from the southeast end of the location, facing south. Photo shows pipe riser, fence and debris remains on the location. Equipment was identified as a "Gasline tie/well" in previous inspection.

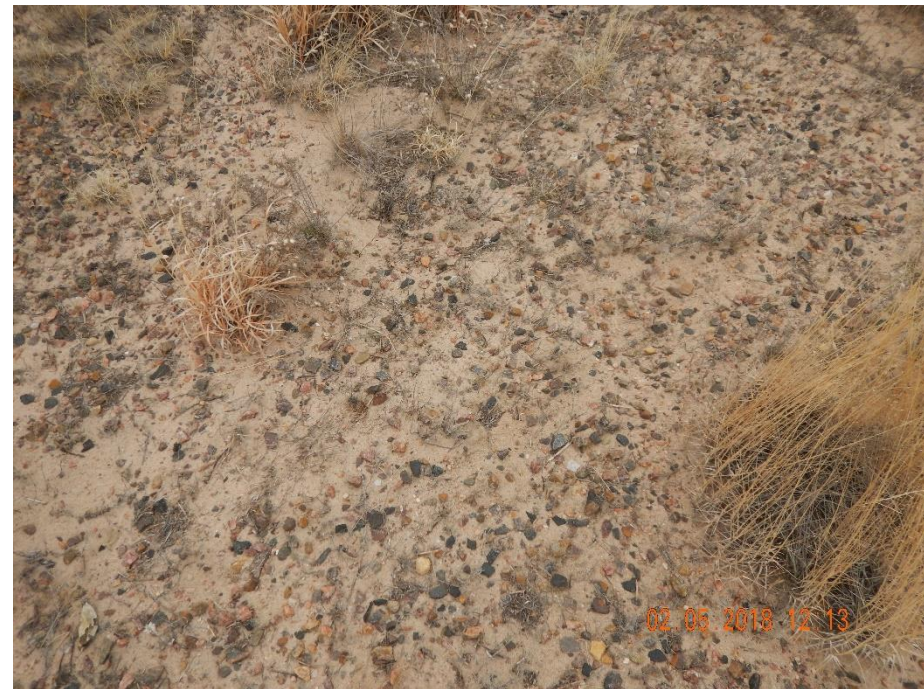
**Photo 10:** Photo taken from the southeast end of the location. Photo shows gravel and debris remaining on location at the "Gasline tie/well".
