Inspection Photos
Location Name: Dolan Ranches #13-27
API: 05-123-07364

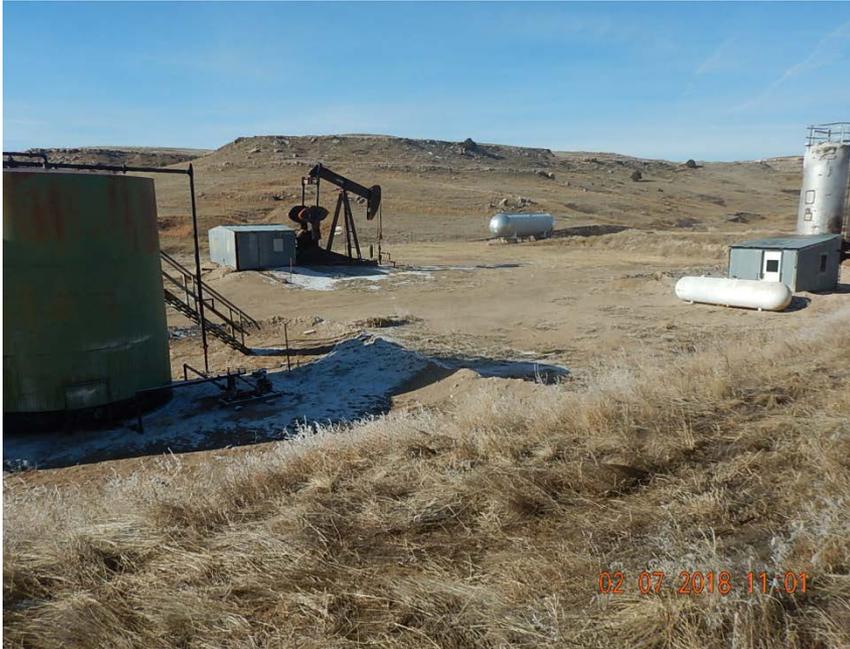
Photo 1: Location, looking NW

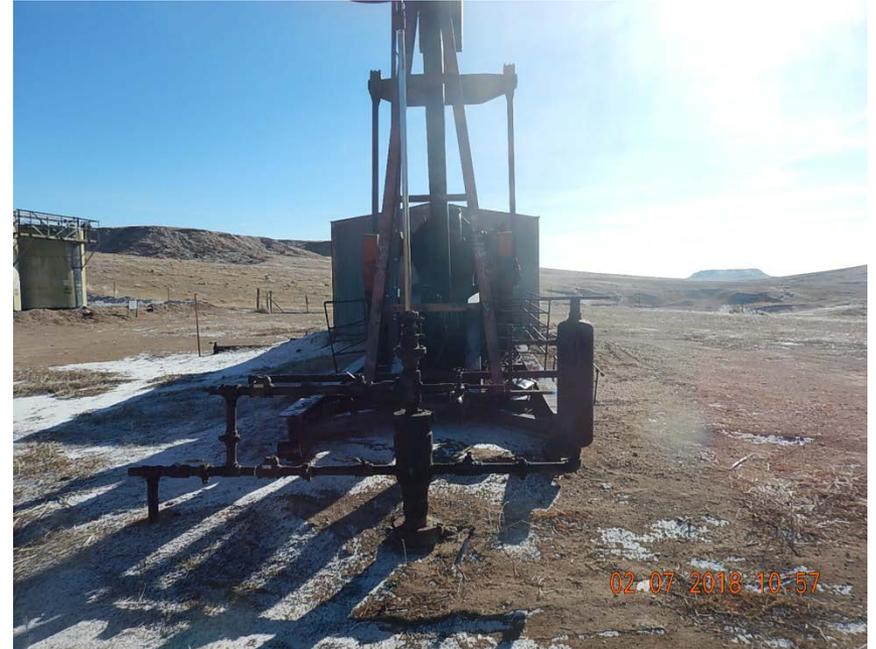
Photo 2: Wellhead, looking S

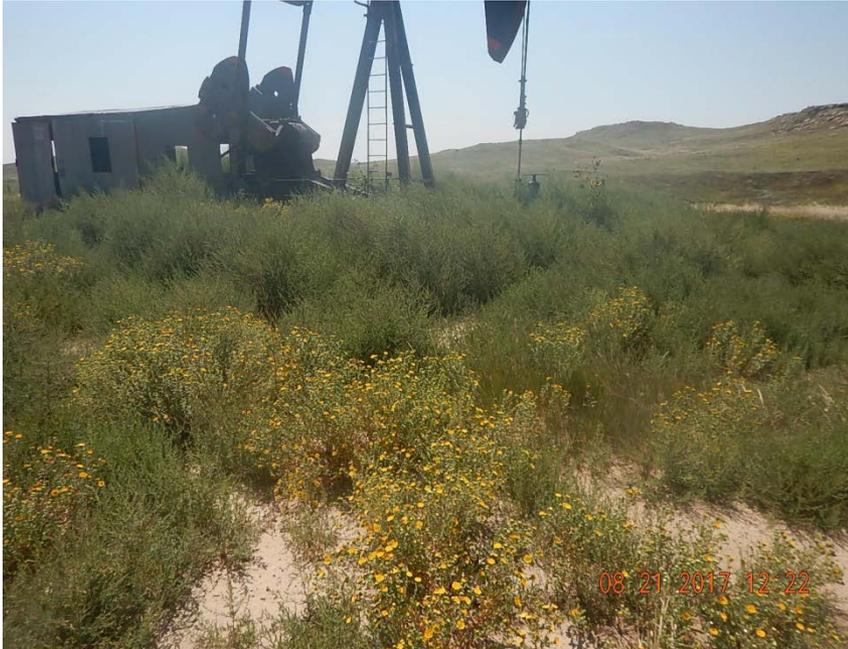
Photo from prior inspection for comparison

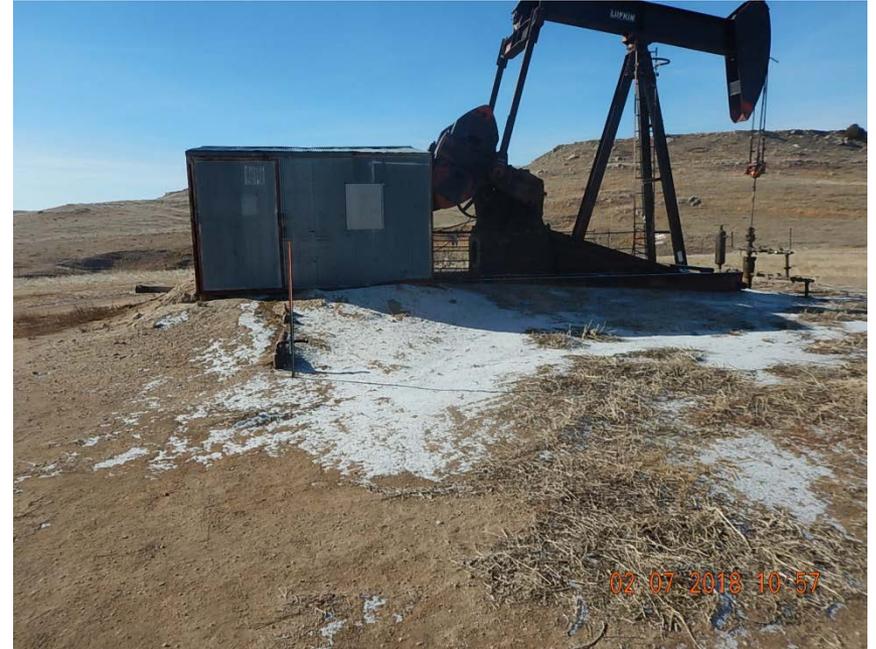
Photo 3: Weeds removed

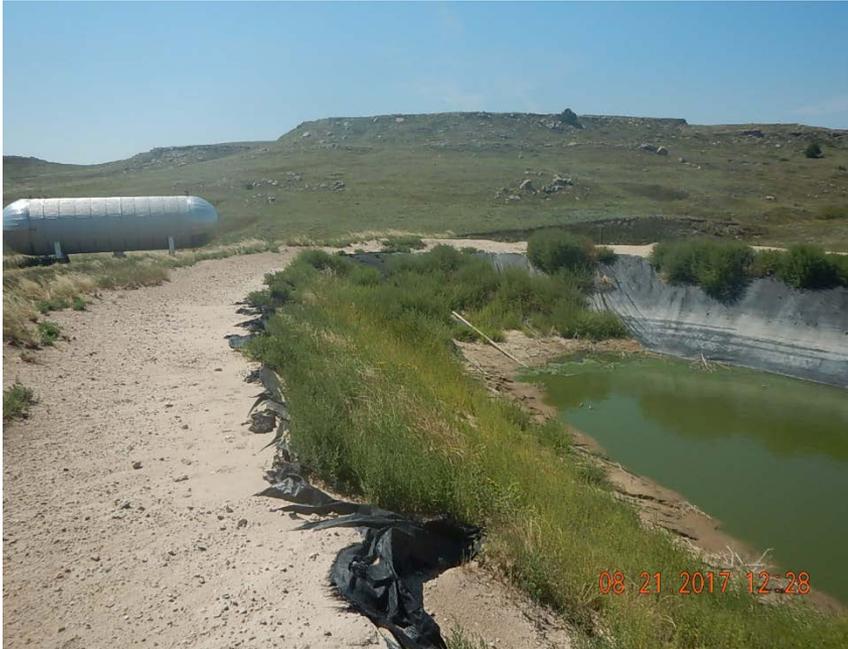
Photo from prior inspection for comparison

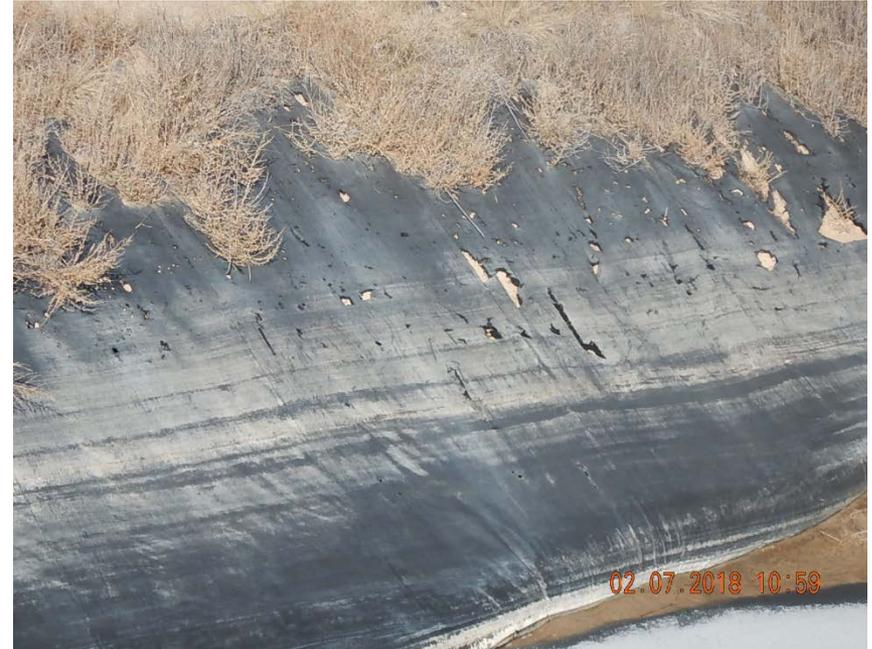
Photo 4: Pit 1 compromised by vegetation, damaged

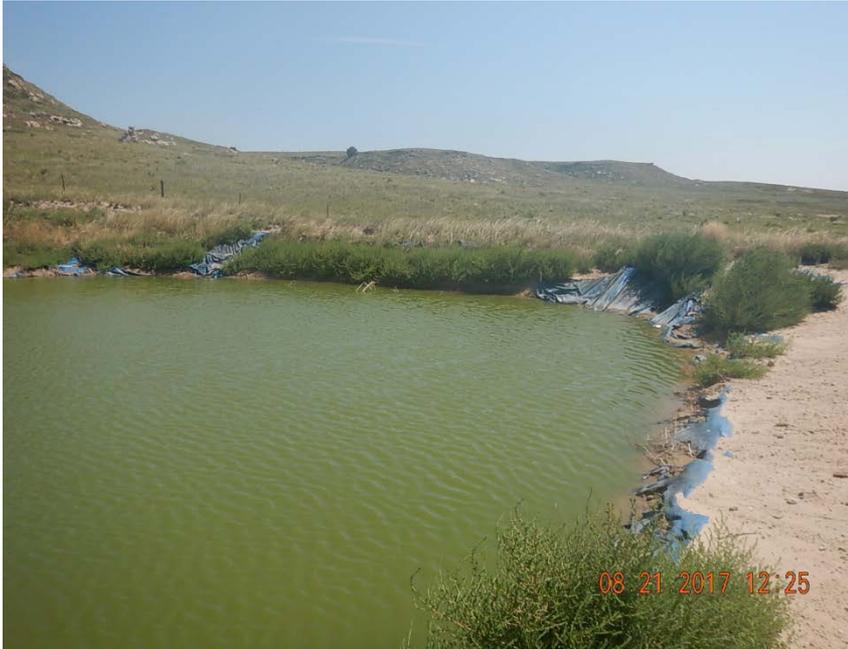
Photo from prior inspection for comparison

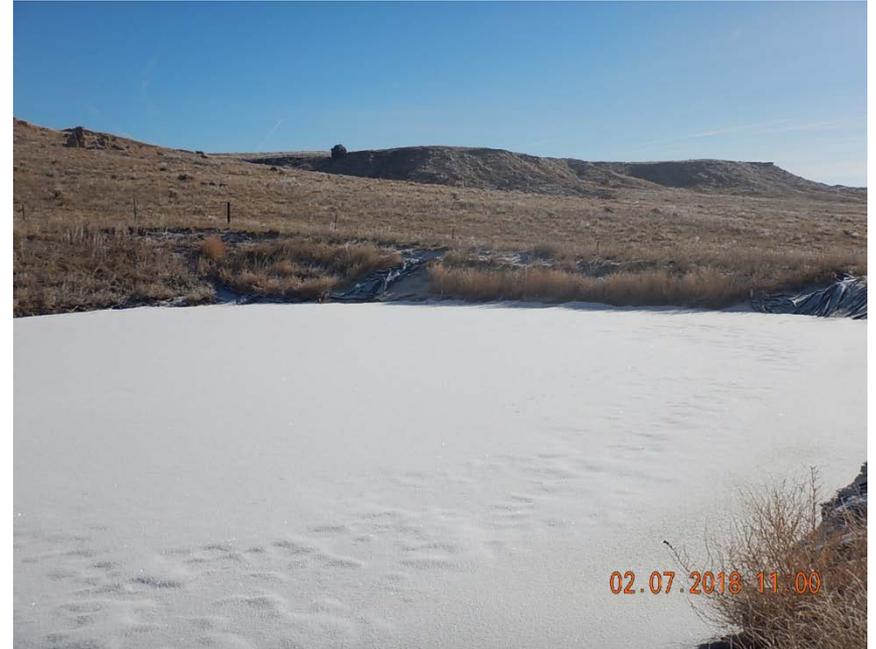
Photo 5: Pit 3 compromised by vegetation

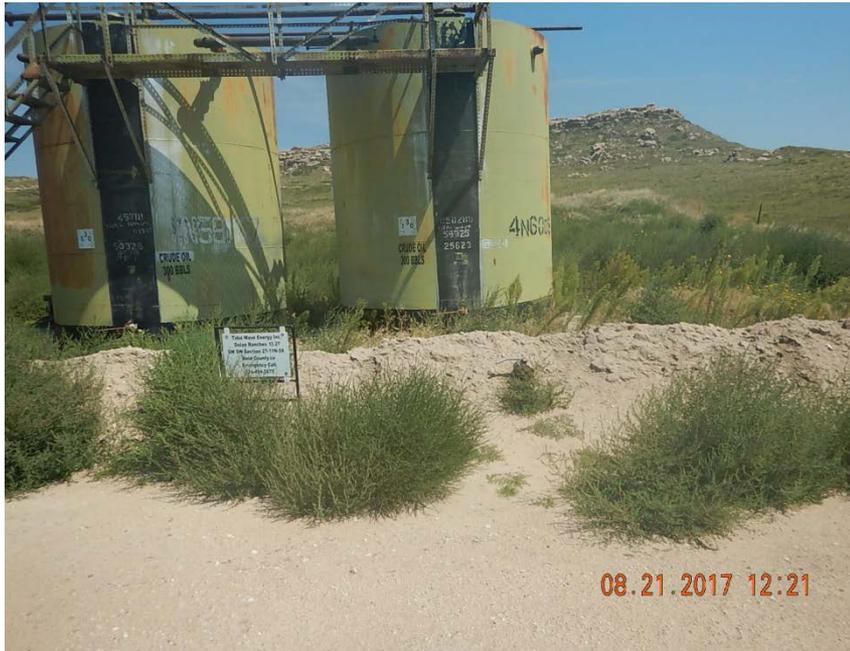
Photo from prior inspection for comparison

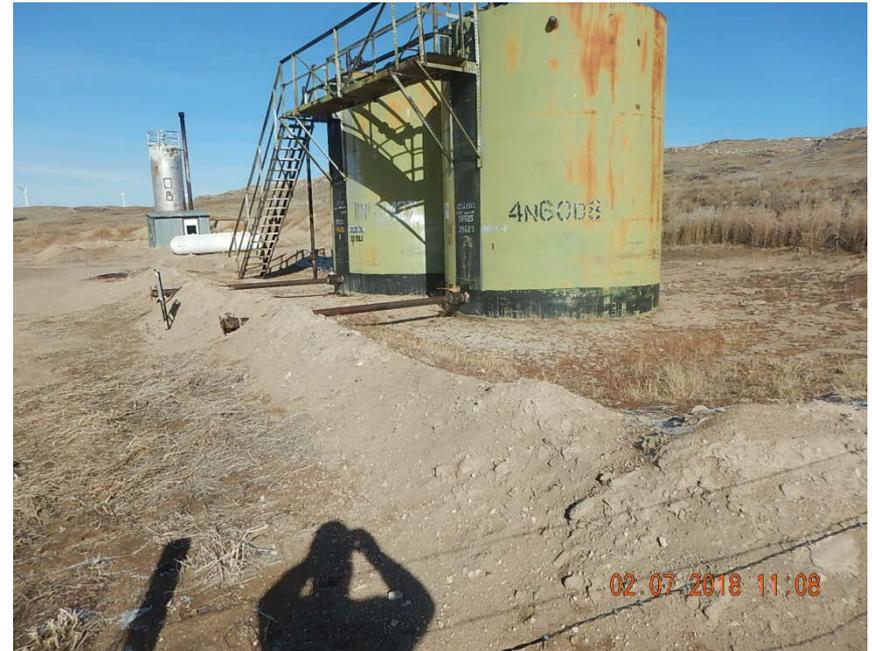
Photo 6: Weeds controlled at tank battery

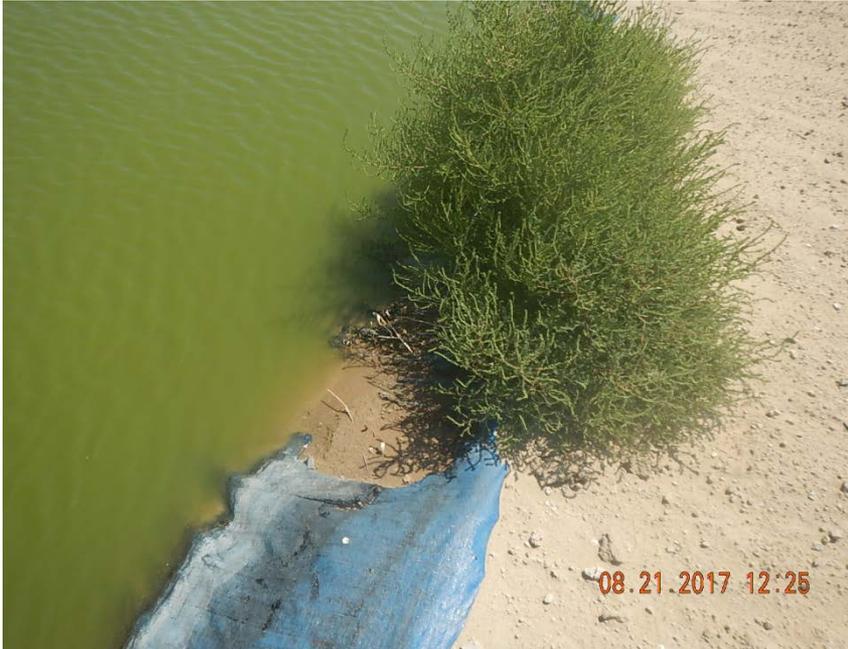
Photo from prior inspection for comparison

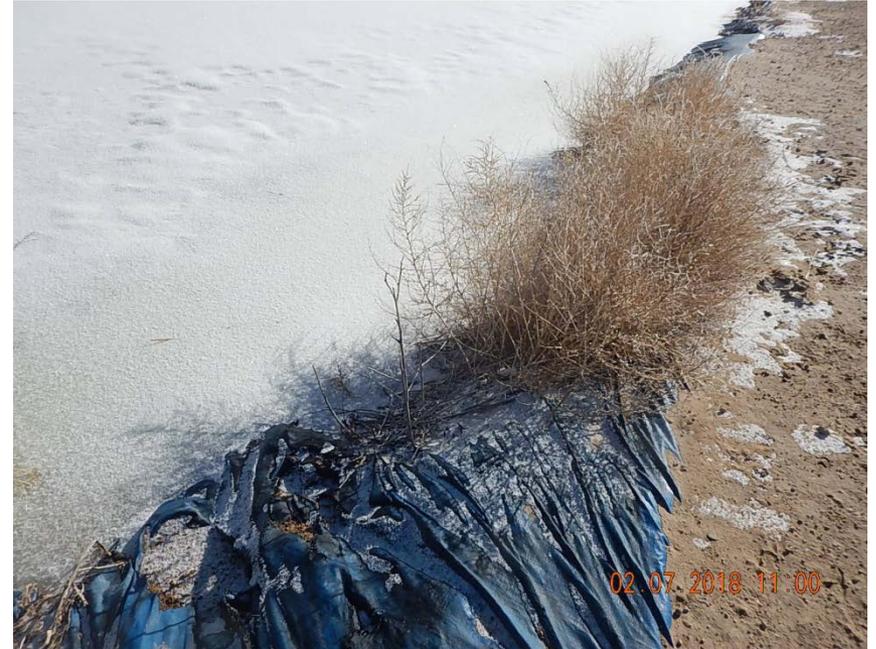
Photo 7: Pit 2 liner, torn and compromised by vegetation

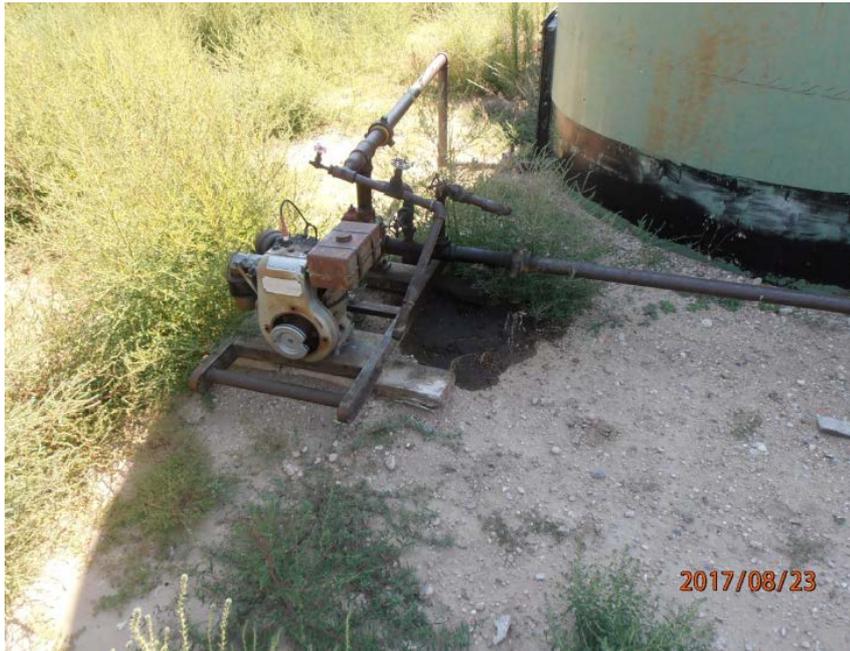
Photo from R Allison's prior inspection for comparison purposes

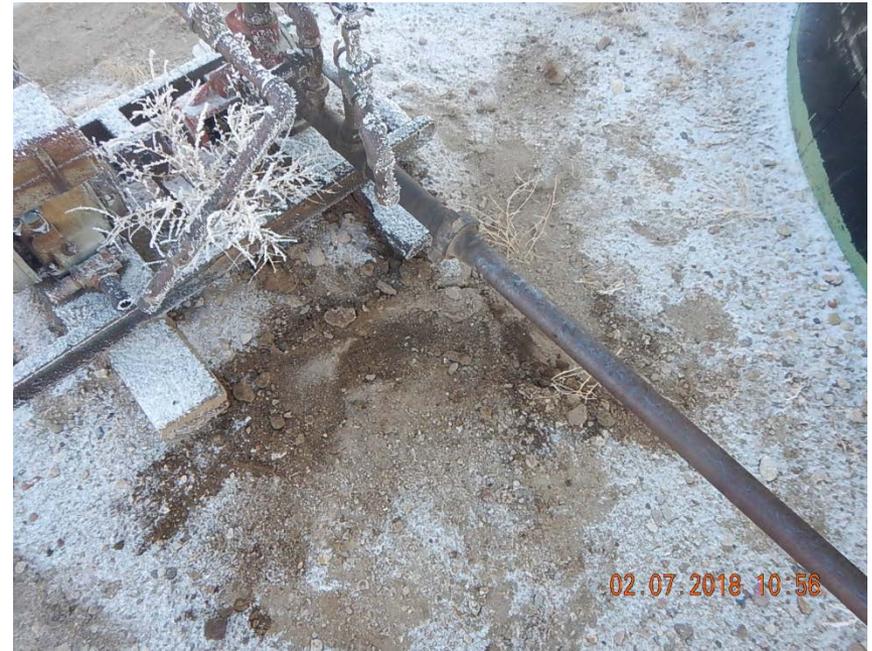
Photo 8: Stained soil at transfer pump

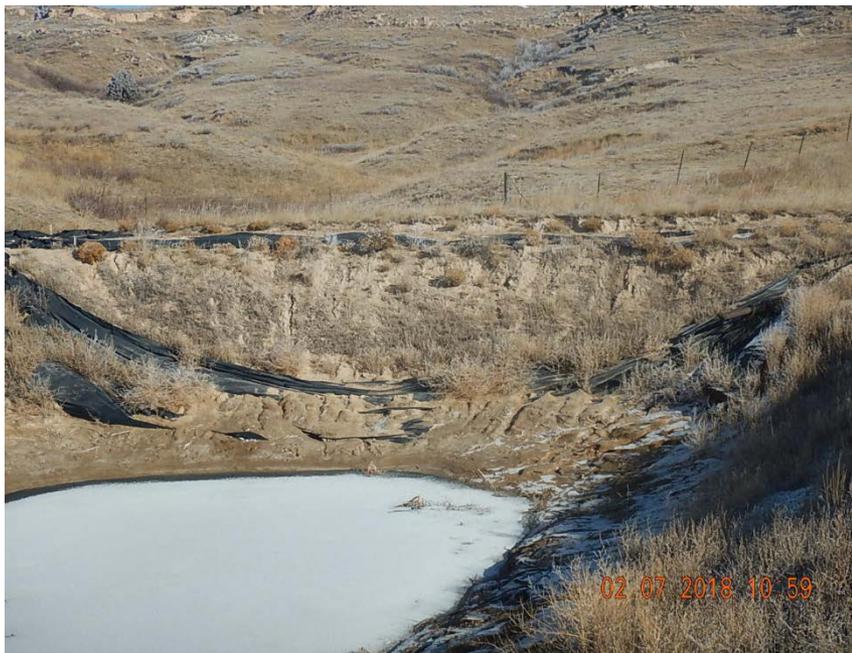
Photo 9: Pit 1, contents sagging into pit

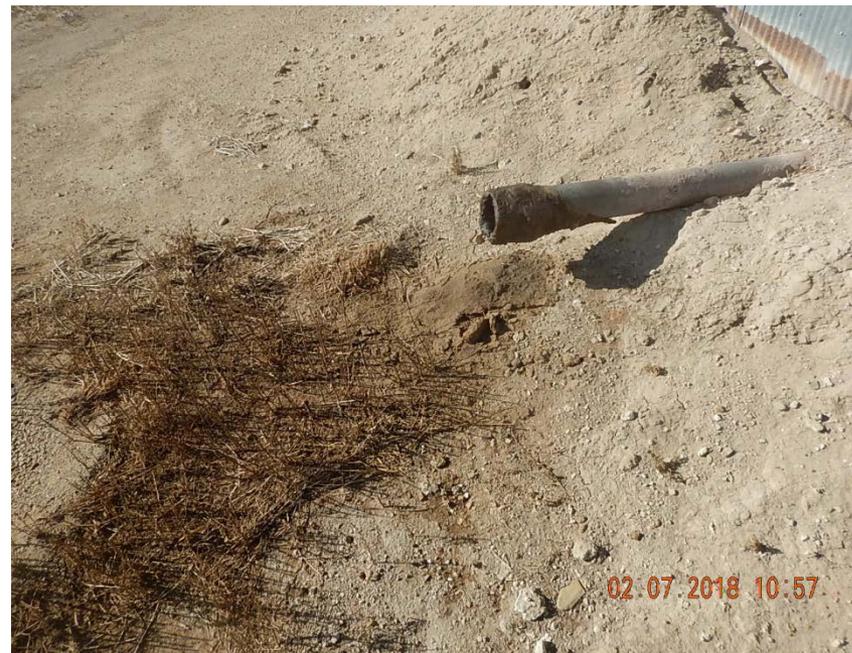
Photo 10: Stained soil at exhaust

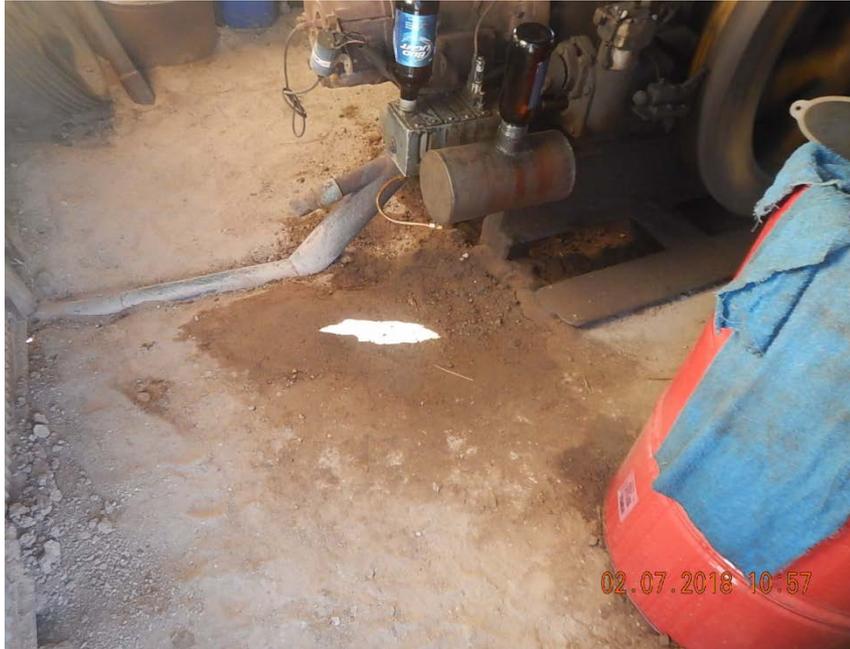
Photo 11: Stained soil at ajax engine

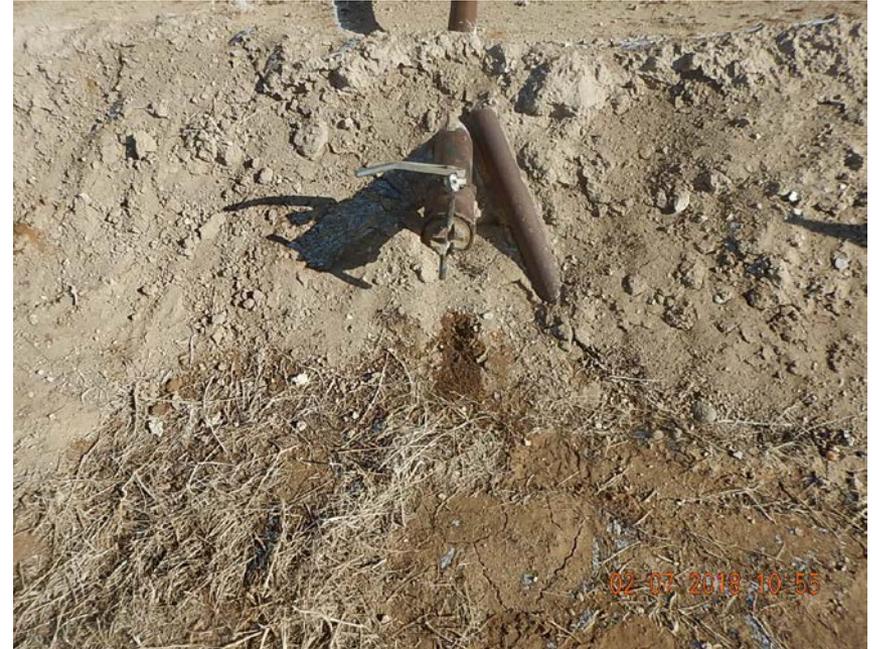
Photo 12: Stained soil at loadout

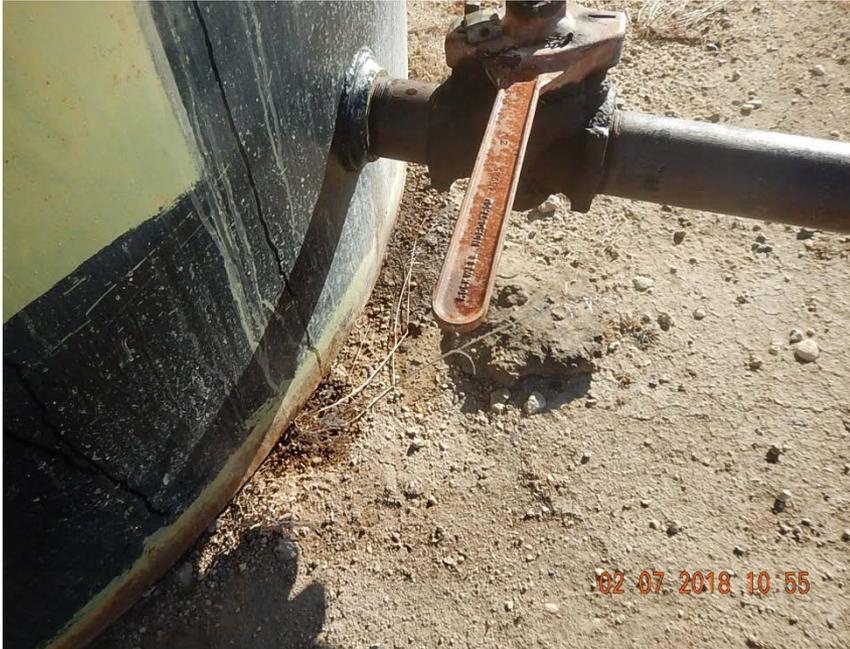
Photo 13: Stained soil at base of tank at loadout

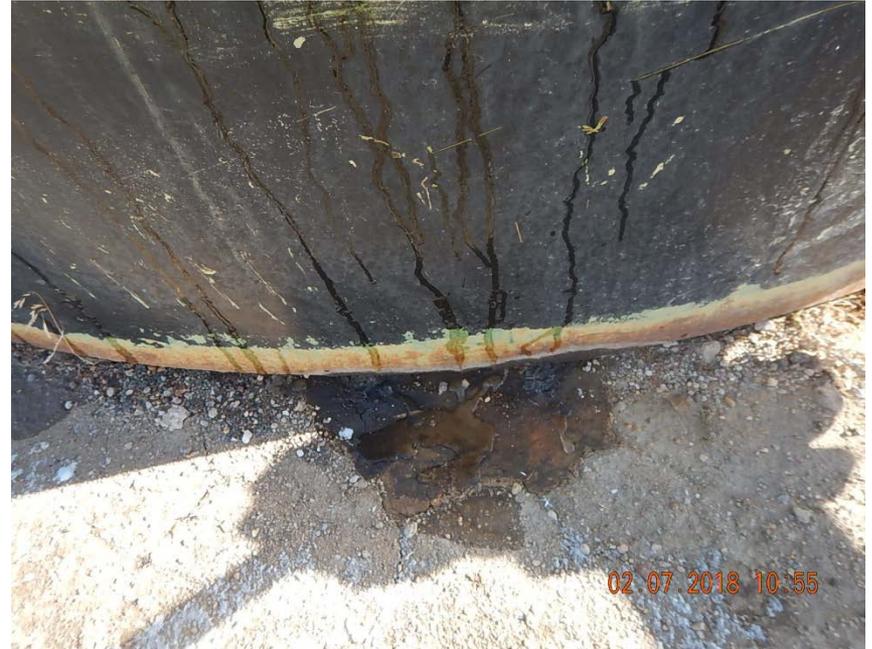
Photo 14: Stained soil and fluid at base of tank on NW side
