Inspection Photos
Location Name: Janet 0780 4-16H21
API: 05-057-06605

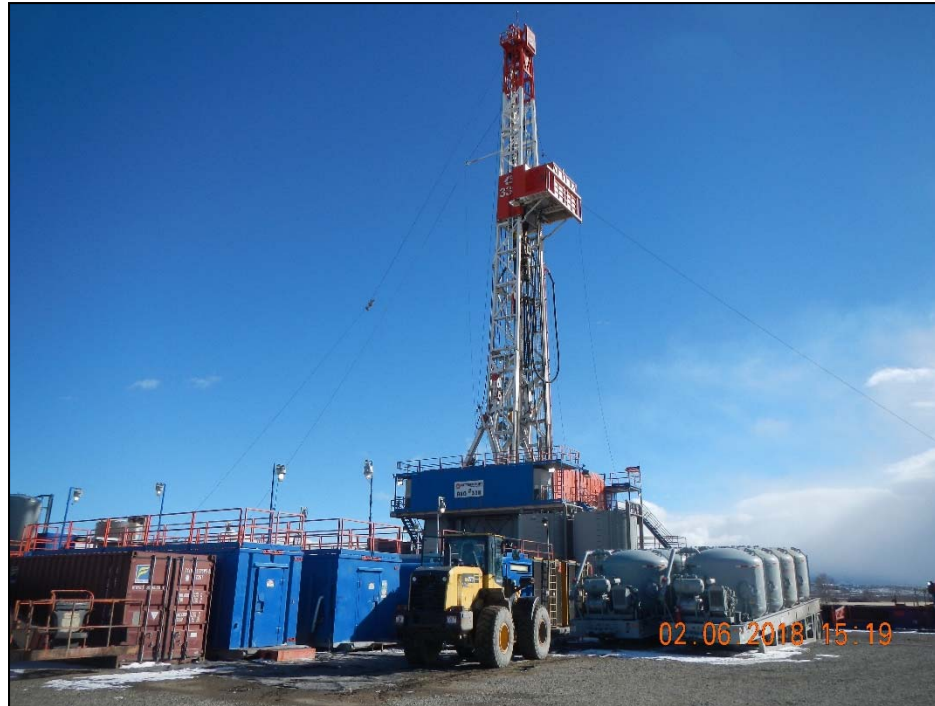
Photo 1. Overview of location taken on northwest side facing southeast..

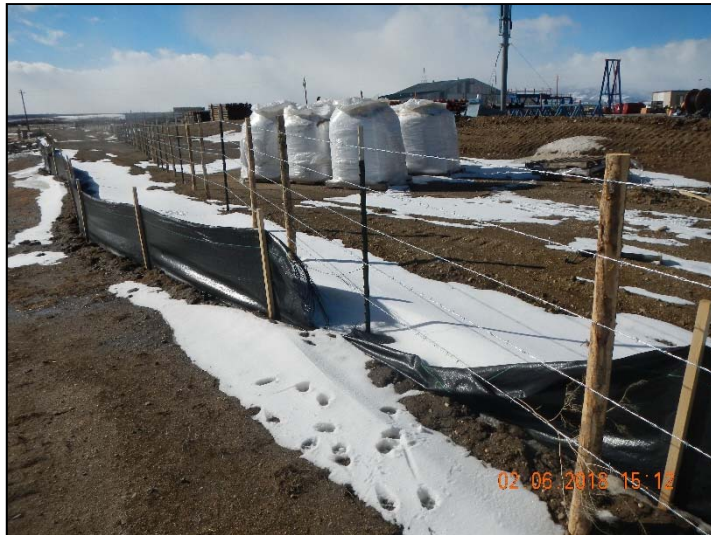
Photo 2. Sagging silt fence as primary storm water control on south side of location.

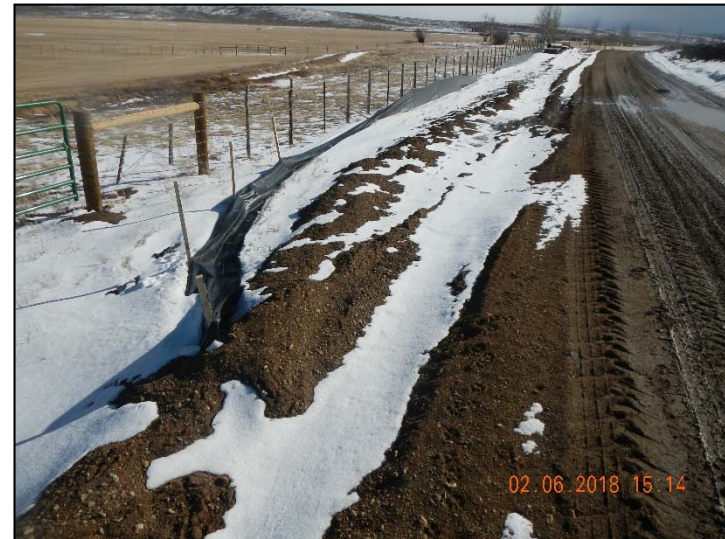
Photo 3. Sagging silt fence acting as primary storm water control on east side of location.

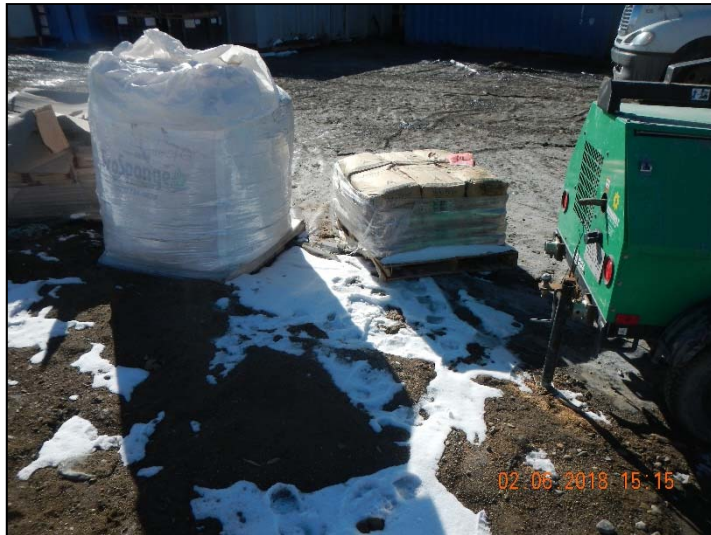
Photo 4. Uncovered mud additives on location perimeter.

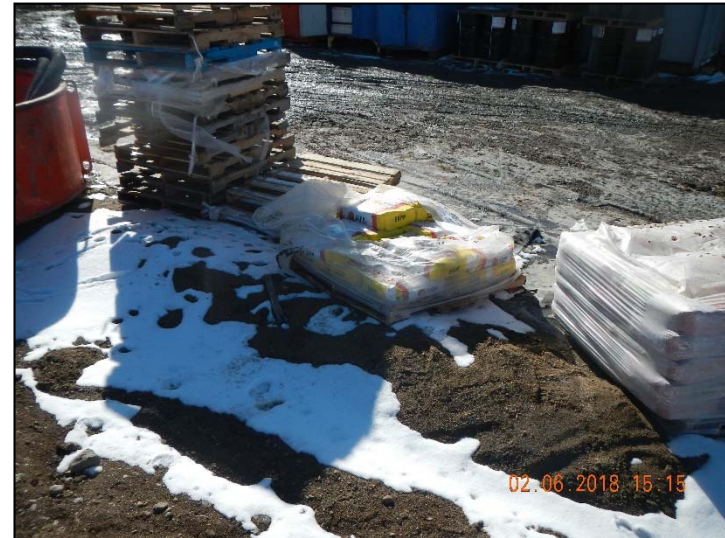
Photo 5. Uncovered mud additives on location perimeter.
