Inspection Photos

API: 05-067-09913

Operator: CATAMOUNT ENERGY PARTNERS LLC

Inspection Number: 680602470

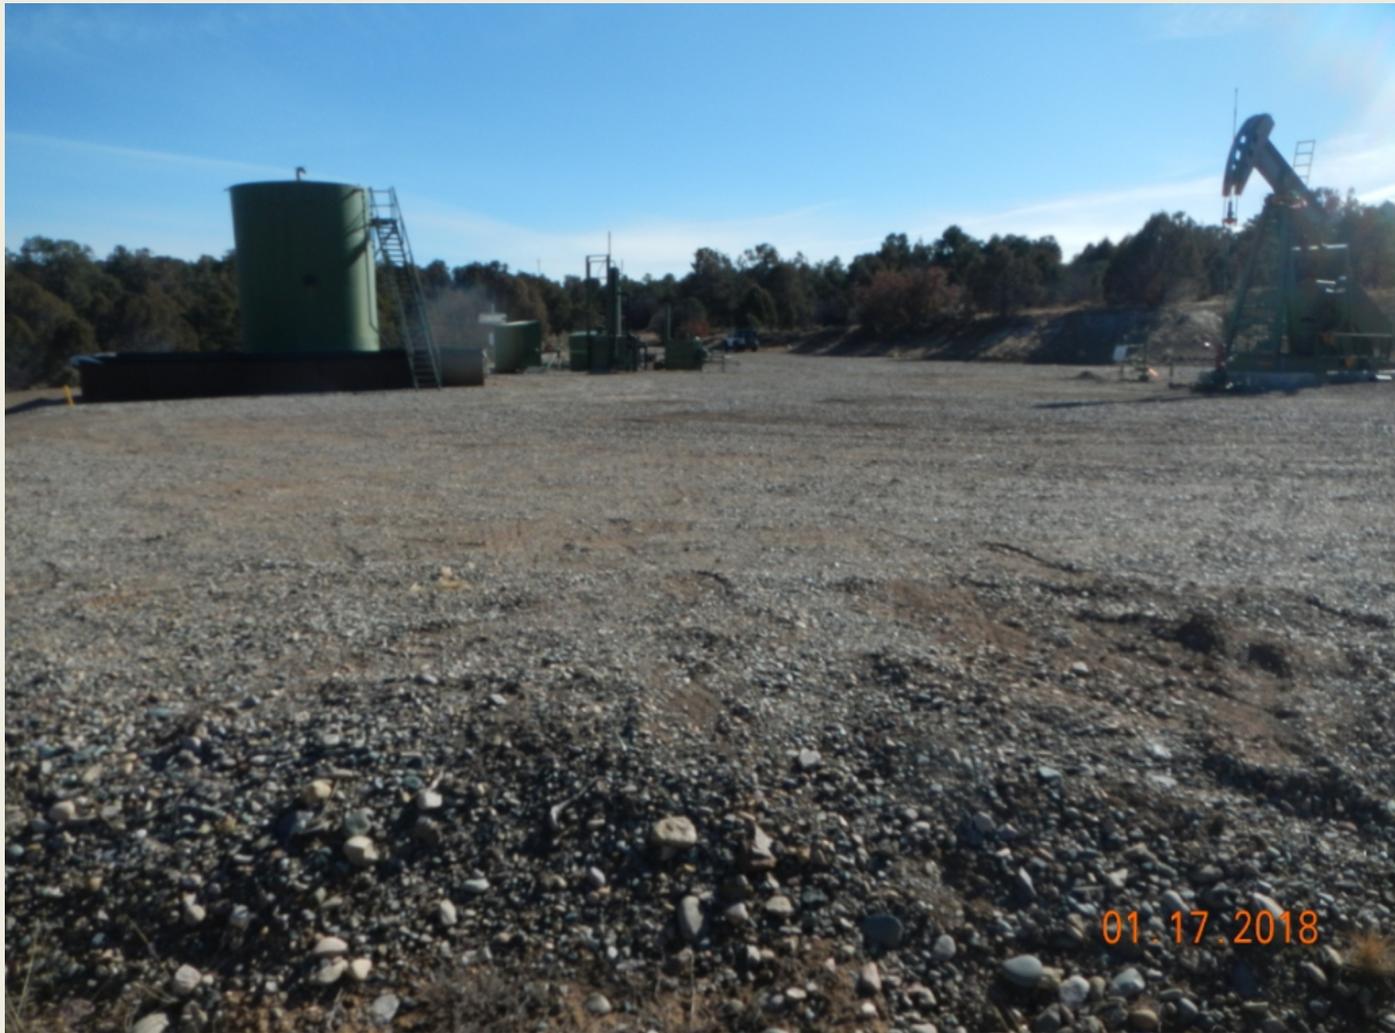
Photo 1. View of the project area from the northern corner facing center.

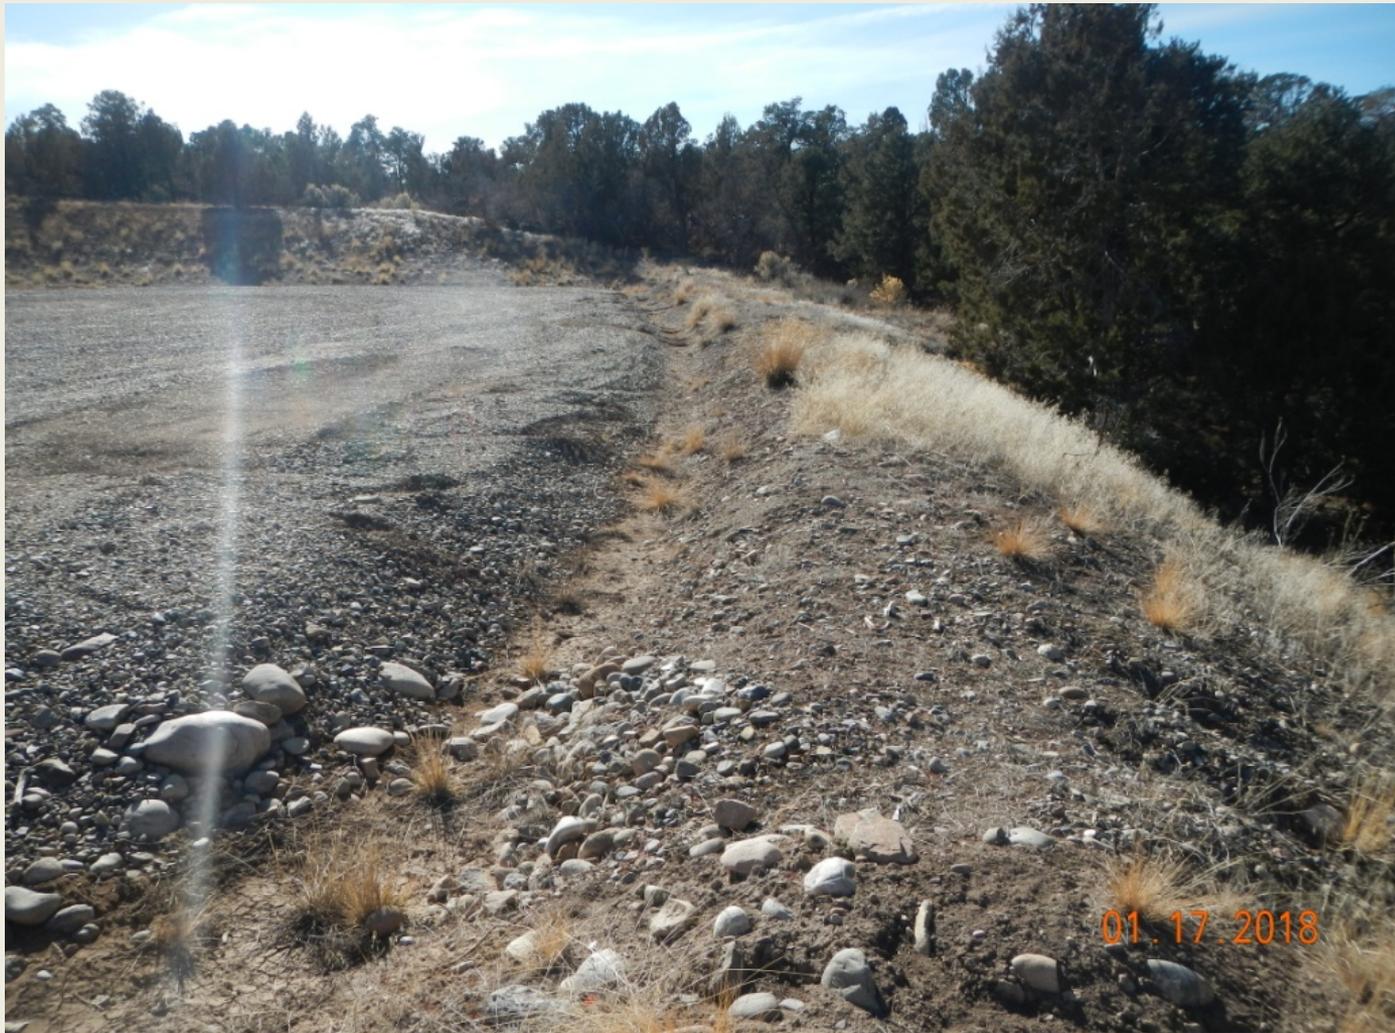
Photo 2. View of the western portion of the project area from the northern corner facing southwestward.

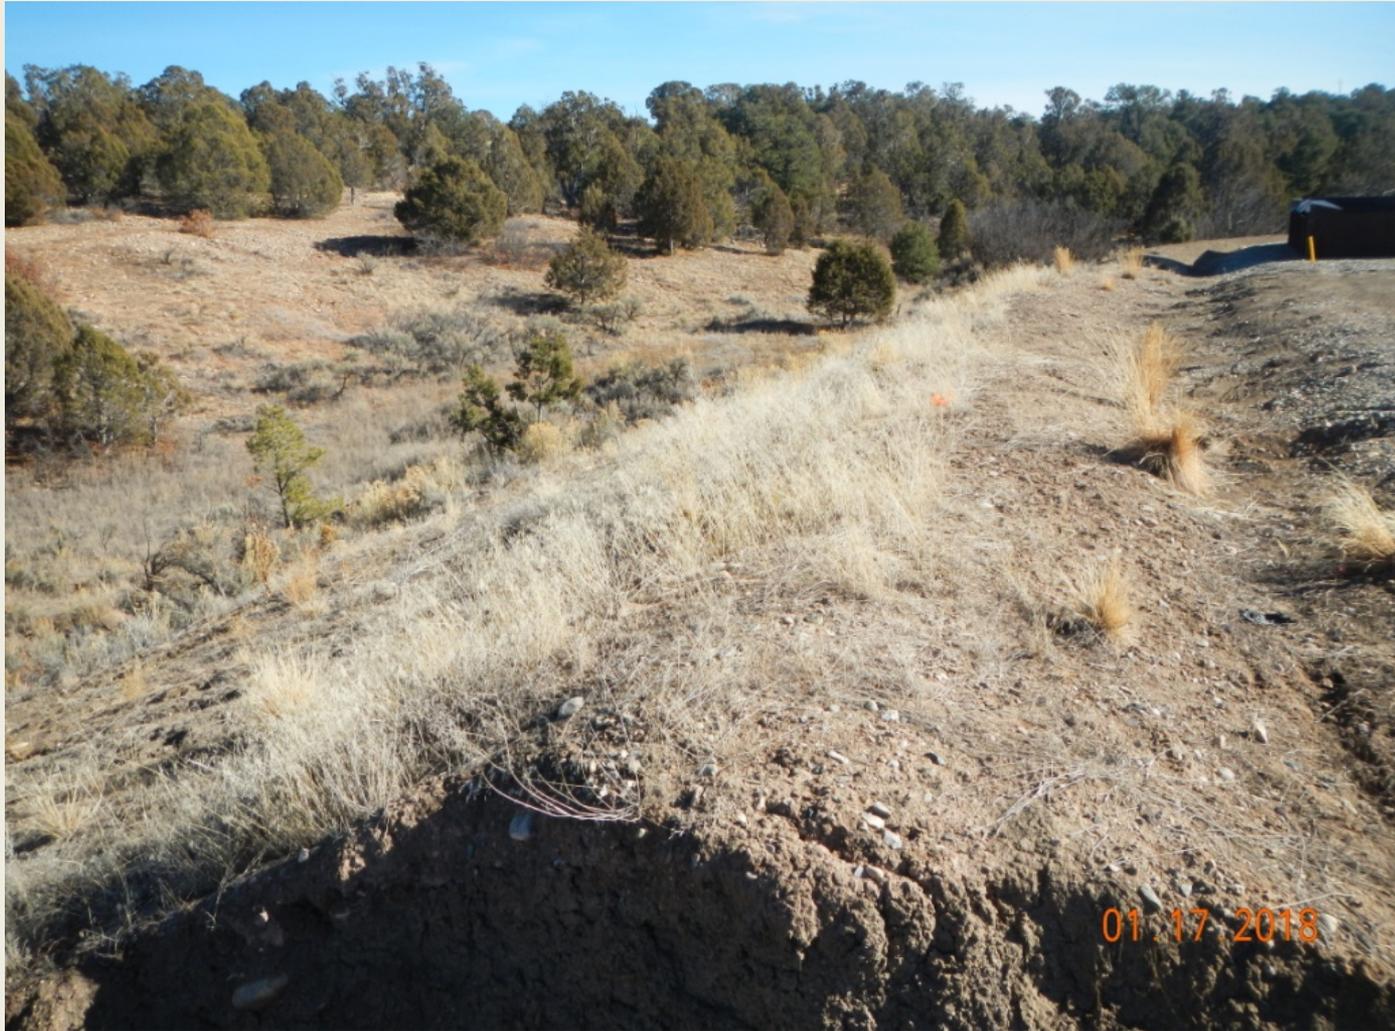
Photo 3. View of the northeastern portion of the project area from northern corner facing southeastward.

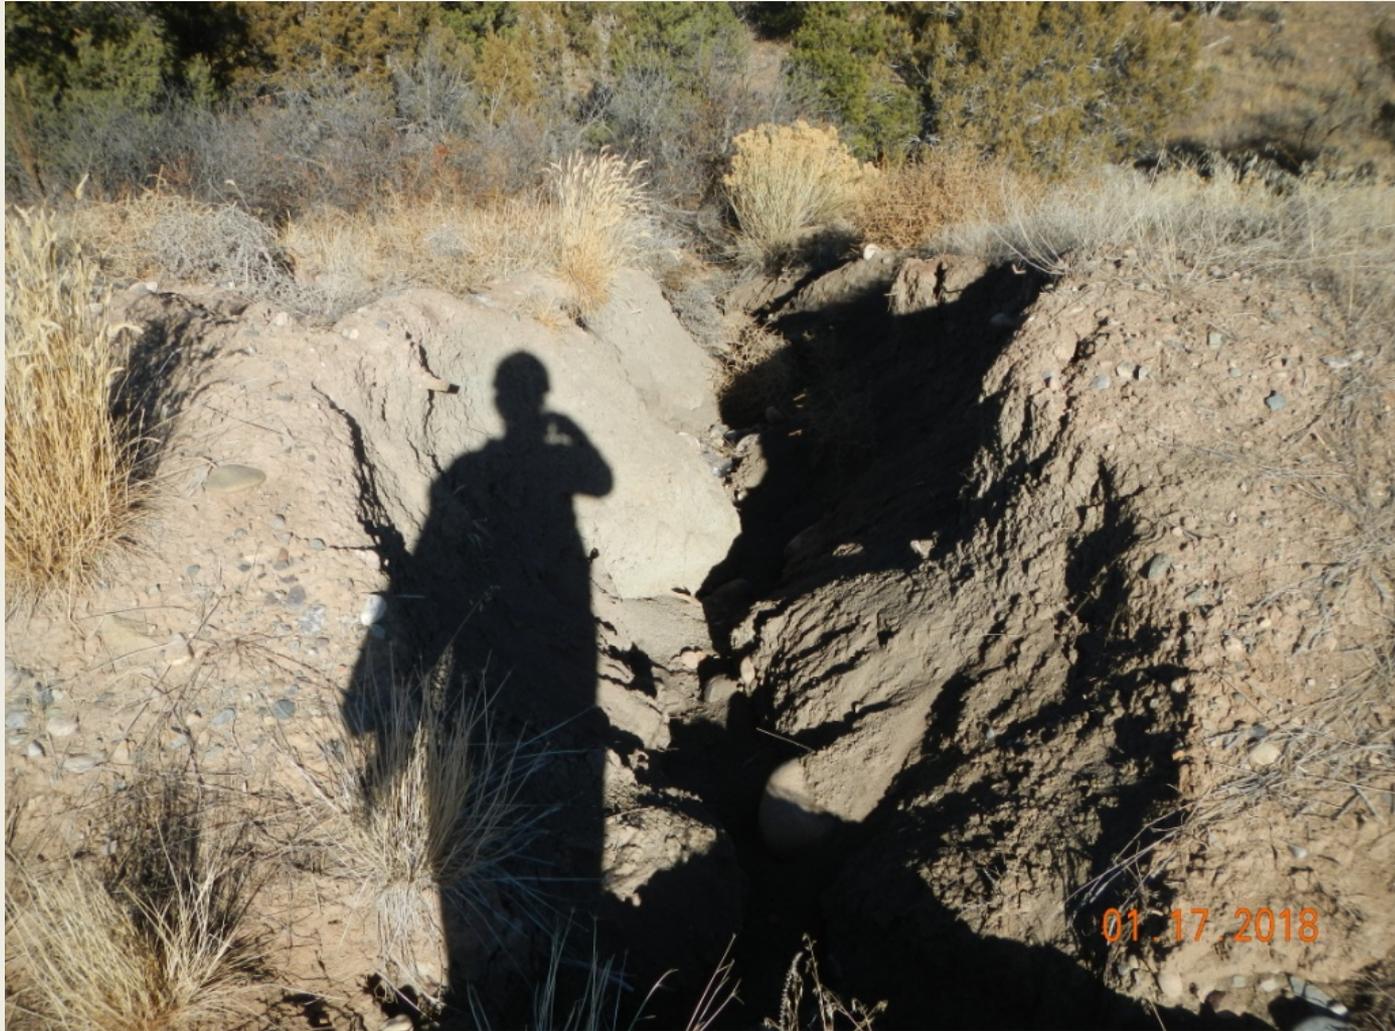
Photo 4. View of an erosional channel approximately 5.5 feet wide and deep in the northern portion of the project area. Stabilization measures are needed here.

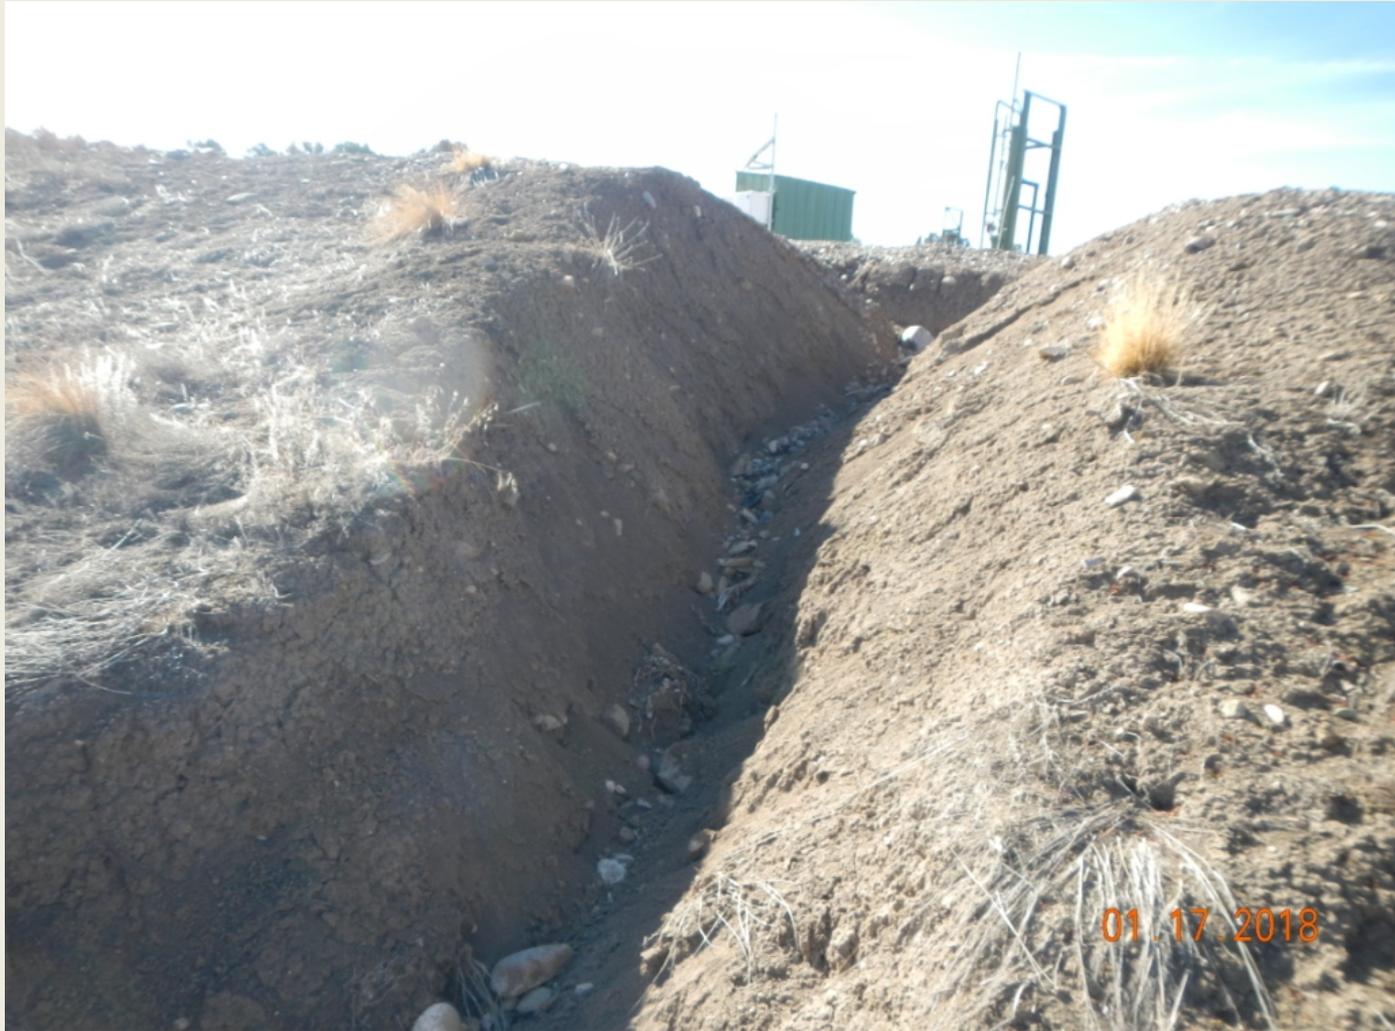
Photo 5. View of another erosional channel approximately 5 feet wide and deep in the eastern portion of the project area. Stabilization measures are needed here.

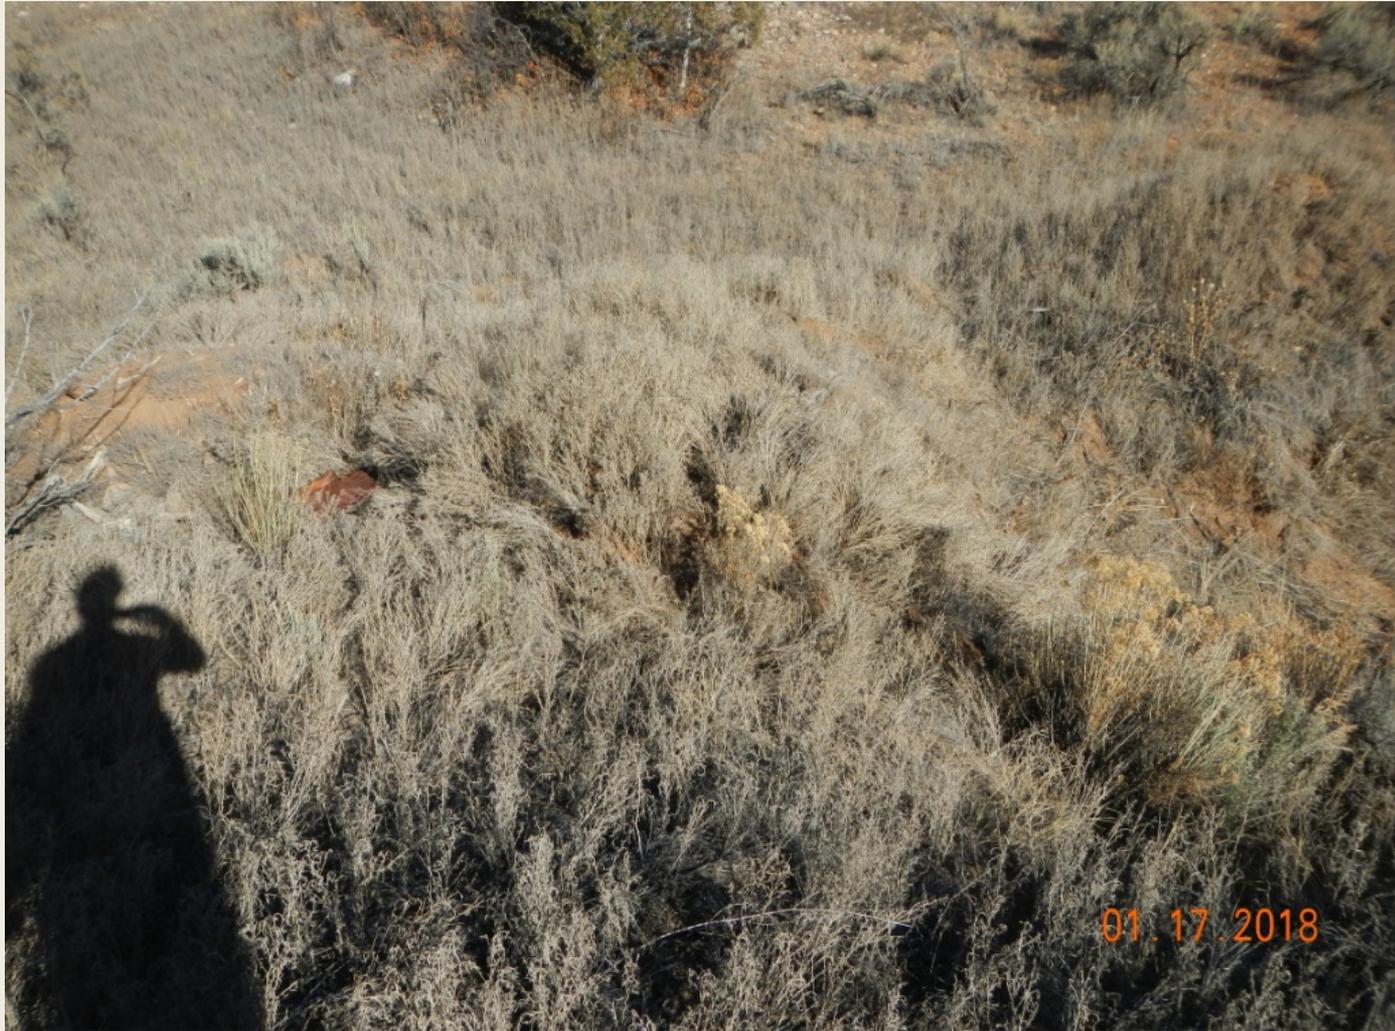
Photo 6. View of Russian knapweed (*Acroptilon repens*) infestation along the northeastern edge of the project area.
