Final Reclamation Inspection

February 6, 2018

Replugging Operator: BARRETT CORPORATION* BILL (BBC)- 10071

API: 05-123-09893

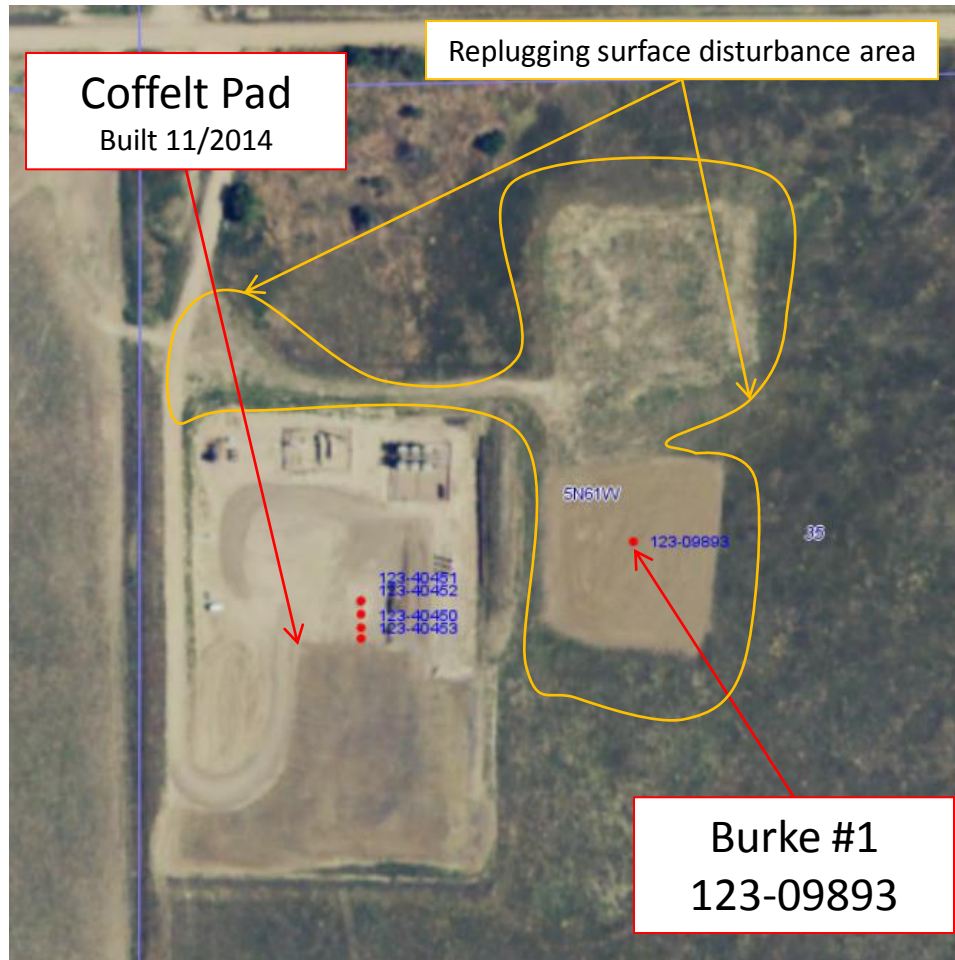
Aerial imagery take in 2015. Imagery illustrates surface disturbance from replugging operations performed by BBC. Well was replugged 12/2/2014. Operator shall comply with Rule 1004 standards for the entire replugging surface disturbance area shown above.

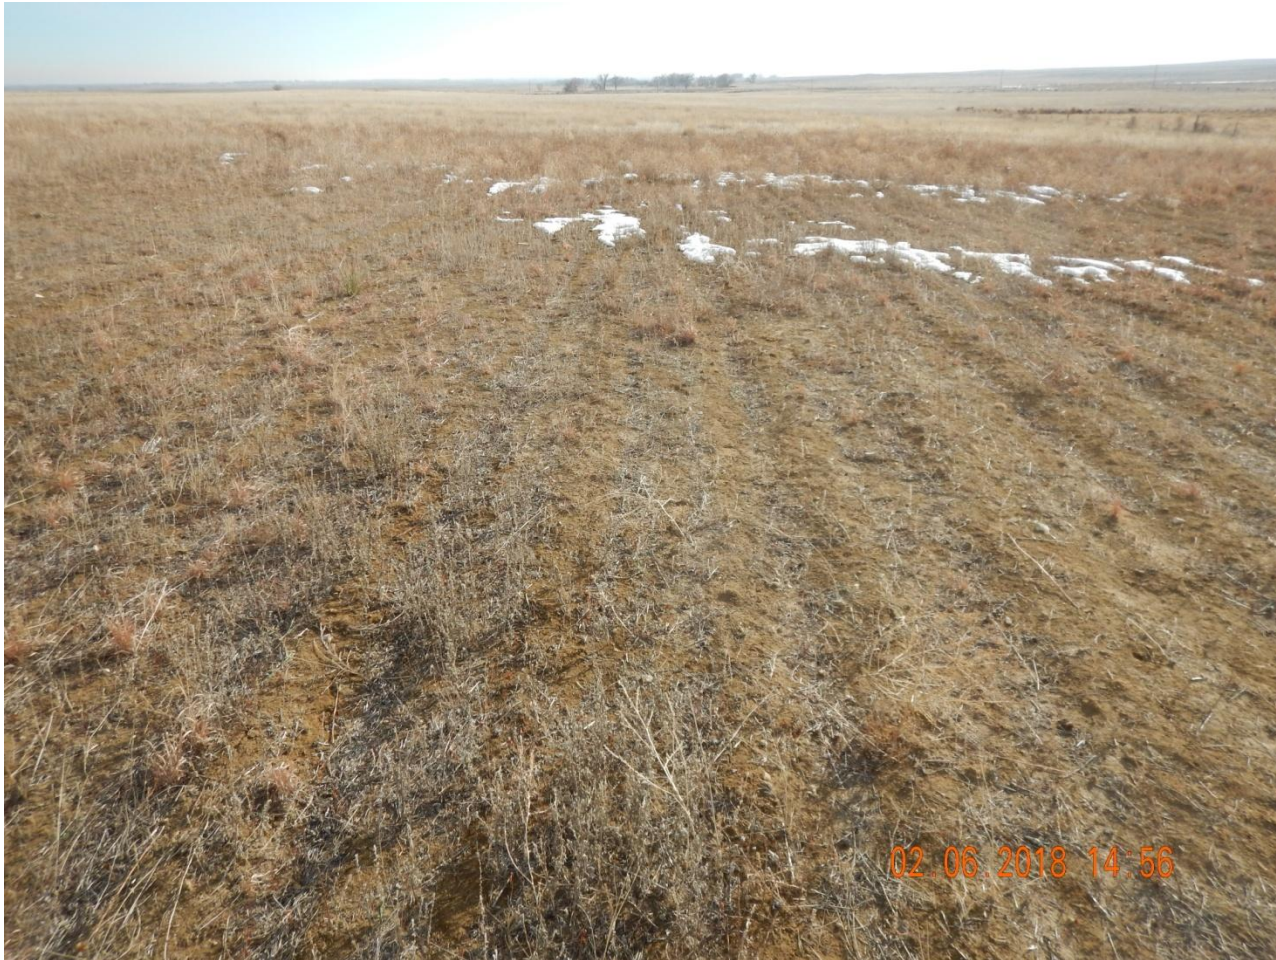
Photo 1. Photo taken from the approximate center of the Burke location, facing South. Location primarily consists of weedy, annual vegetation (Kochia, Russian thistle and cheatgrass) which is not reflective of reference area vegetation.

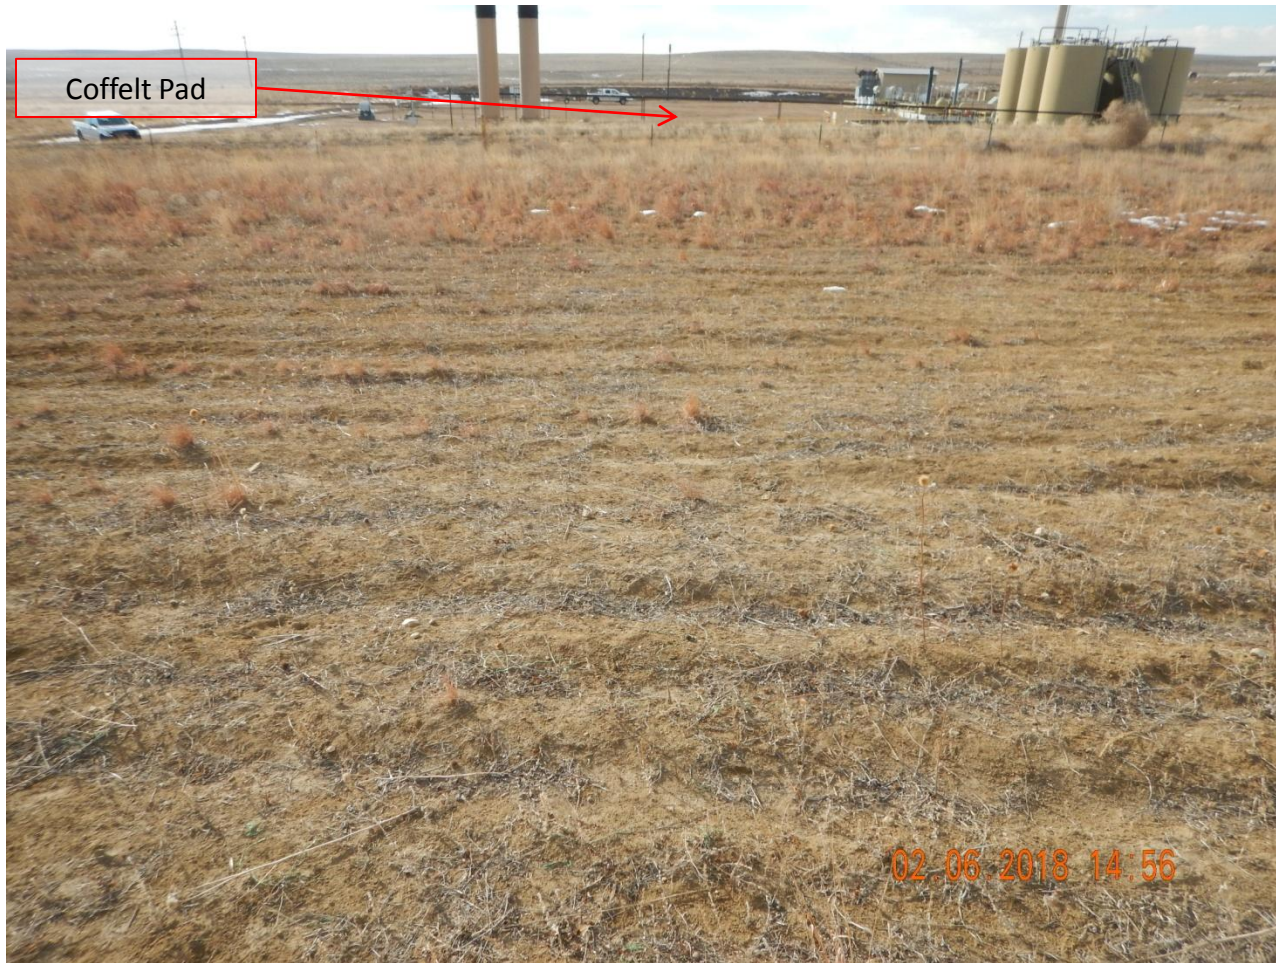
Photo 2. Photo taken from the approximate center of the Burke location, facing West. See comments under Photo 1.

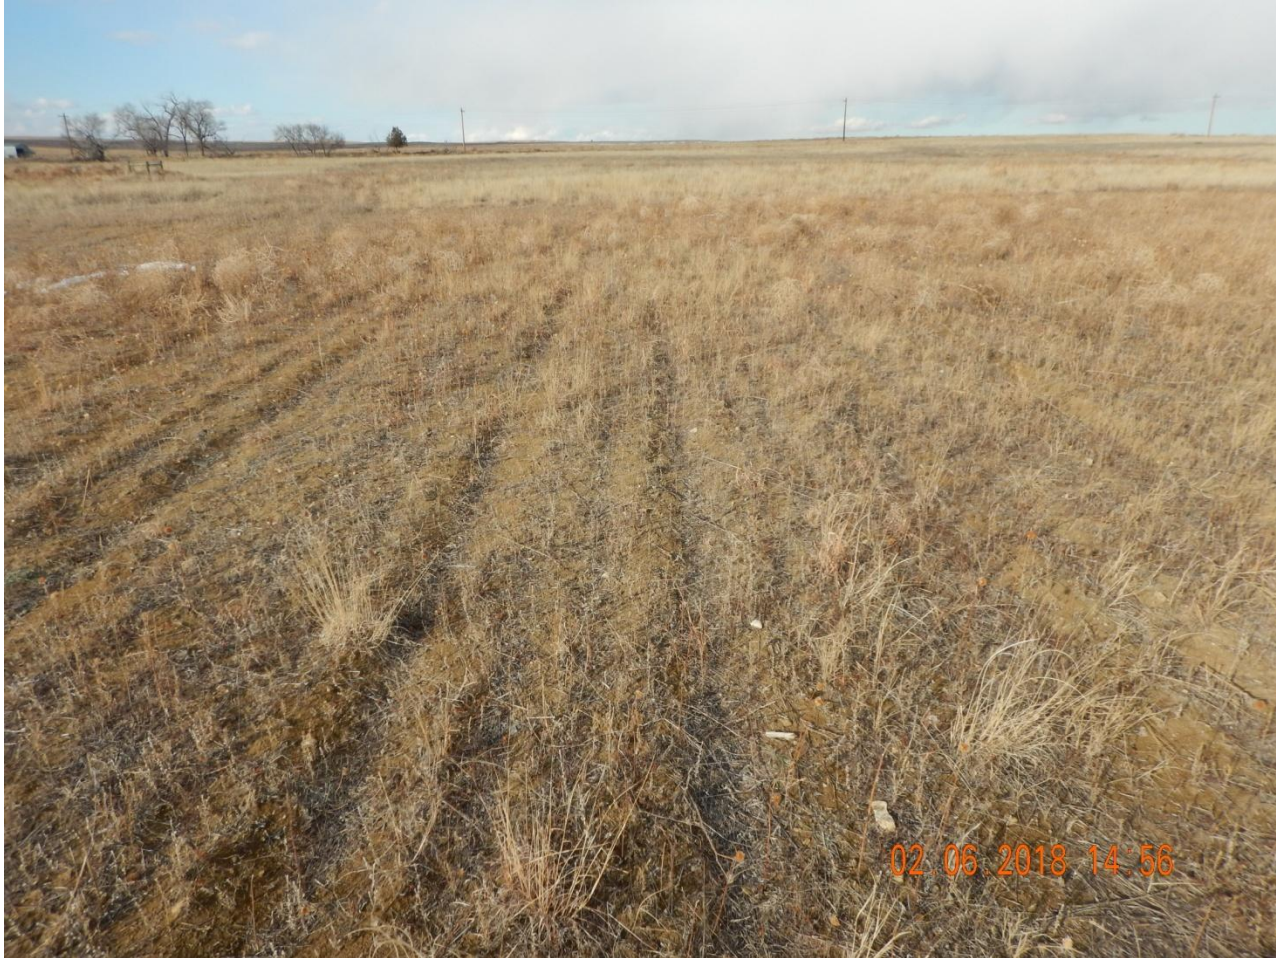
Photo 3. Photo taken from the approximate center of the Burke location, facing North.
See comments under Photo 1.

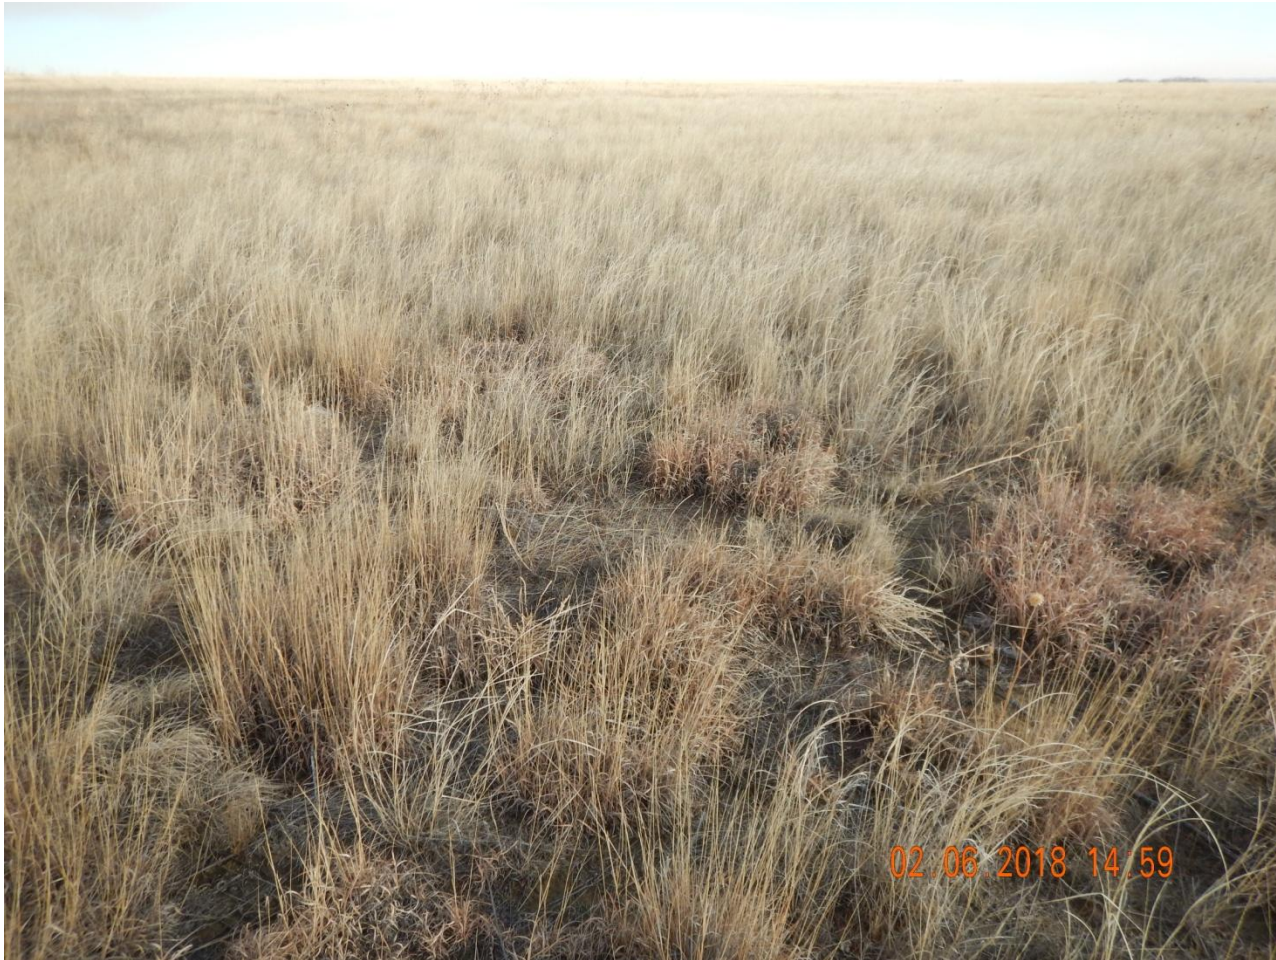
Photo 4. Reference photo taken east of the replugging surface disturbance area, facing East. Reference area vegetation consists of, but not limited to, Sand dropseed (*Sporobolus cryptandrus*), Sideoats grama (*Bouteloua curtipendula*), and Blue grama (*Bouteloua gracilis*).

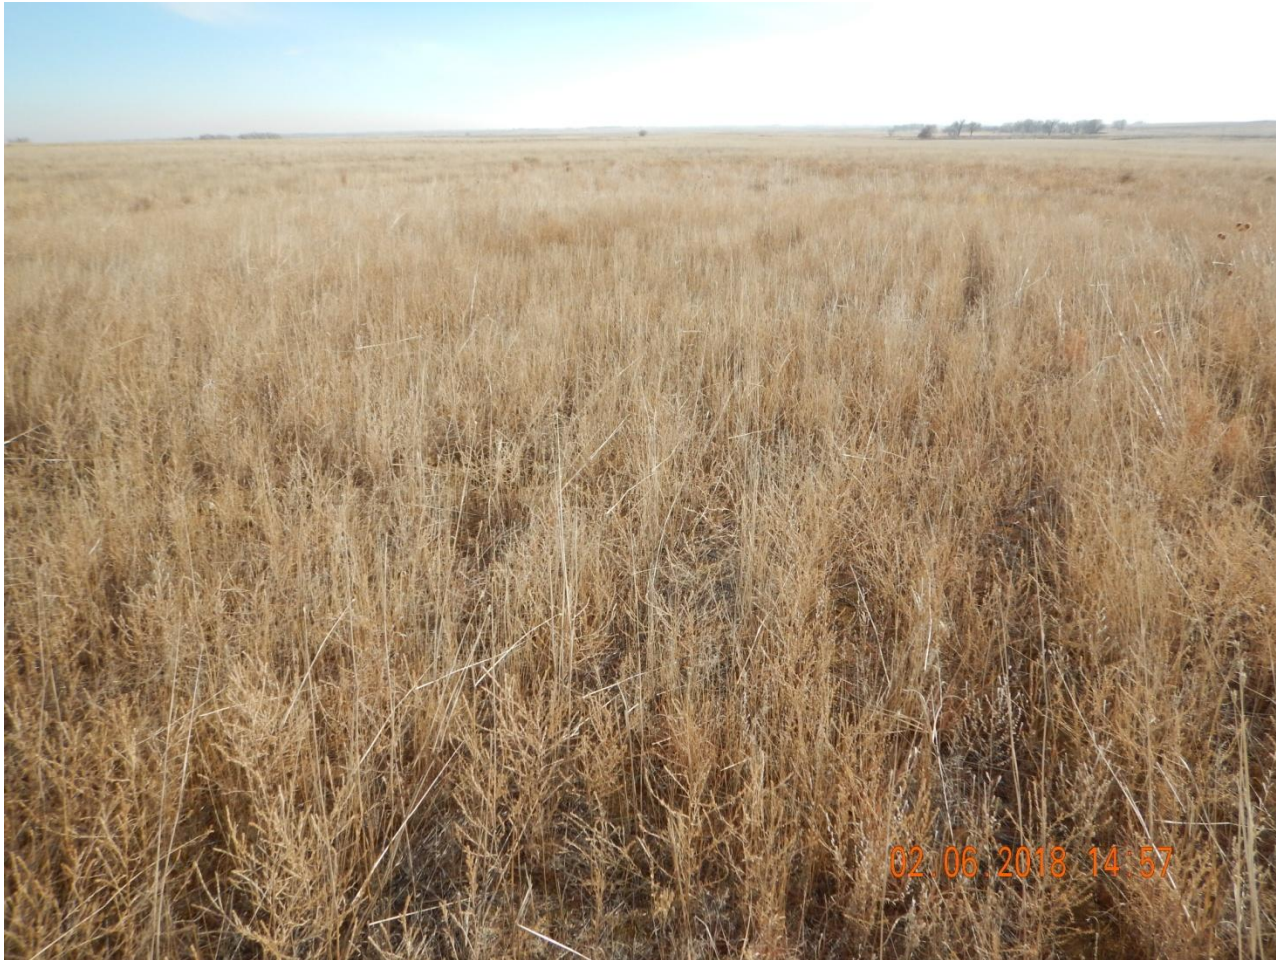
Photo 5. Photo taken from the approximate center of the northern replugging disturbance area, facing South. Some reference area vegetation was observed but weedy, annual vegetation has a higher abundance than desirable species. See comments under Photo 1.

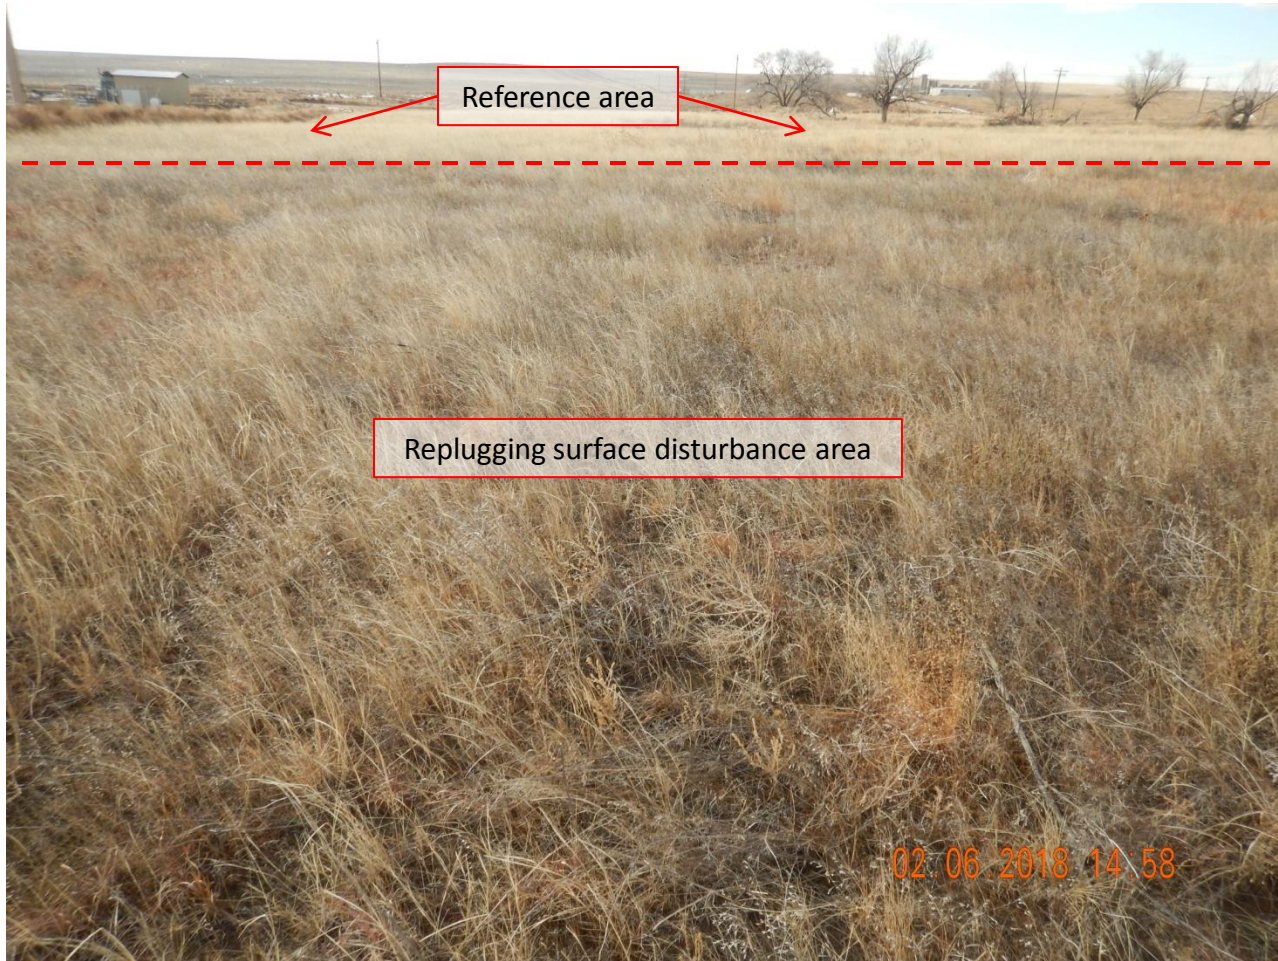
Photo 6. Photo taken from the approximate center of the northern replugging disturbance area, facing West. See comments under Photo 5.
