Interim Reclamation and Stormwater Inspection

February 6, 2018

Operator: BARRETT CORPORATION* BILL - #10071

Inspection Photos
Location Name: Anschutz-Williams /5-61-27 SWSW
Location ID: 452726

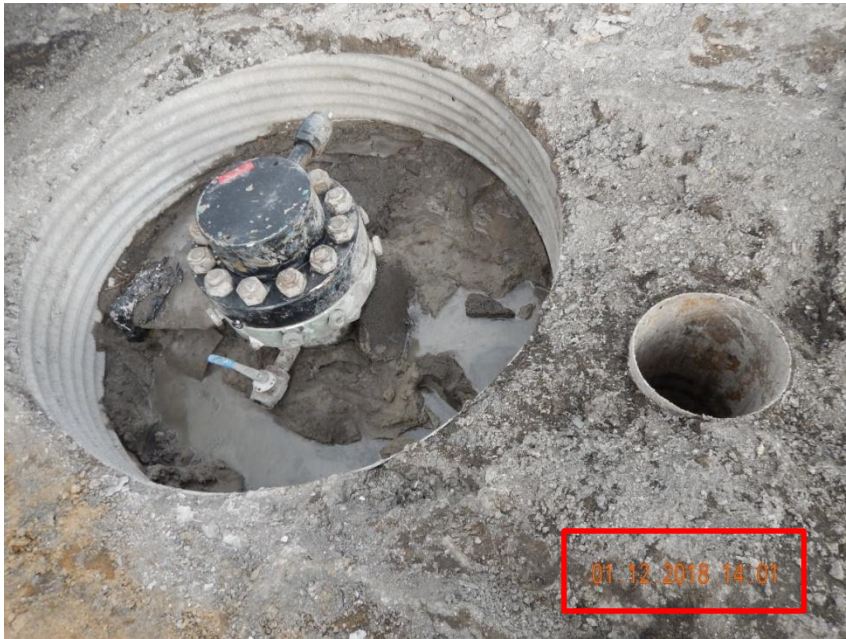
Photo 1. Photo taken from one of the wellheads at location on January 12, 2018. Photo illustrates a rat hole left open. This is a potential safety and wildlife hazard. Operator should also consider placing safety fence around the wellhead area for safety measures.

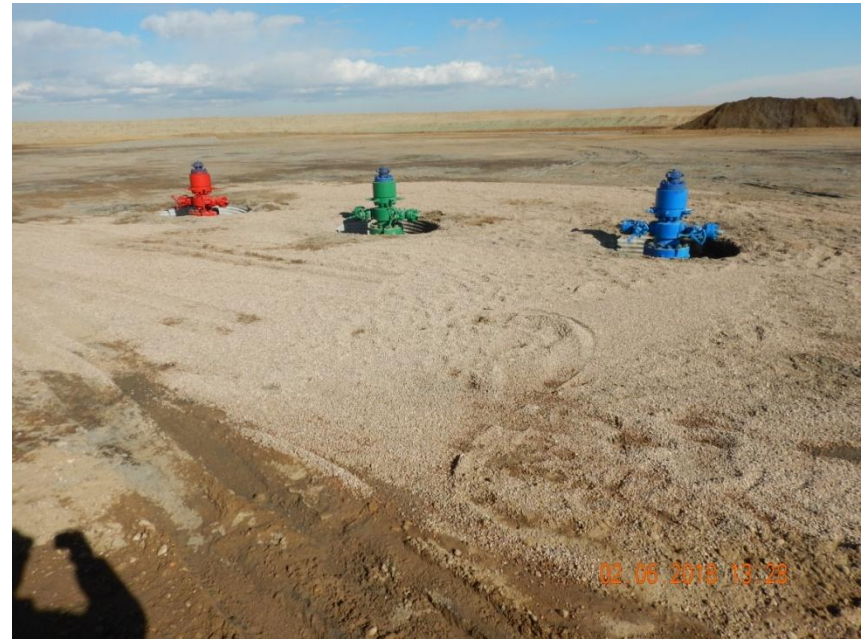
Photo 2. Photo taken from the wellheads at location on February 6, 2018. Operator has backfilled rat holes.

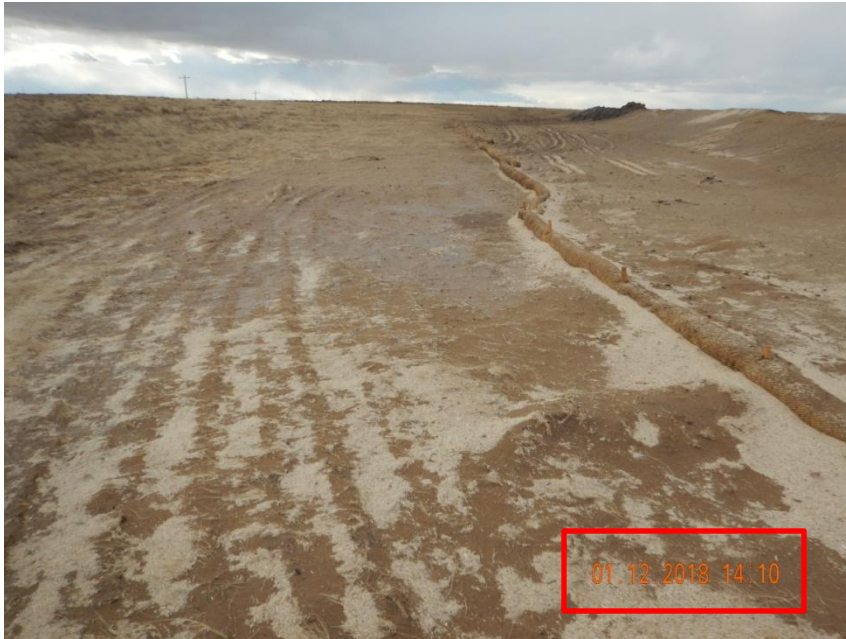
Photo 3. Photo taken from the southeastern perimeter of the location on January 12, 2018, facing West. Operator needs to store/handle sawdust left at location because it is blowing off location. Comments from Photo 5 apply to this area as well.

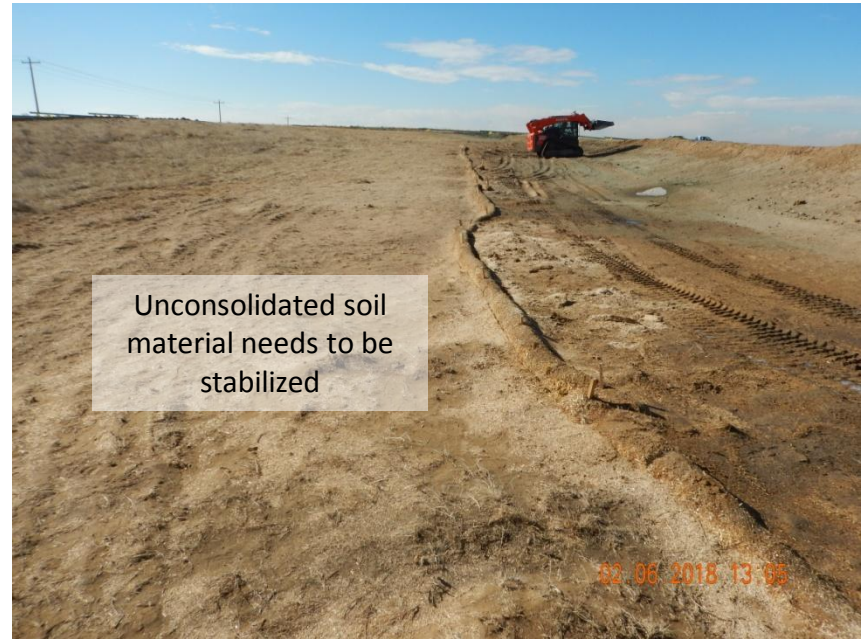
Photo 4. Photo taken from the southeastern perimeter of the location on February 6, 2018, facing West. Portions of the southern perimeter remain unconsolidated and needs to be stabilized. Operator plans to stabilize the outer perimeter disturbance with hydromulch to prevent wind erosion.

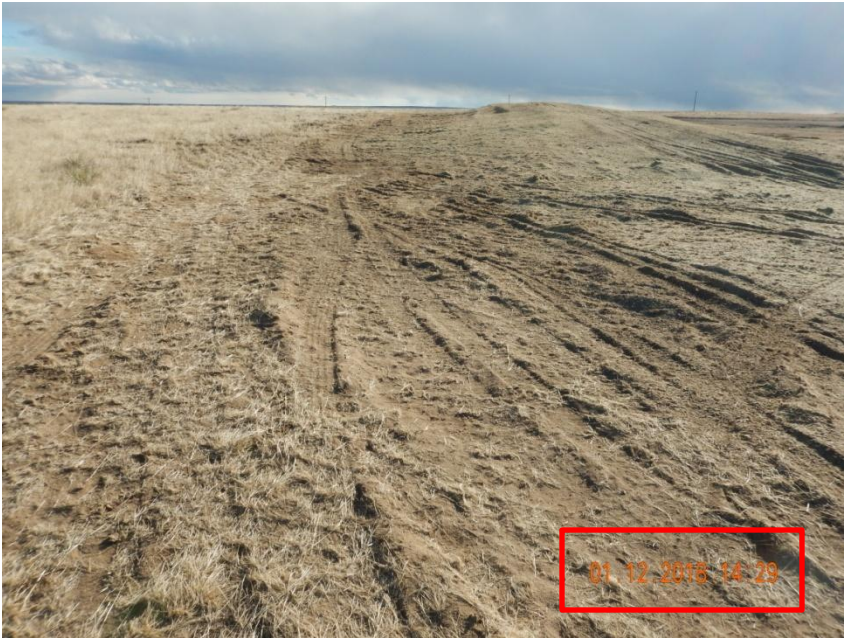
Photo 5. Photo taken from the northeast perimeter of the location on January 12, 2018, facing South. Operator does not have sufficient stormwater BMPs along the perimeter of the location.

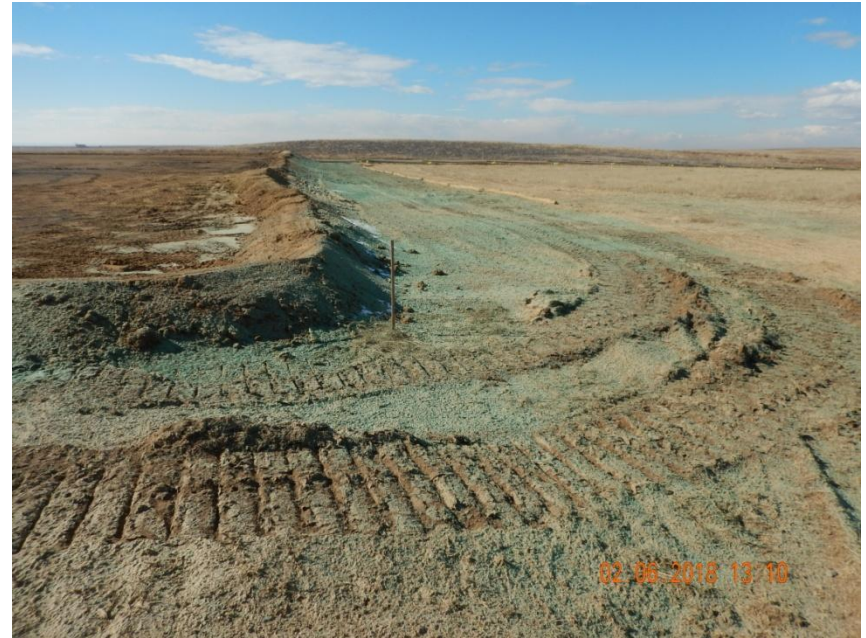
Photo 6. Photo taken from the northeast perimeter of the location on February 6, 2018, facing West. See comments under Photo 4.

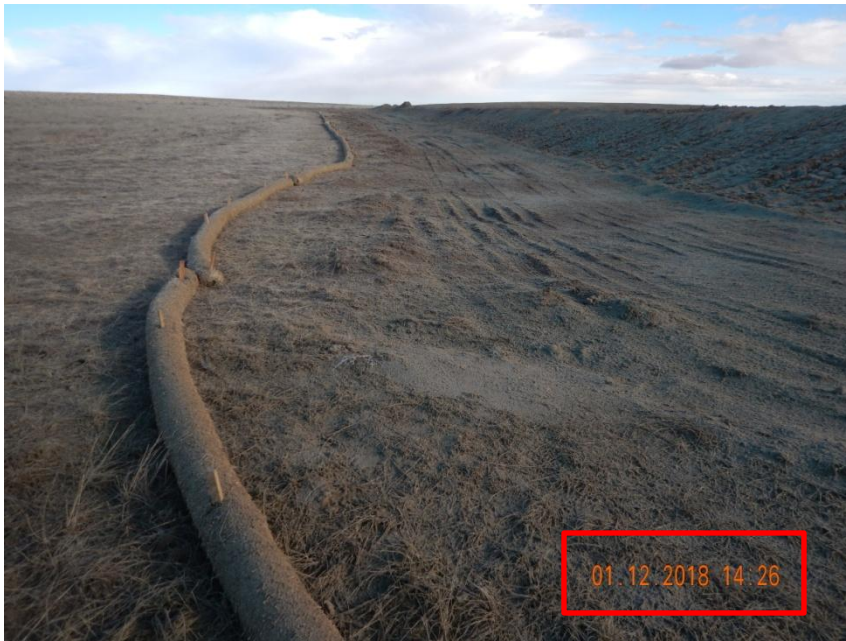
Photo 7. Photo taken from the northwest perimeter of the location on January 12, 2018, facing East. Straw wattle BMP has been installed and appears hydromulch has been applied to portions of unconsolidated soil material along the perimeter of the location.

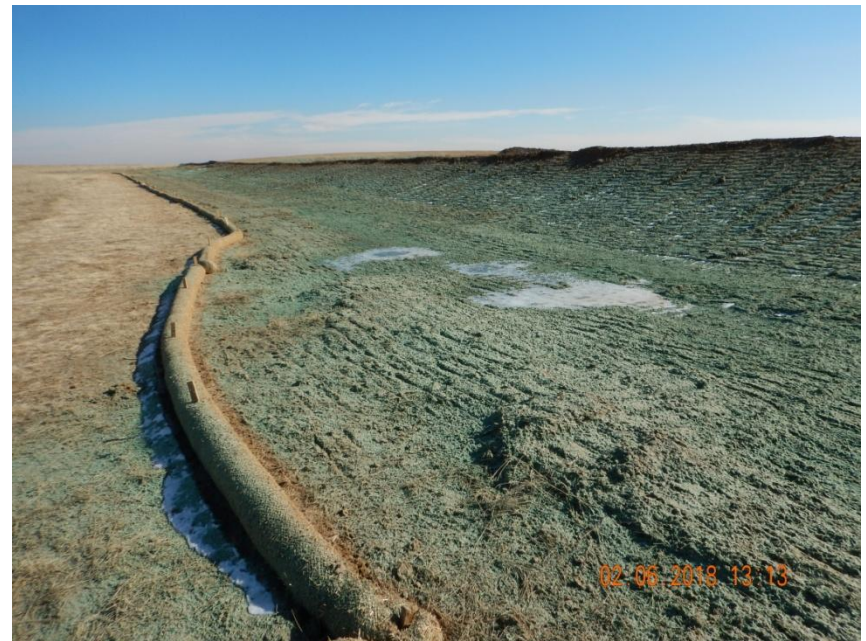
Photo 8. Photo taken from the northwest perimeter of the location on February 6, 2018, facing East. Operator has re-tracked fill slopes and applied more hydromulch. Operator plans to stabilize the outer perimeter disturbance with hydromulch to prevent wind erosion.

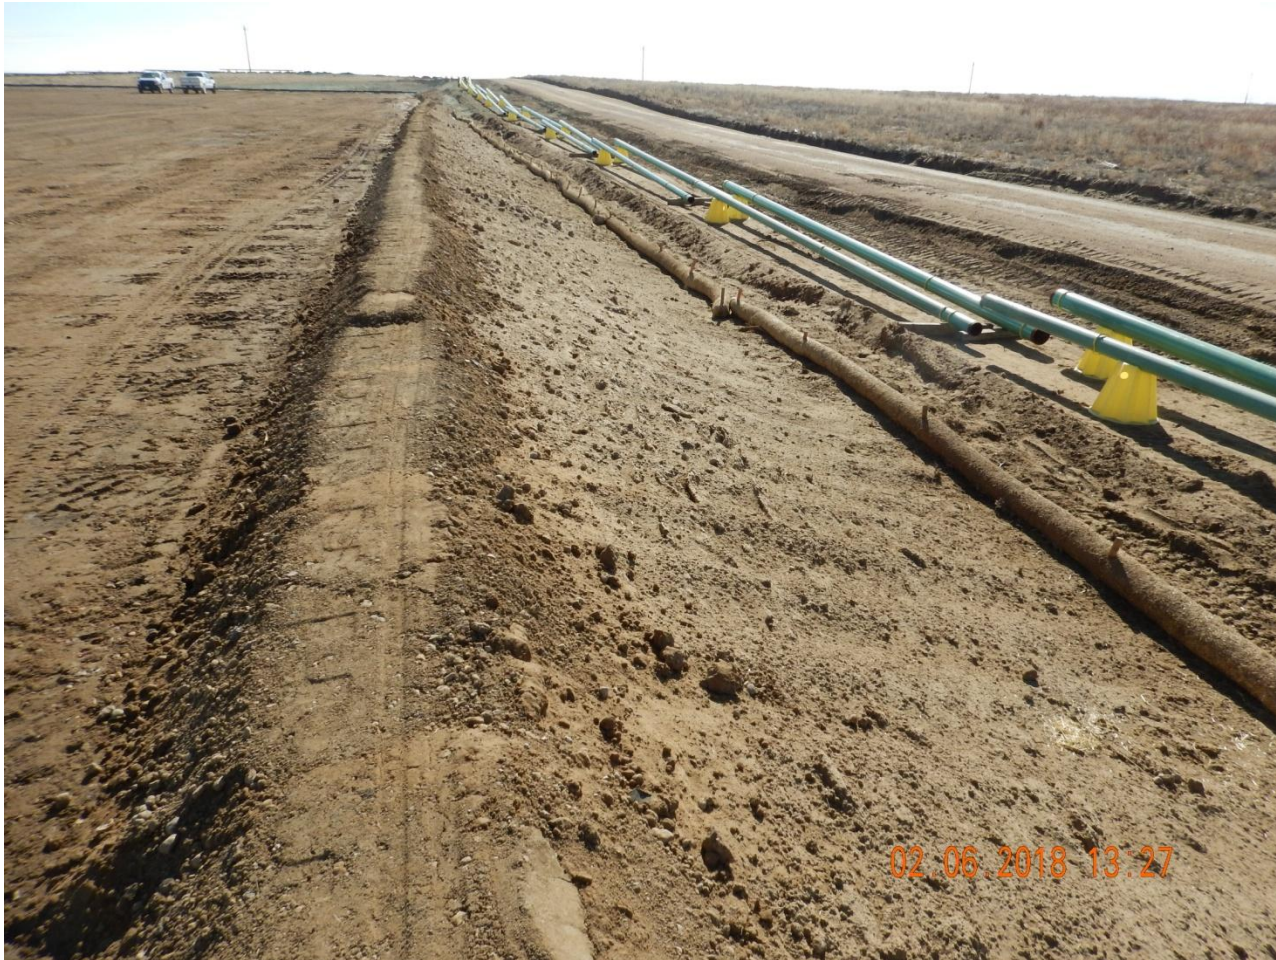
Photo 9. Photo taken from the western perimeter of the location on February 6, 2018, facing South. Pipeline installation is in-process and appears to have compromised portions of the perimeter straw wattle BMPs. Operator shall work with the Pipeline company to ensure stormwater BMPs are maintained at all times.
