Interim Reclamation and Stormwater Inspection

Operator: BARRETT CORPORATION* BILL - #10071

Location ID: 452695

Inspection Photos
Location Name: Anschutz-Williams /5-61-27 CW2
Location ID: 452695

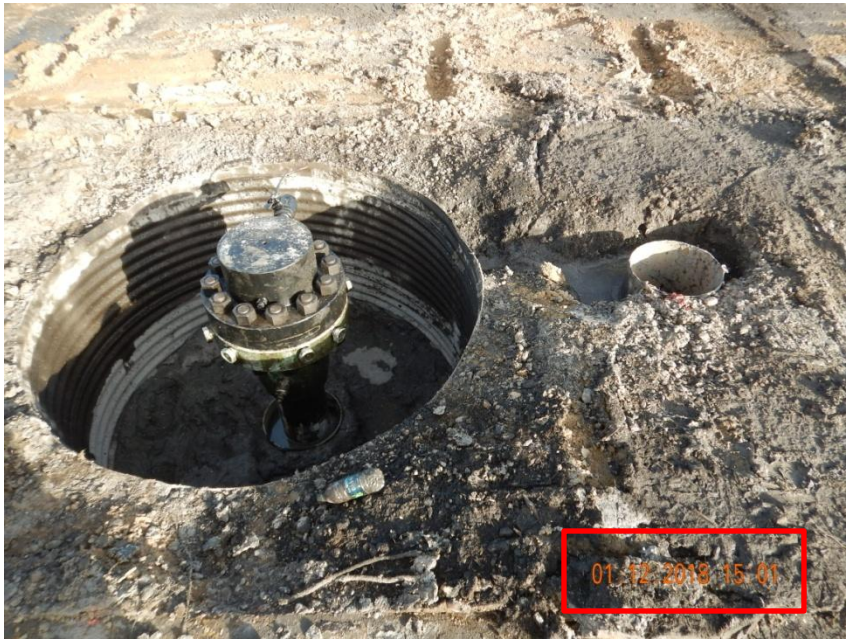
Photo 1. Photo taken from one of the wellheads at location on January 12, 2018. Photo illustrates a rat hole left open. This is a potential safety and wildlife hazard. Operator should also consider placing safety fence around the wellhead area for safety measures.

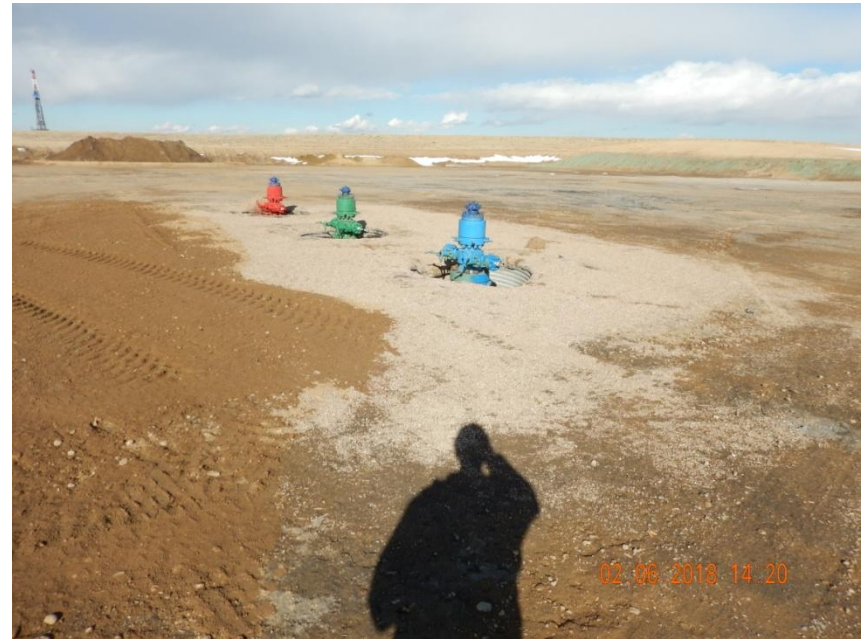
Photo 2. Photo taken from the wellheads at location on February 6, 2018. Operator has backfilled rat holes.

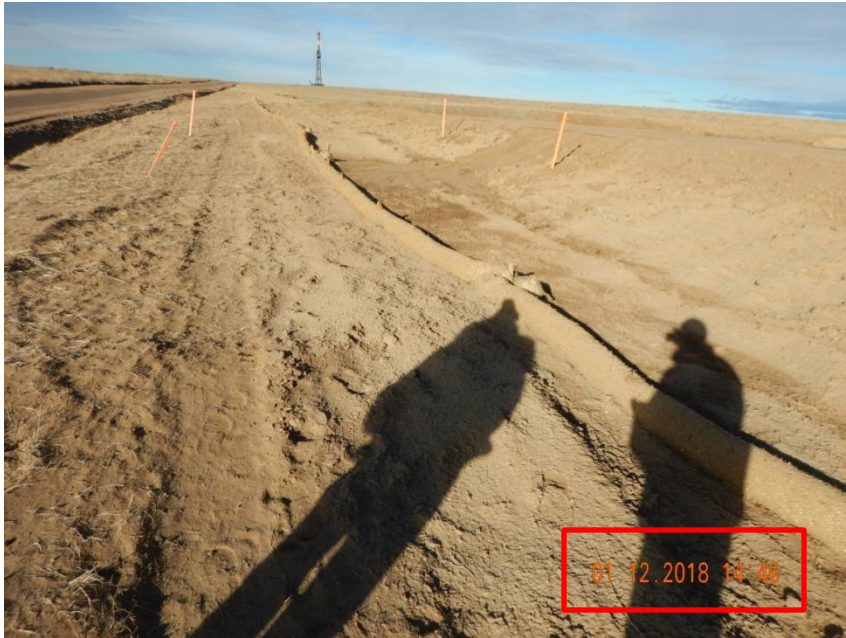
Photo 3. Photo taken from the western perimeter of the location on January 12, 2018, facing North. Straw wattle BMP has been installed and hydromulch has been applied to unconsolidated soil material along the perimeter of the location.

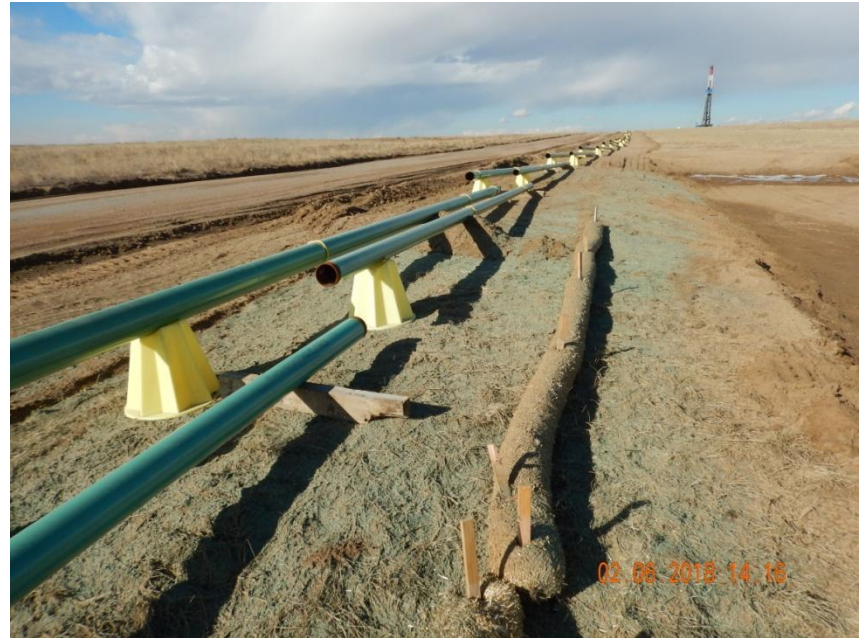
Photo 4. Photo taken from the western perimeter of the location on February 6, 2018, facing North. Pipeline installation is in-process and appears to have compromised portions of the perimeter straw wattle BMPs. Operator shall work with the Pipeline company to ensure stormwater BMPs are maintained at all times.

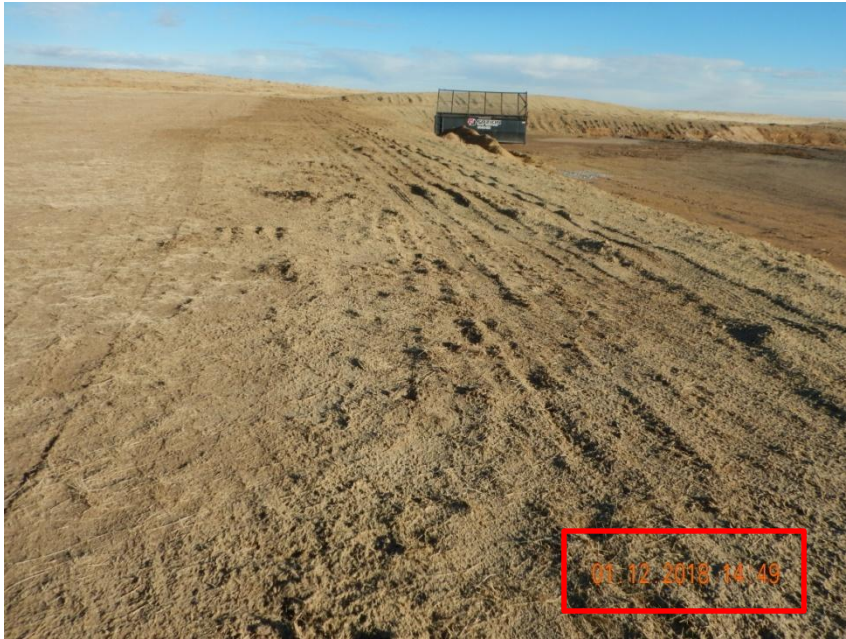
Photo 5. Photo taken from the northern perimeter of the location on January 12, 2018, facing East. Appears a surface roughening BMP has been installed along portions of the perimeter; however, this does not appear to be a sufficient and appropriate BMP for the sandy soil conditions.

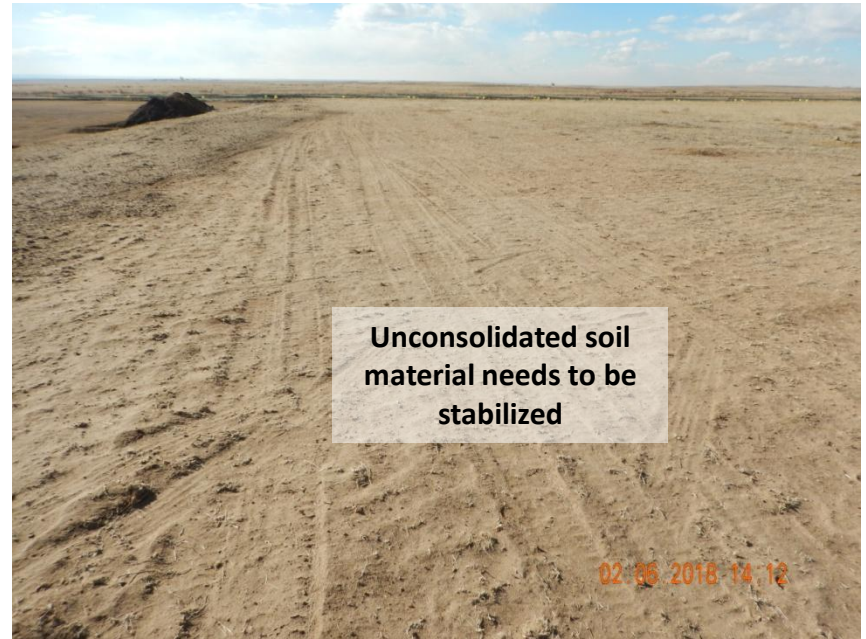
Photo 6. Photo taken from the northern perimeter of the location on February 6, 2018, facing East. Portions of the northern perimeter remain unconsolidated and needs to be stabilized. Operator plans to stabilize the outer perimeter disturbance with hydromulch to prevent wind erosion.

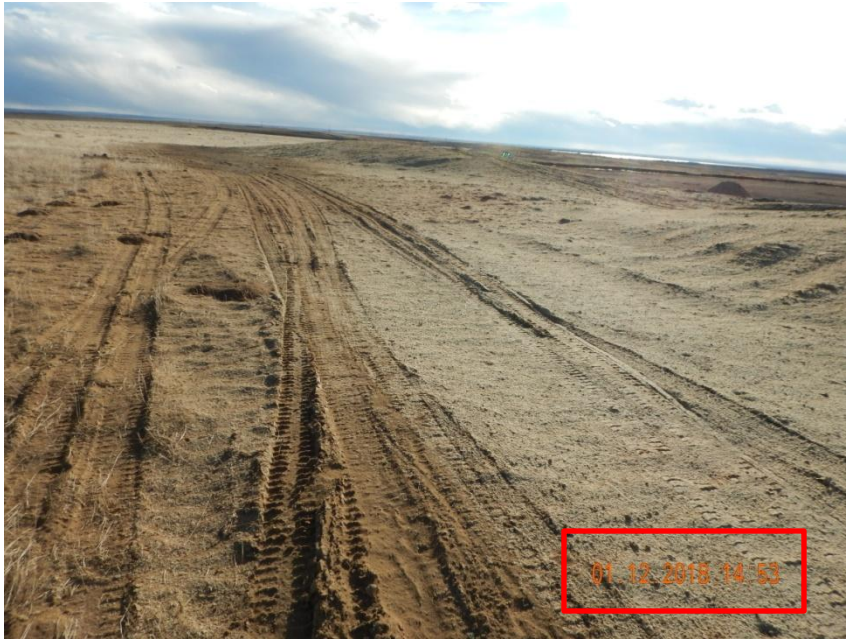
Photo 7. Photo taken from the eastern perimeter of the location on January 12, 2018, facing South. Appears the Operator has temporarily stabilized the topsoil stockpile with hydromulch. Operator does not have sufficient stormwater BMPs along the perimeter of the location.

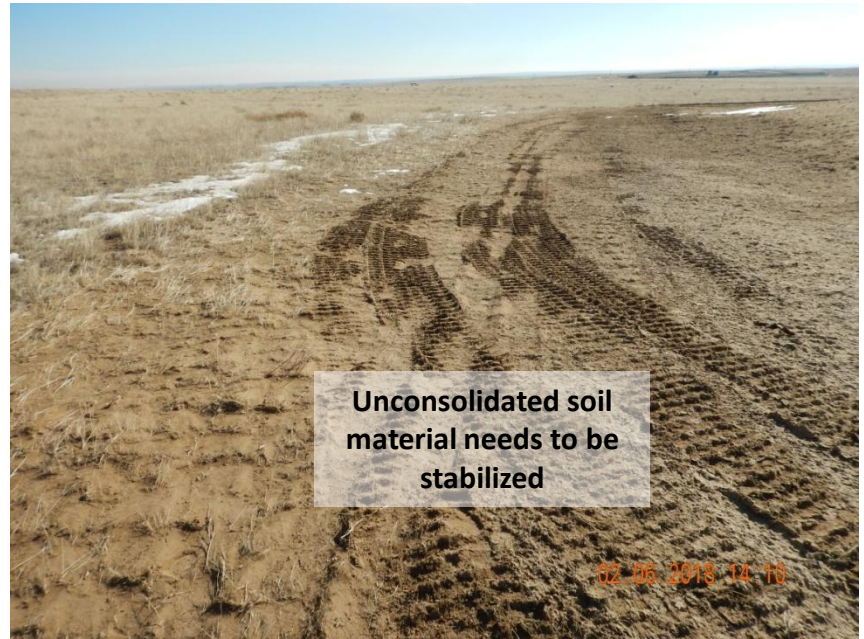
Photo 8. Photo taken from the eastern perimeter of the location on February 6, 2018, facing South. Portions of the eastern perimeter remain unconsolidated and needs to be stabilized. Operator plans to stabilize the outer perimeter disturbance with hydromulch to prevent wind erosion.

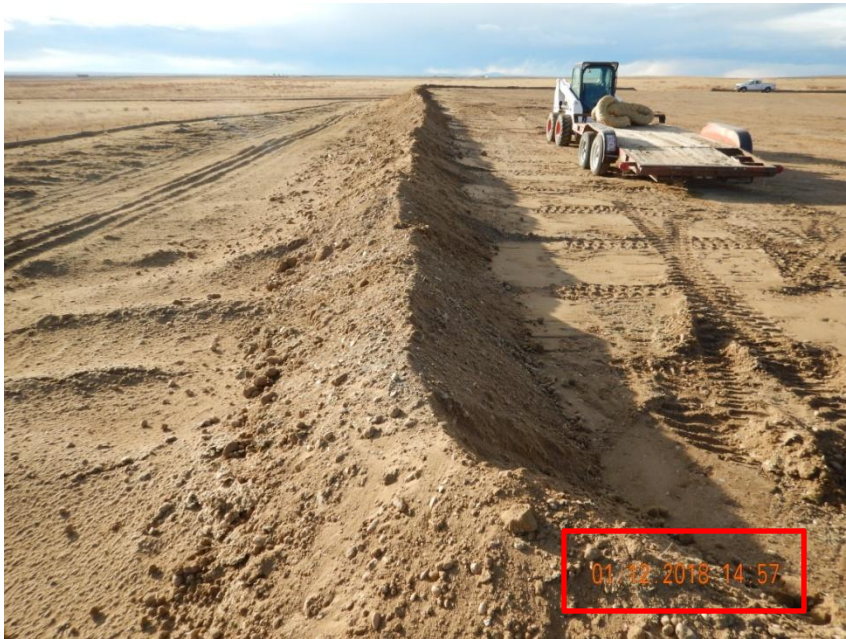
Photo 9. Photo taken from the southeastern perimeter of the location on January 12, 2018, facing West. Operator has not properly stabilized the berm BMP.

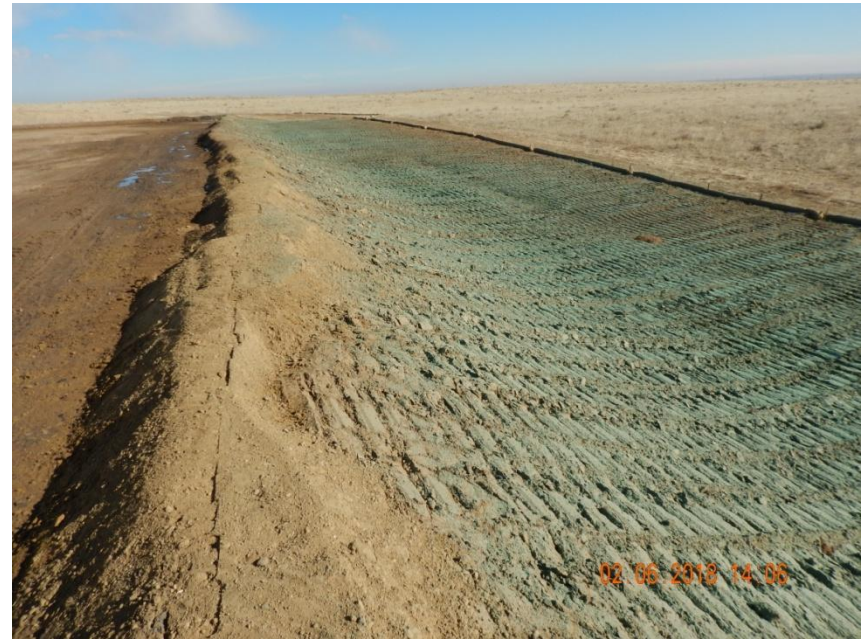
Photo 10. Photo taken from the southeastern perimeter of the location on February 6, 2018, facing East. Operator has re-tracked fill slopes, compacted the berm BMP and applied more hydromulch. Operator plans to stabilize the outer perimeter disturbance with hydromulch to prevent wind erosion.

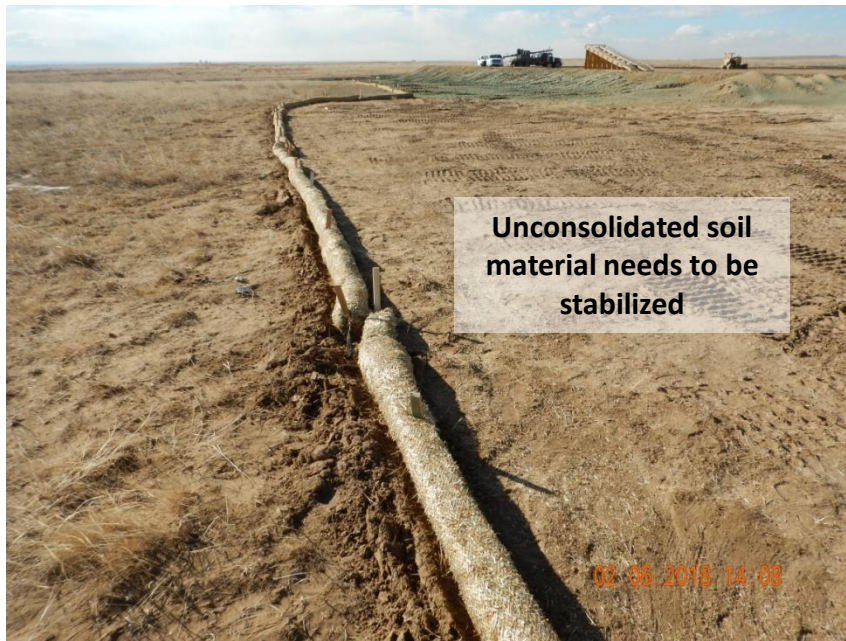
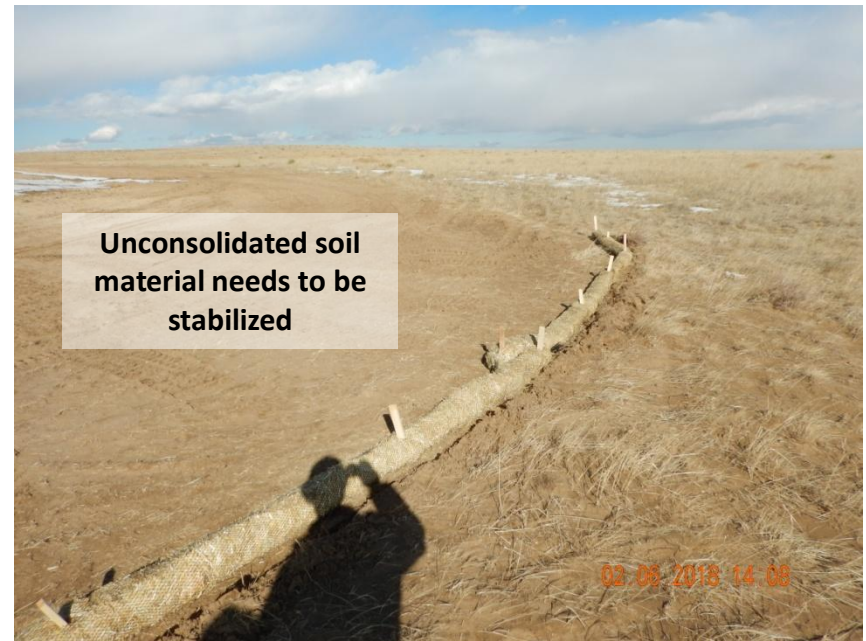
Photo 11. Photo taken from the southeast perimeter of the location on February 6, 2018, facing West. Portions of the southeastern perimeter remain unconsolidated and needs to be stabilized. Operator plans to stabilize the outer perimeter disturbance with hydromulch to prevent wind erosion.

Photo 12. Photo taken from the southeast perimeter of the location on February 6, 2018, facing North. See comments under Photo 11.
