Inspection Photos

Location Name: Lucero 34-10 flowline API: 05-123-17156 Spill ID #454029

Inspection Date: 02/14/2018

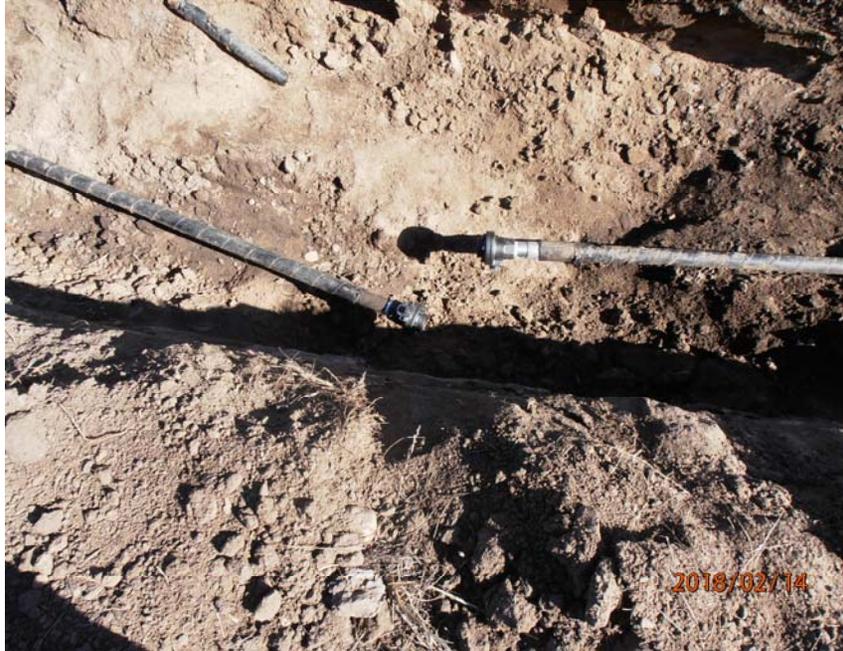
Photo 1 - Hammer union location of spill/release ID 454029

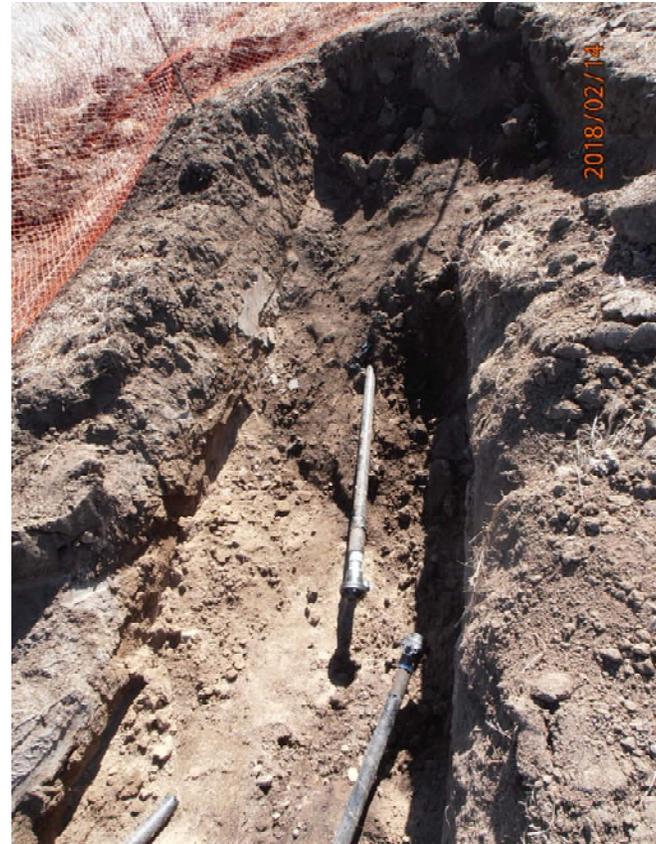
Photo 2 – Photo of flowline trench at release point, looking south.

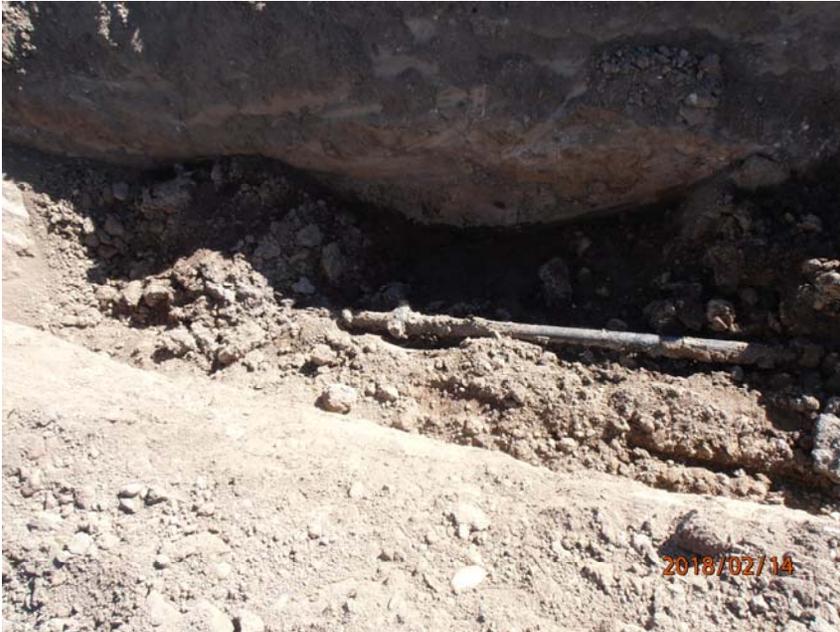
Photo 3 – Second hammer union suspected release point.

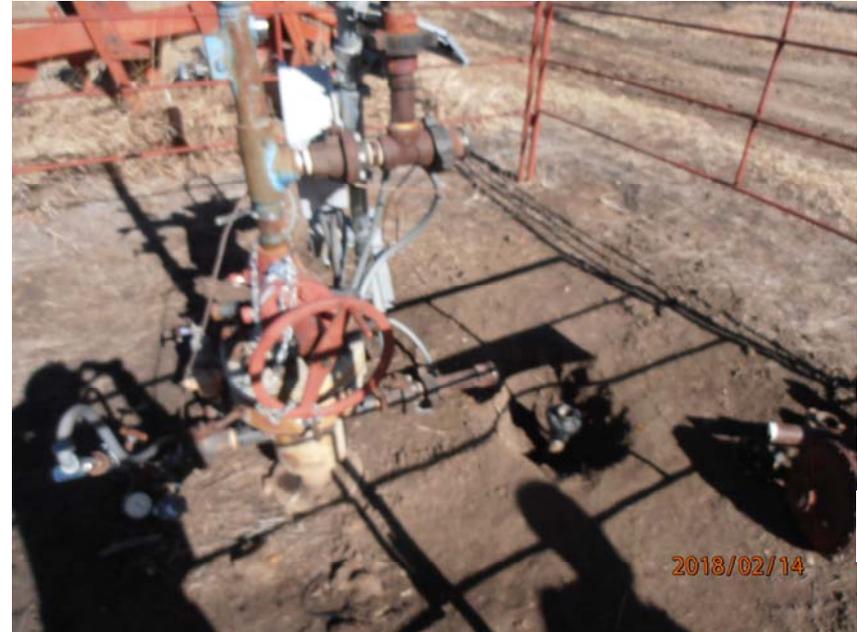
Photo 4 – with riser disconnected from wellhead.
