Inspection Photos
Location Name: Law #1-17
Location ID: 319375

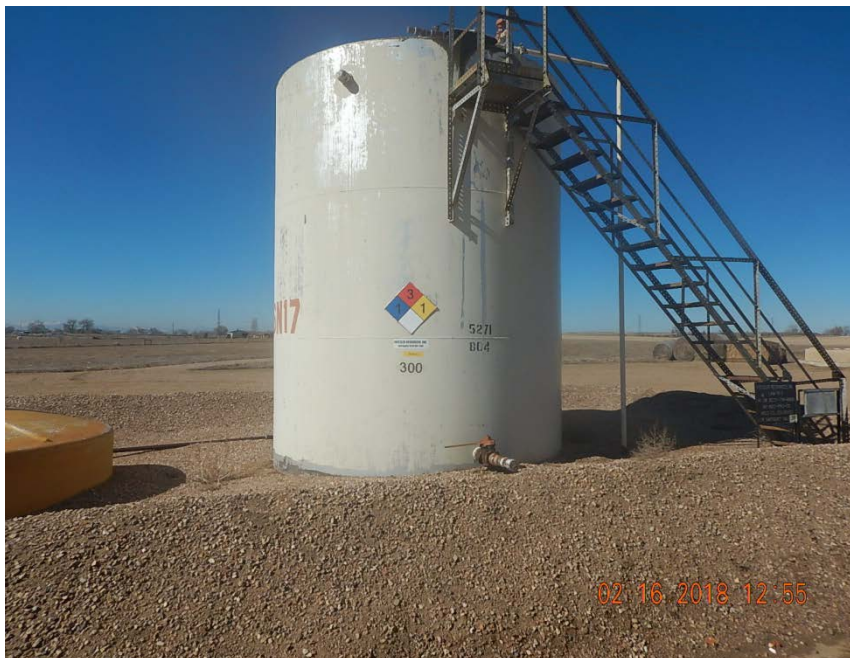
Photo 1: Location, looking NW, tank requires painting.

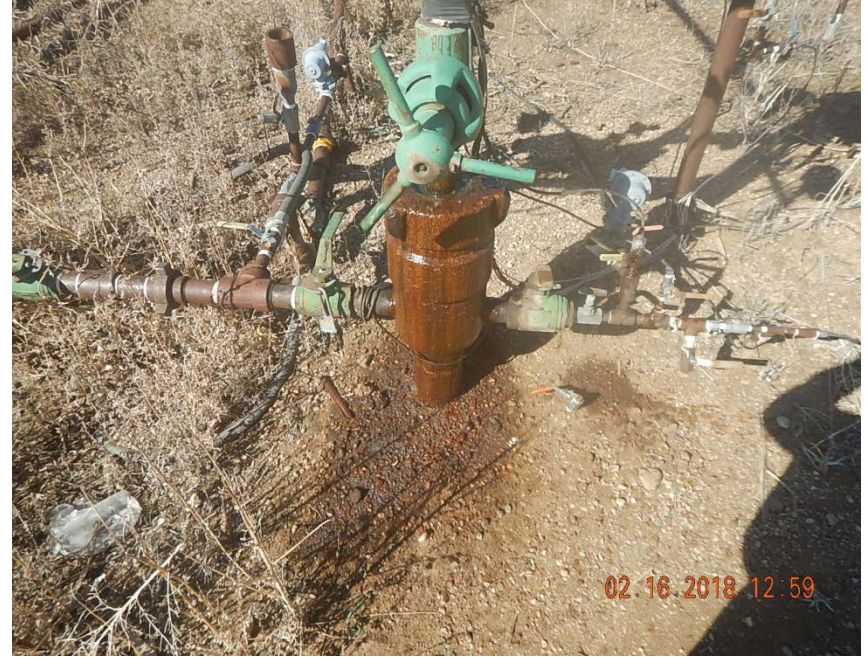
Photo 3: Stained soil at wellhead, leaking at wellhead

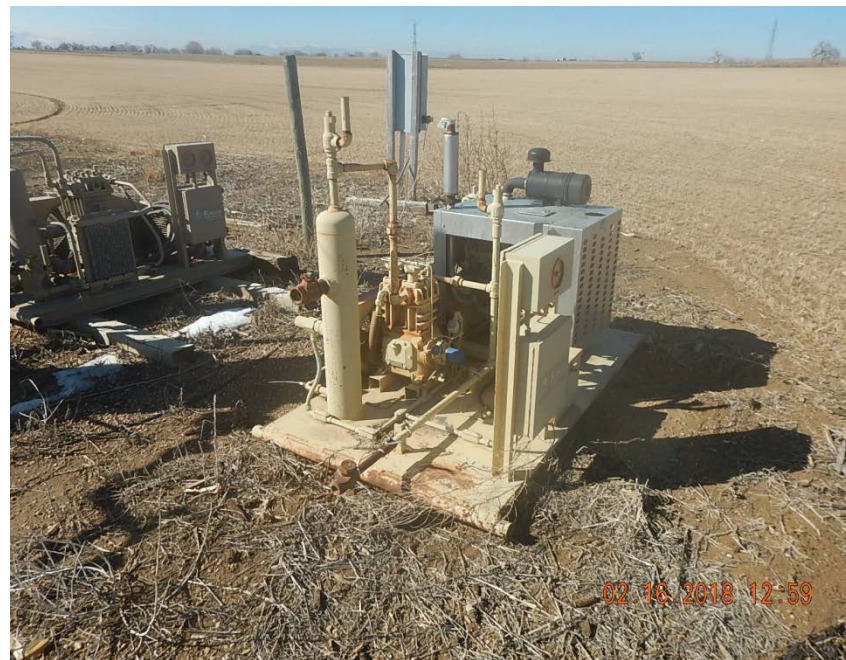
Photo 4: Unused compressor noted in prior inspection

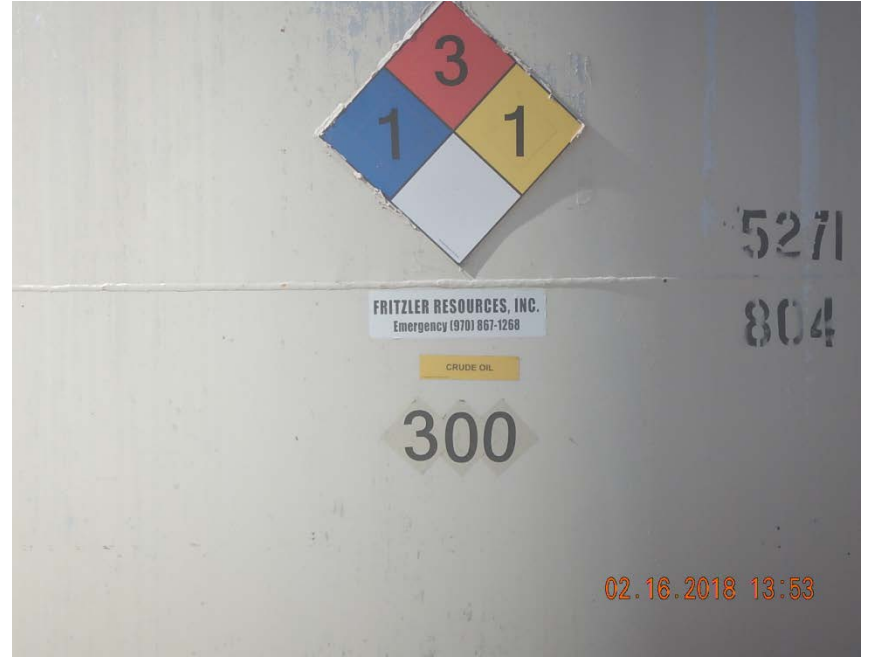
Photo 5: Emergency number decal not readable at 100 ft

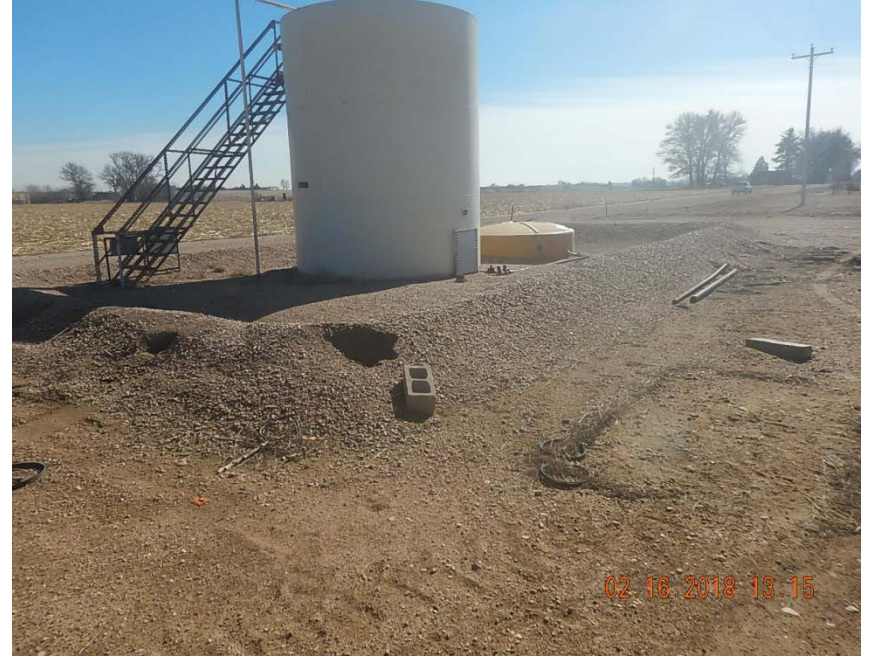
Photo 6: Unused equipment removed, some debris remains. Burrows in berms.

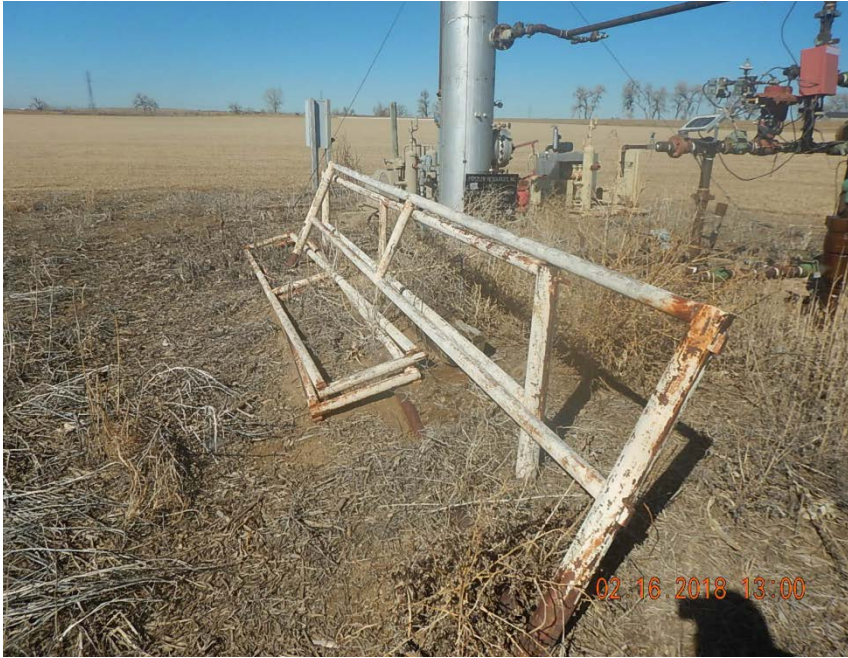
Photo 7: Unused fence at wellhead

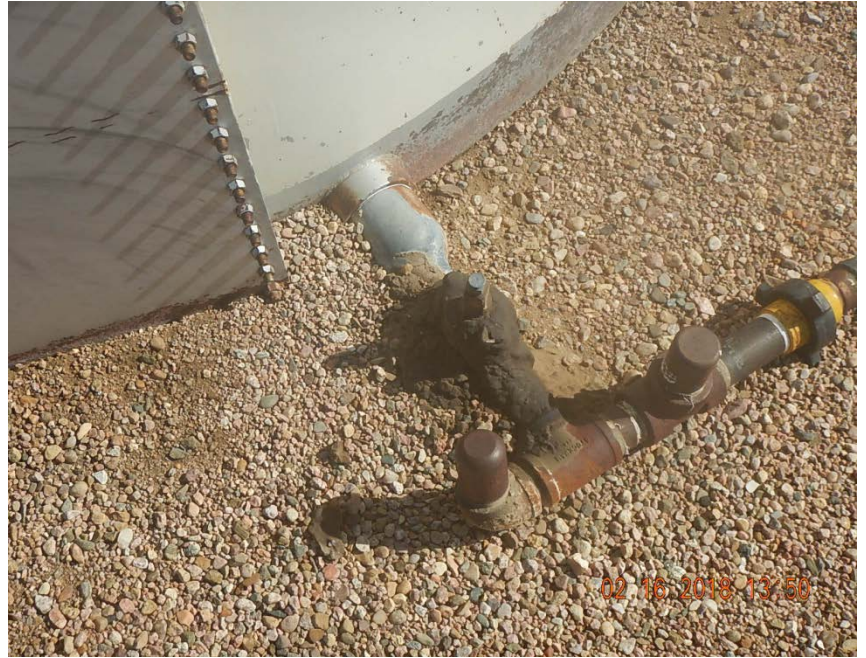
Photo 8: Stained soil at tank valve.
