Well Name : Wright 33-5 21-1

API # : 007-06276

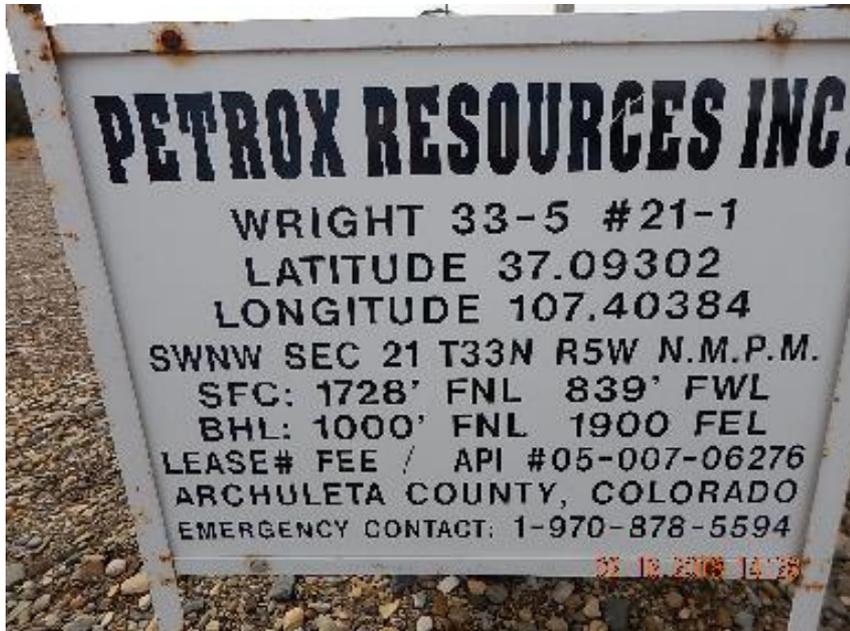
Photo 1: Wellhead sign.

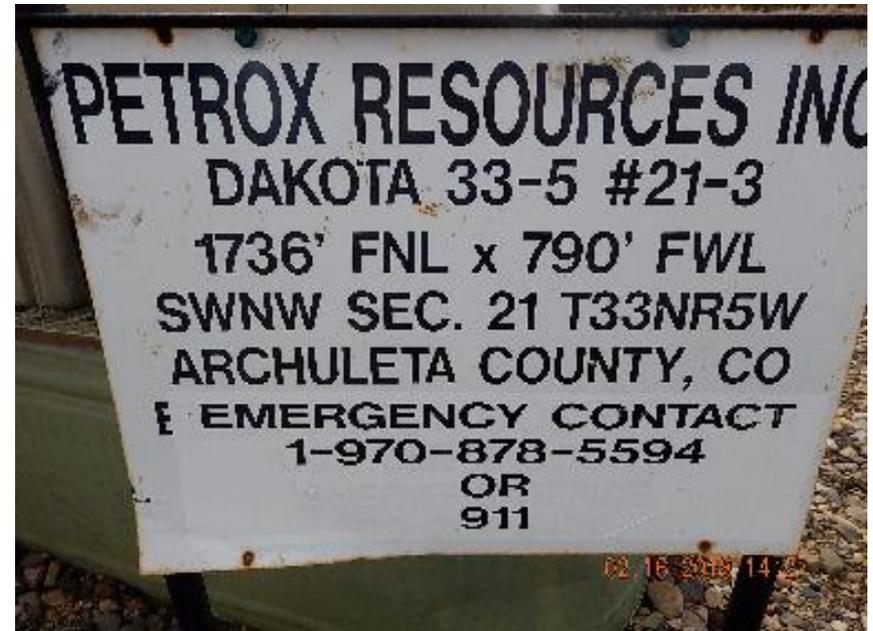
Photo 2: Wellhead sign.

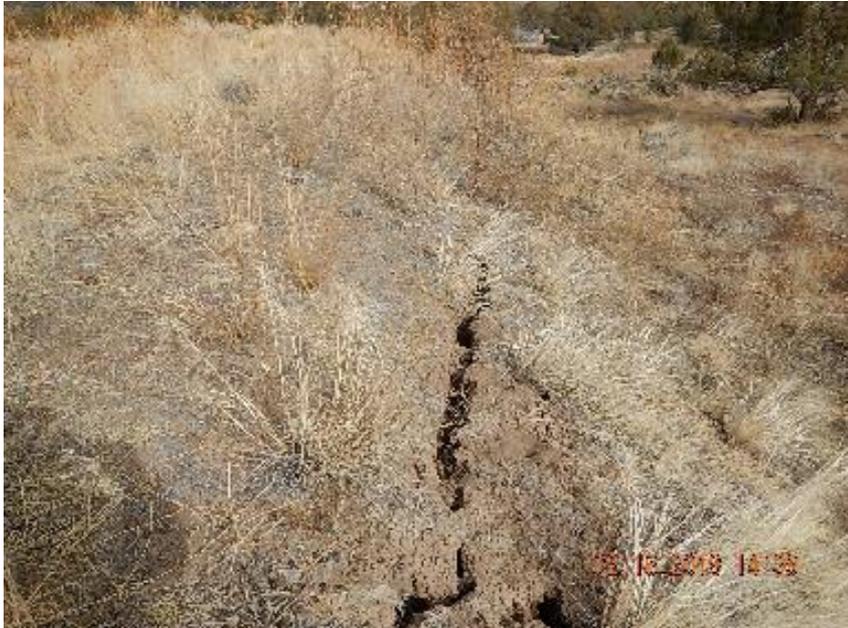
Photo 3: Soil separation at SE corner slope.

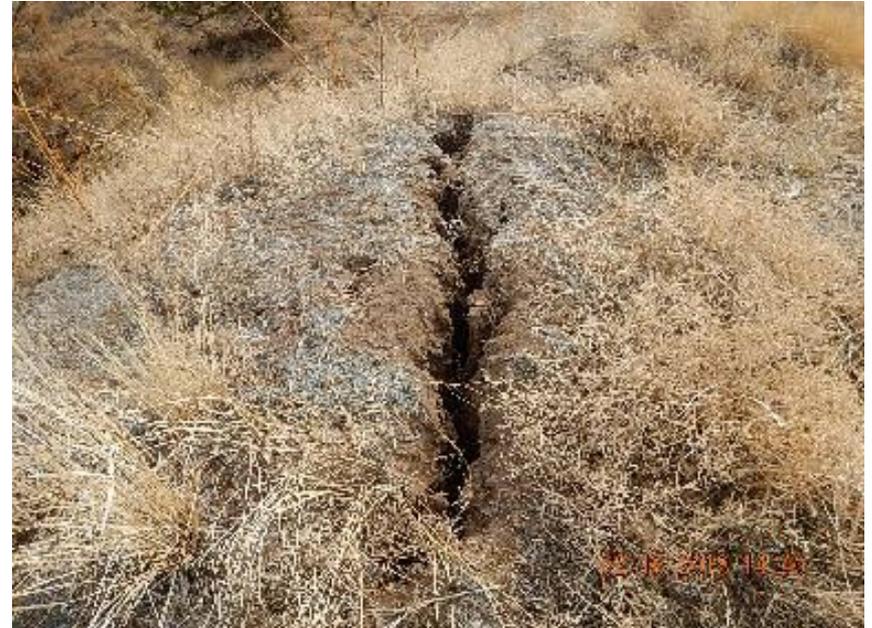
Photo 4: Soil separation at SE corner.

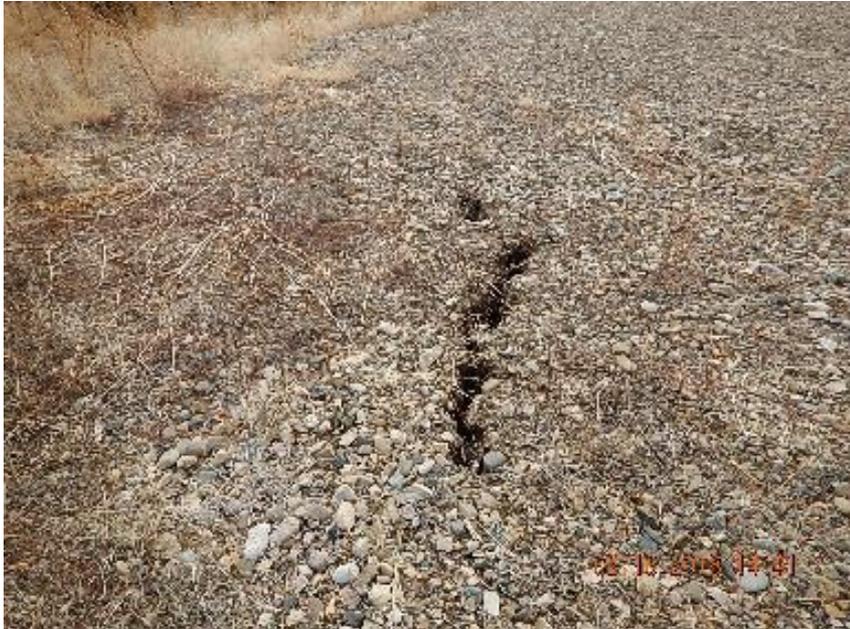
Photo 5: Soil separation at SE corner.

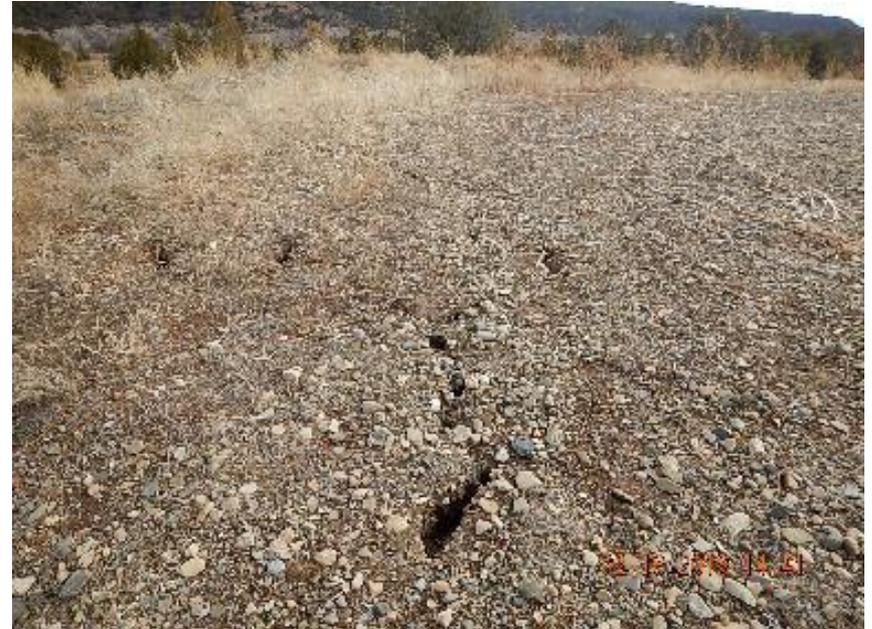
Photo 6: Soil separation at SE corner.

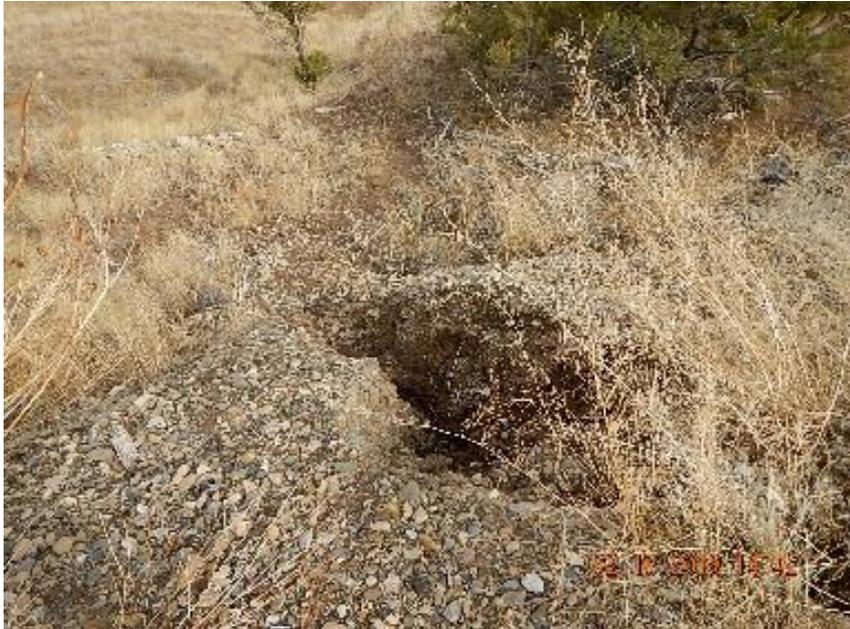
Photo 7: Erosion channel on E perimeter looking down slope.

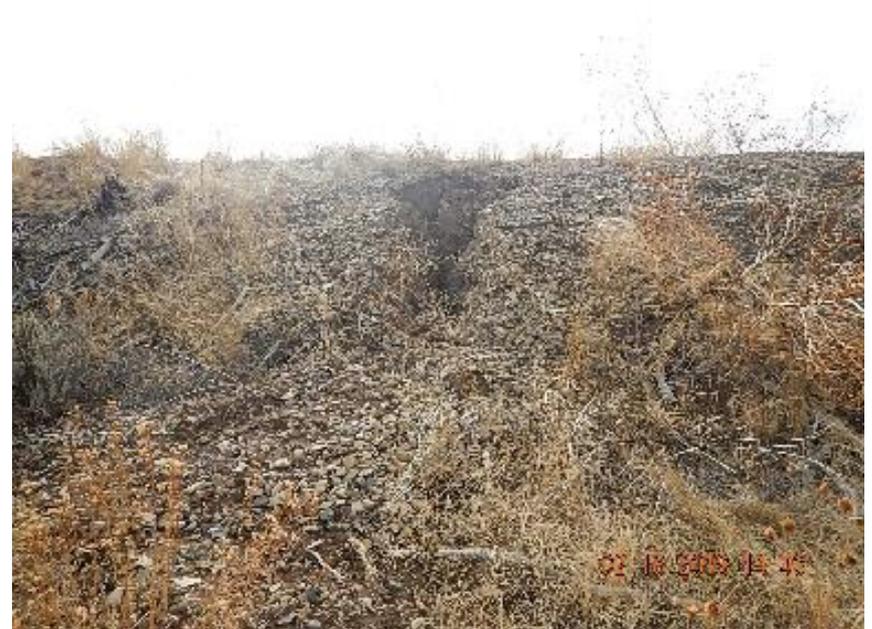
Photo 8: Erosion channel on E perimeter looking up slope.

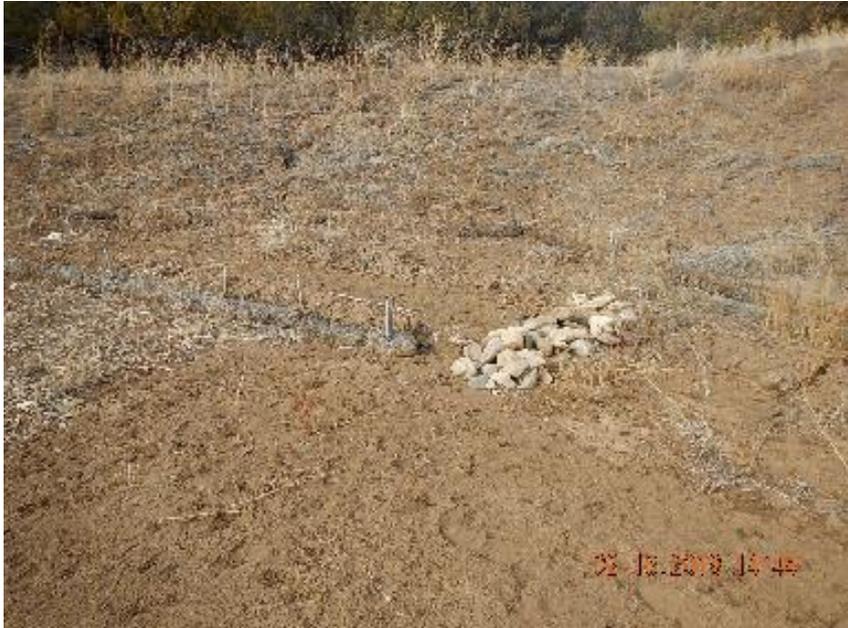
Photo 9: Check dam and waddle breach in NE corner.

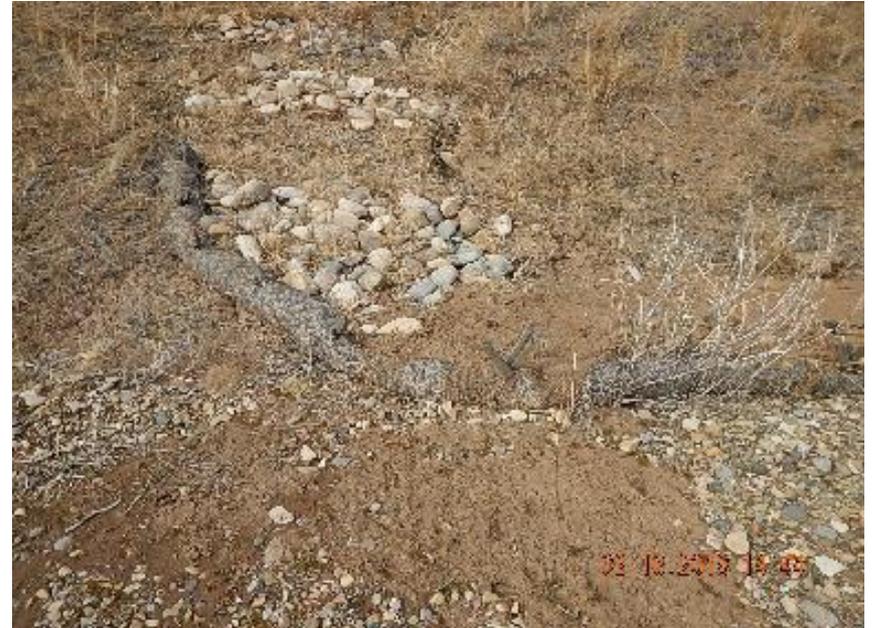
Photo 10: Waddle failing due to sediment filling up backside allowing stormwater and sediment to flow onto location.
