Inspection Photos

API: 05-067-09367

Operator: Hilcorp Energy Company

Inspection Number: 680602491

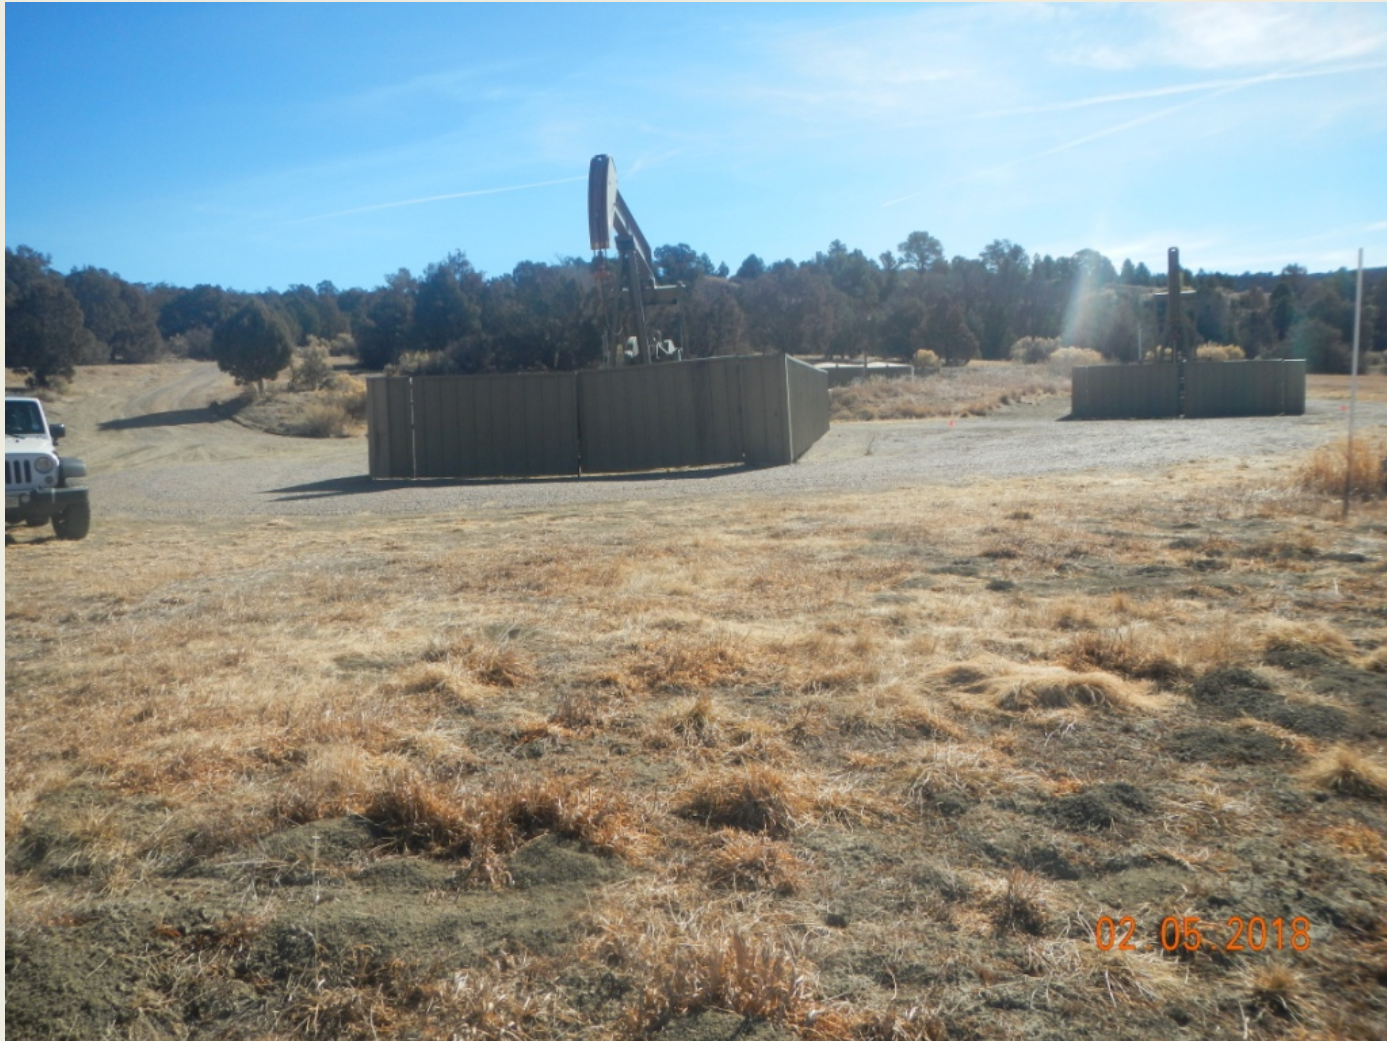
Photo 1. View of the project area from the northwestern corner facing center.

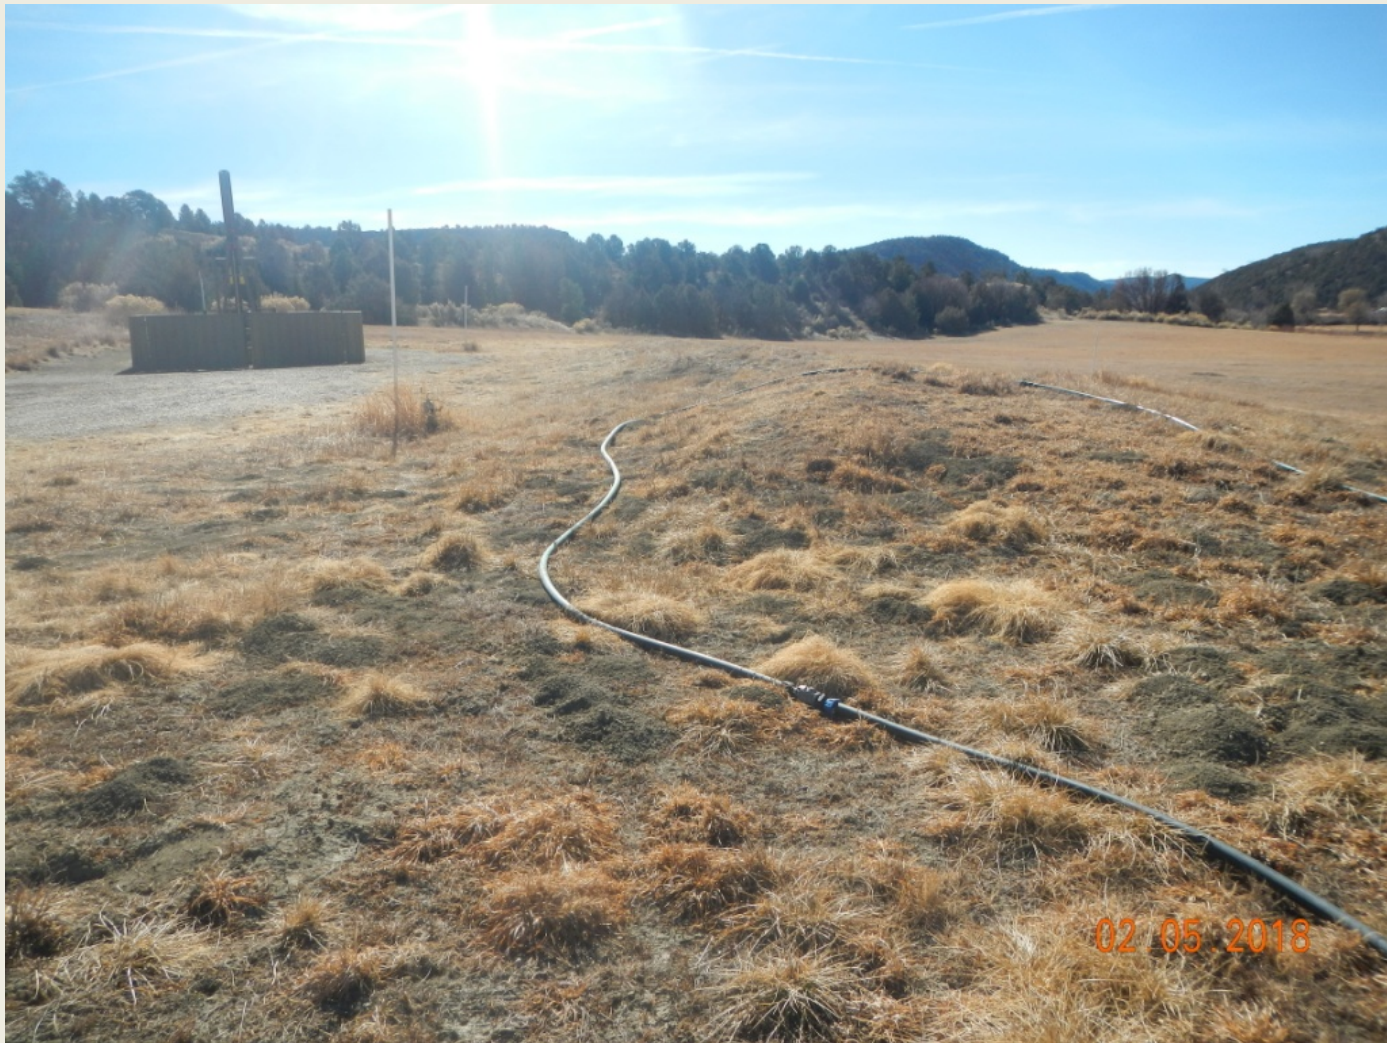
Photo 2. View of the western portion of the project area from the northwestern corner facing southward. Revegetation is progressing with grasses such as smooth brome (*Bromus inermis*), intermediate wheatgrass (*Thinopyron intermedium*), and dropseed (*Sporobolus* sp.).

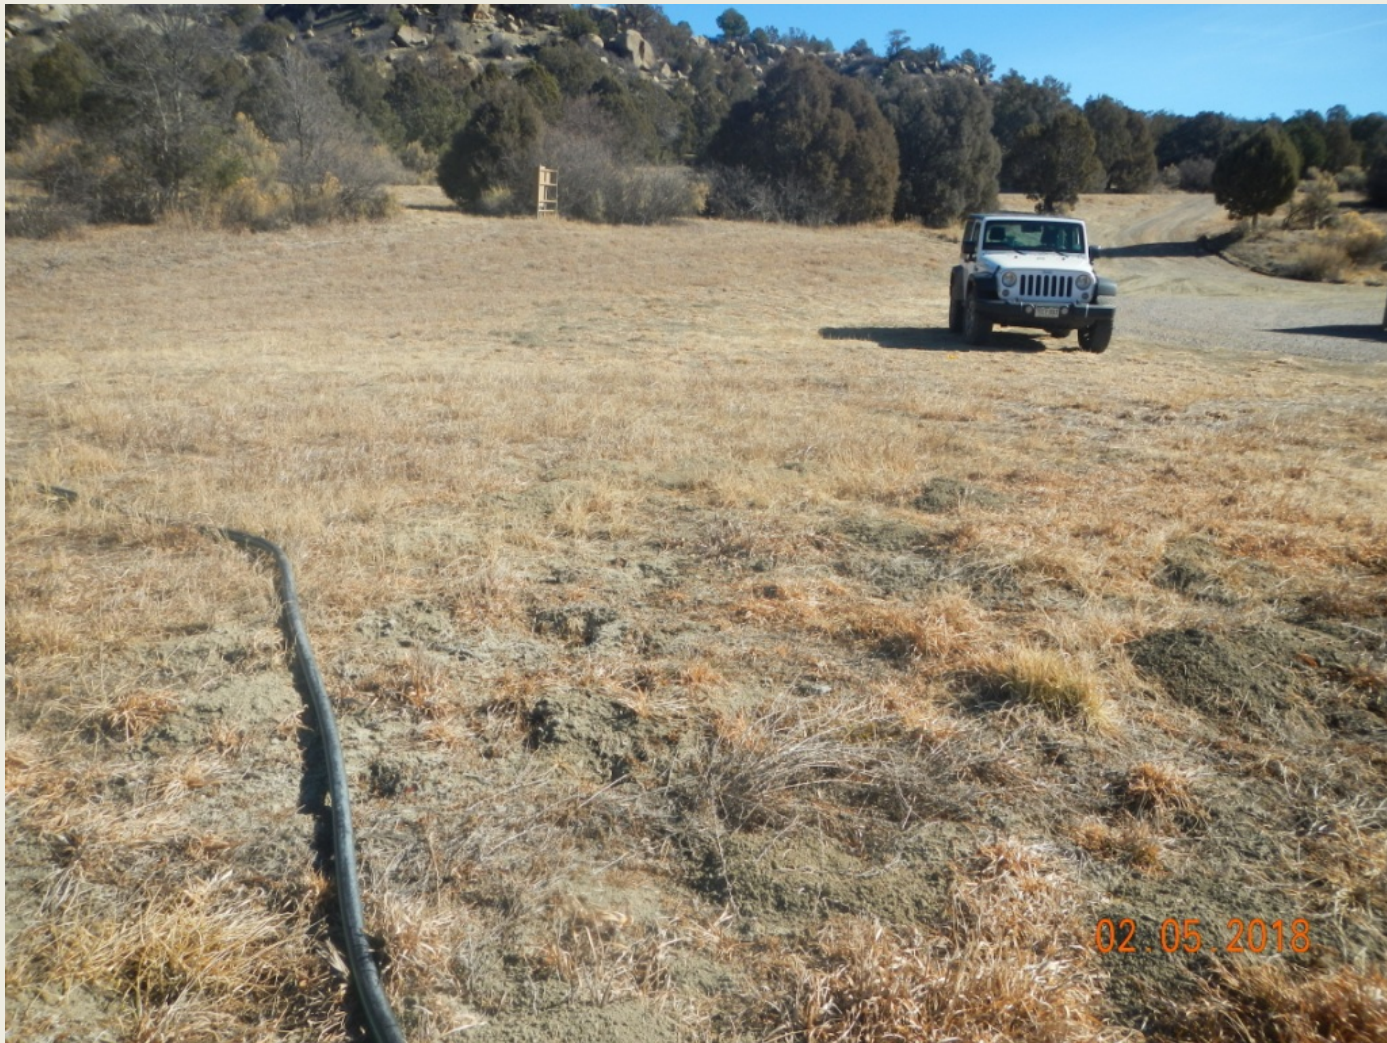
Photo 3. View of the eastern edge of the working area from the northeastern corner facing southward.

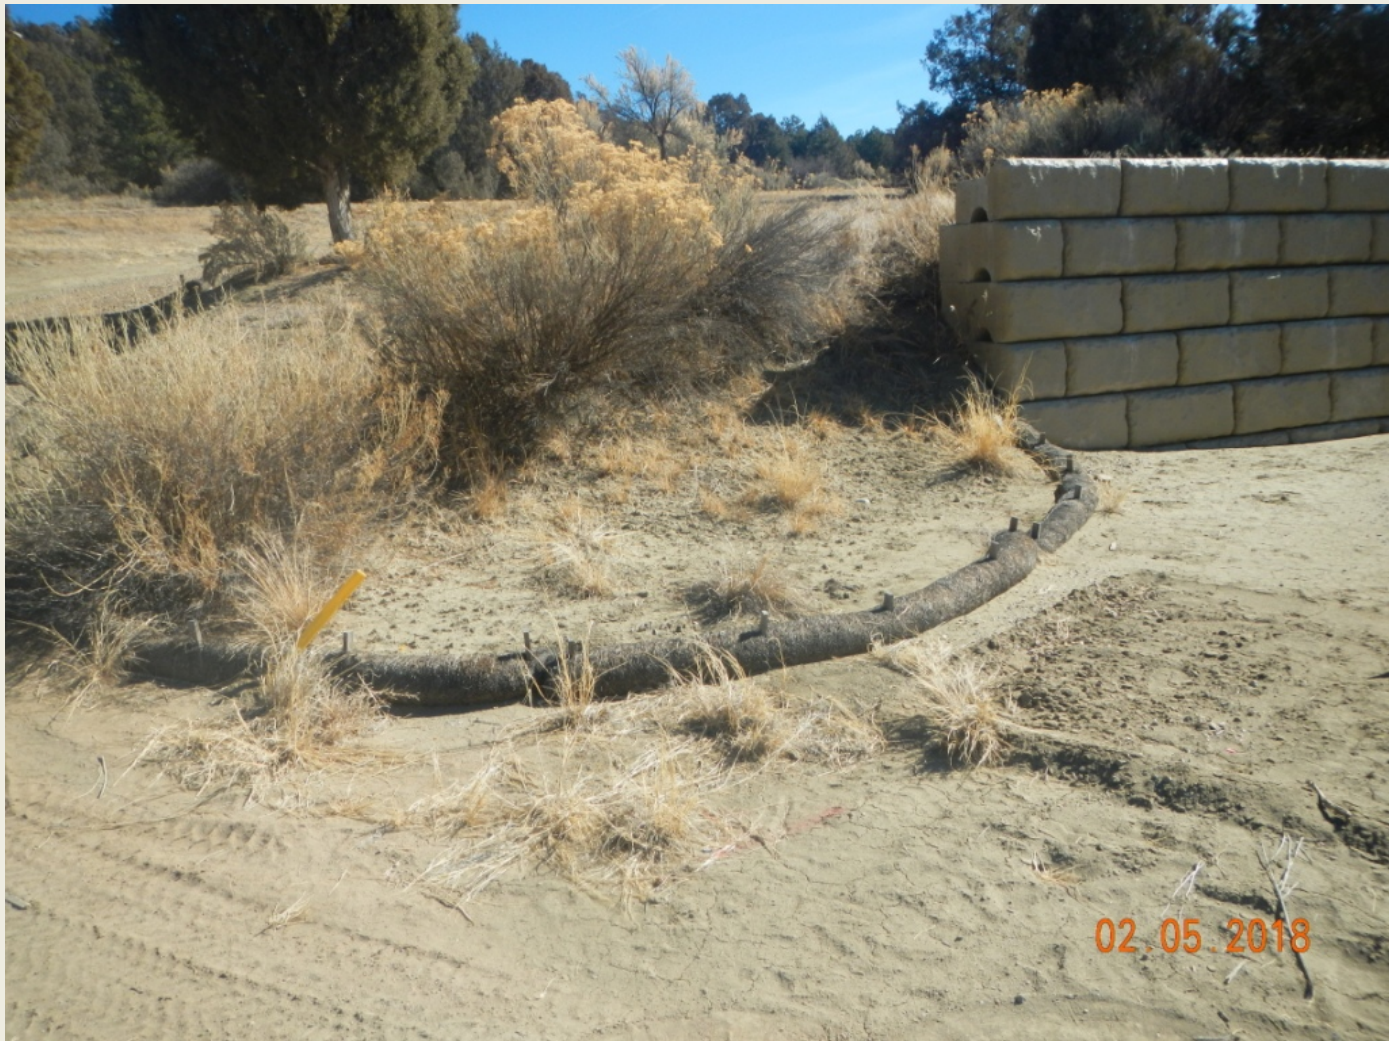
Photo 4. View of stormwater controls south of the access entrance. Appear to be functioning.

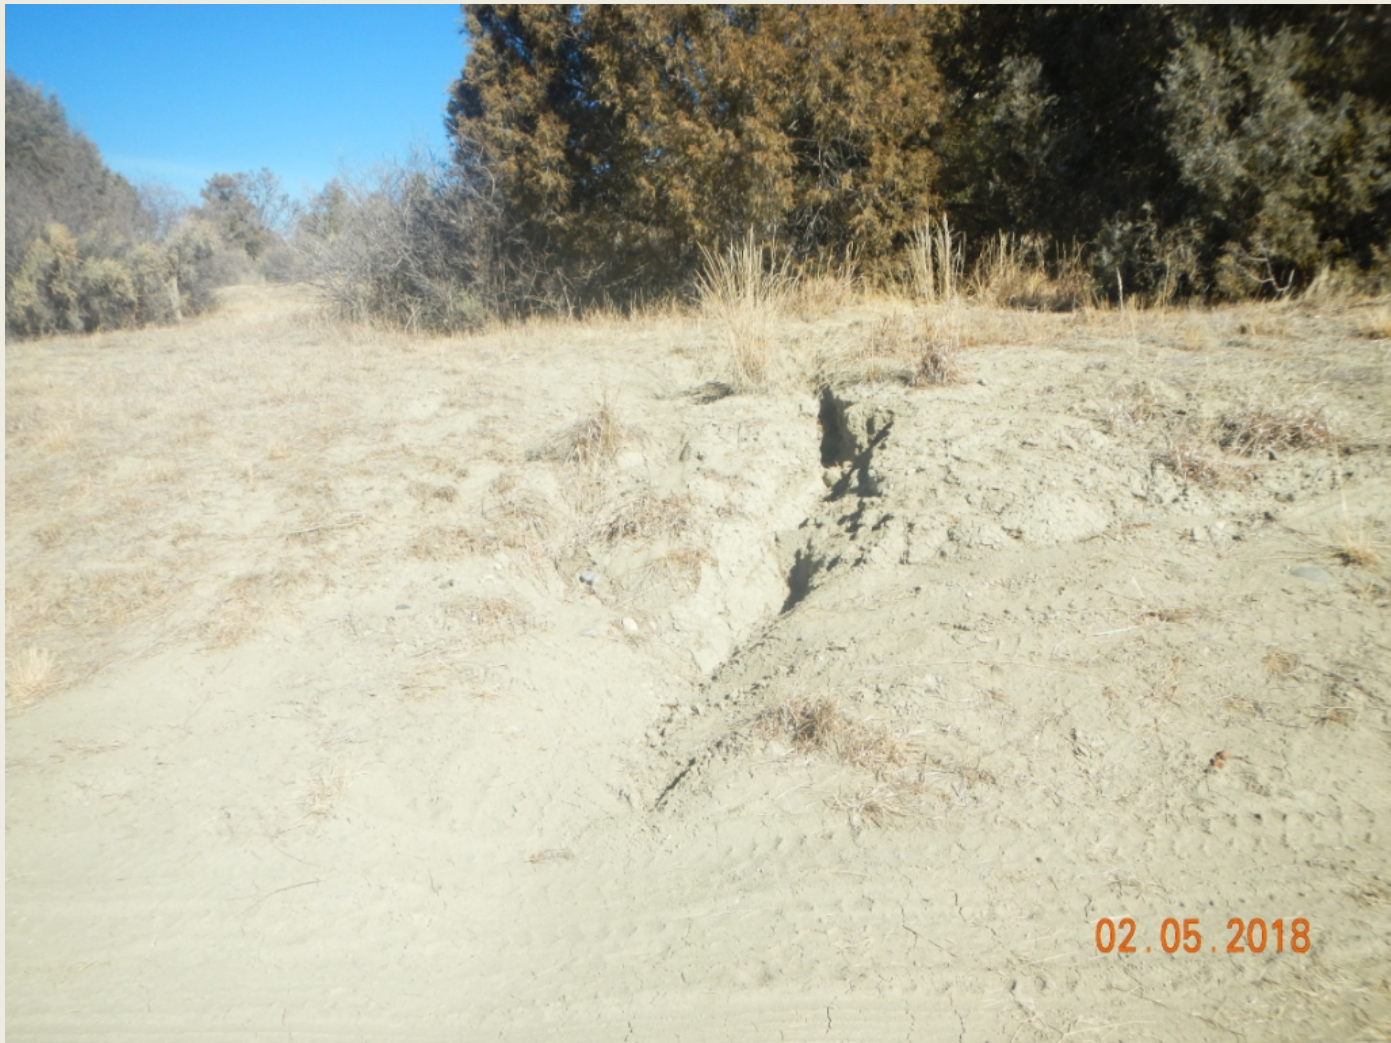
Photo 5. View of erosional channel forming in the northeastern portion of the project area.

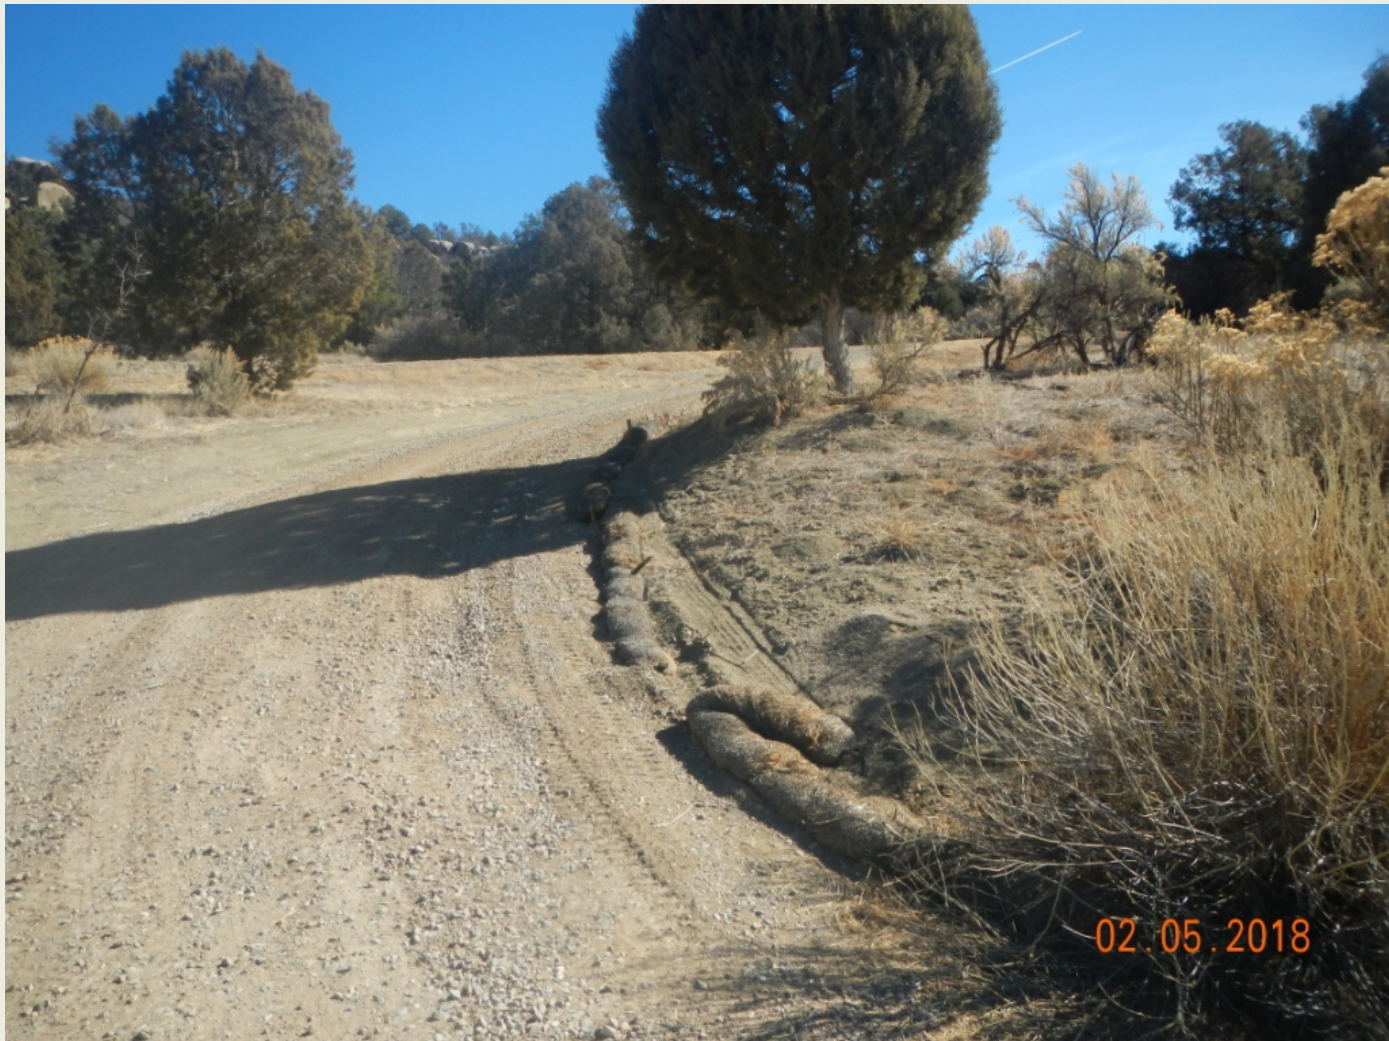
Photo 6. View of wattles on the south side of the access near the well pad entrance that need maintenance/replacement.
