Inspection Photos

API: 05-067-06381

Operator: BP AMERICA PRODUCTION COMPANY

Inspection Number: 680602489

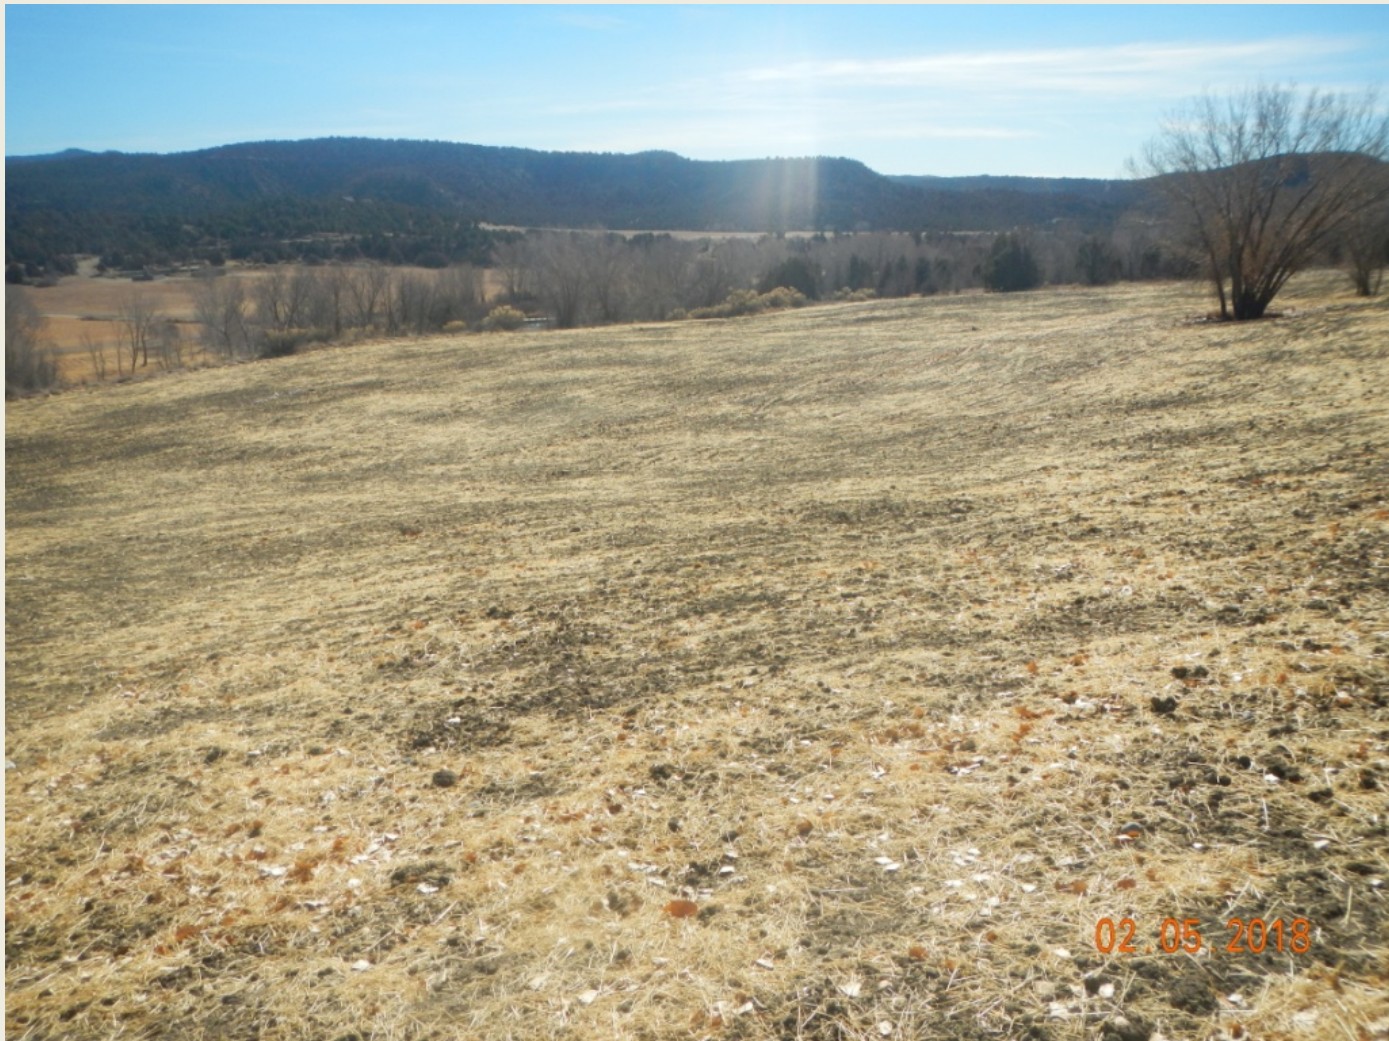
Photo 1. View of the project area from the northwestern corner facing center. Well pad and access are recontoured, appear to be seeded, and is mulched with straw mulch. Germination, weeds, stormwater, and vegetation establishment will continue to need monitoring.

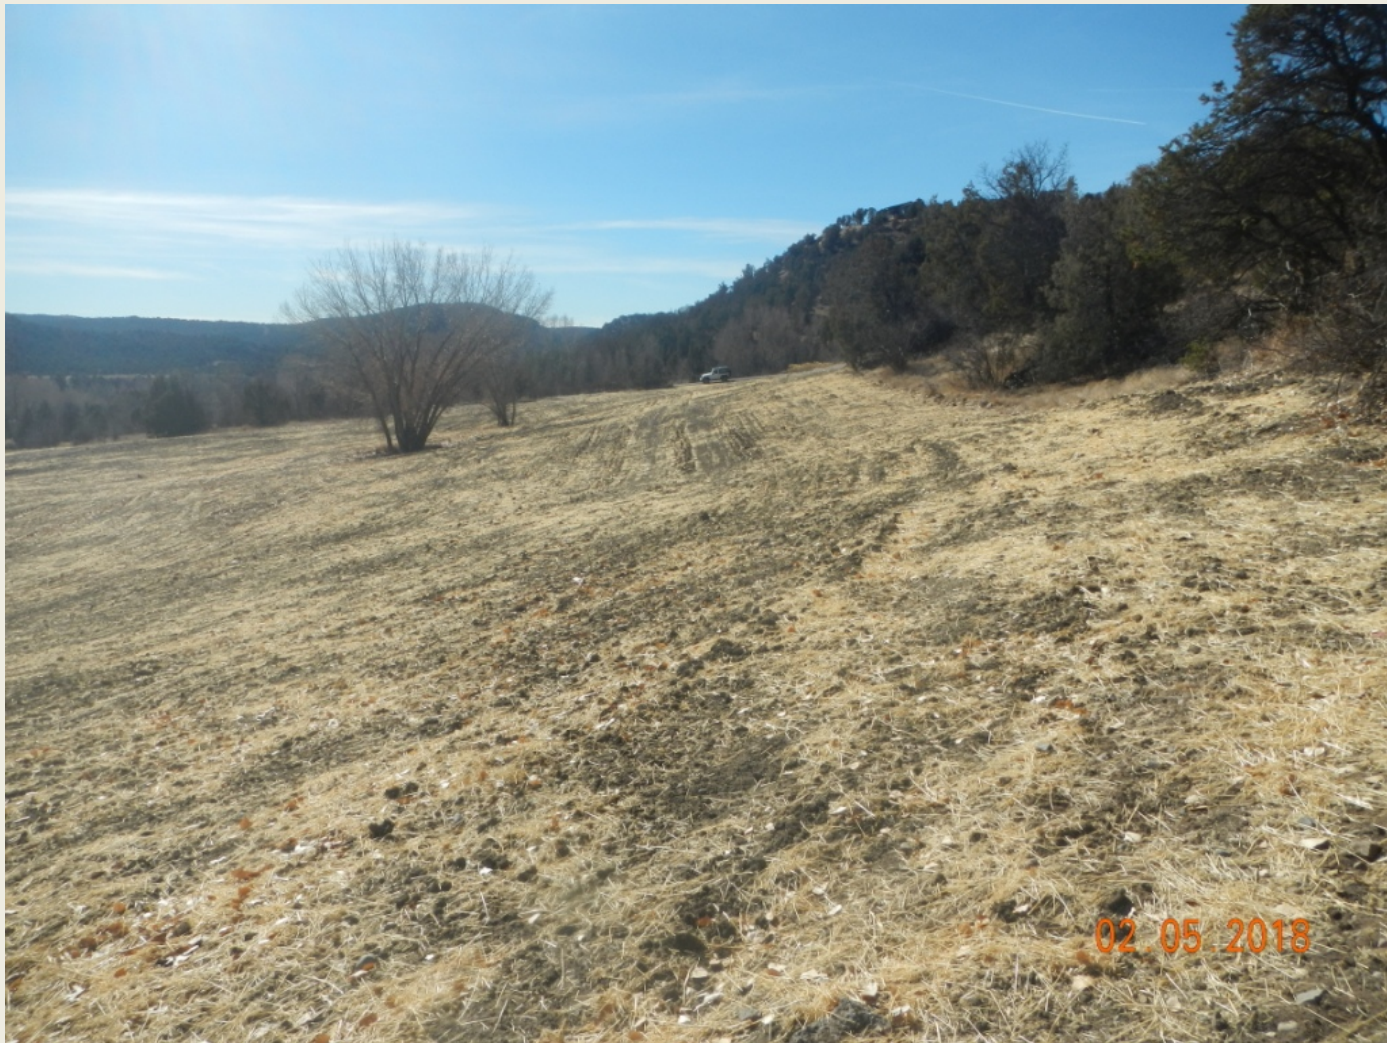
Photo 2. View of the western portion of the project area from the northwestern corner facing eastward.

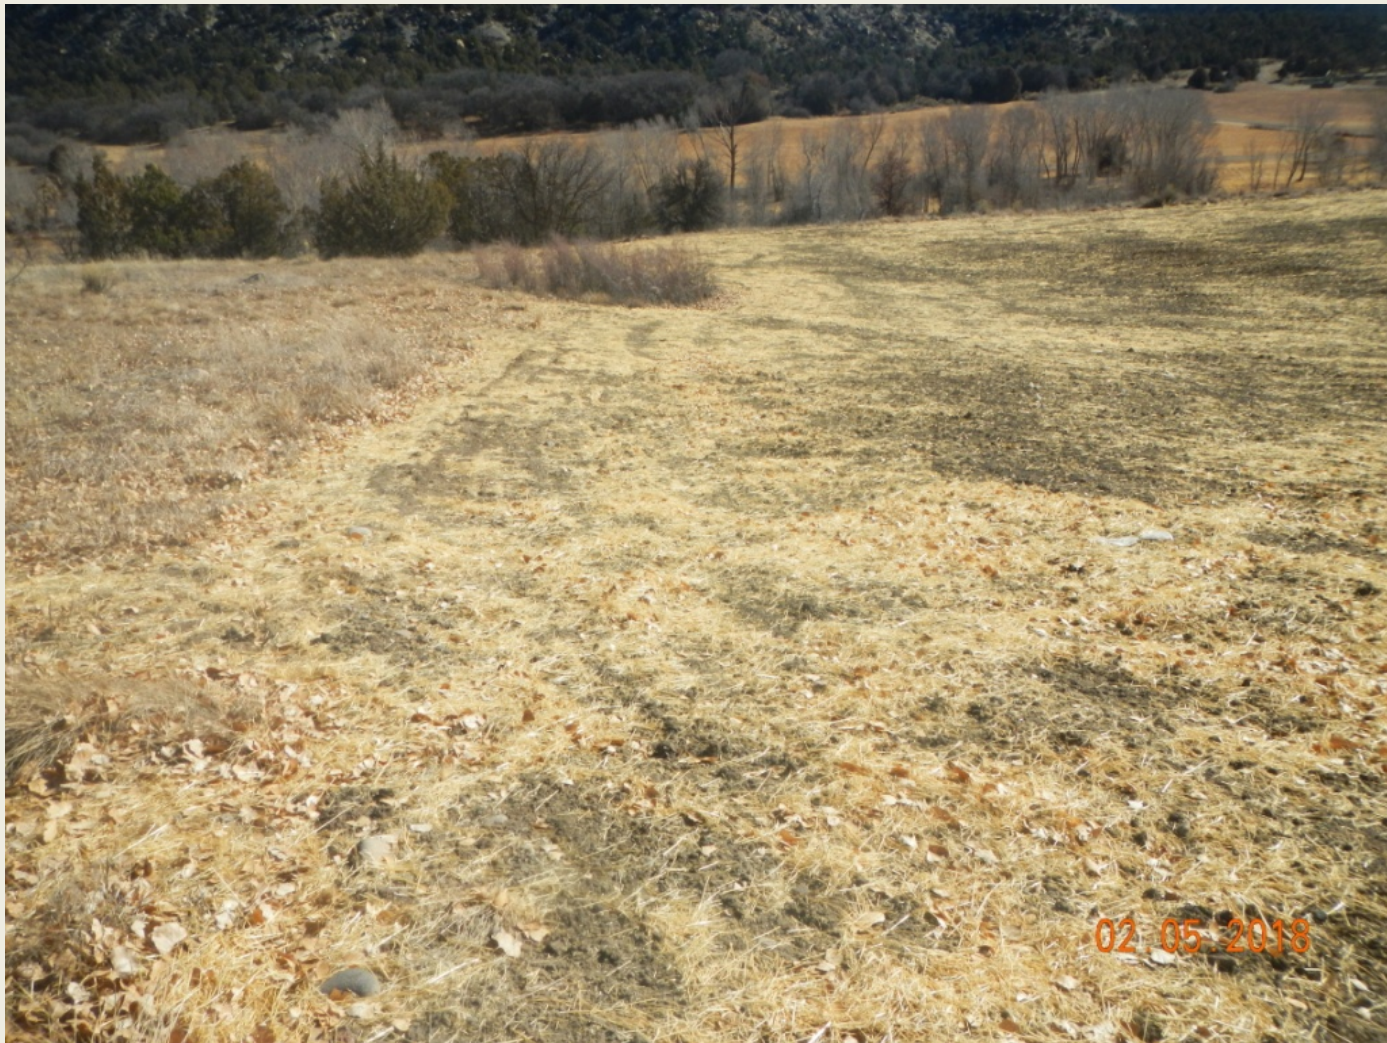
Photo 3. View of the northern edge of the working area from the northwestern corner facing eastward.

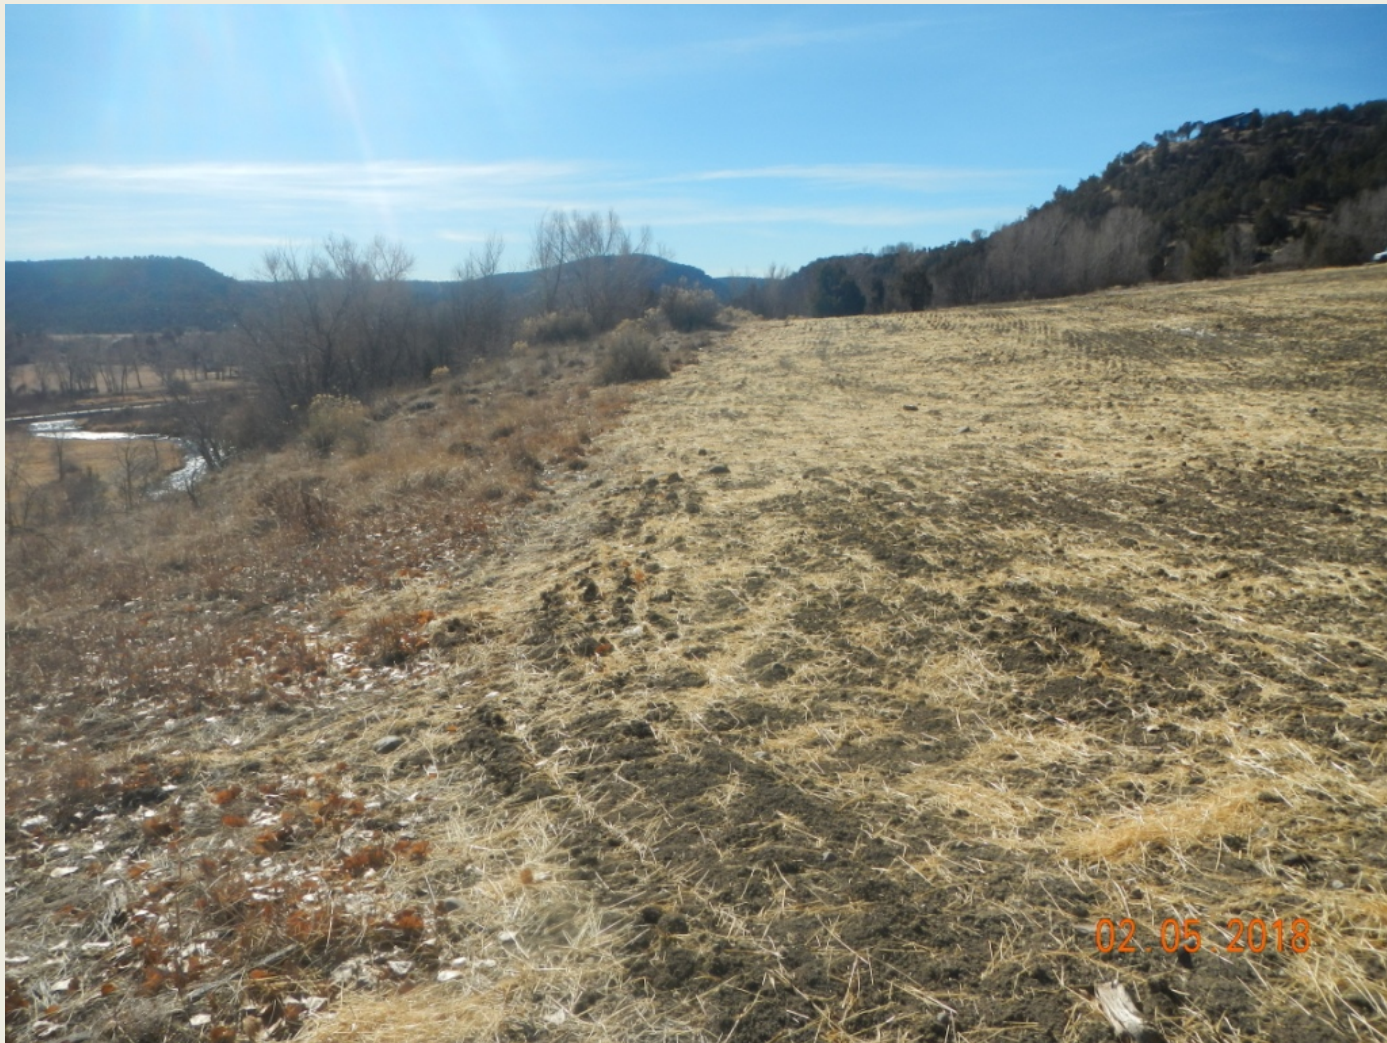
Photo 4. View of the eastern portion of the project area from the northeastern corner facing southward. Stormwater erosion appears to be controlled at this time.

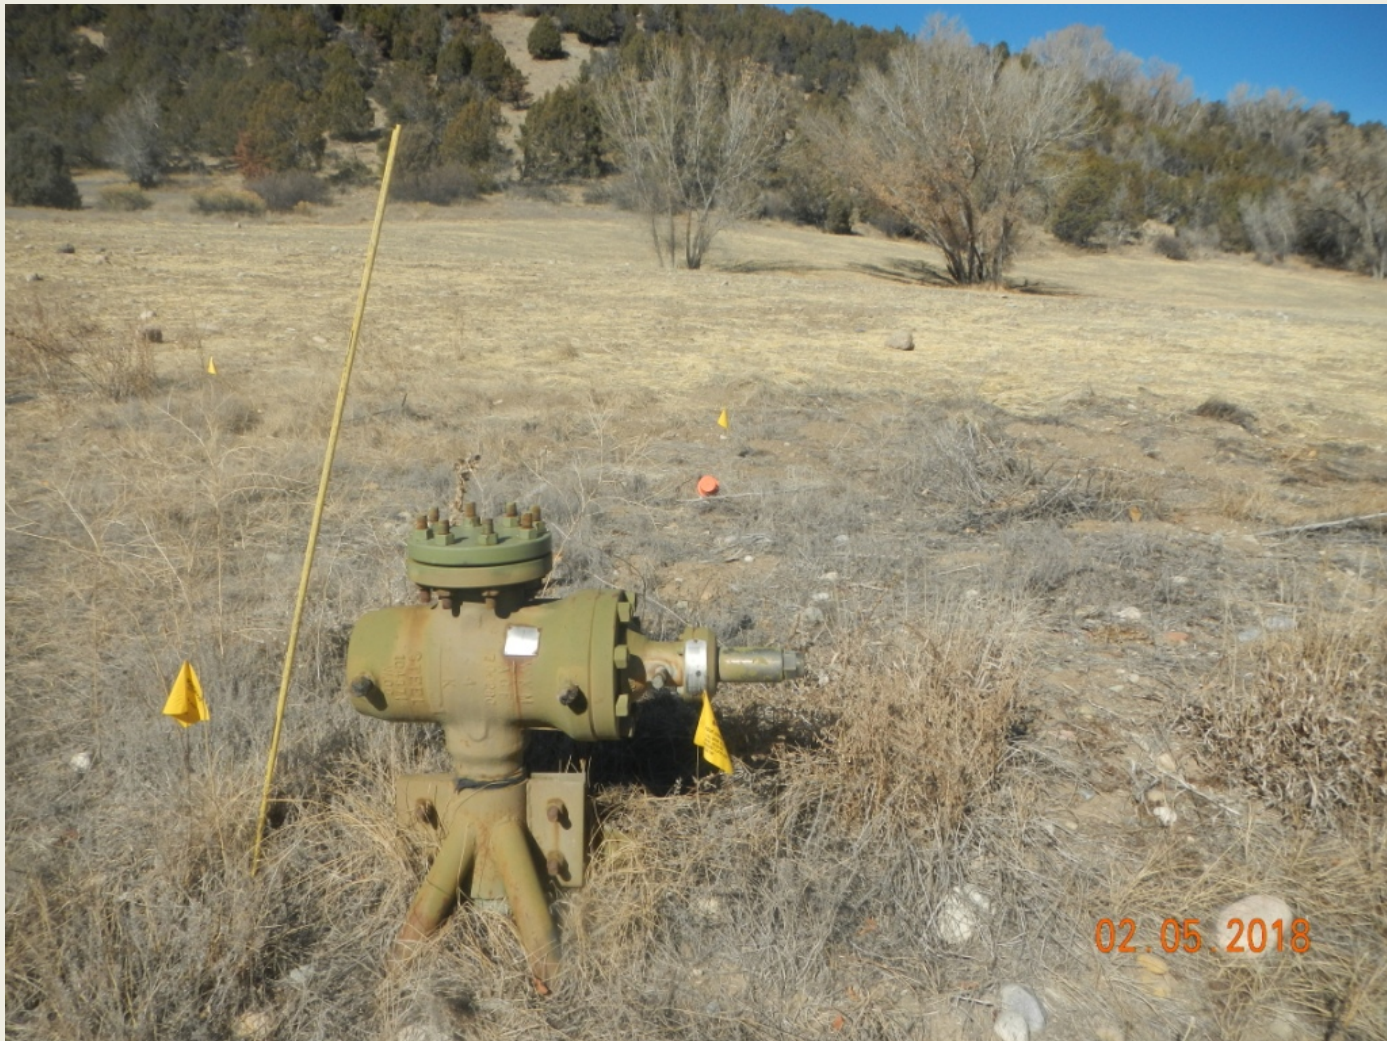
Photo 5. View of riser southeast of the project area that is still in place.
