Well Name : Marquez A2  
API # : 007-06327

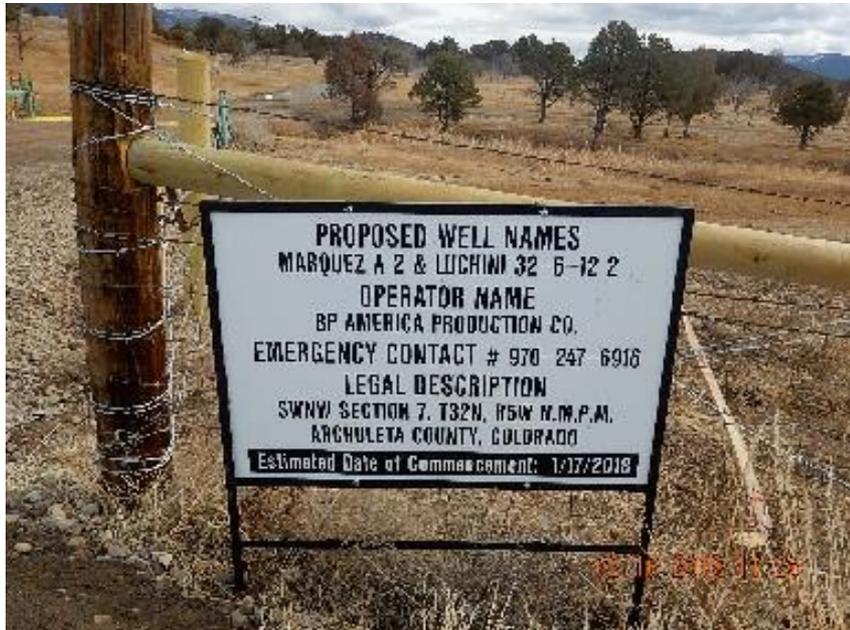
Photo 1: Wellhead sign at turn off from CR.

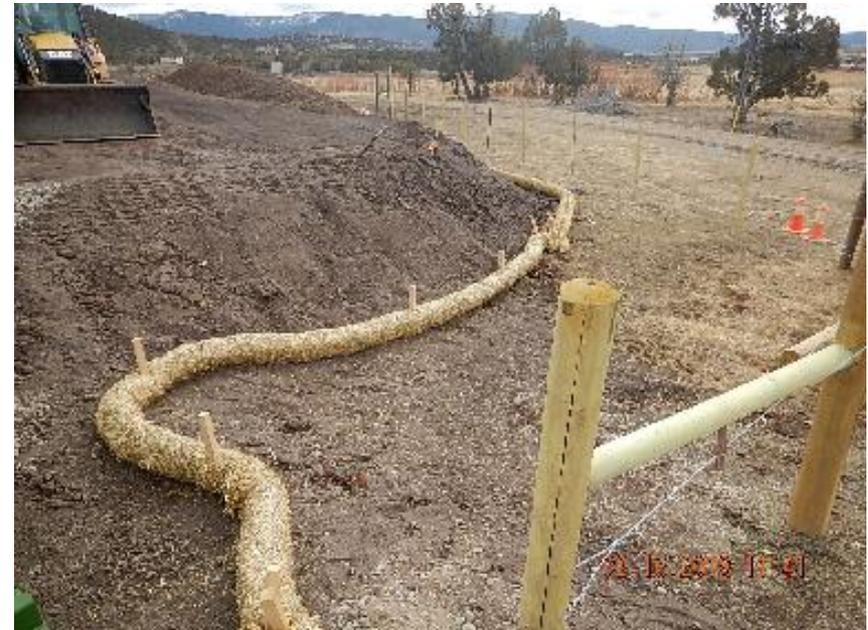
Photo 2: Erosion control waddle in SW corner not trenched in, not back filled, and improperly staked.

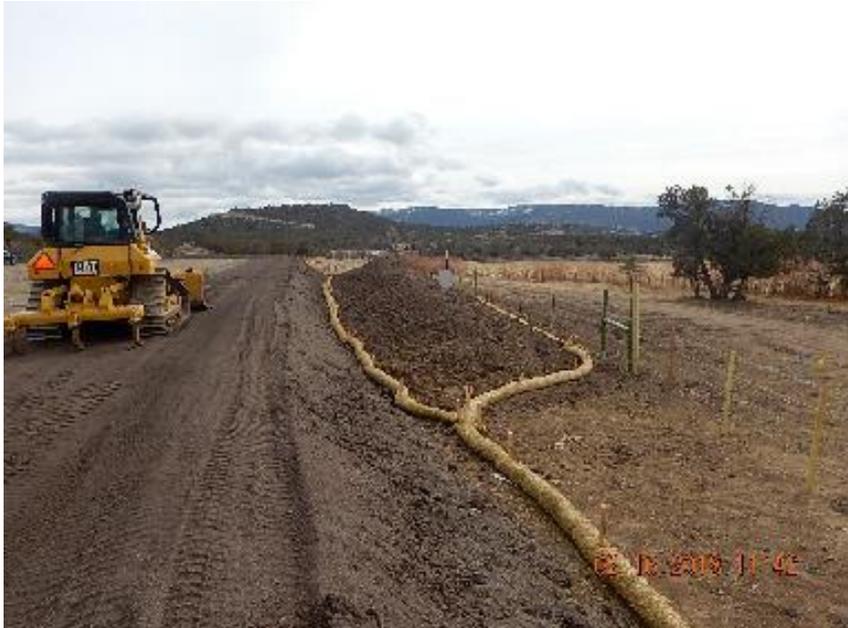
Photo 3: S perimeter looking E. Erosion control waddle and top soil pile along S perimeter. Waddle improperly installed.

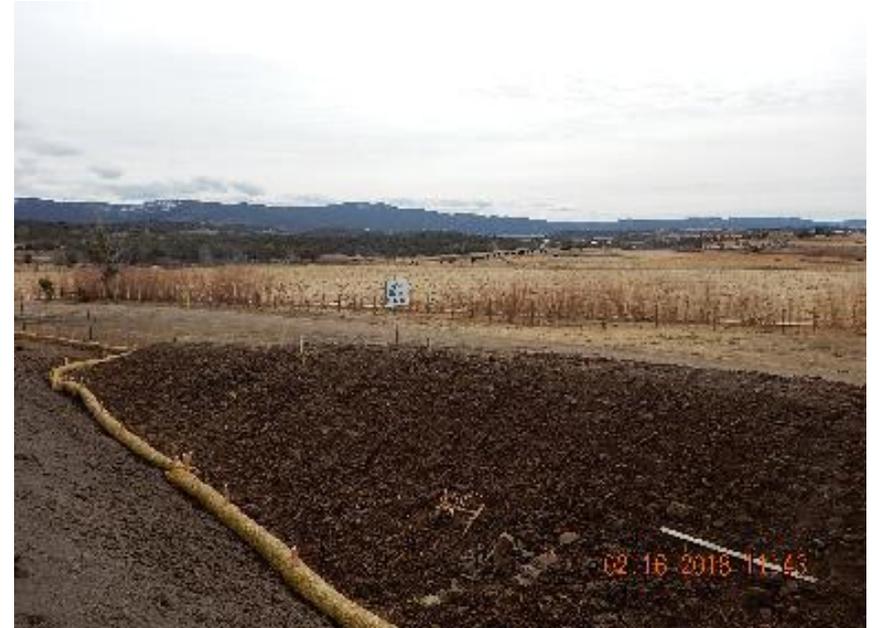
Photo 4: Sign marking top soil pile.

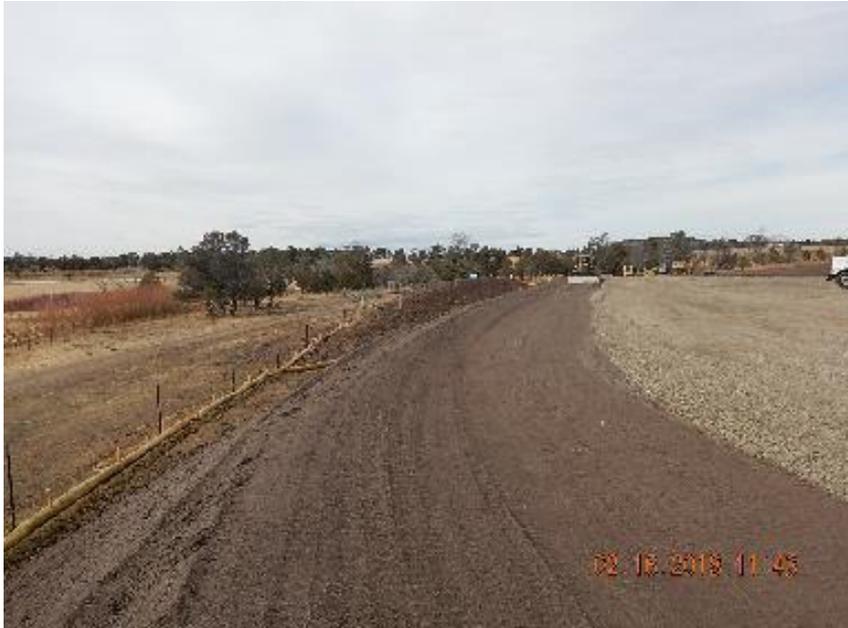
Photo 5: S perimeter looking NW.  
Waddles, berm, and edge of gravel not yet to base of berm.

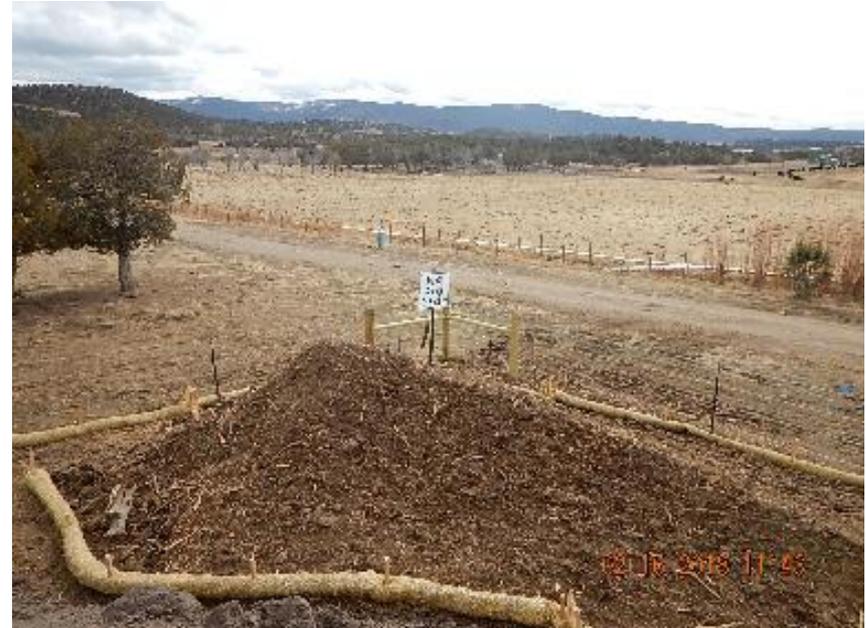
Photo 6: Additional top soil pile in SE corner with waddles and sign. Waddles improperly installed.

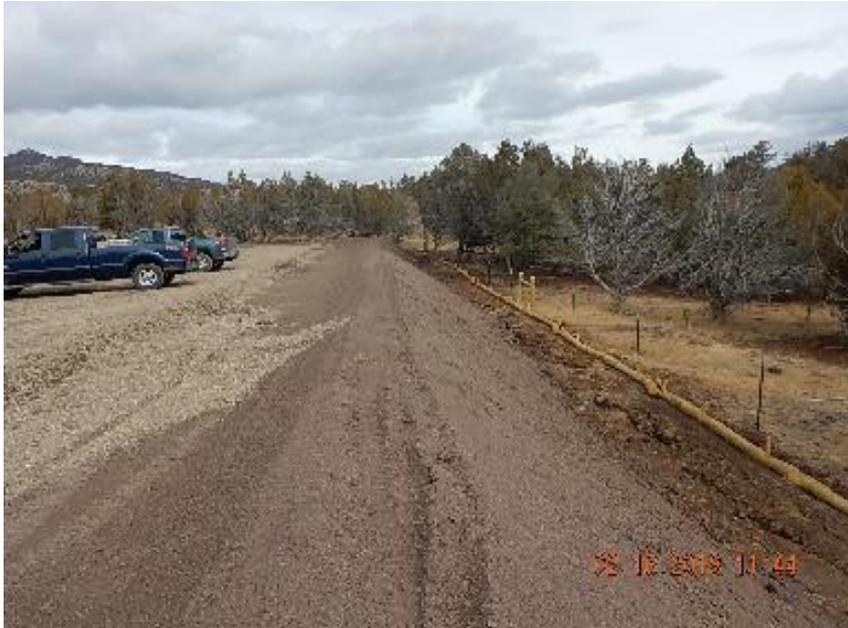
Photo 7: E perimeter looking N. Berm and erosion control waddles. Waddles improperly installed.

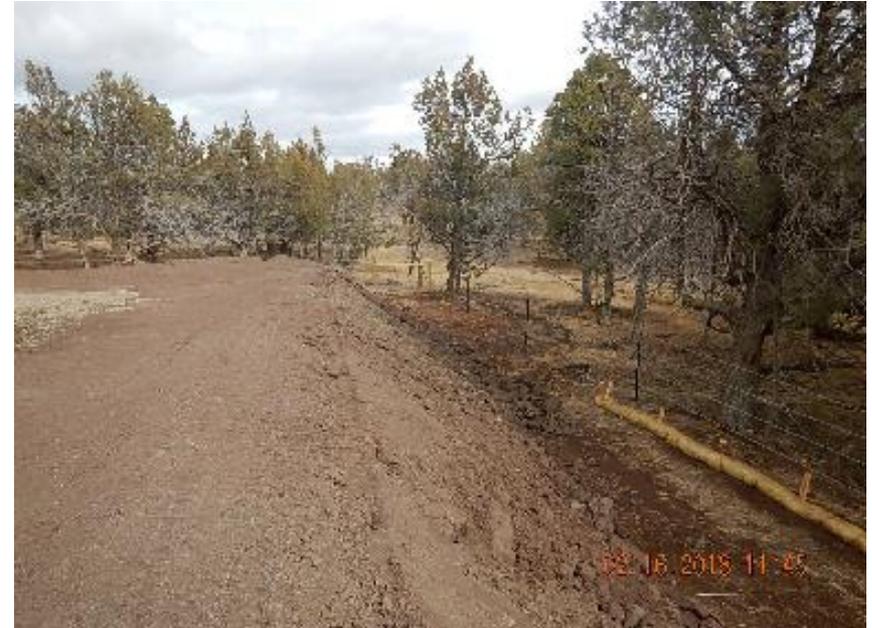
Photo 8: E perimeter with erosion control waddle line ending short of NE corner.

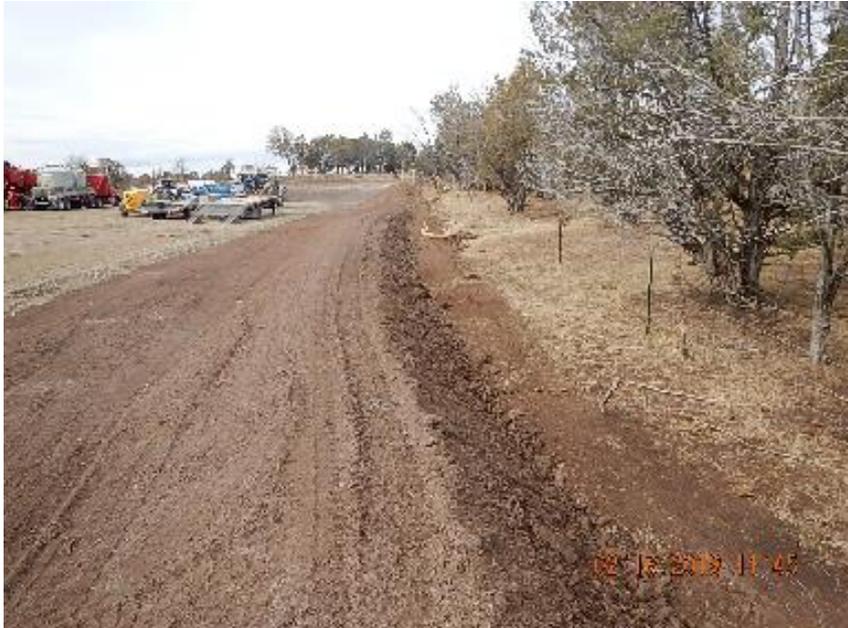
Photo 9: N perimeter looking NW. Berm and no erosion control waddle line. Single erosion control waddle check dam.

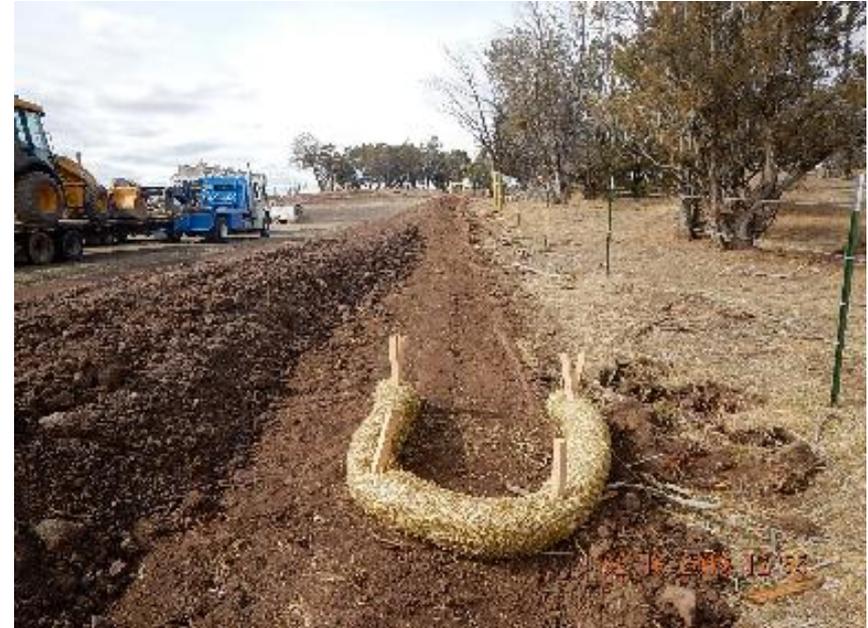
Photo 10: Check dam on N perimeter. Waddle improperly installed.

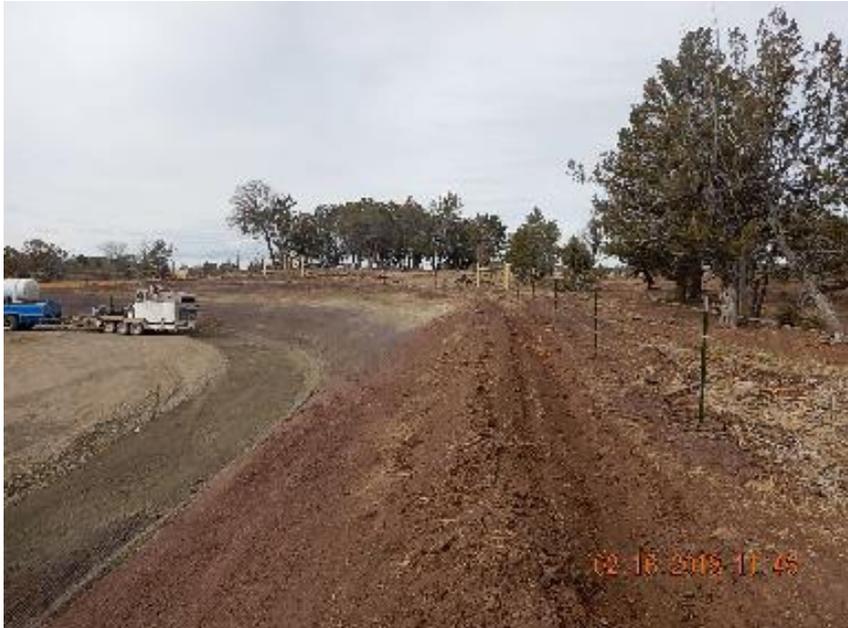
Photo 11: N perimeter approaching top of cut slope. Ditch and berm. No velocity control BMPs installed in ditch.

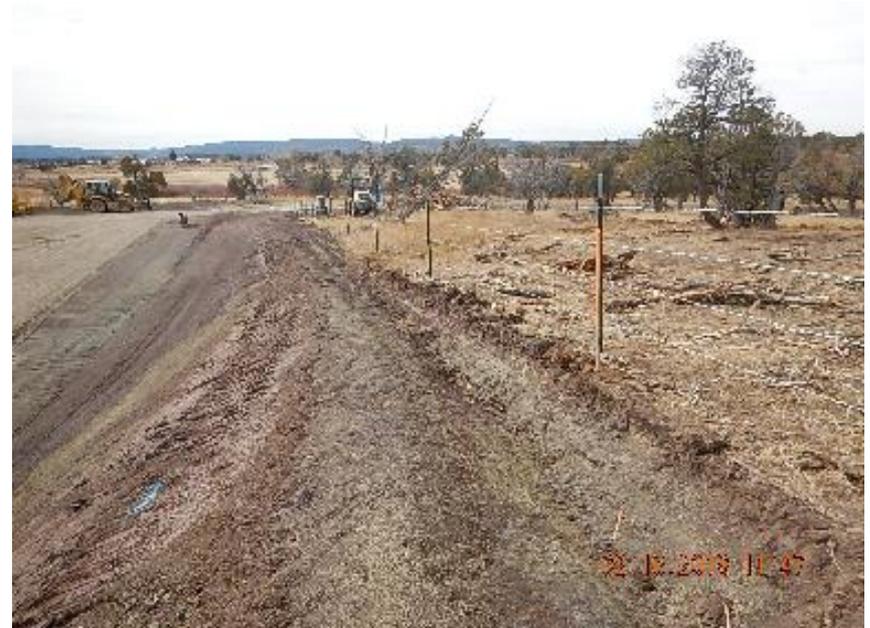
Photo 12: Top of cut slope looking S. Ditch and berm. No erosion control waddle line and no velocity control BMPs installed in ditch.

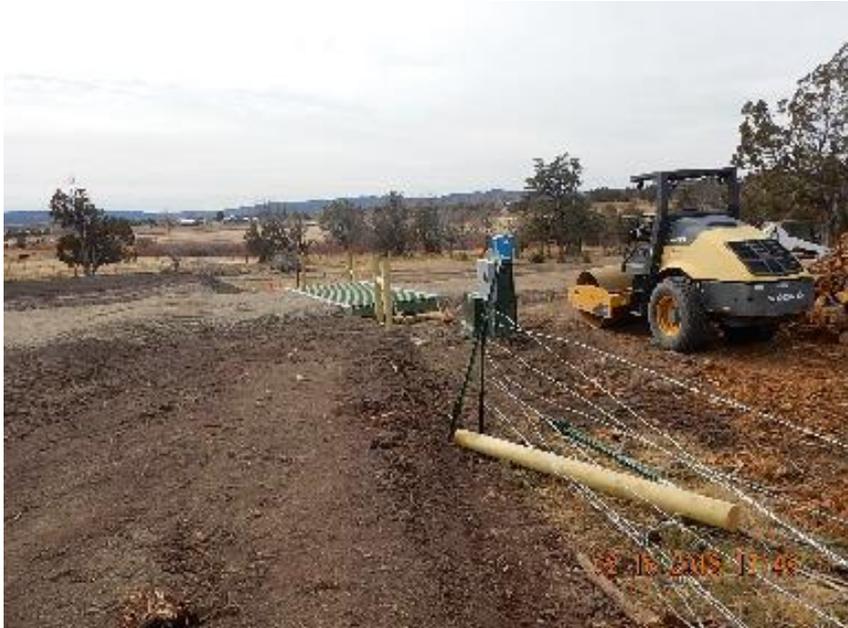
Photo 13: Cattle guard installed at entrance.

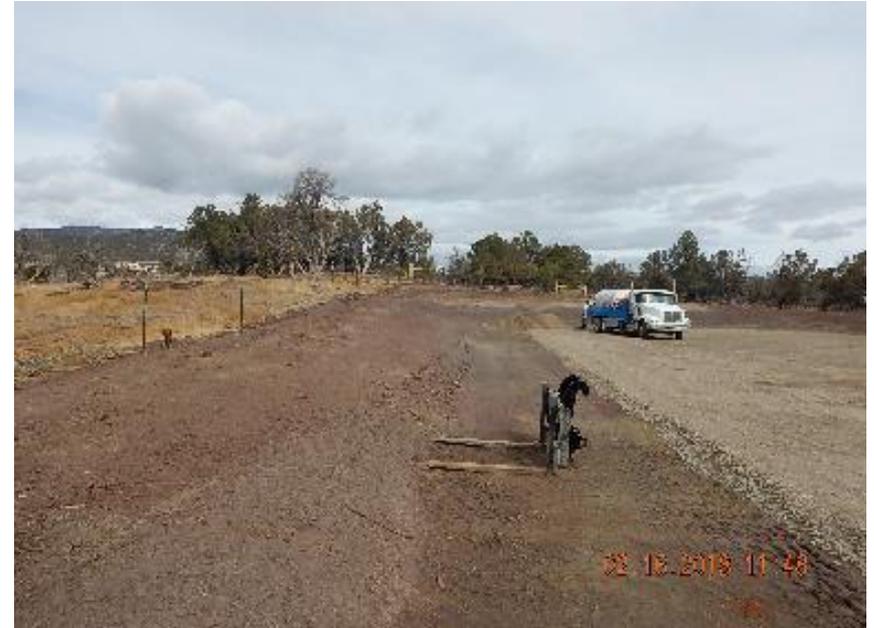
Photo 14: W perimeter looking N.
