Location Name: MUSF #2 Well COGCC WW# 454138 Inspection Date: 2/23/18

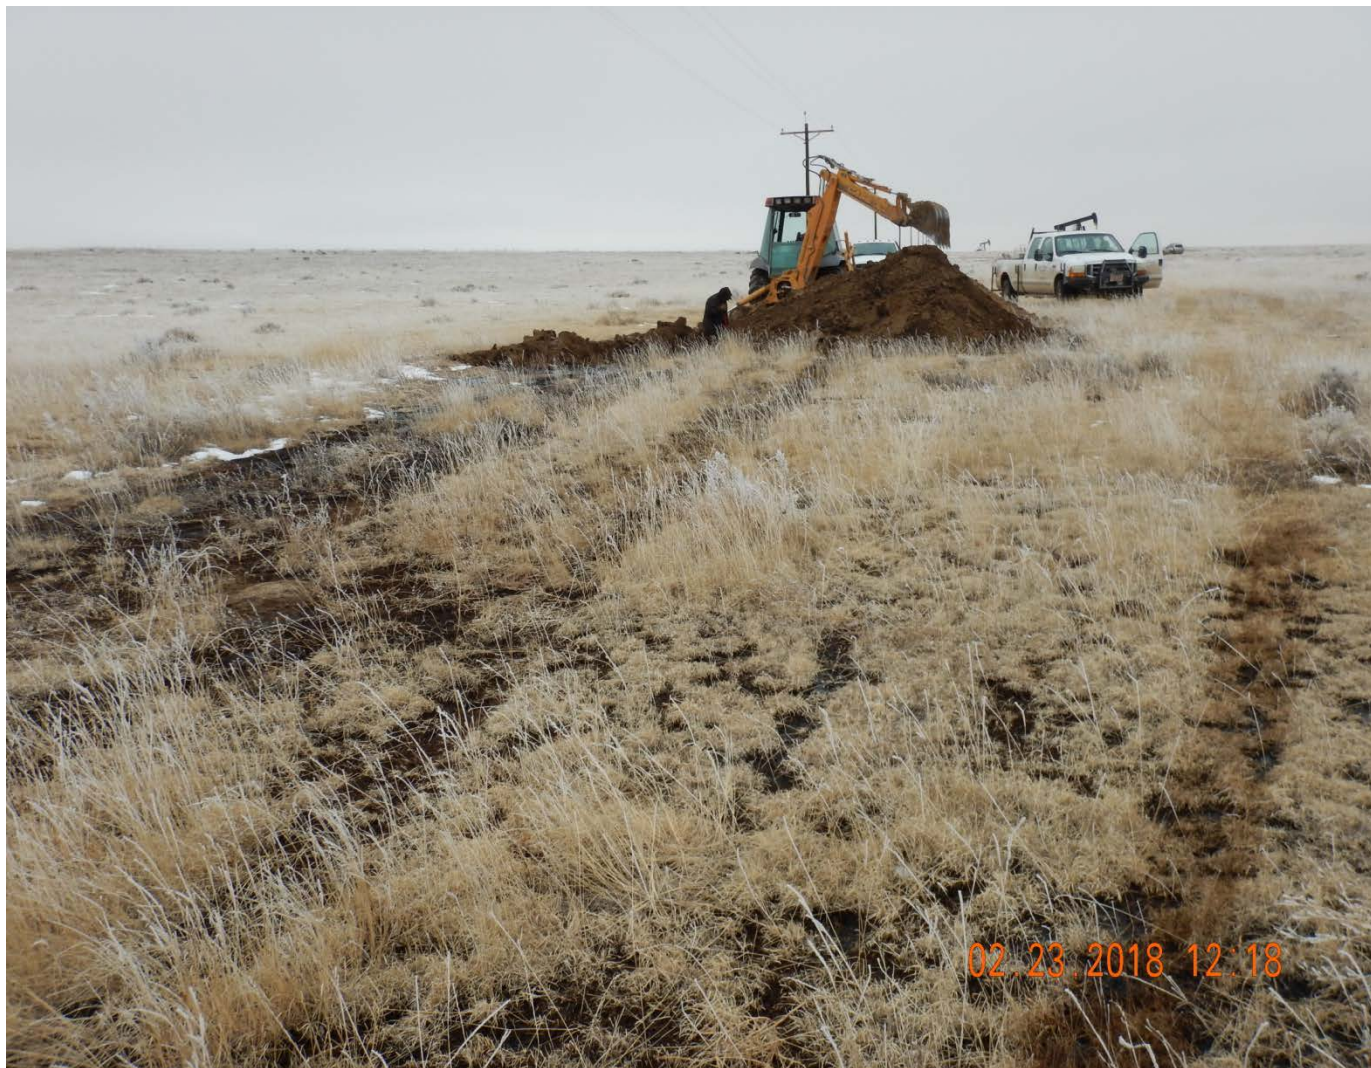
Spill area below excavation

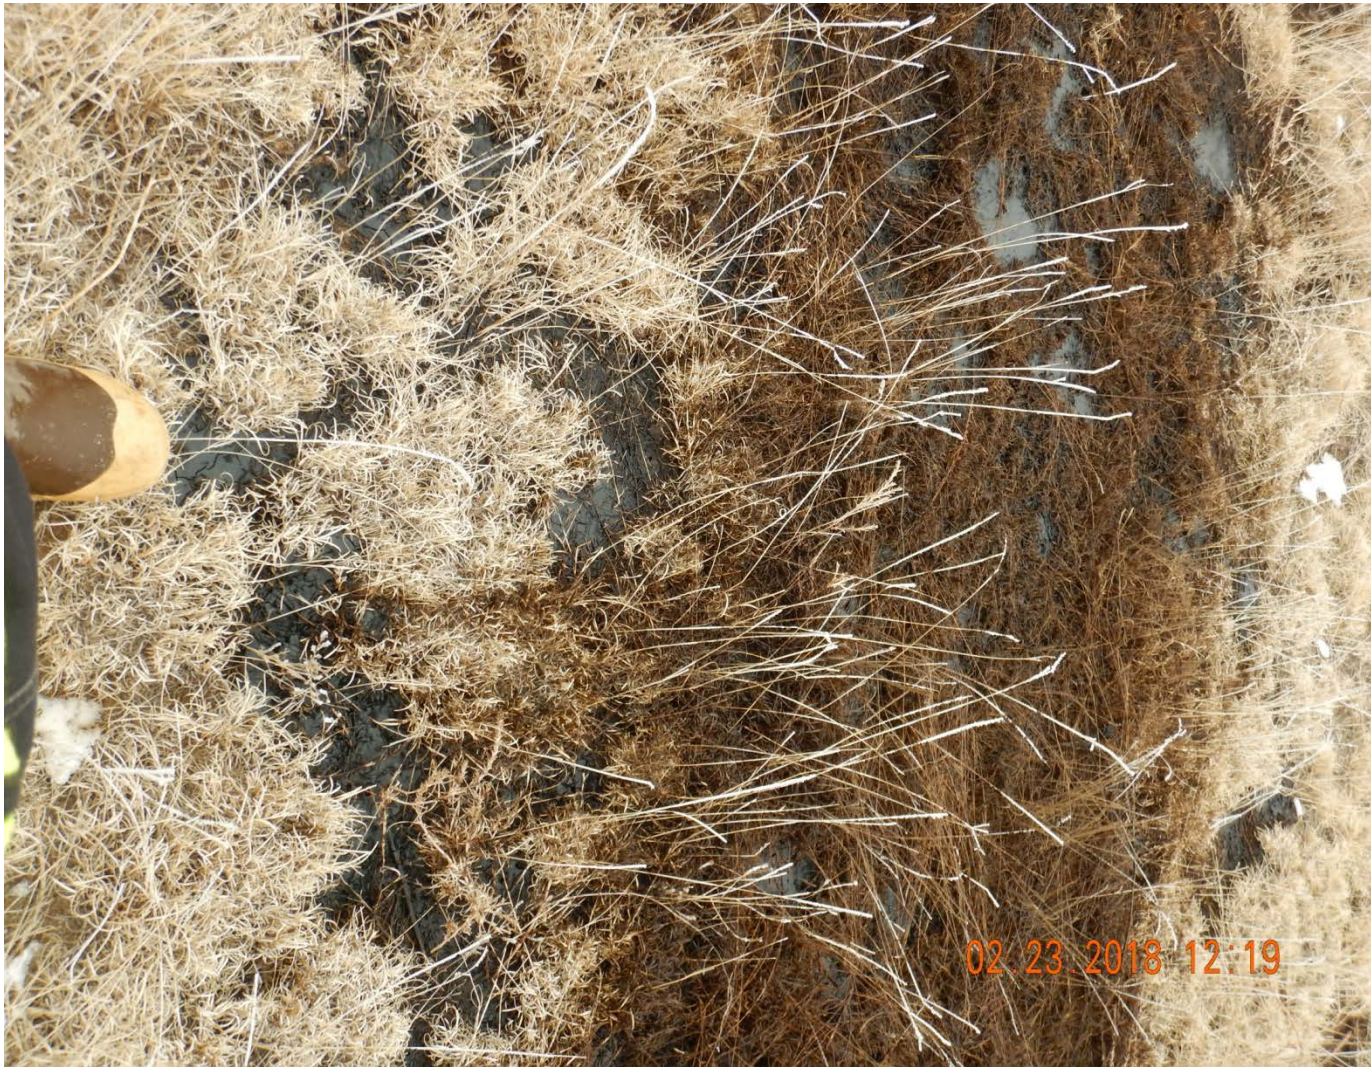
Spill area

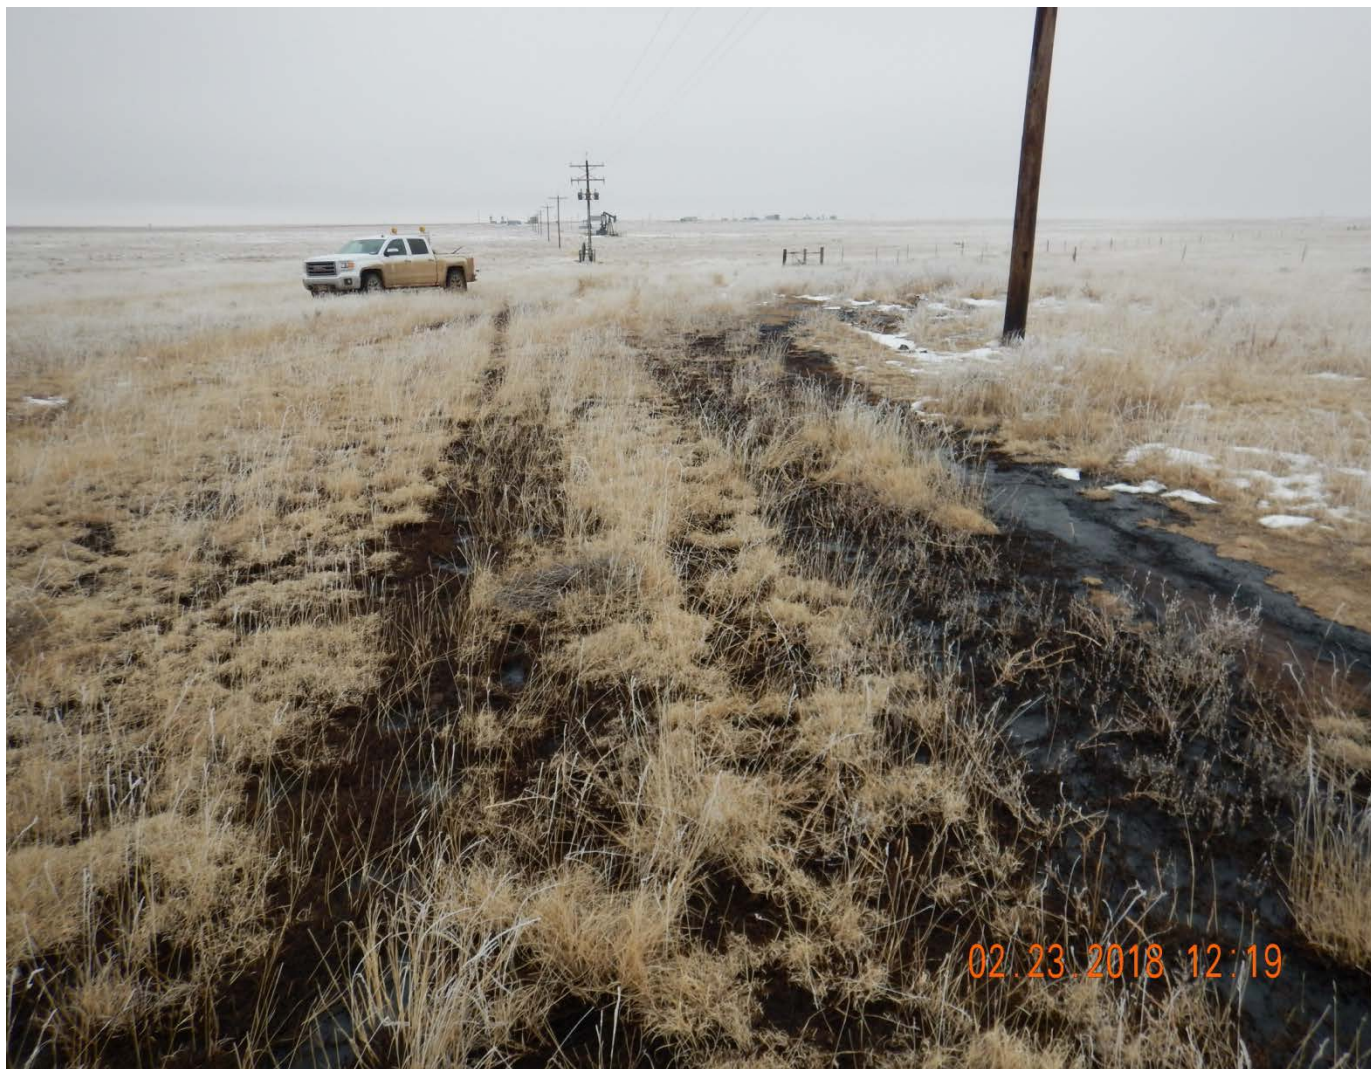
From spill area looking down flow line to toward tank battery.

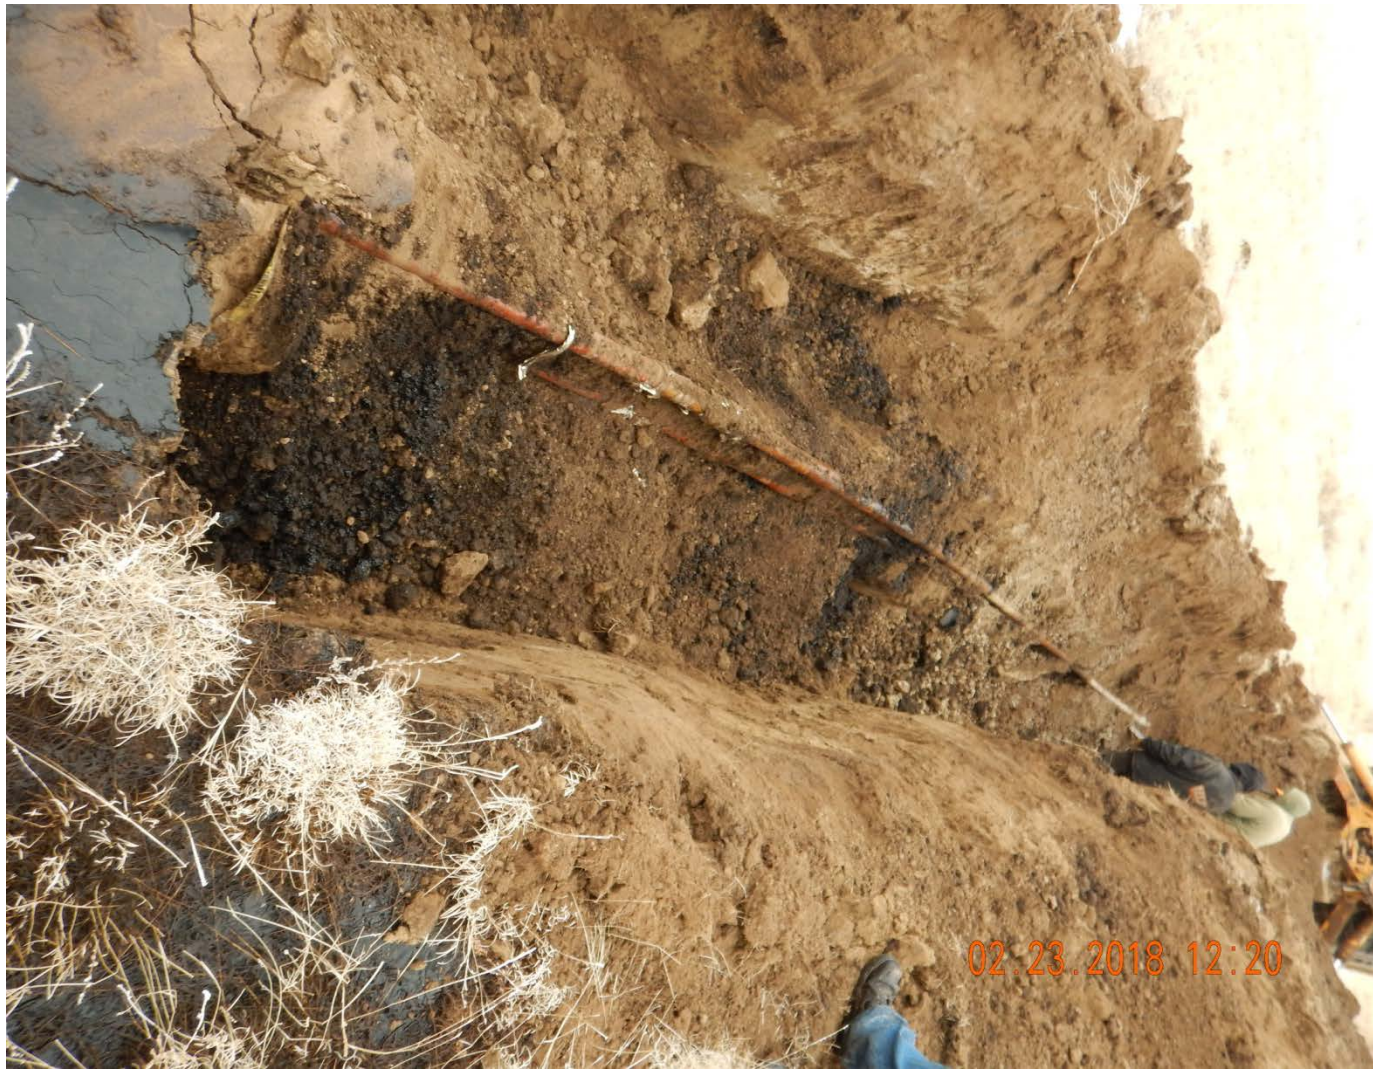
Pipeline excavation. Pipeline on top is source of leak.

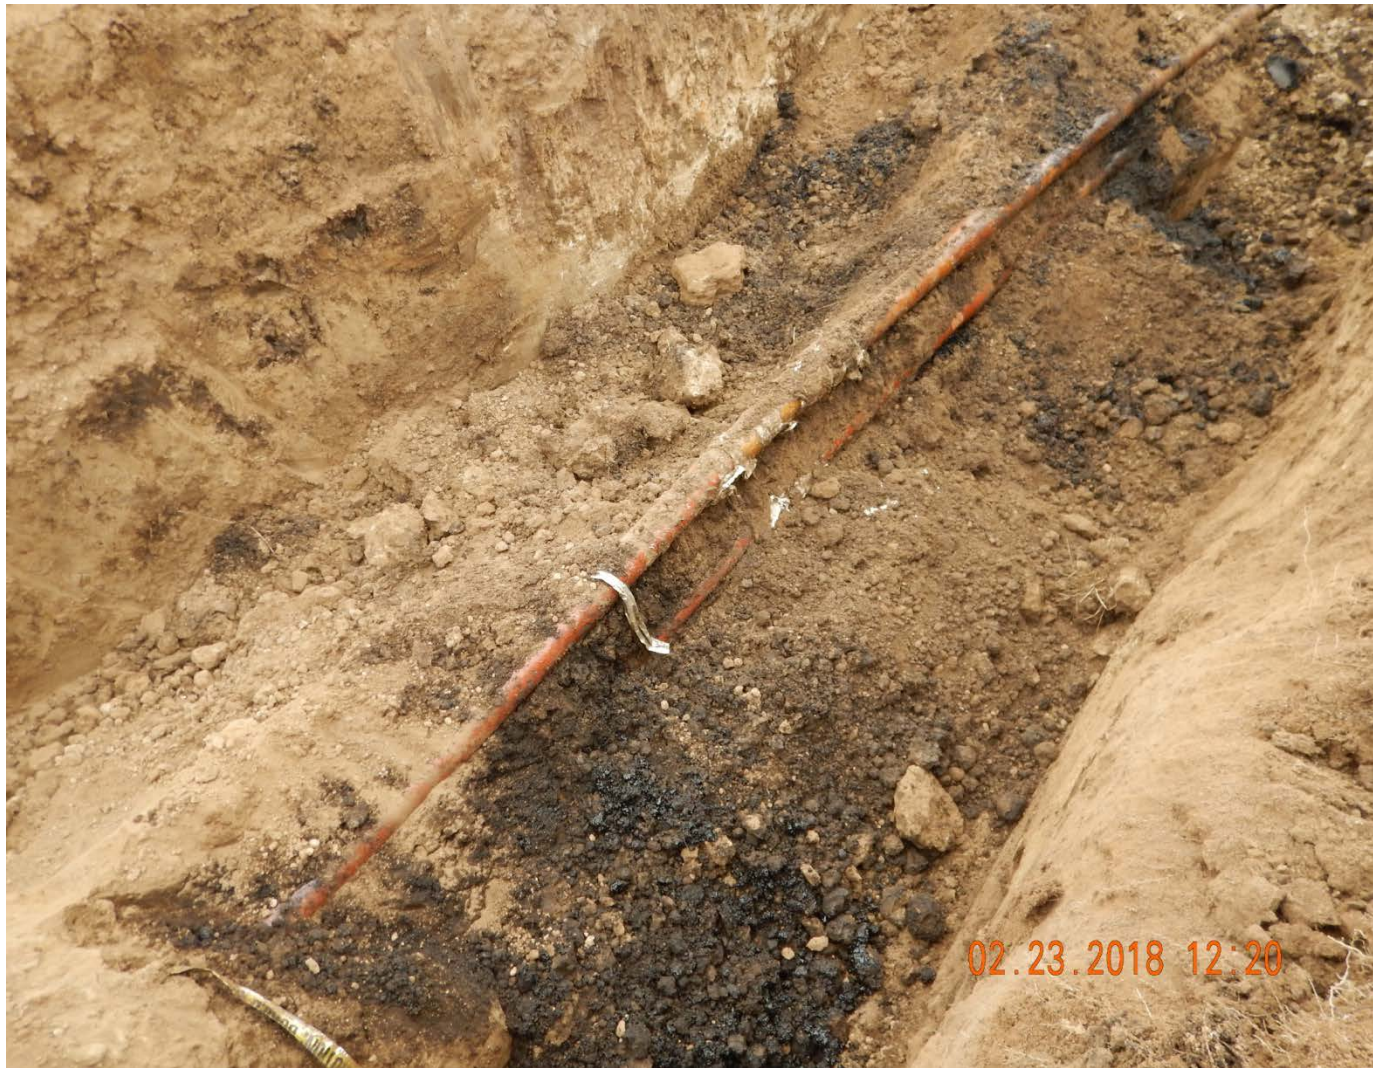
Pipeline excavation. Pipeline on top is source of leak.

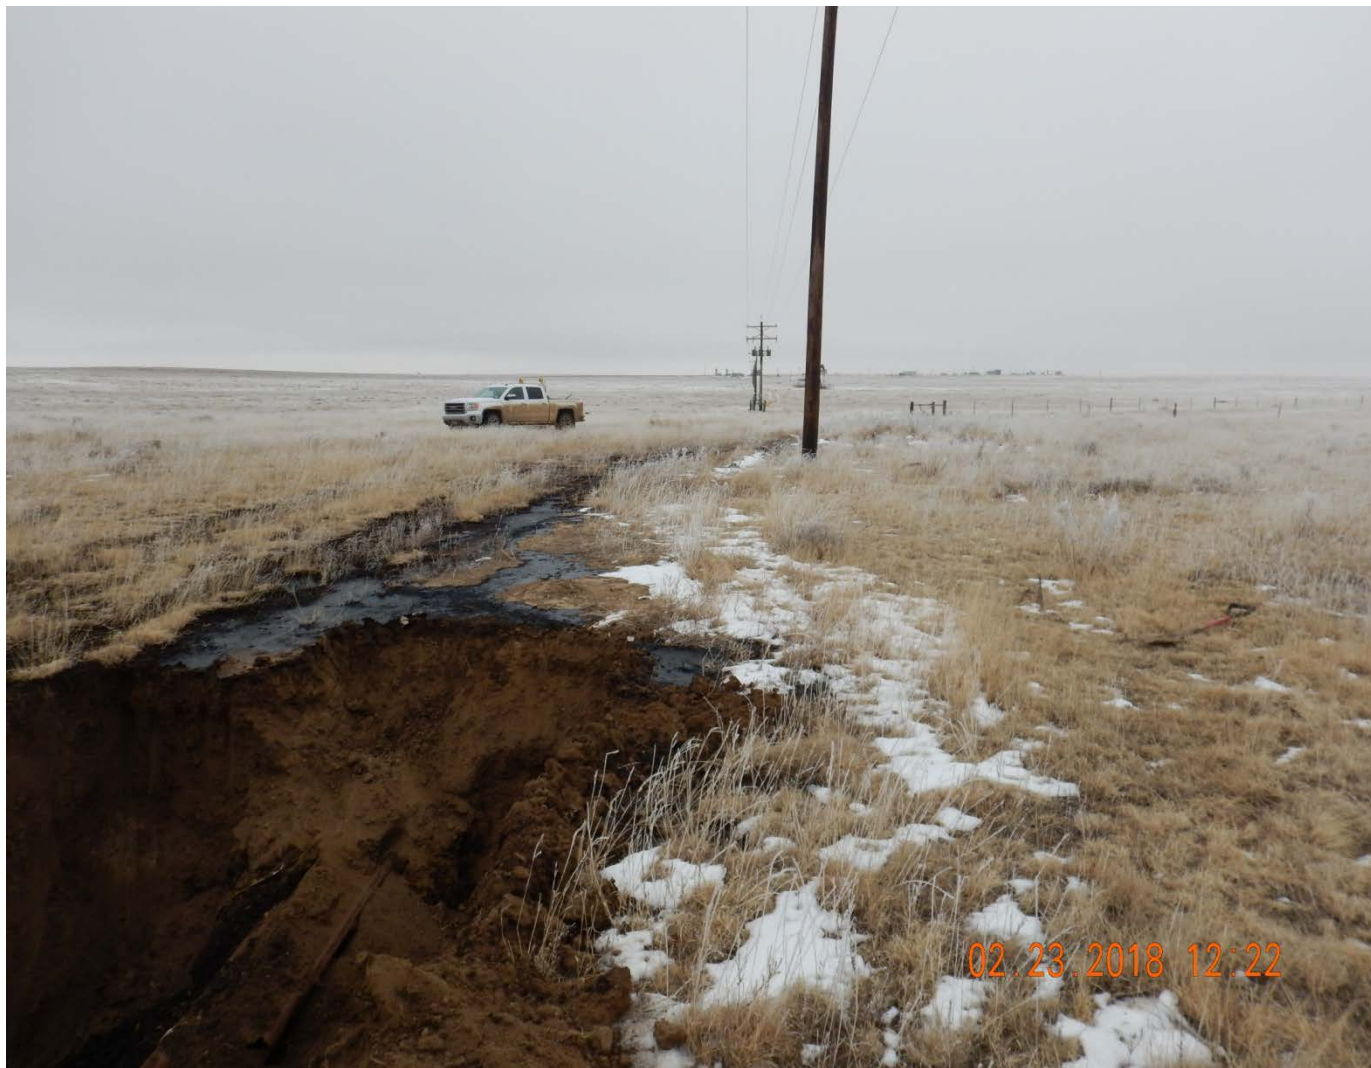
Pipeline excavation and spill area.

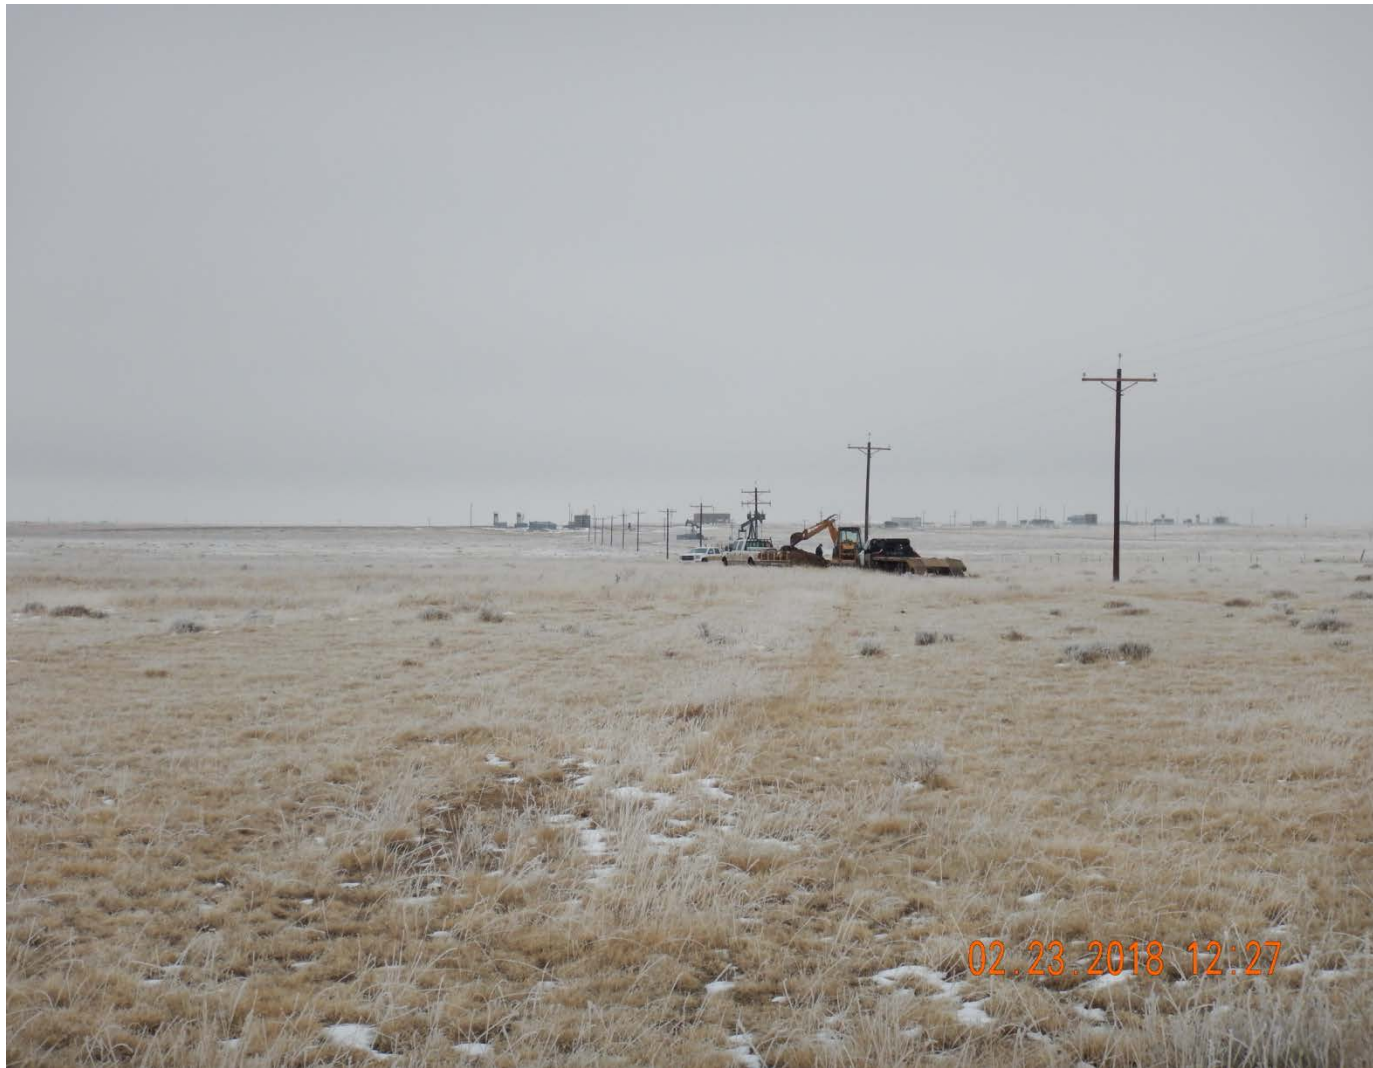
Pipeline excavation. Pipeline flows toward tank battery visible in background of photo.
