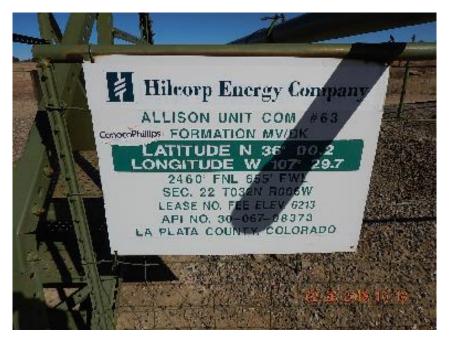
Photo 1: Wellhead sign.

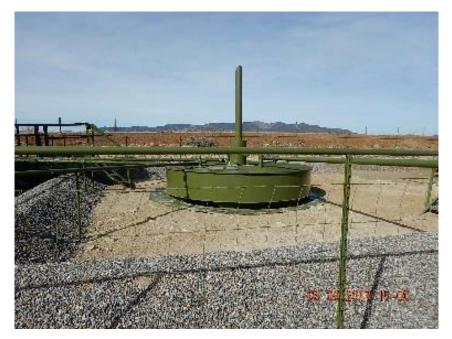
Photo 3: Open top tank without signs previous inspection.

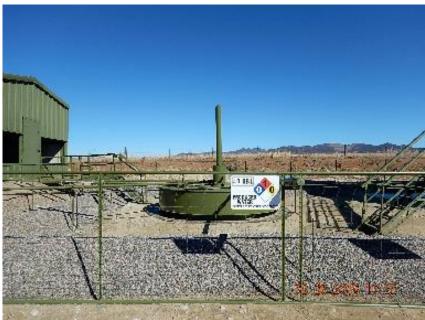
Photo 4: Open top tank with new sign.

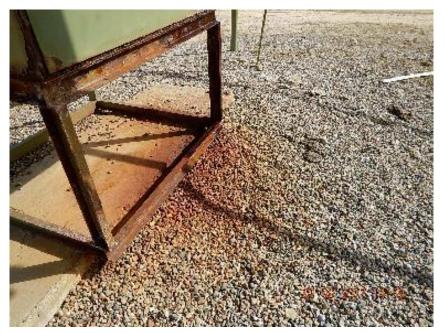
Photo 5: Stained soil and gravel under separator for Allison Unit Com #63 previous inspection.

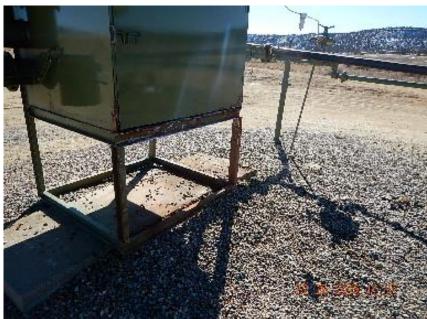
Photo 6: Cleaned up soil and gravel under separator for Allison Unit Com #63.

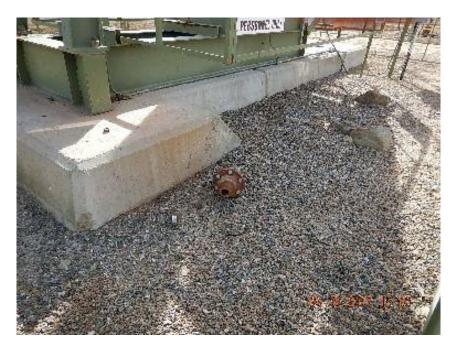
Photo 7: Unused equipment at pump jack previous inspection.

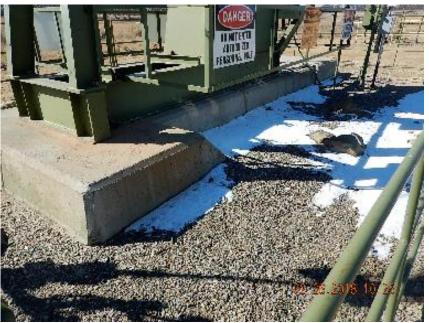
Photo 8: Removed unused equipment at pump jack.

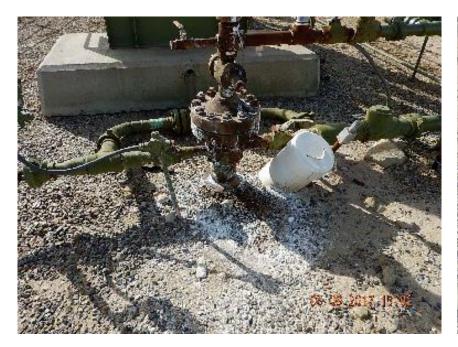
Photo 9: Impacted soil at wellhead previous inspection.

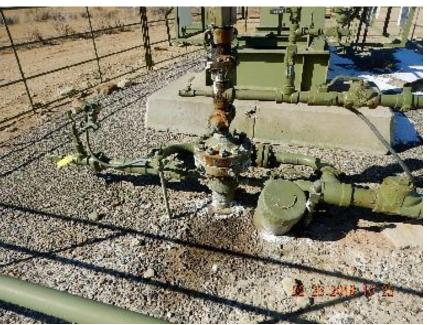
Photo 10: Impacted soil at wellhead current inspection.

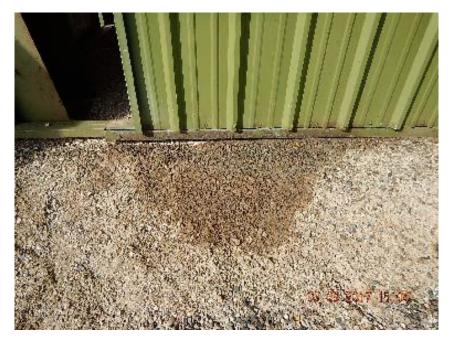
Photo 11: Impacted soil and gravel outside compressor entry noted in previous inspection.

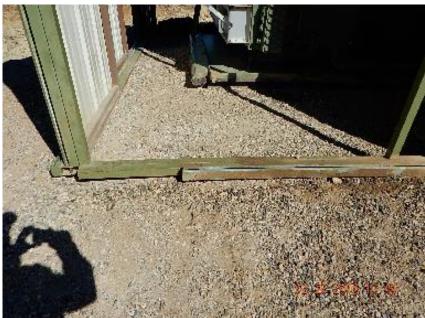
Photo 12: Impacted soil and gravel outside compressor entry way.

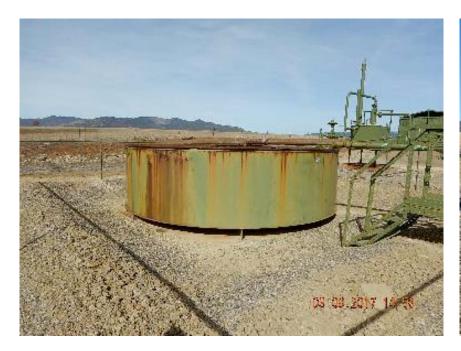
Photo 13: Rust streaked open top tank previous inspection.

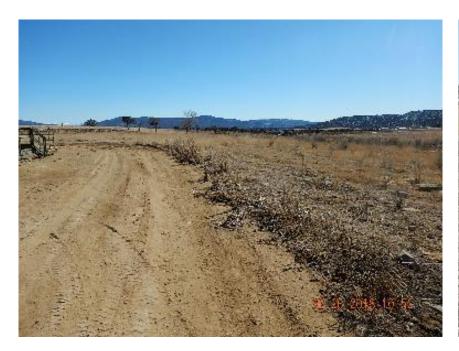
Photo 15: Dried thistle along well access road.

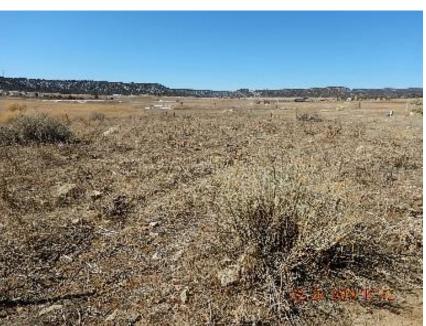
Photo 16: Dried thistle in S perimeter.
