# Construction and Stormwater Inspection

February 27, 2018

Operator: ENERPLUS RESOURCES (USA) CORPORATION - #10177

Location ID: 450827

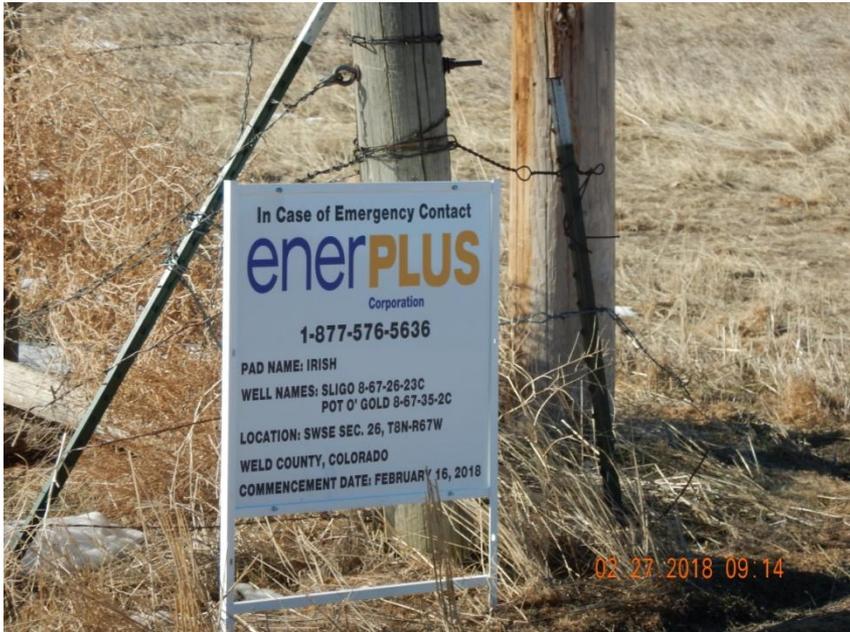
**Photo 1.** Photo taken from the entrance of location off CR 90, facing South. Photo illustrates Operator sign.

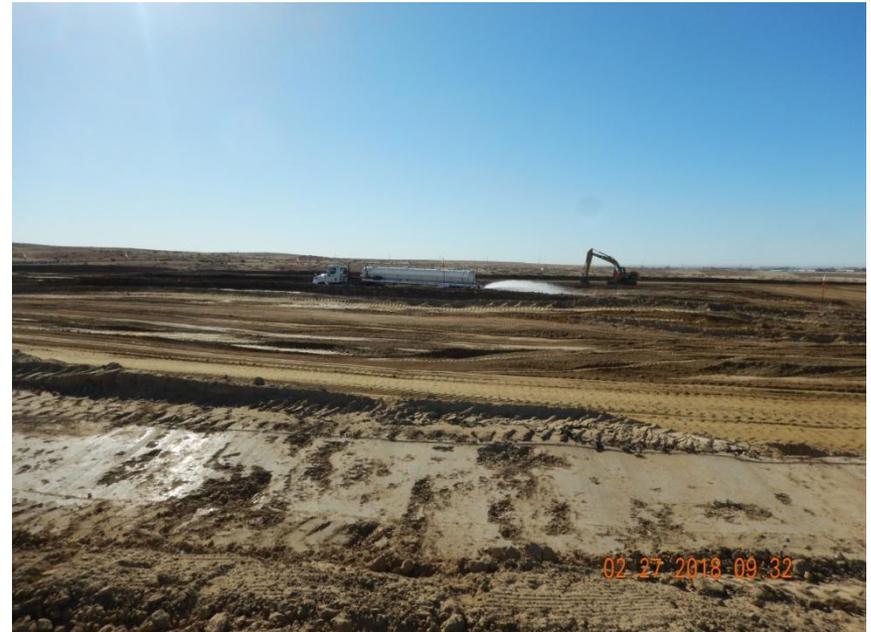
**Photo 2.** Photo taken from the northern perimeter of the location, facing South. Water truck at location to aid in construction operations and controlled fugitive dust.

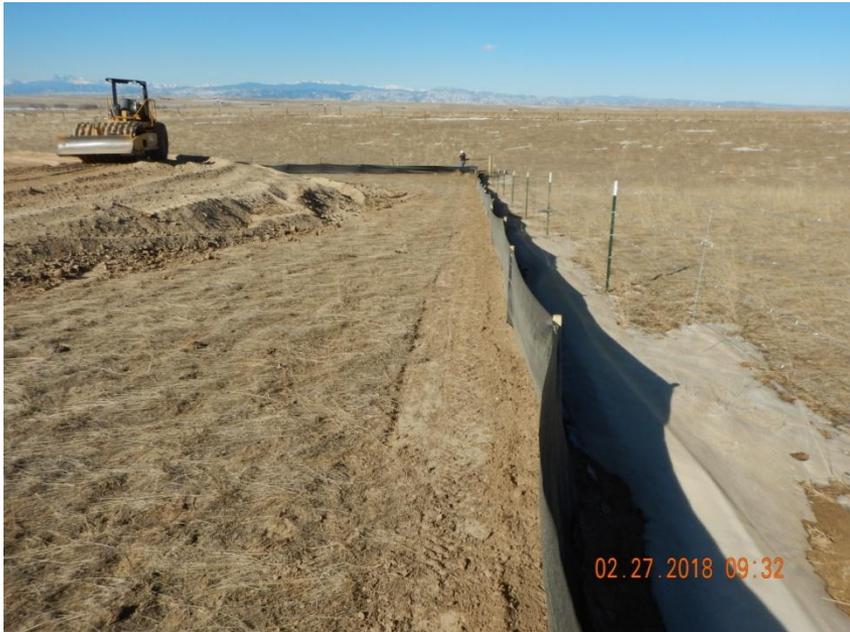
**Photo 3.** Photo taken from the northwest perimeter of the location, facing West. Silt fence BMP has been installed around portions of the northern and eastern location, and the entire southern and western perimeter of the location.

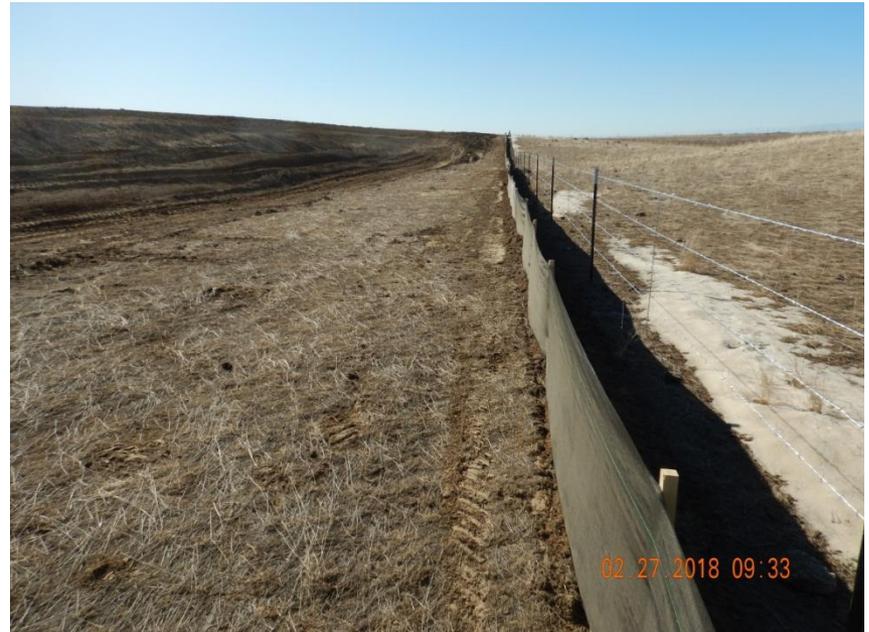
**Photo 4.** Photo taken from the northwest perimeter of the location, facing South. See comments under Photo 3.

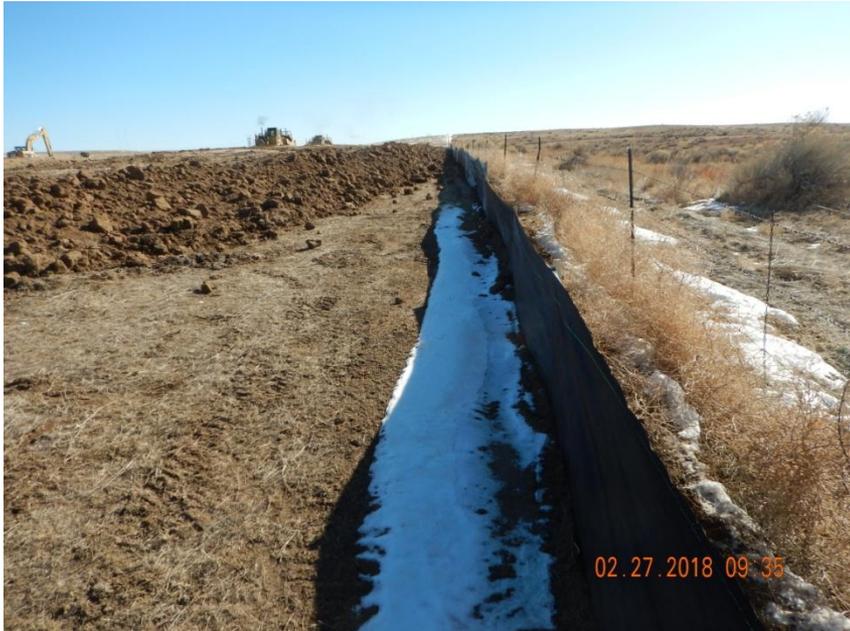
**Photo 5.** Photo taken from the southwest perimeter of the location, facing East. See comments under Photo 3.

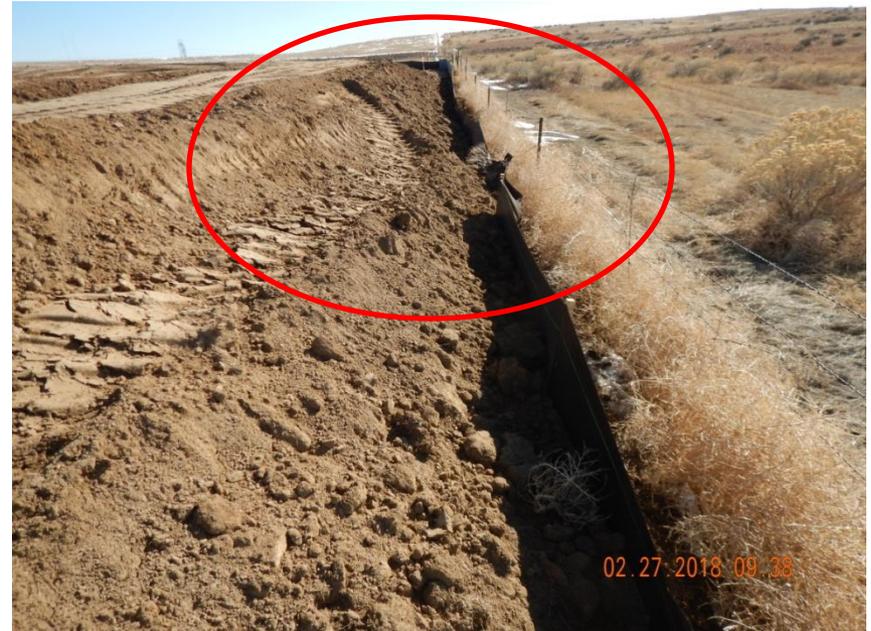
**Photo 6.** Photo taken from the southern perimeter of the location, facing East. Silt fence BMP has been damaged from topsoil storage operations. Operator representative at location indicated the BMP was scheduled to be fixed sometime on February 27, 2018.

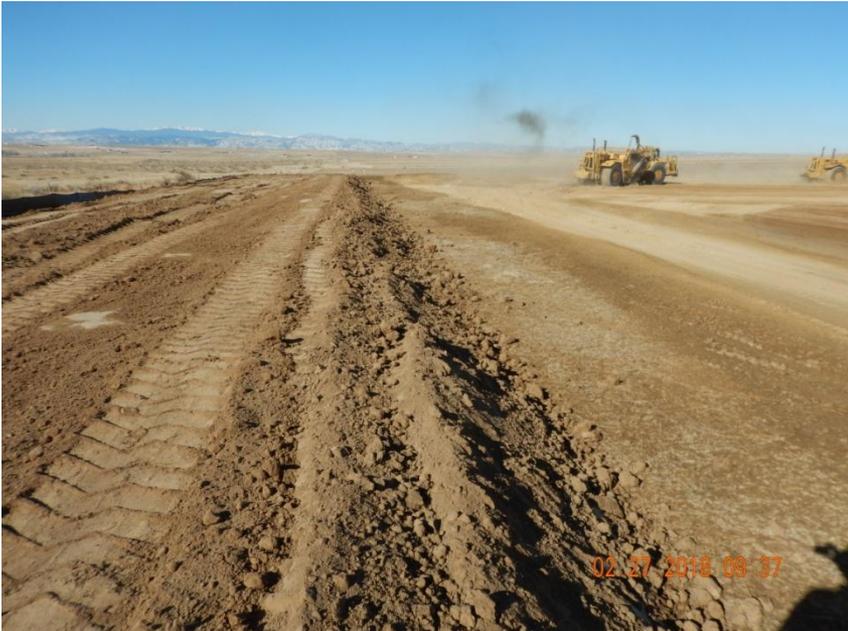
**Photo 7.** Photo taken from the southern location on the topsoil stockpile, facing West. Appears the Operator is still in-process of salvaging topsoil. Topsoil is being stored along the eastern and southern perimeter of the location.

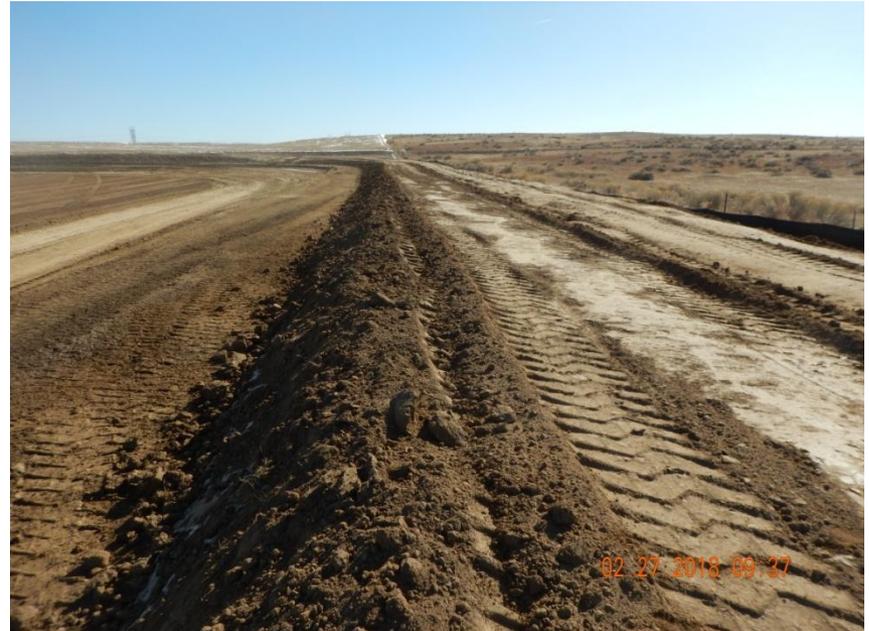
**Photo 8.** Photo taken from the southern location on the topsoil stockpile, facing East. See comments under Photo 7.

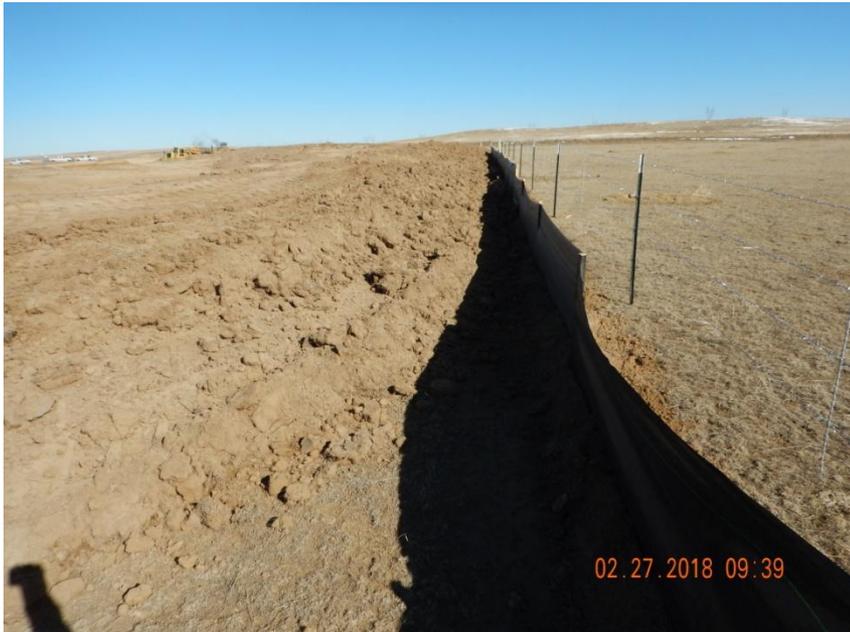
**Photo 9.** Photo taken from the southeast perimeter of the location, facing North. See comments under Photo 3.

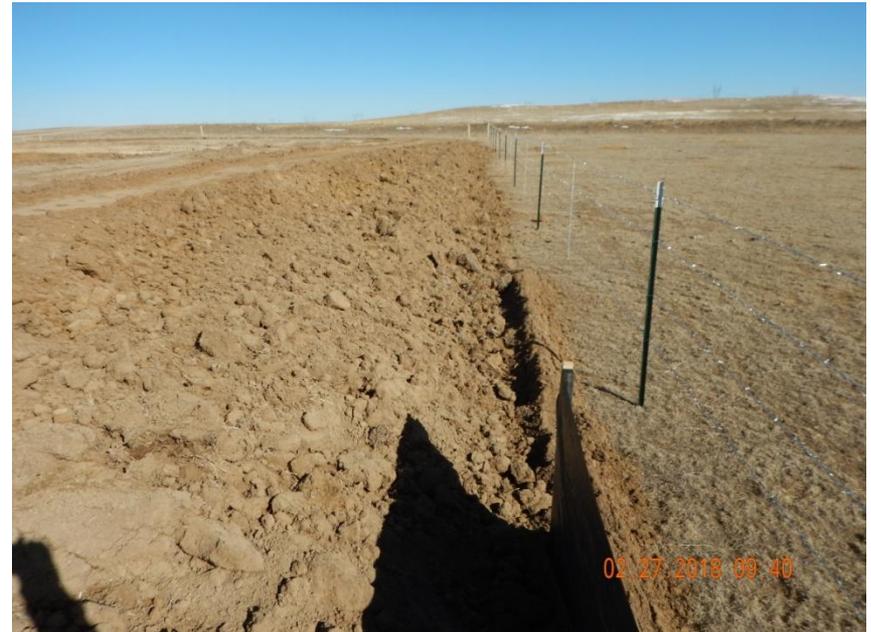
**Photo 10.** Photo taken from the eastern perimeter of the location, facing North. Silt fence BMP stops before the end of the topsoil stockpile. Operator shall install BMPs around all topsoil stockpiles. Operator representative at location indicated a BMP would be installed around the topsoil stockpile but did not provide a date.
