# Interim Reclamation and Stormwater Inspection

February 27, 2018

Operator: ENERPLUS RESOURCES (USA) CORPORATION - #10177

Location ID: 449800

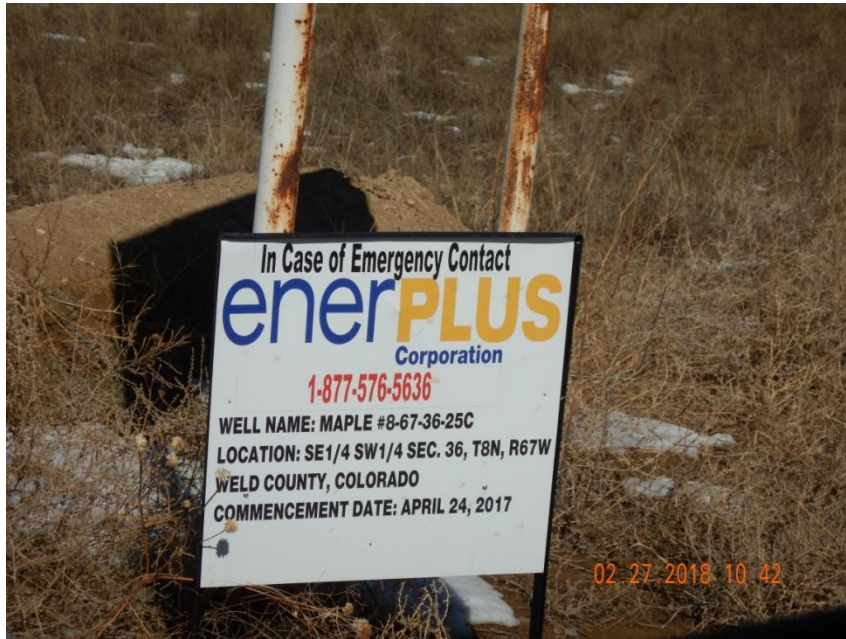
**Photo 1.** Photo taken from the entrance of the location off the intersection of CR 25 & CR 86. Photo illustrates Operator sign.

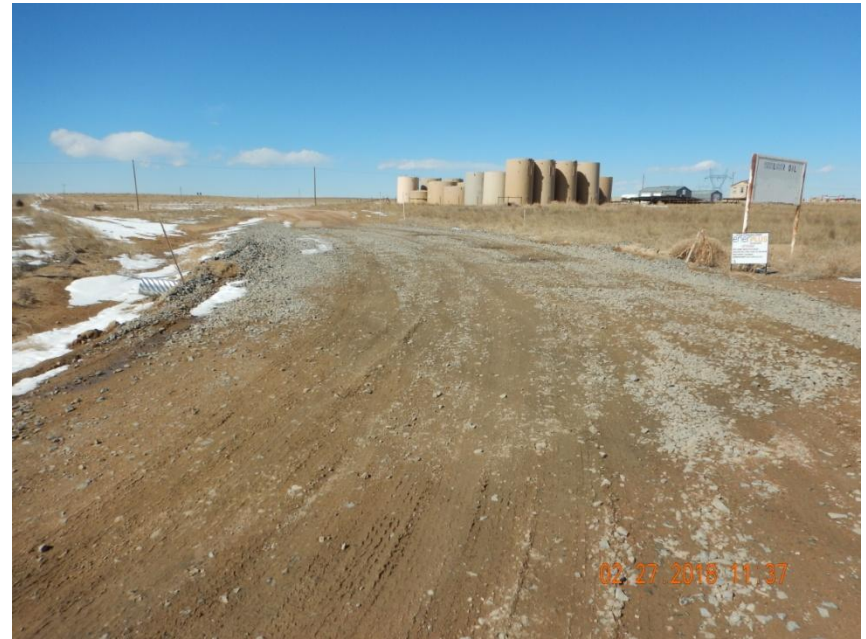
**Photo 2.** Photo taken from the entrance of the location off the intersection of CR 25 & CR 86, facing West. Operator has installed a tracking pad device. Appears maintenance may be needed for the tracking pad.

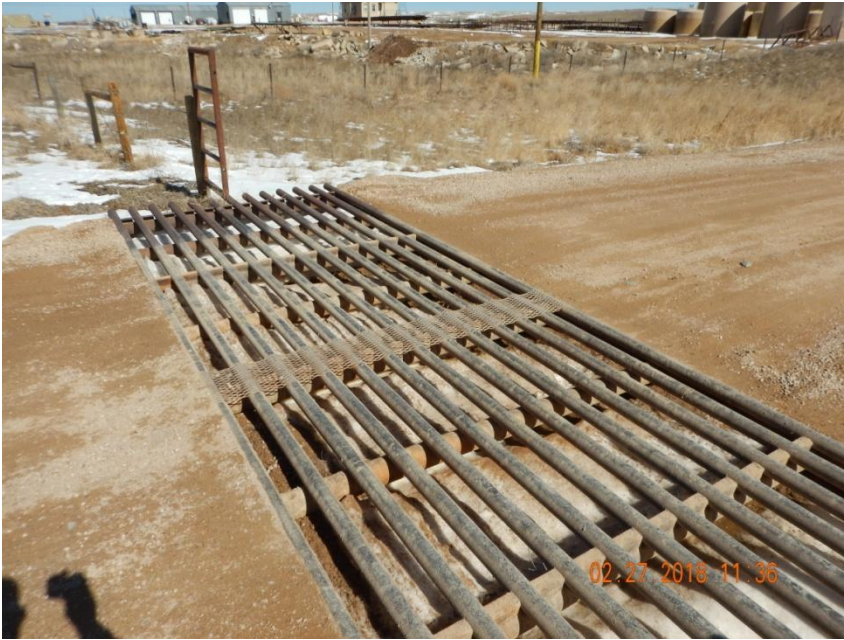
**Photo 3.** Photo taken of another tracking pad device along the eastern main access road, facing North. Tracking pad device appears to be proper functioning condition.

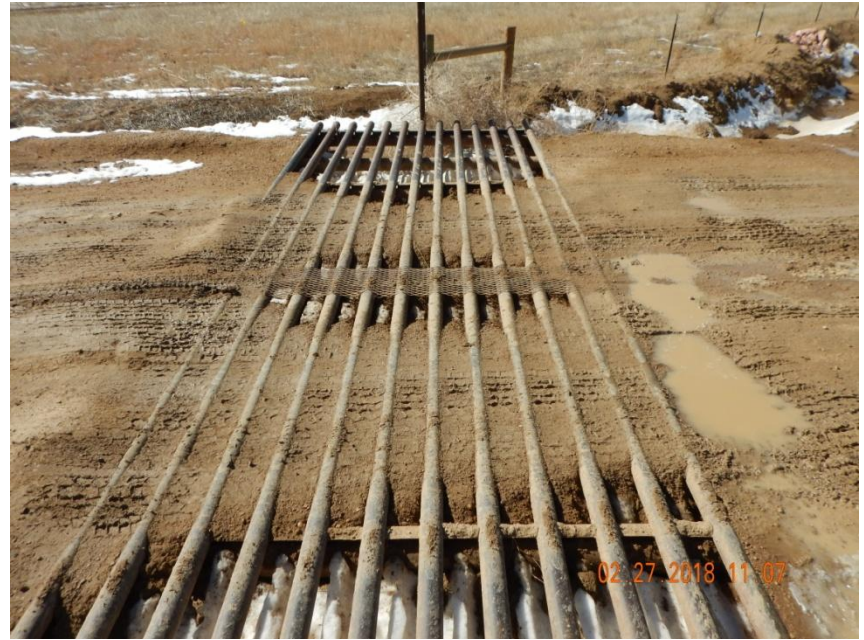
**Photo 4.** Photo taken from the tracking pad device at the entrance of the well pad location, facing West. Appears maintenance is required as sediment has accumulated in the tracking pad device and is no longer properly functioning.

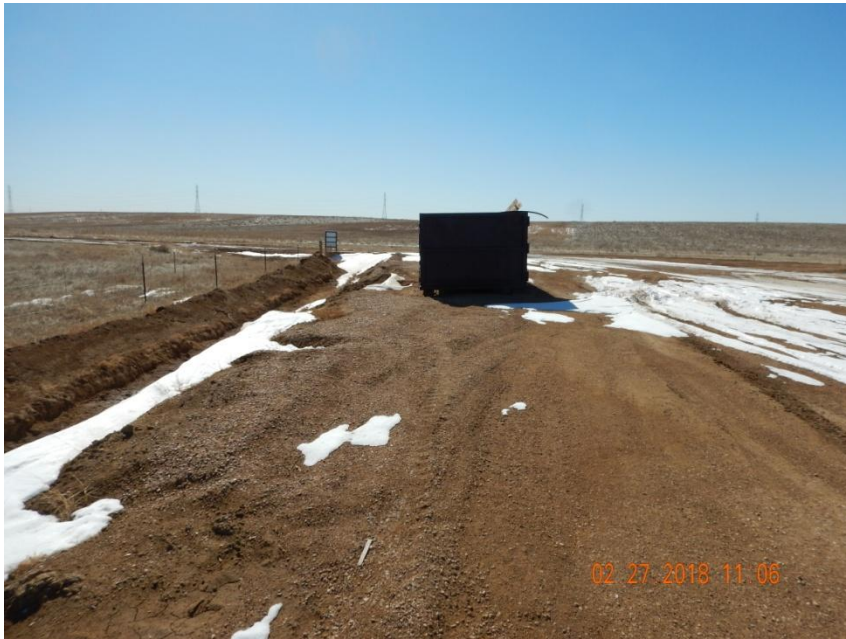
**Photo 5.** Photo taken near the entrance of the well pad location, facing South. Operator has a trash bin at location which is not covered- see Photo 6.

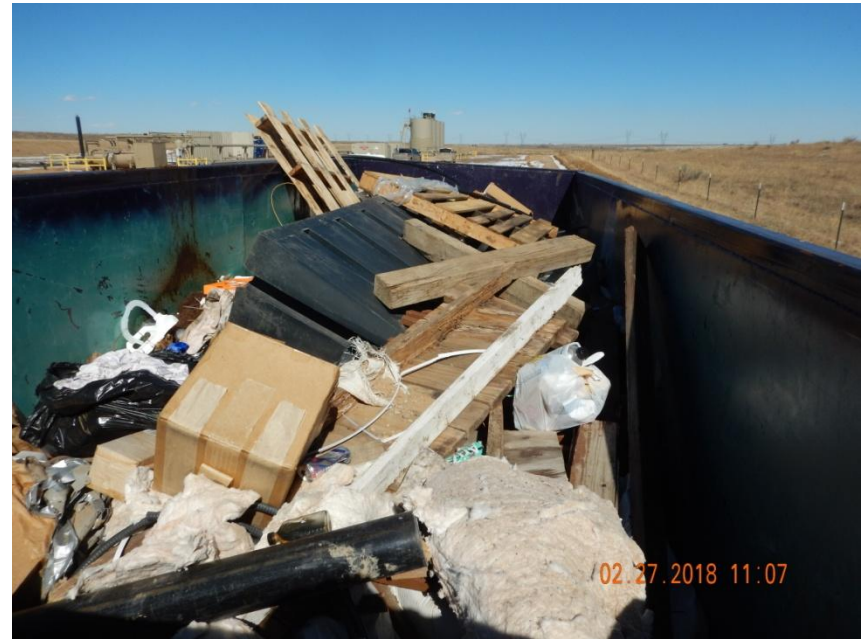
**Photo 6.** Photo taken from the trash bin. Operator shall cover trash bin to prevent trash from blowing off location.

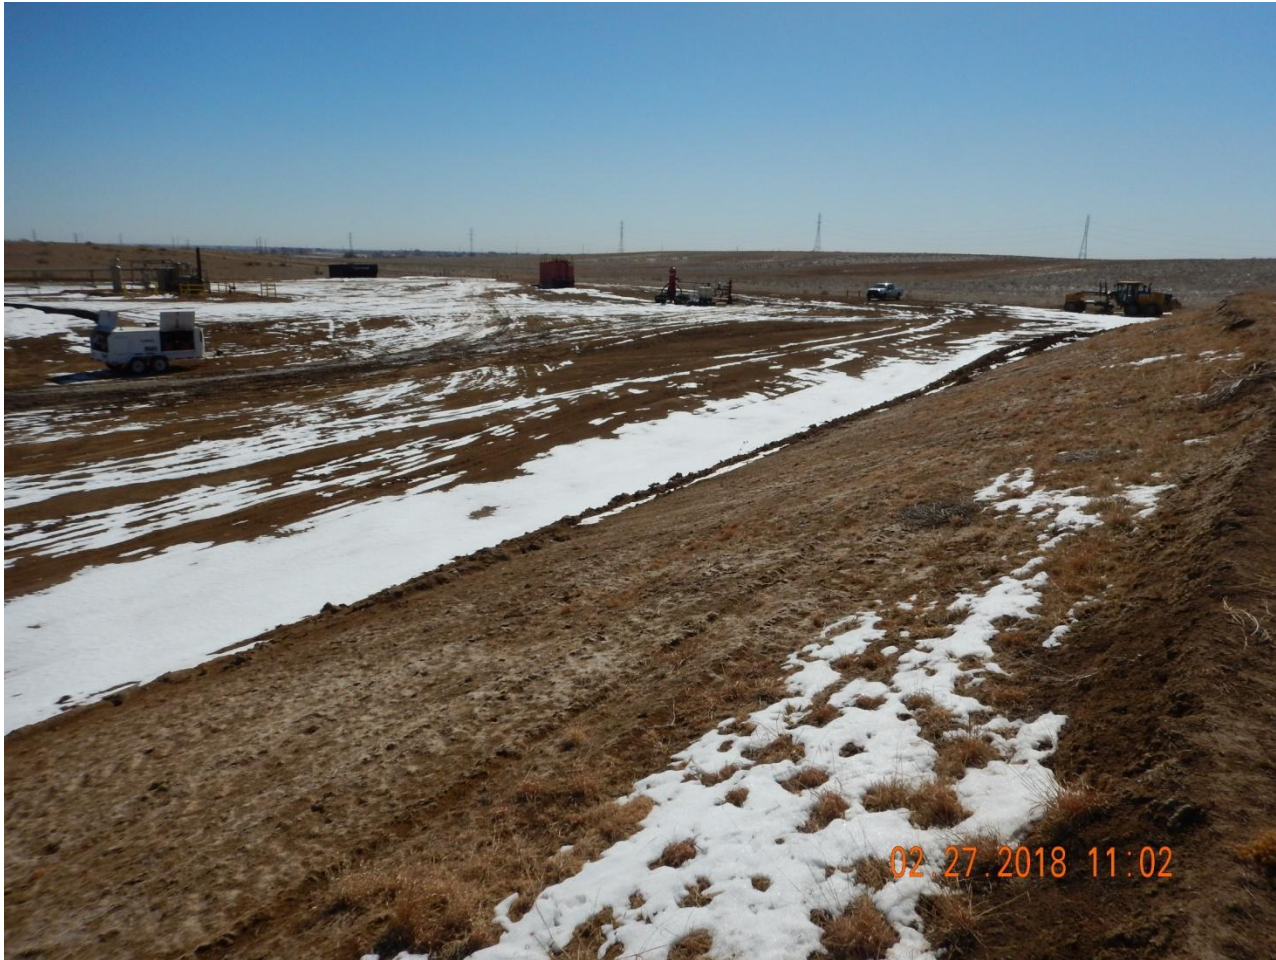
**Photo 7.** Photo taken from the western perimeter of the location, facing South. Operator has failed to perform interim reclamation to reduce areas not needed for production operations per Rule 1003.

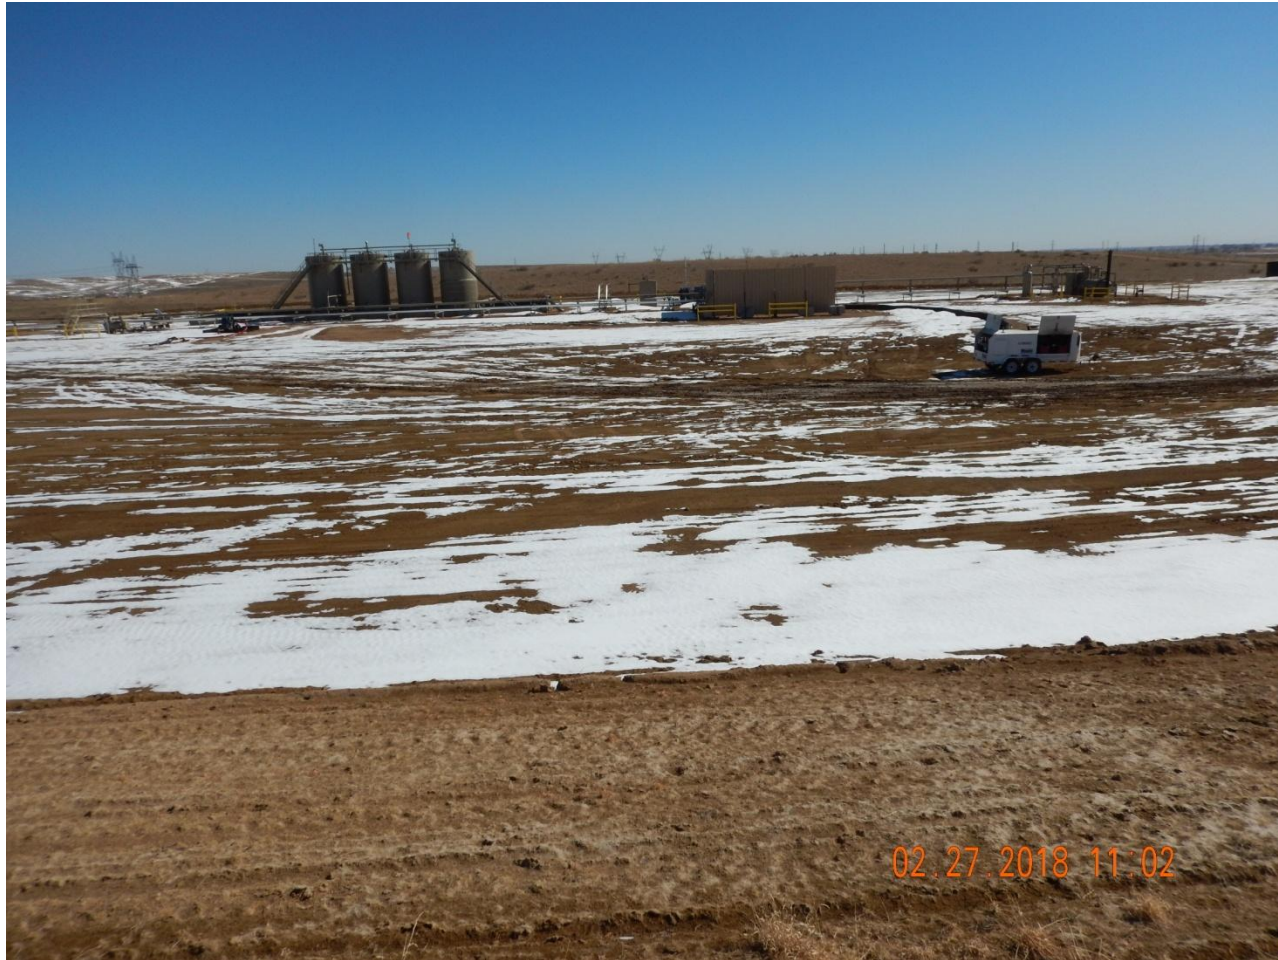
**Photo 8.** Photo taken from the western perimeter of the location, facing East. See comments under Photo 7.

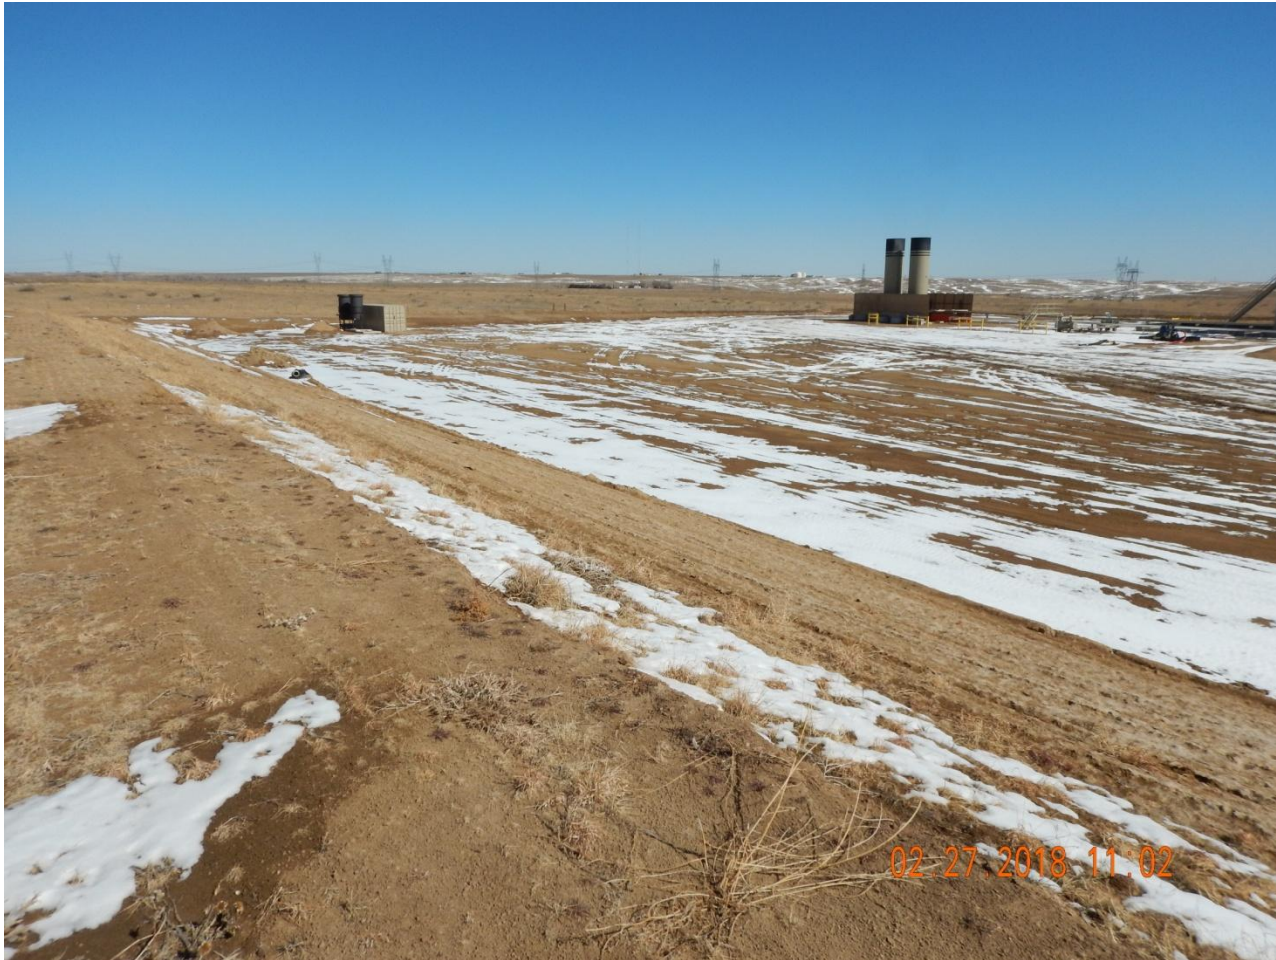
**Photo 9.** Photo taken from the western perimeter of the location, facing North. See comments under Photo 7.

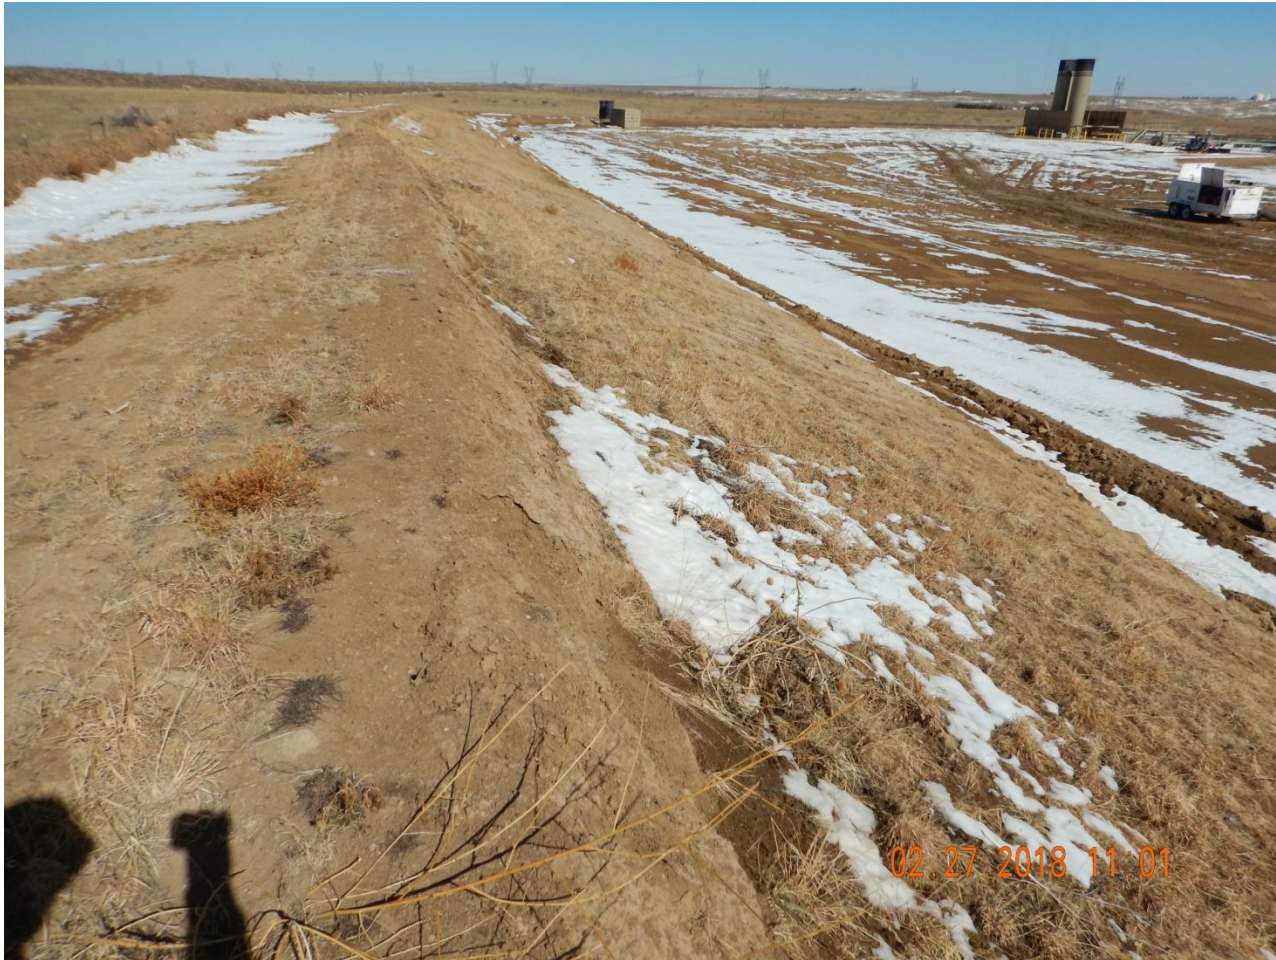
**Photo 10.** Photo taken from the western perimeter of the location, facing North. Topsoil stockpile appears to be in compliance with Rule 1002.c.

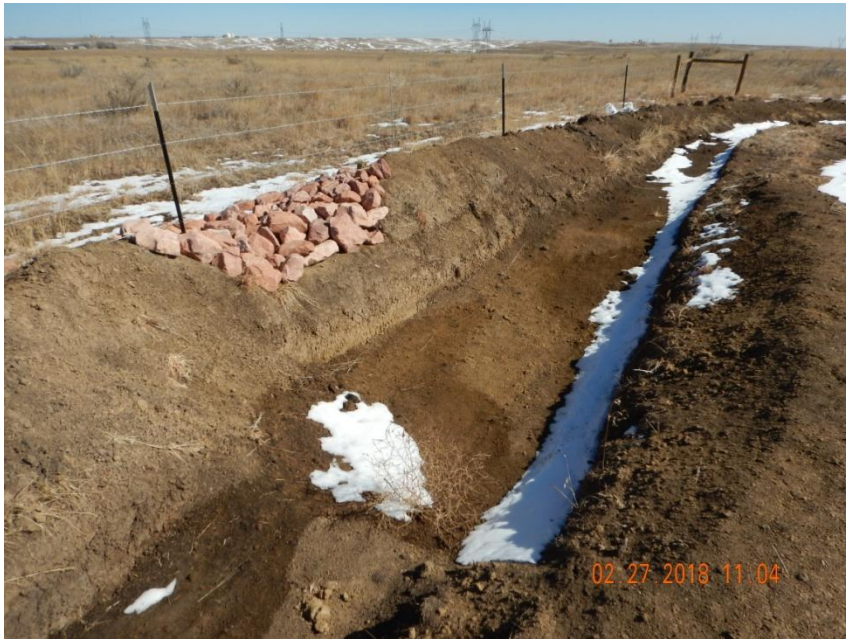
**Photo 11.** Photo taken from the northeast sediment trap, facing East. Sediment trap appears to be in proper functioning condition. No sediment discharge from location was observed.

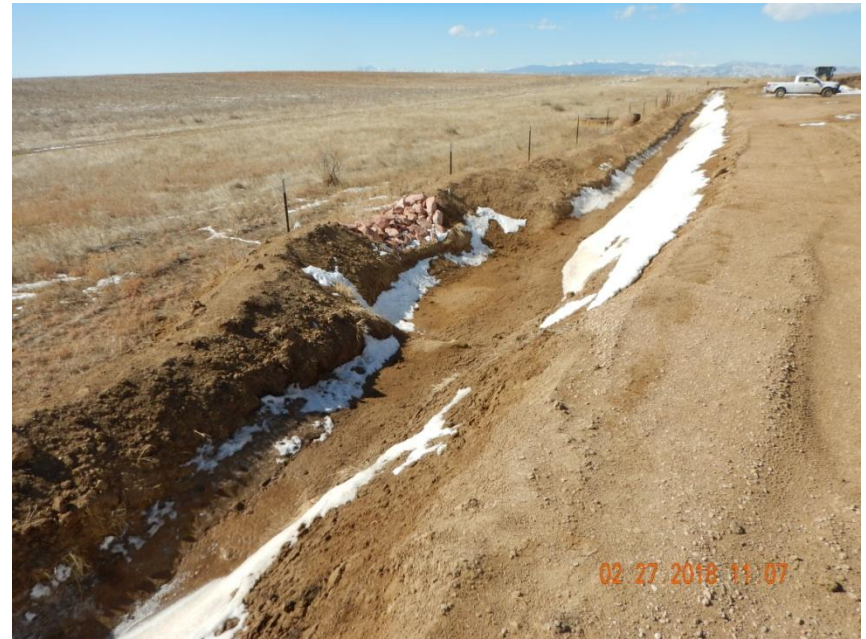
**Photo 12.** Photo taken from the southeast sediment trap, facing West. See comments under Photo 11.
