BISON OIL AND GAS LLC

Castor 8-59 19-24-16 Production

Job Date: Wednesday, December 06, 2017

1.1 Executive Summary

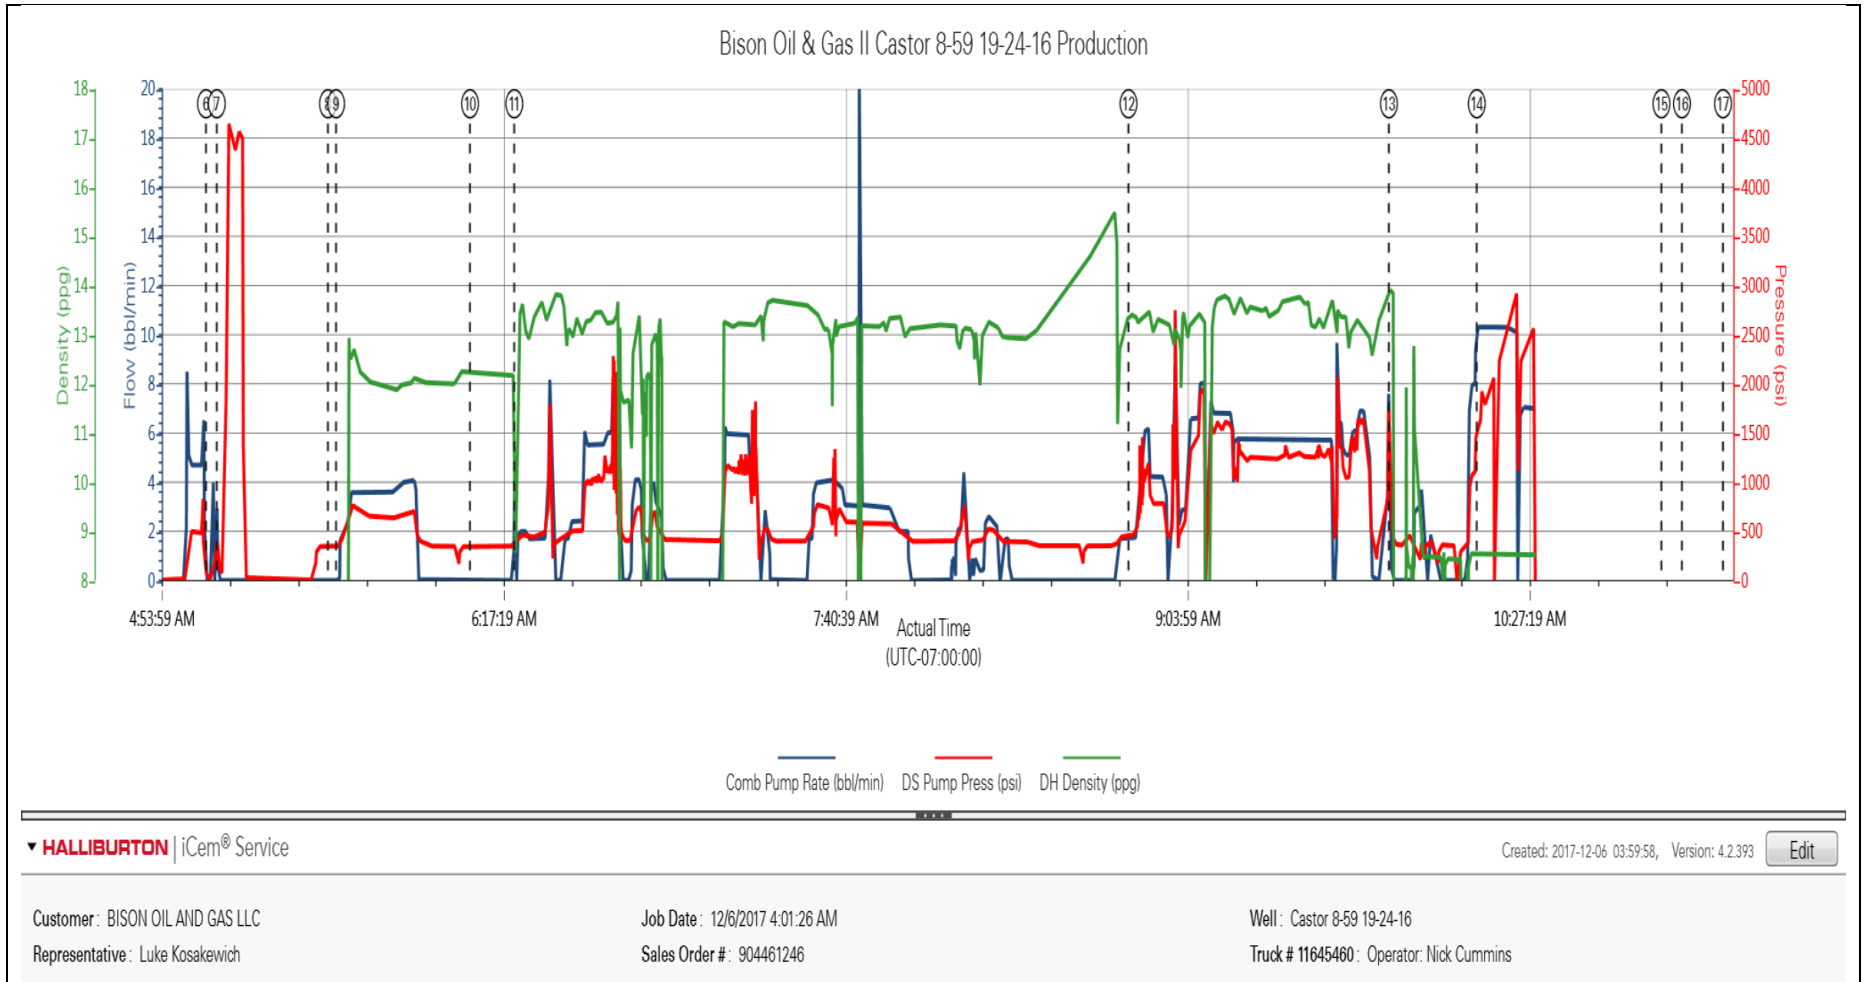
3.1 Bison Oil & Gas II Castor 8-59 19-24-16 Production Job Chart

Lead was cut short due to mixing issues. Lead top estimated at 1,357'. Chart was not able to record the last portion of displacement.

company man.
Event	14	Pump Displacement	Pump Displacement	12/6/2017	10:15:00	USER	10.30	1556.00	8.52	Pumped 295 bbls. of fresh water for displacement with MMCR in the first 20 bbls. Displacement did not chart due to the flex shorting out.
Event	15	Bump Plug	Bump Plug	12/6/2017	11:00:00	USER				Bumped the plug 500 psi. over 2,200 psi. Final pressure was 2,700 psi. Got 15 bbls. of spacer to surface. Estimated TOL is 1,357' and TOT is 6,895'
Event	16	Check Floats	Check Floats	12/6/2017	11:05:00	USER				Bled off pressure to check floats. Floats held. Got 5 bbls. of fluid back to the truck.
Event	17	End Job	End Job	12/6/2017	11:15:00	USER				Washed pumps and lines until clean.
Event	18	Pre-Rig Down Safety Meeting	Pre-Rig Down Safety Meeting	12/6/2017	11:20:00	USER				Halliburton cement crew held a pre rig down safety meeting and JSA.
Event	19	Rig-Down Equipment	Rig-Down Equipment	12/6/2017	11:30:00	USER				Rigged down all lines, hoses and equipment.
