Interim Reclamation and Stormwater Inspection

February 27, 2018

Location ID: 419217

Location Name: G & D Hanks /10-27 Pad

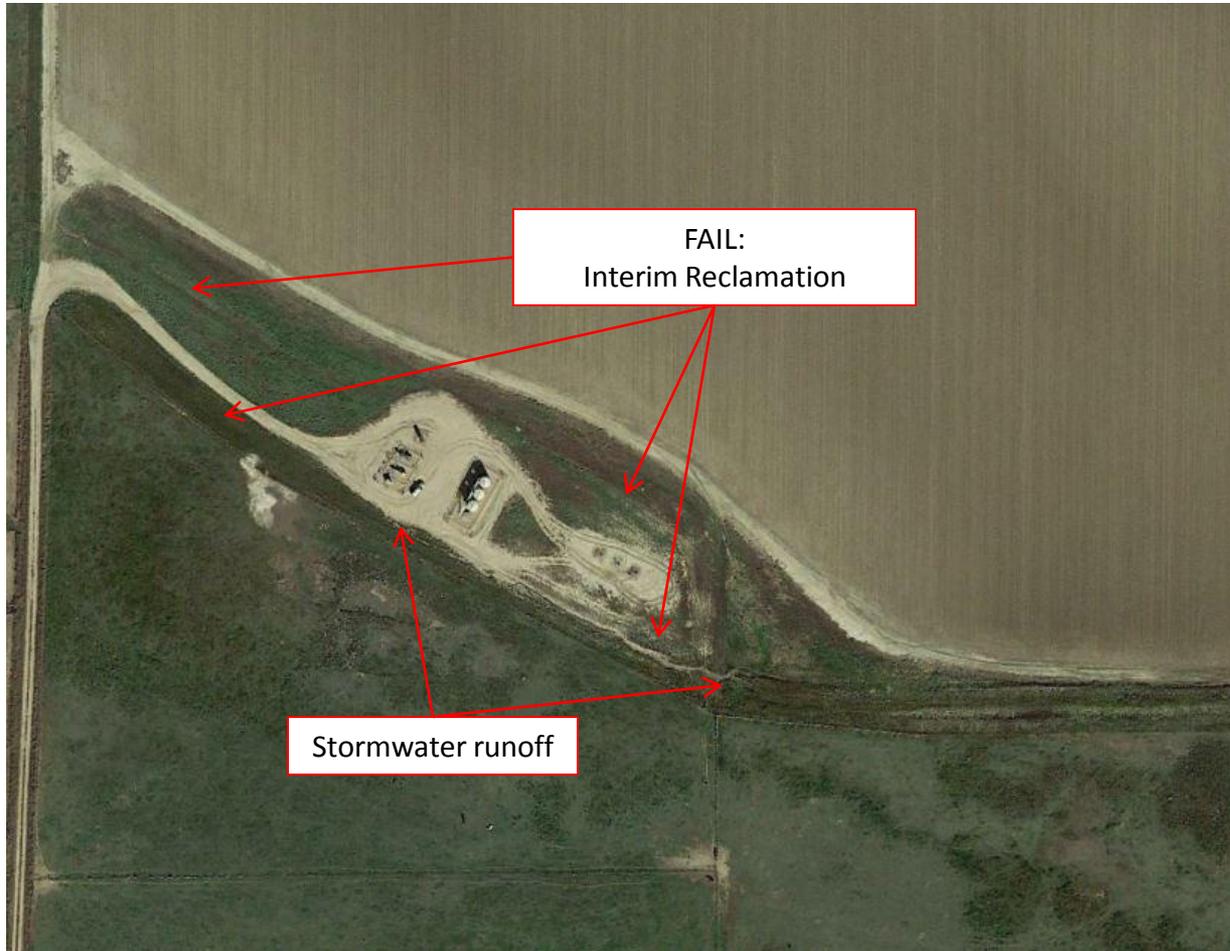
Google Earth aerial imagery taken October 14, 2017. Photo illustrates stormwater runoff from the facility and well location- see the following close-up aerial imagery. Interim reclamation areas do not meet Rule 1003 standards.

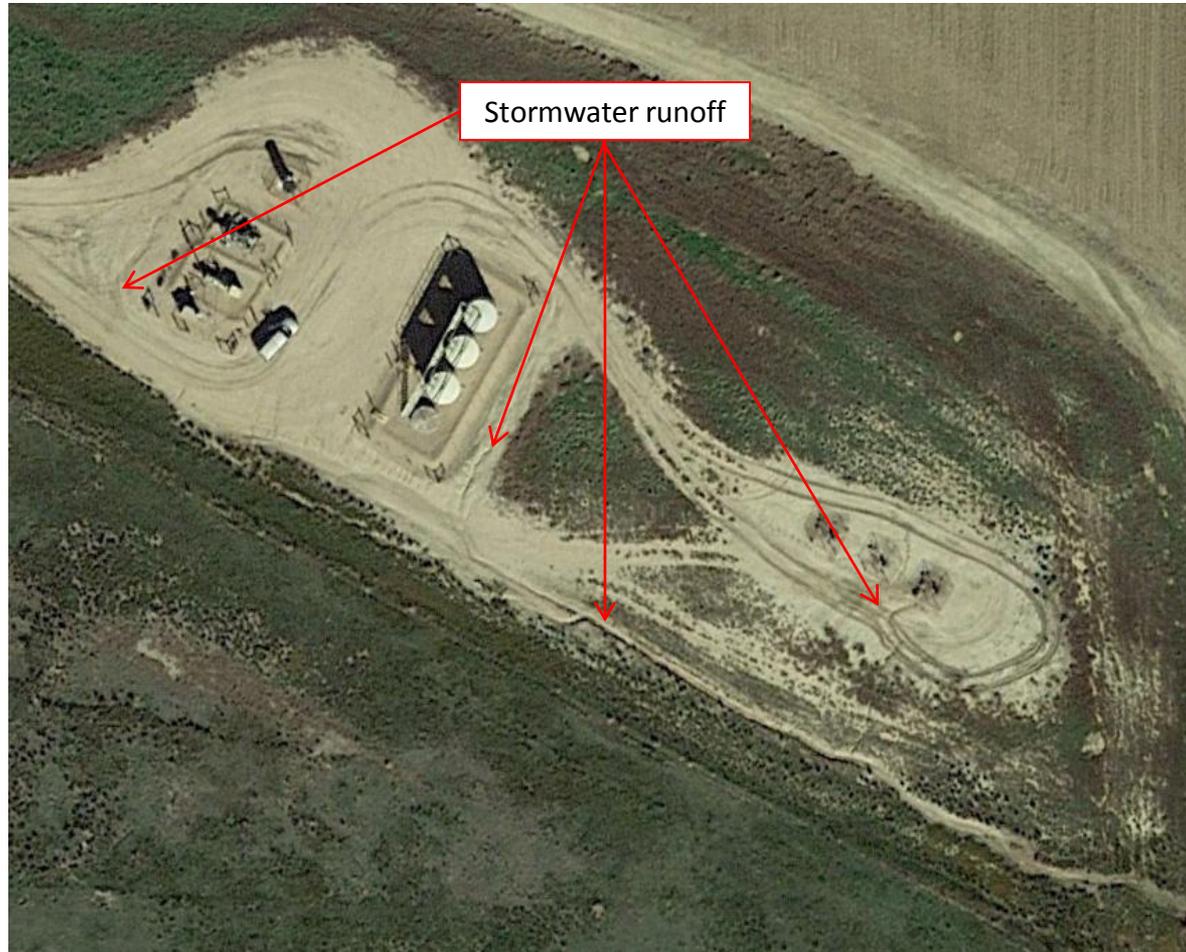
Close-up aerial imagery illustrates stormwater runoff from location.

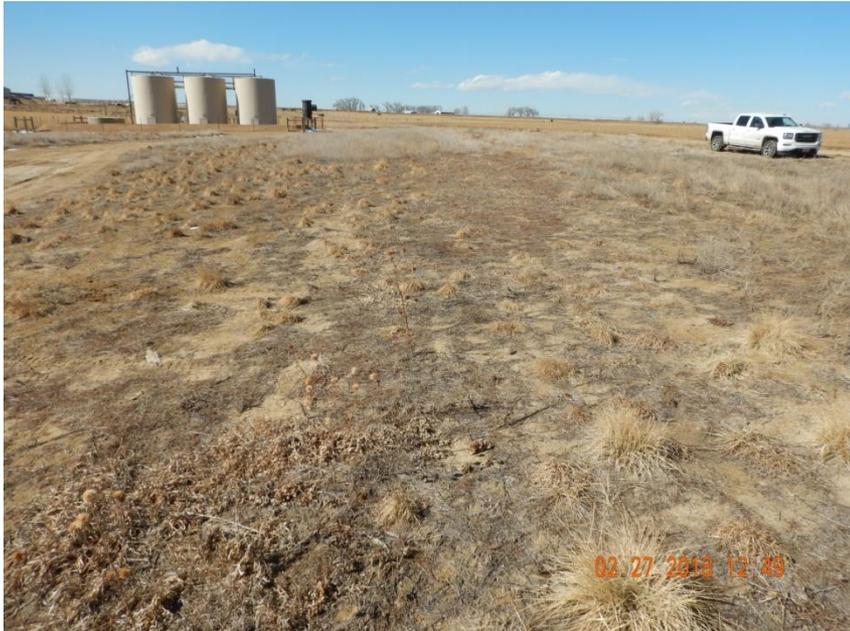
Photo 1. Photo taken from the eastern interim reclamation area, facing West. This area does not meet Rule 1003 standards, as weedy, annual vegetation (Kochia and cheatgrass) and bare ground dominates the area which is not reflective of reference area vegetative levels.

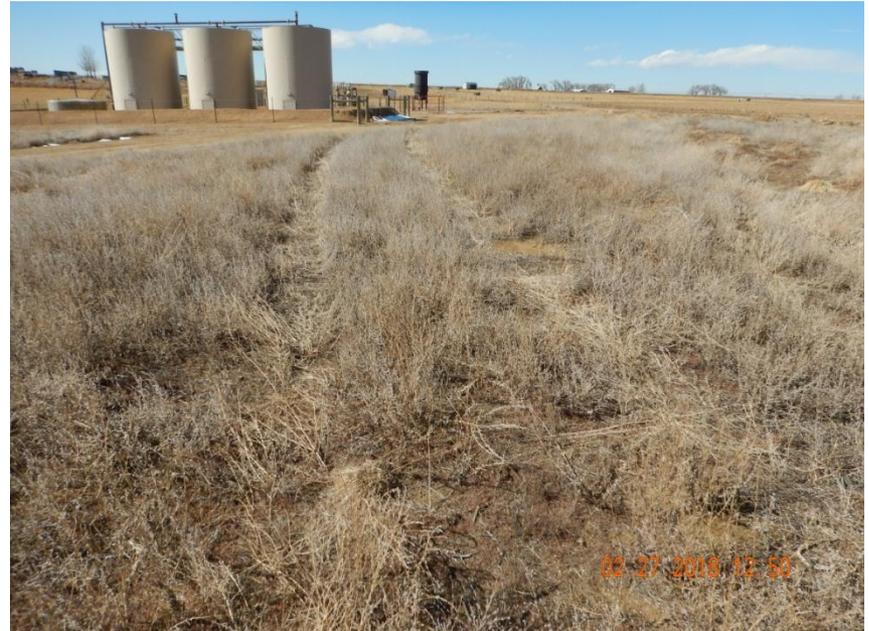
Photo 2. Photo taken from the eastern interim reclamation area, facing West. See comments under Photo 1.

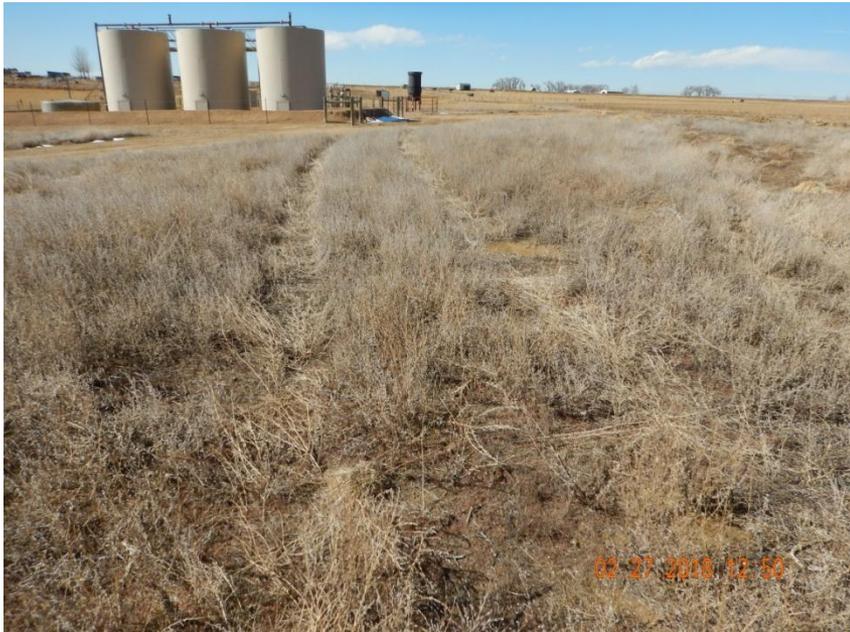
Photo 3. Photo taken from the eastern interim reclamation area, facing West. See comments under Photo 1.

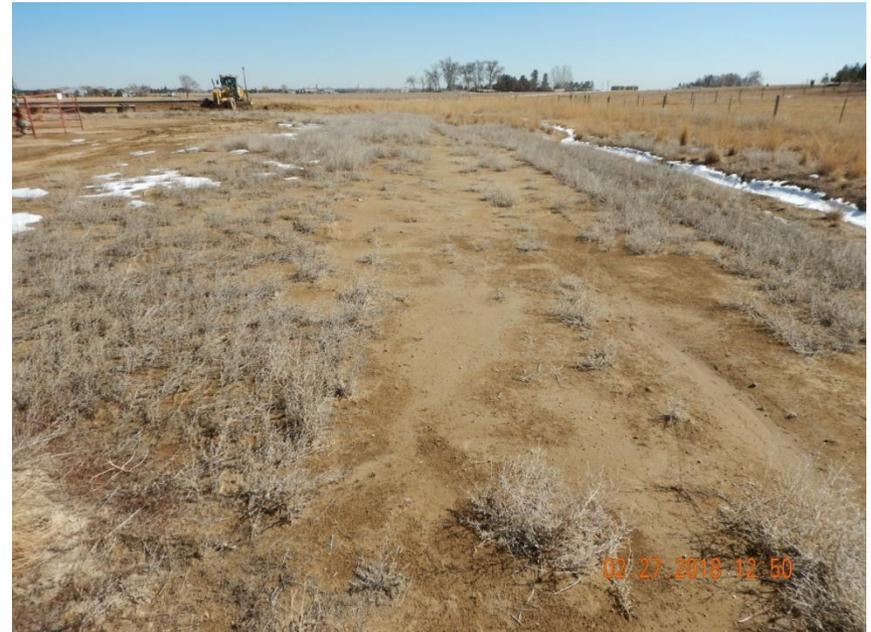
Photo 4. Photo taken from the southeastern interim reclamation area, facing East. See comments under Photo 1.

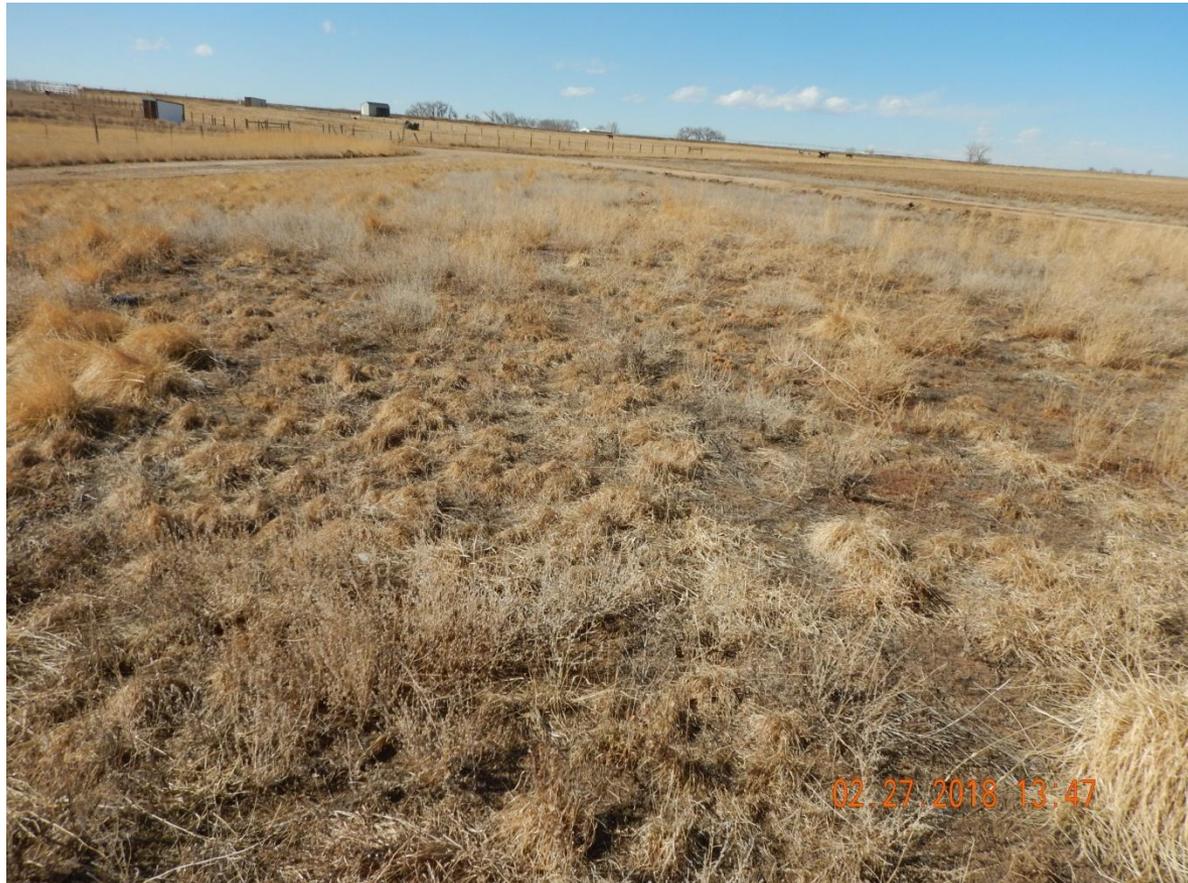
Photo 5. Photo taken from the western interim reclamation area, facing West. See comments under Photo 1.

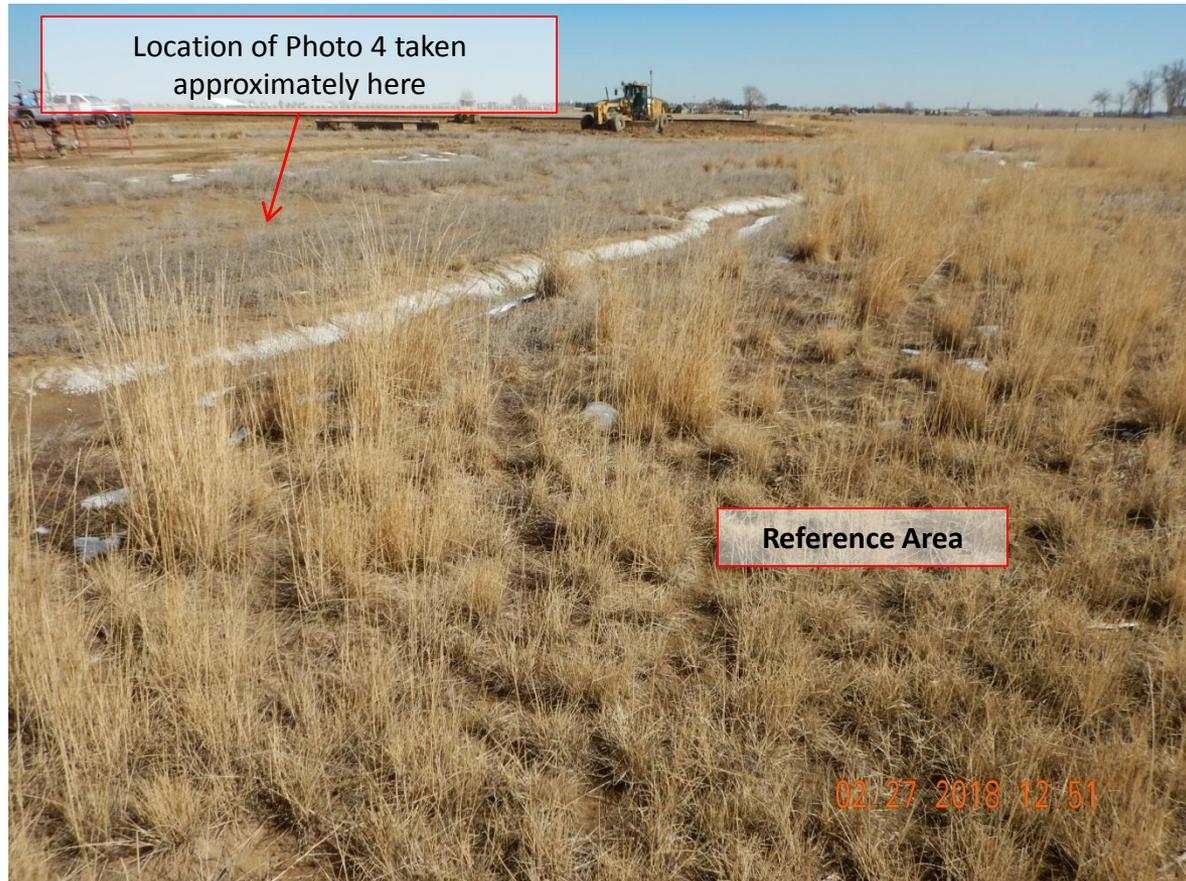
Photo 6. Reference photo taken south of the location, facing East. See comments under Photo 1. Reference area vegetation mainly consists of, but not limited to, Intermediate wheatgrass (*Thinopyrum intermedium*), Crested wheatgrass (*Agropyron cristatum*), Smooth brome (*Bromus inermis*) and Salt grass (*Distichlis spicata*).

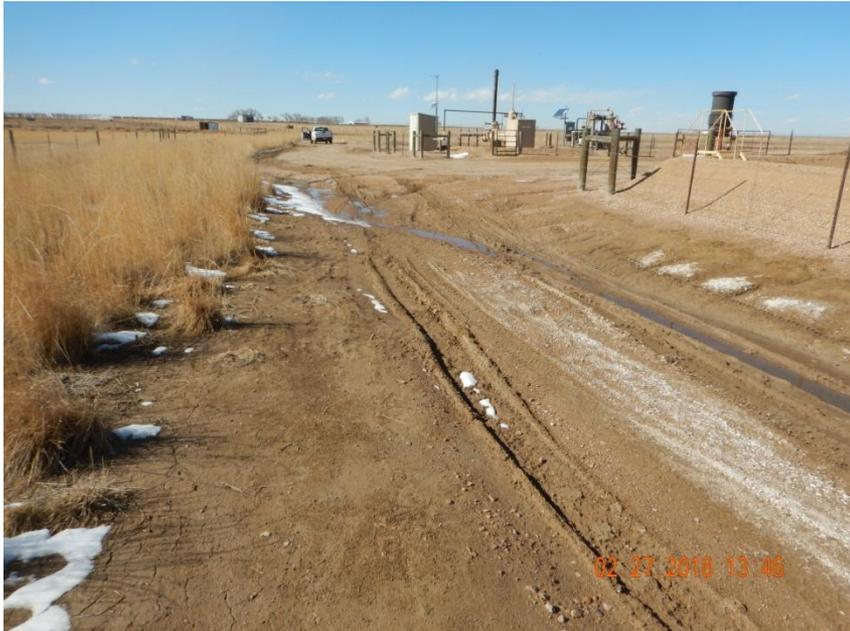
Photo 7. Photo taken from the southern location, facing West. Photo illustrates stormwater runoff from location.

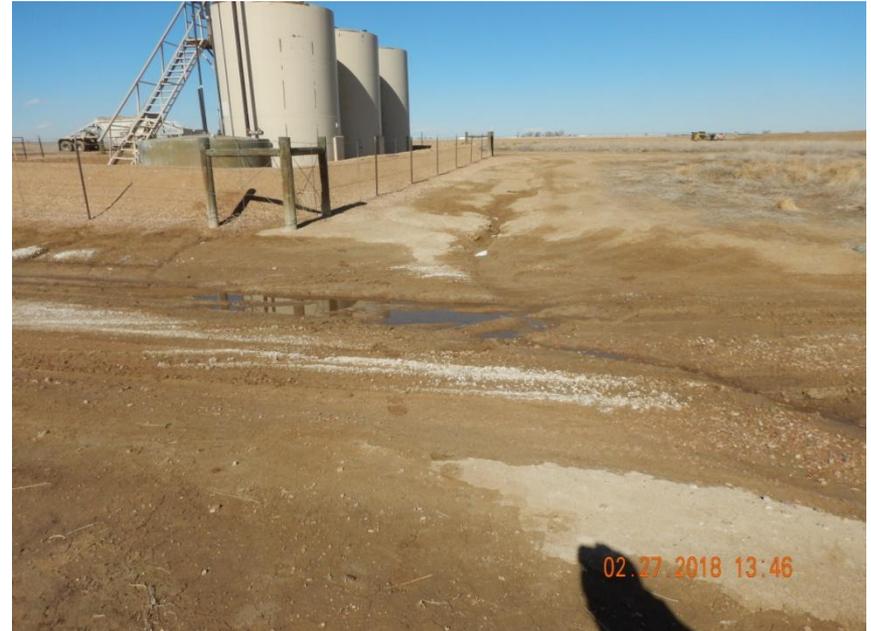
Photo 8. Photo taken from the southern location, facing North. See comments under Photo 6.

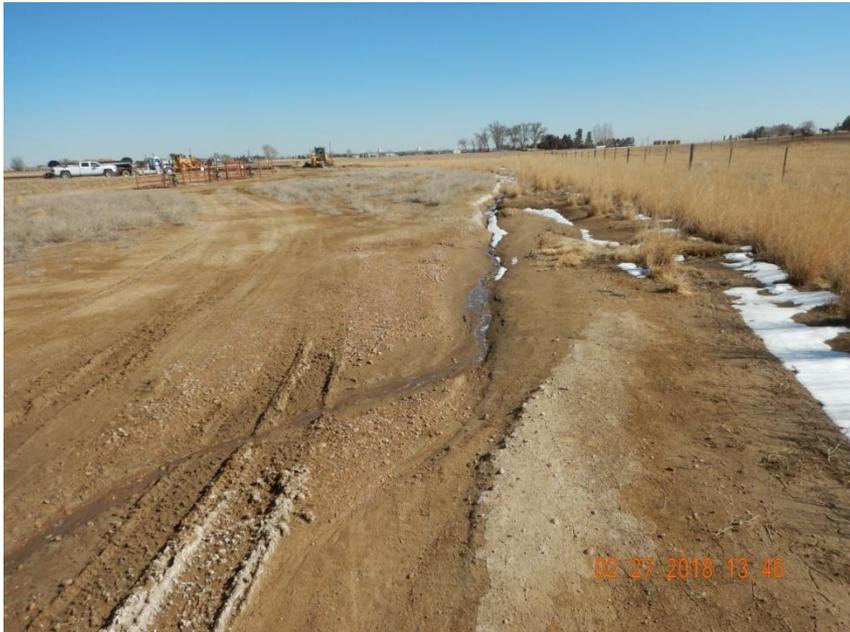
Photo 9. Photo taken from the southern location, facing East. See comments under Photo 6.

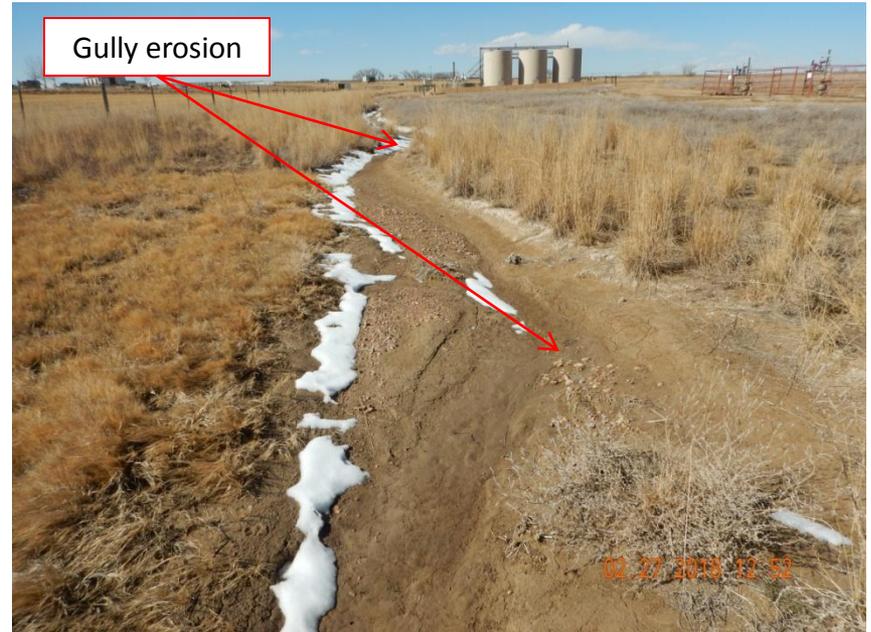
Photo 10. Photo taken east off location, facing West. Gully erosion evident from stormwater runoff from location.
