Inspection Photos

02/26/2018

Operator: WESTERN OPERATING COMPANY -
95620

Location ID: 312291

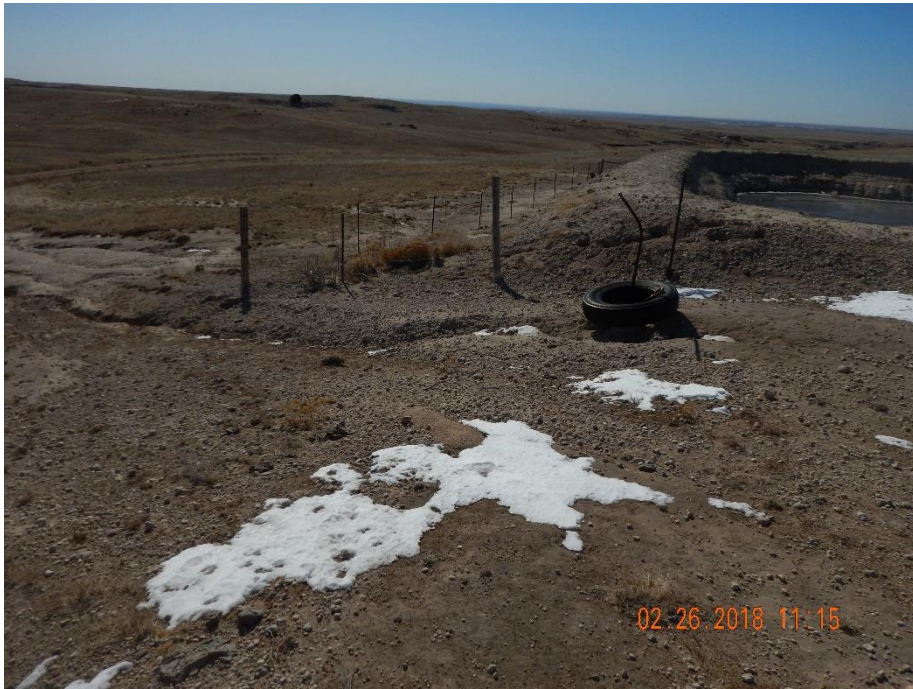
Photo 1: Photo taken from the east end of the location, facing south. The following photos show areas of erosion degradation, where erosion has not been repaired and no stabilization and stormwater BMPs have been installed or maintained per corrective actions. Additionally, photos show no remediation/reclamation activities appear to have been conducted per corrective actions.

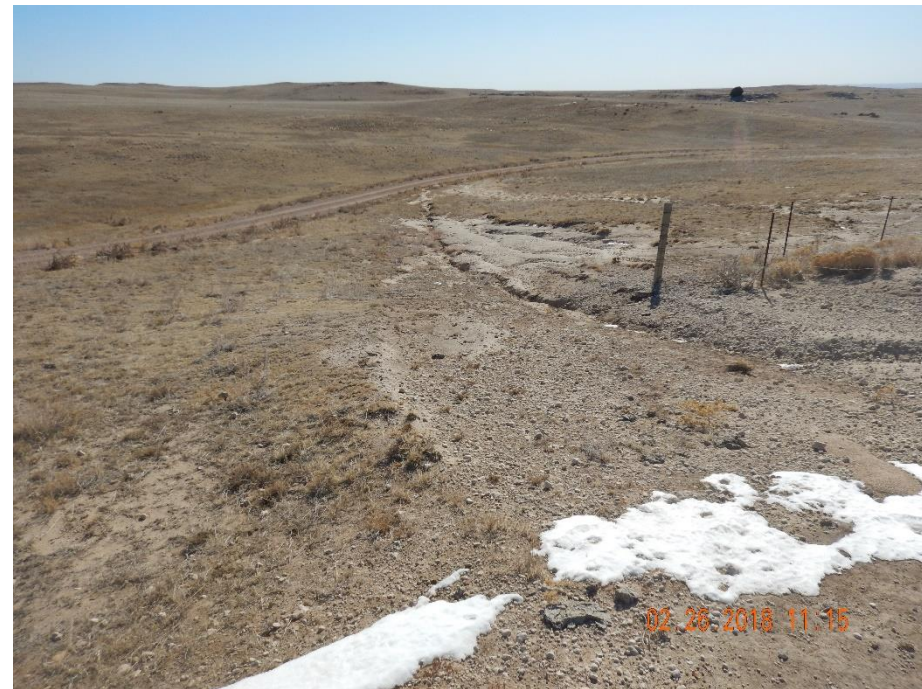
Photo 2: Photo taken from the east end of the location, facing southeast. See comments under photo 1.

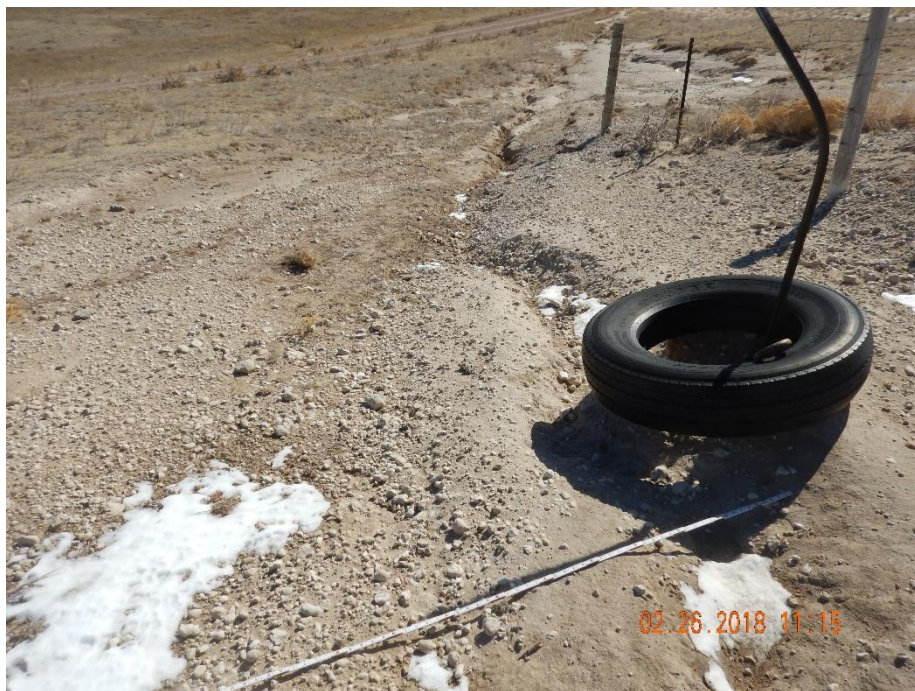
Photo 3: Photo taken from the east end of the location, facing east. See comments under photo 1. 6 foot measuring stick for reference.

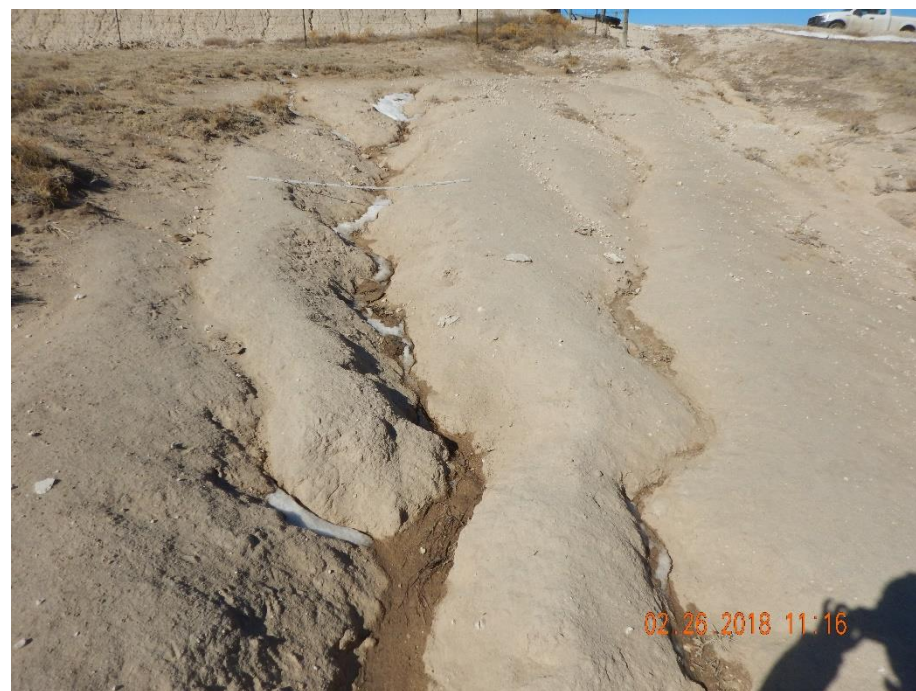
Photo 4: Photo taken from the east of the location, facing west. See comments under photo 1. 6 foot measuring stick for reference.

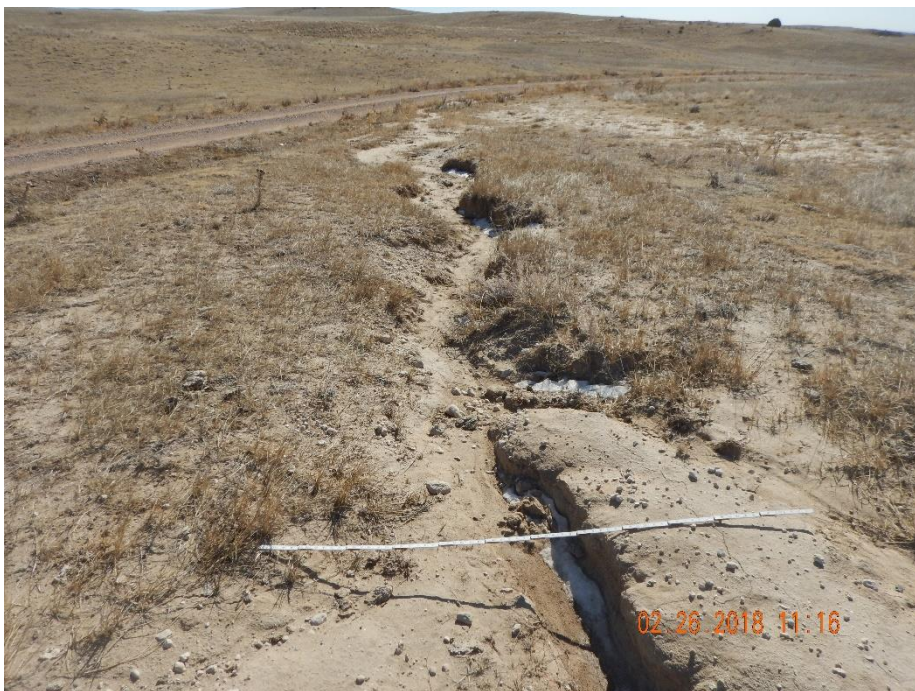
Photo 5: Photo taken from the east of the location, facing southeast. See comments under photo 1. 6 foot measuring stick for reference.

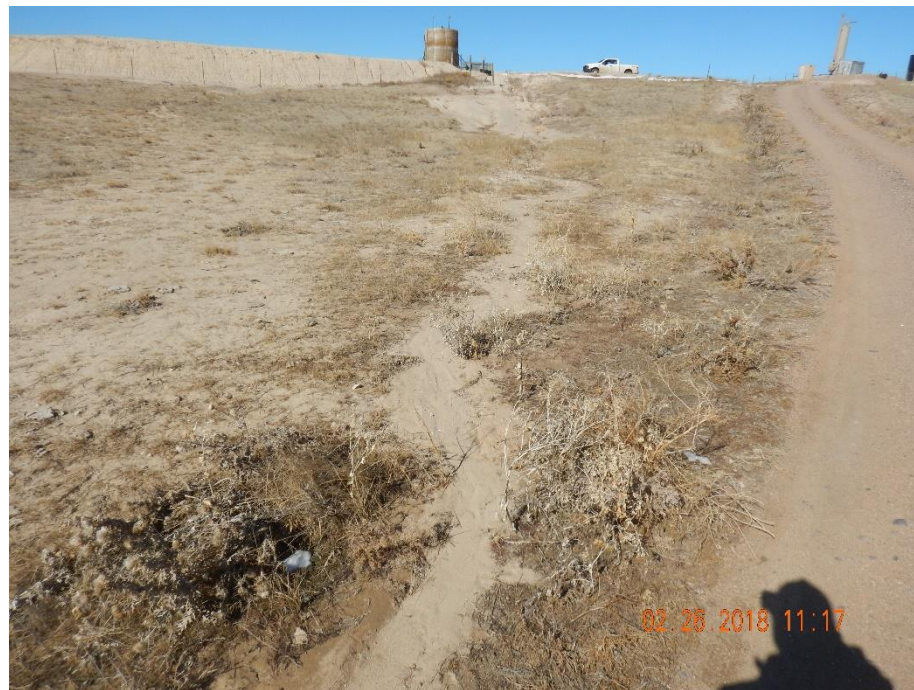
Photo 6: Photo taken from the east of the location, facing west. See comments under photo 1. 6 foot measuring stick for reference.

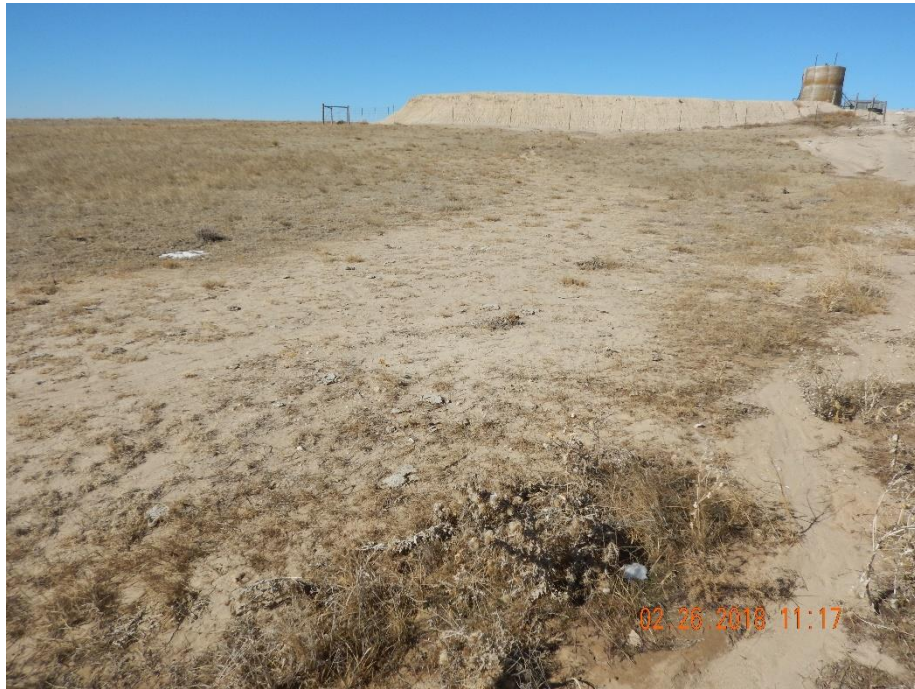
Photo 7: Photo taken from the southeast of the location, facing northwest. See comments under photo 1. 6

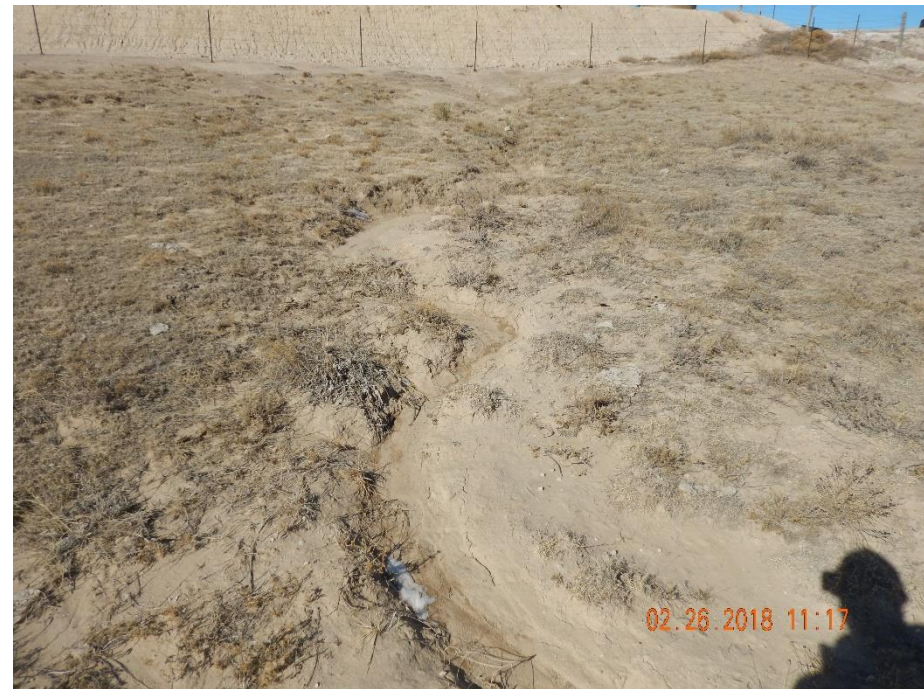
Photo 8: Photo taken from the east of the location, facing northwest. See comments under photo 1.

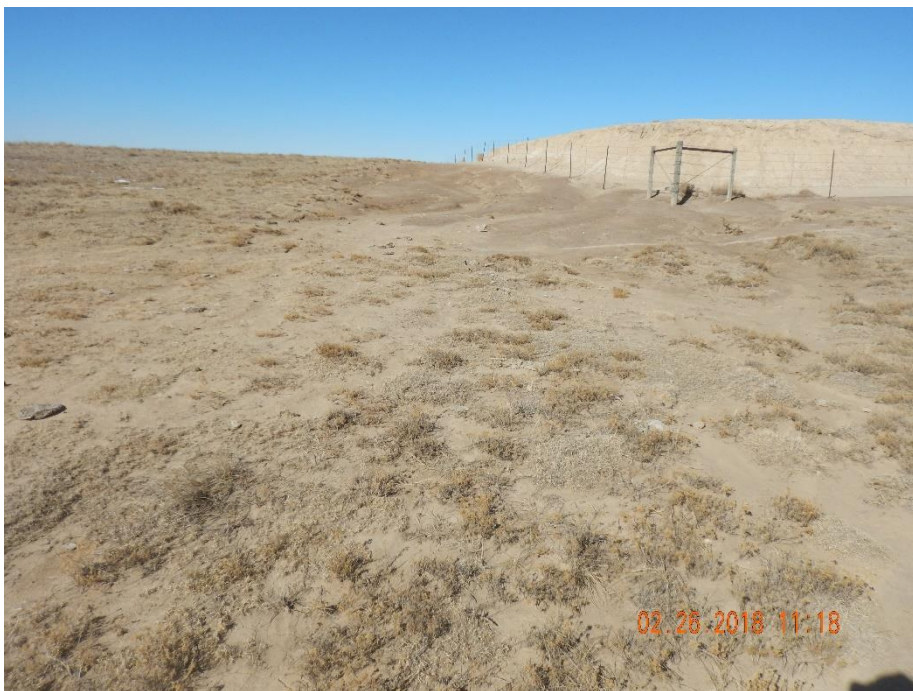
Photo 9: Photo taken from the southeast of the location, facing northwest. See comments under photo 1.

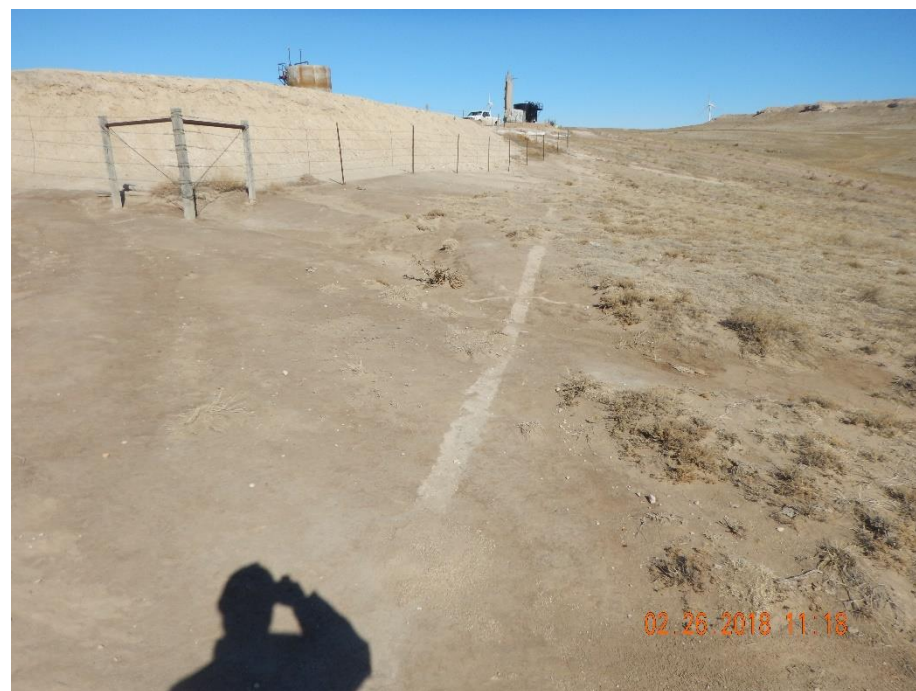
Photo 10: Photo taken from the southeast of the location, facing north. See comments under photo 1.

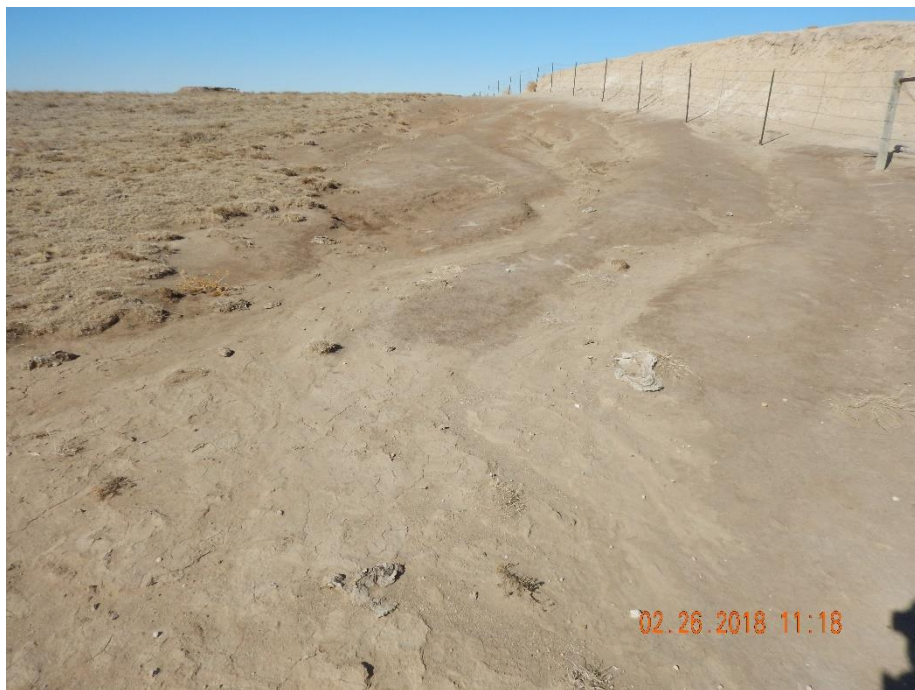
Photo 11: Photo taken from the southeast of the location, facing northwest. See comments under photo 1.

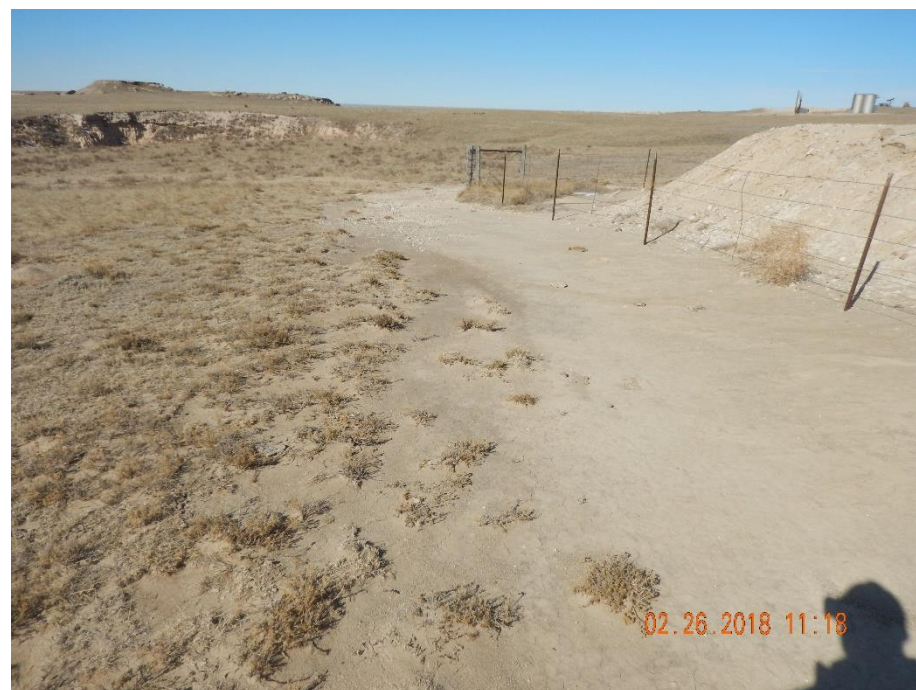
Photo 12: Photo taken from the south end of the location, facing northwest. See comments under photo 1.

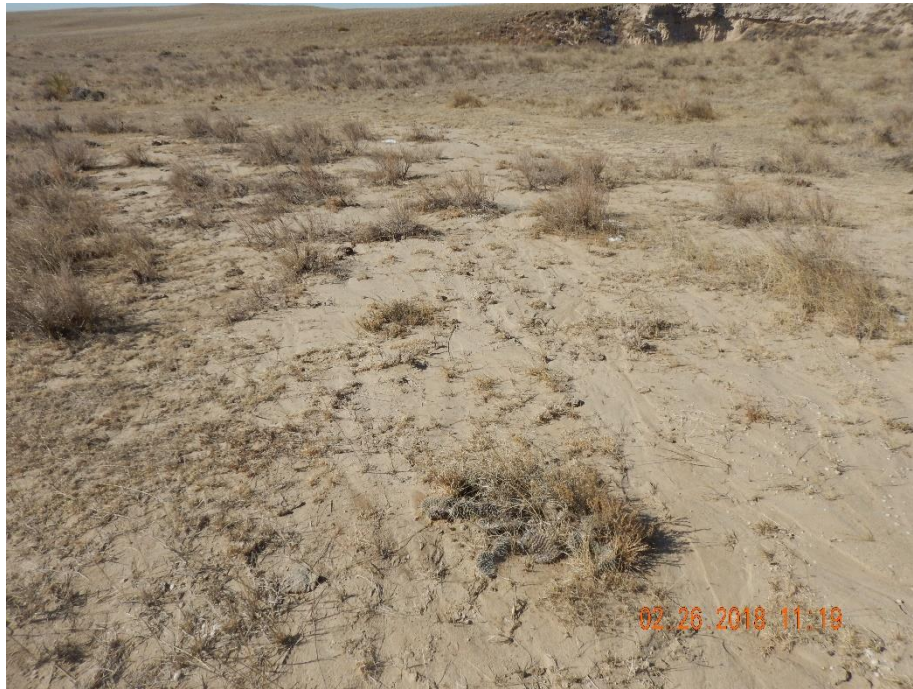
Photo 13: Photo taken from the southwest of the location. Photo shows areas where sediment deposition from sediment laden stormwater runoff from the location has degraded the vegetation in the adjacent areas.

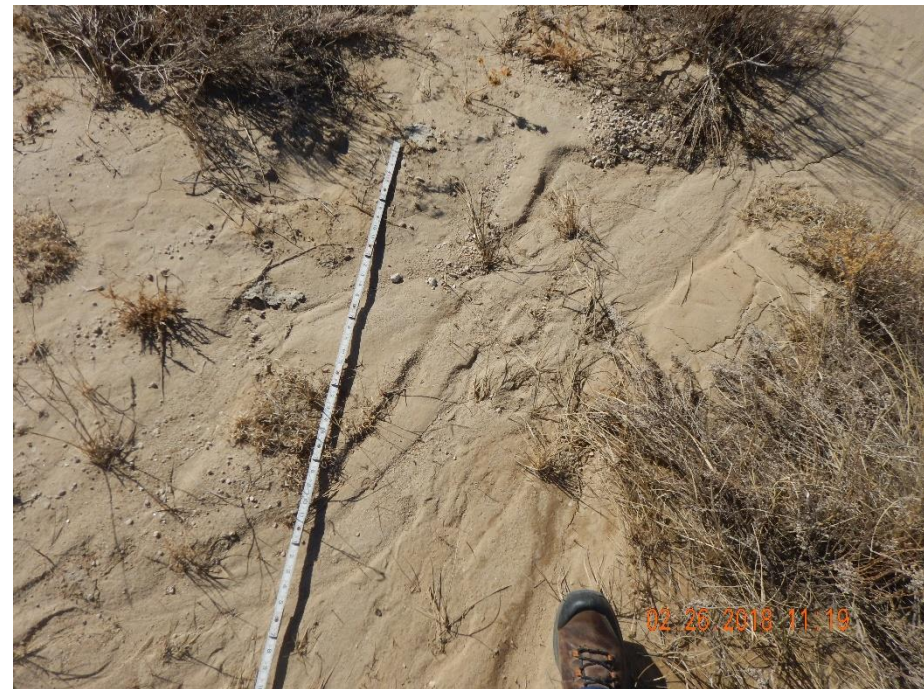
Photo 14: See comments under photo 13. 6 foot measuring stick for reference.

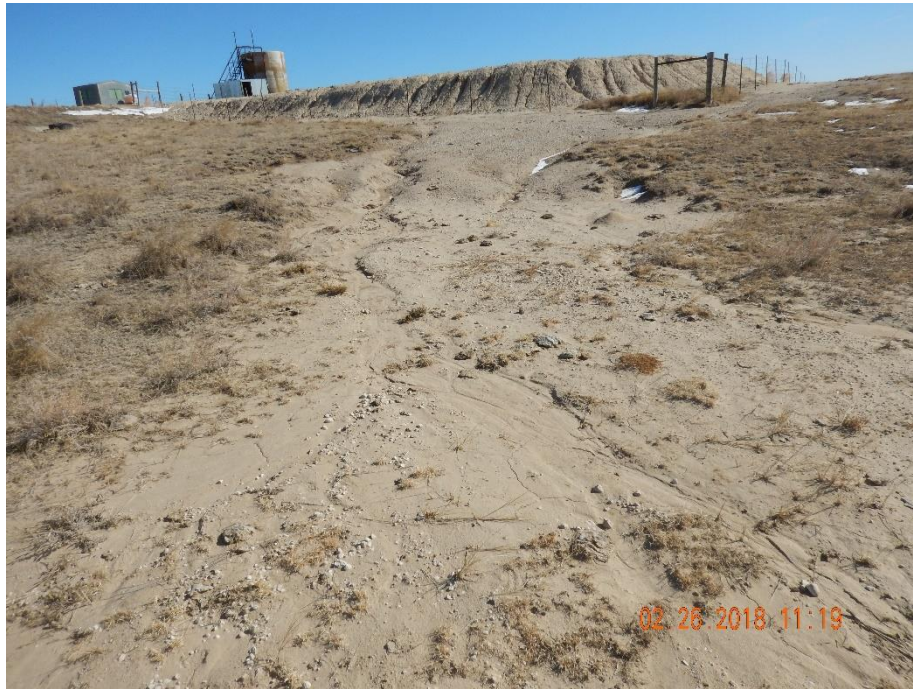
Photo 15: Photo taken from the southwest end of the location, facing northeast. See comments under photo 1.

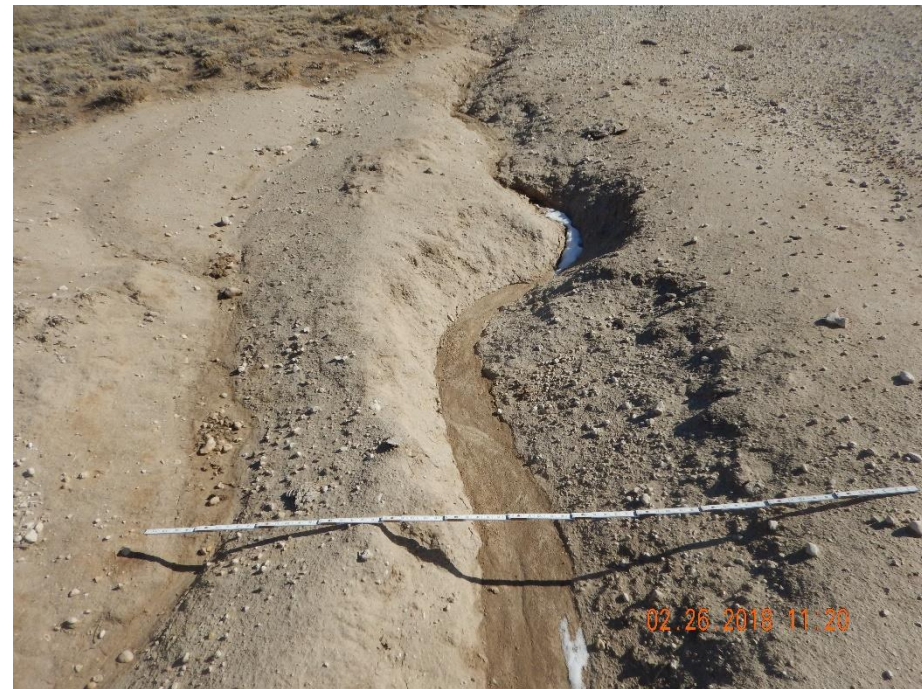
Photo 16: Photo taken from the southwest end of the location. Photo shows stormwater erosion degradation on the adjacent areas due to stormwater runoff from the location. See comments under photo 1.

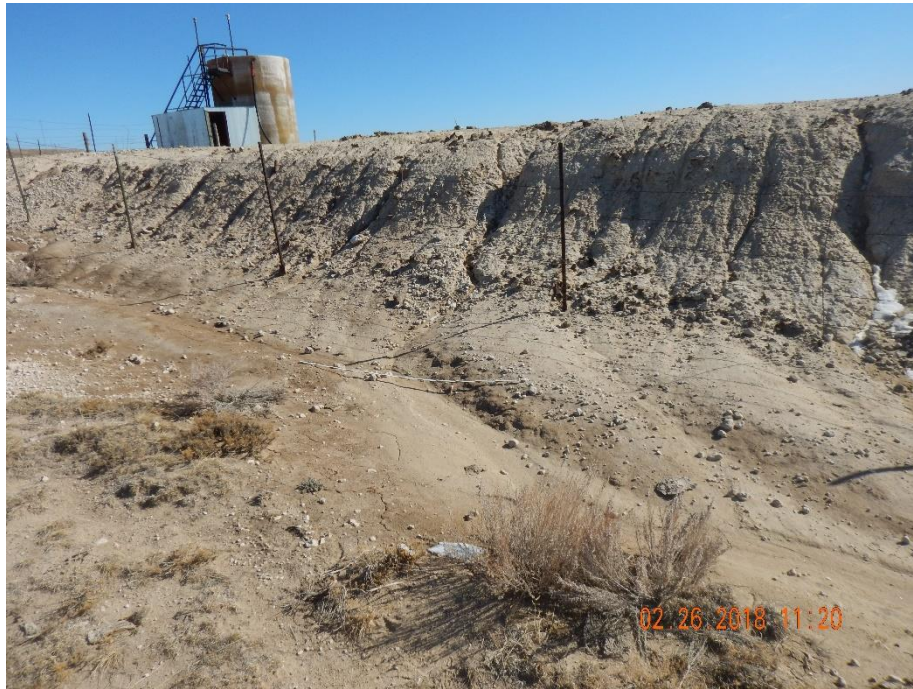
Photo 17: Photo taken from the west end of the pit, facing east. Photo shows stormwater runoff has caused erosion degradation at the pit walls, which has then contributed to degraded to the adjacent areas.

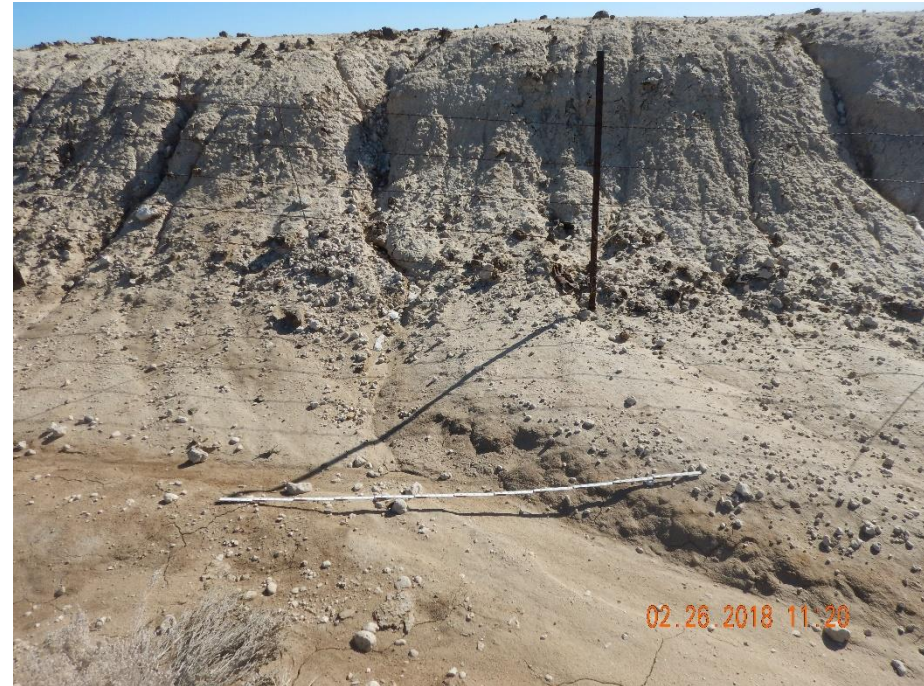
Photo 18: See comments under photo 17. 6 foot measuring stick for reference

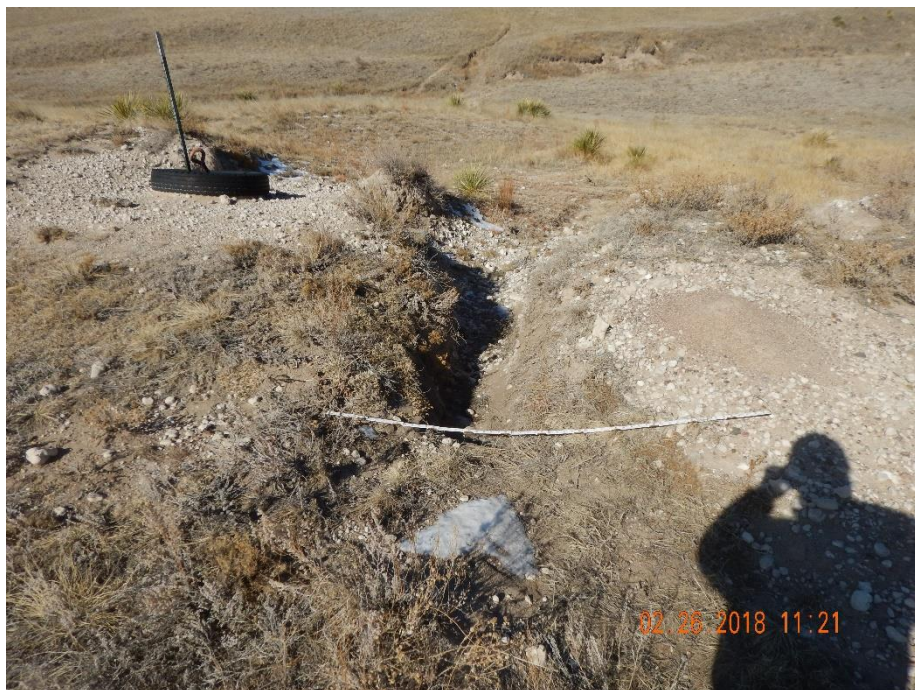
Photo 19: Photo taken from the west end of the location, facing west. Photo shows gully erosion due to stormwater erosion from the location has not been repaired, stabilized or reclaimed. No stabilization and stormwater BMPs have been installed or maintained. 6 foot measuring stick for reference.

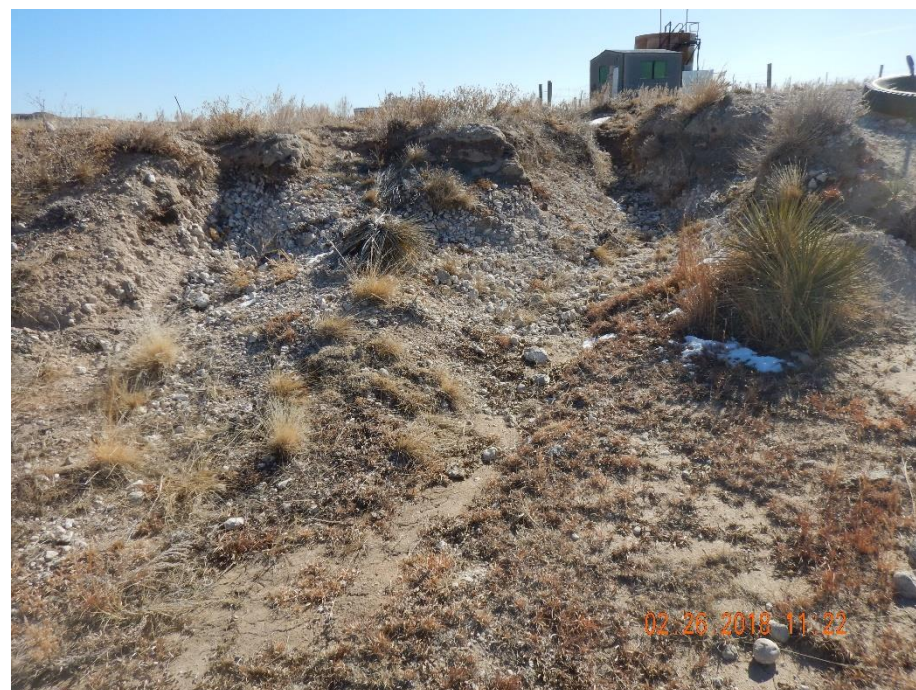
Photo 20: Photo taken from the west end of the location, facing east. See comment under photo 19.
