Inspection Photos
Location Name: WGR Hallmark #1-32
API: 05-067-08004

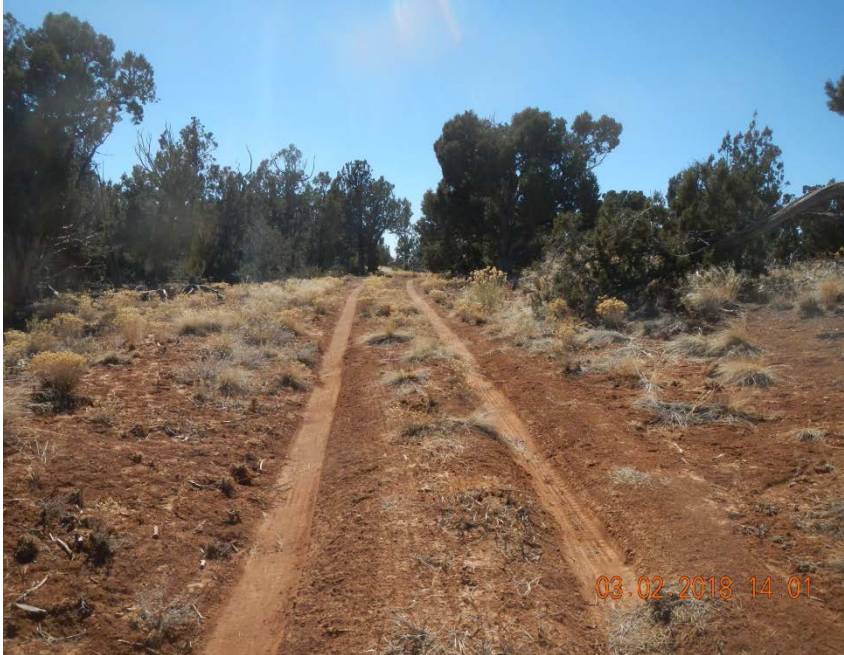
Access road photo from location looking south.

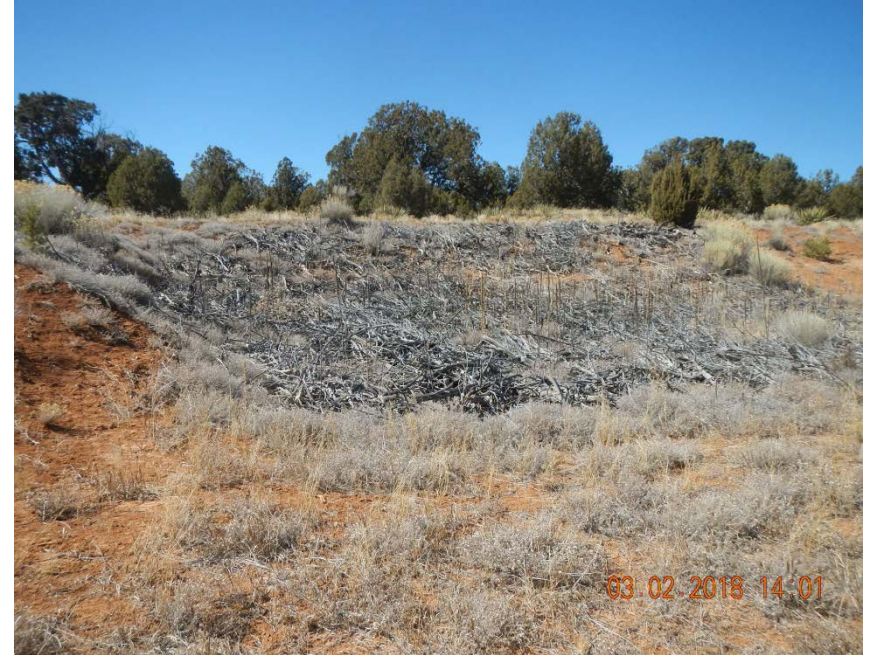
Woody debris in SW corner of location.

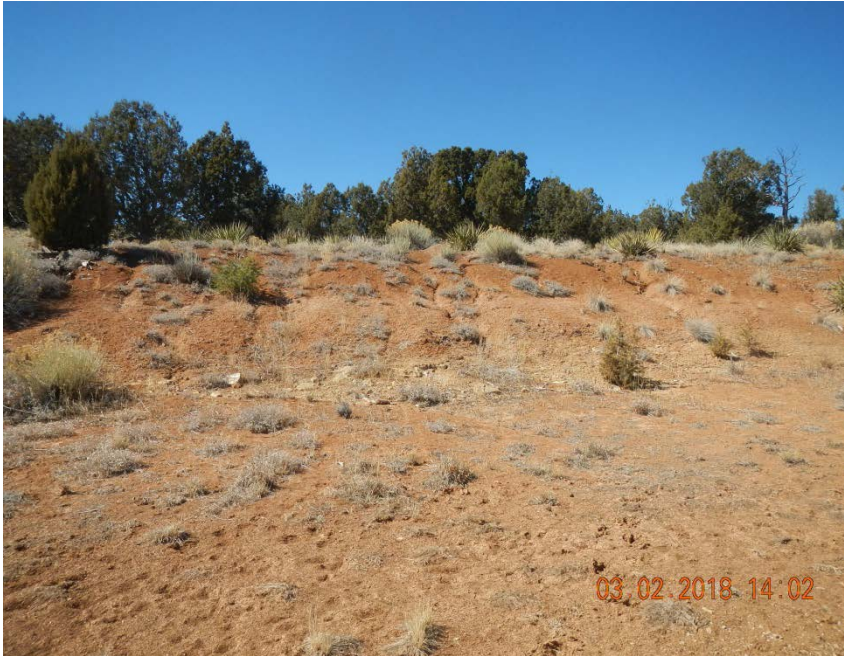
Rilling on cut slope along western edge of location.

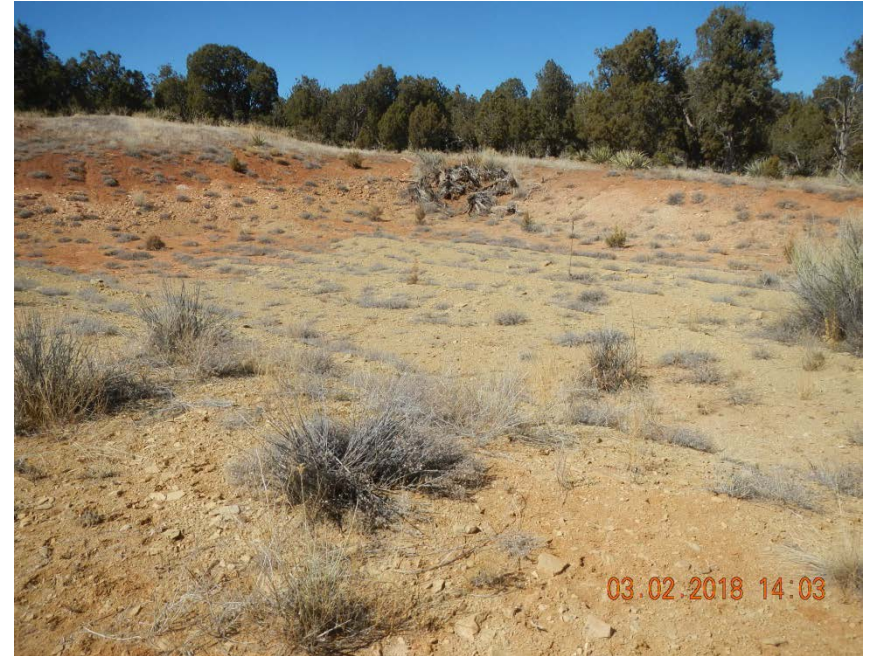
Wind-rowed soil in NW corner of location.

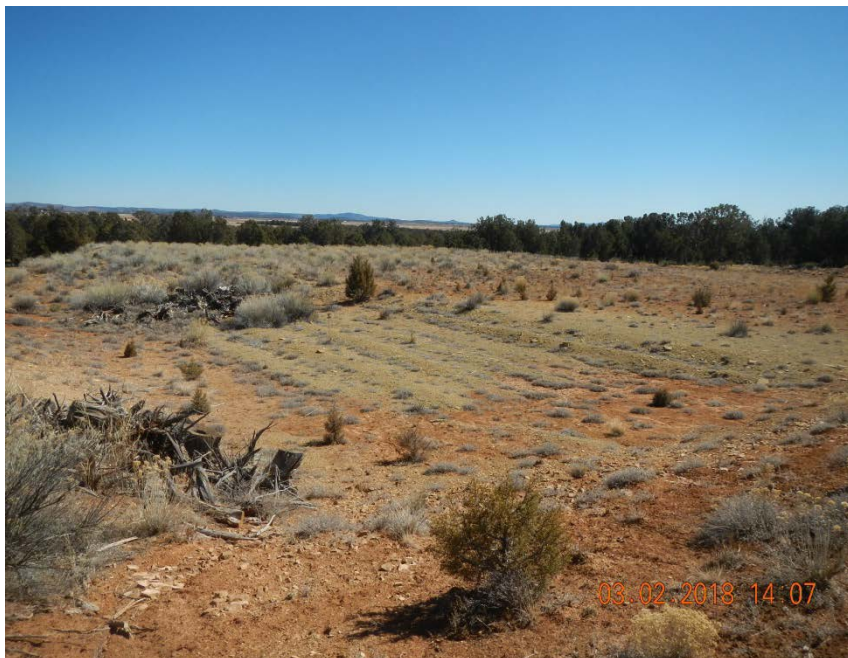
Alternate view of soil in NW corner.

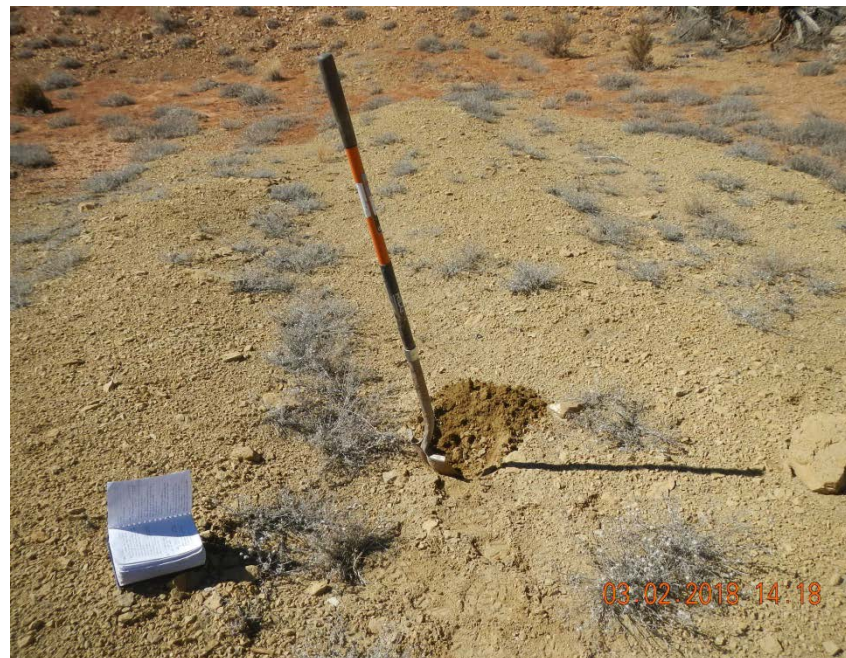
Soil in wind rows does not appear to be impacted material.

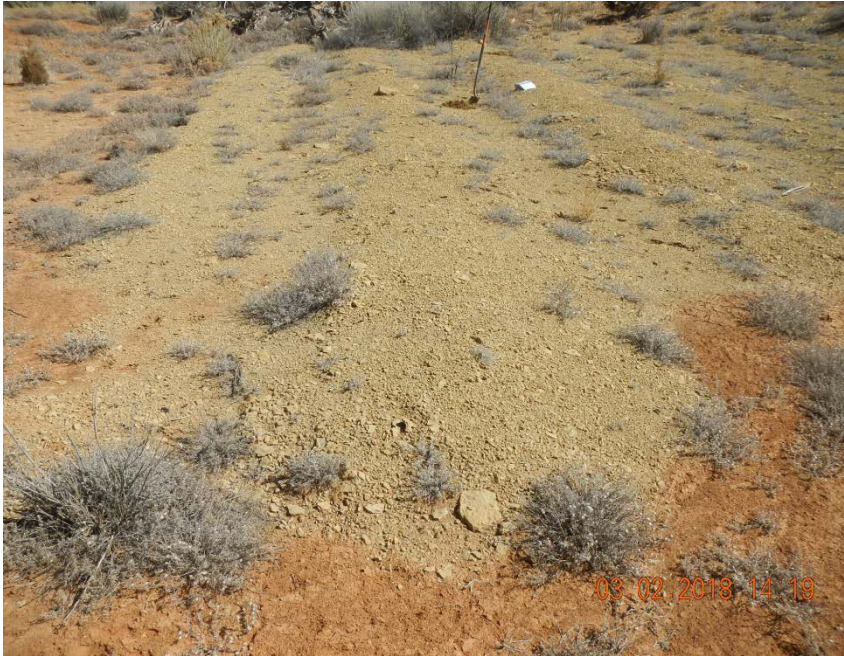
Light tan soil in wind rows.

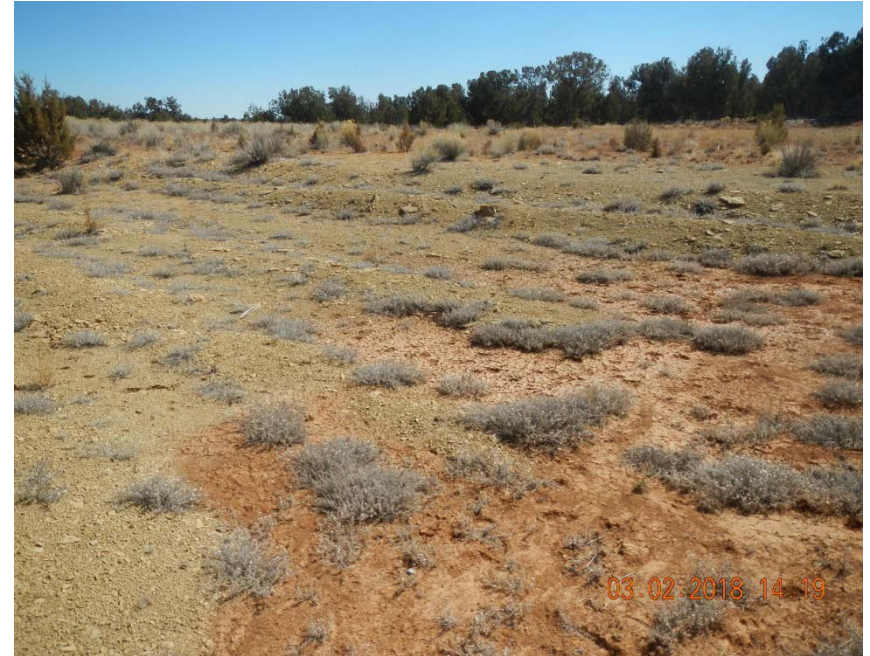
Ground level in northwest corner of location is lower than the rest of the pad.

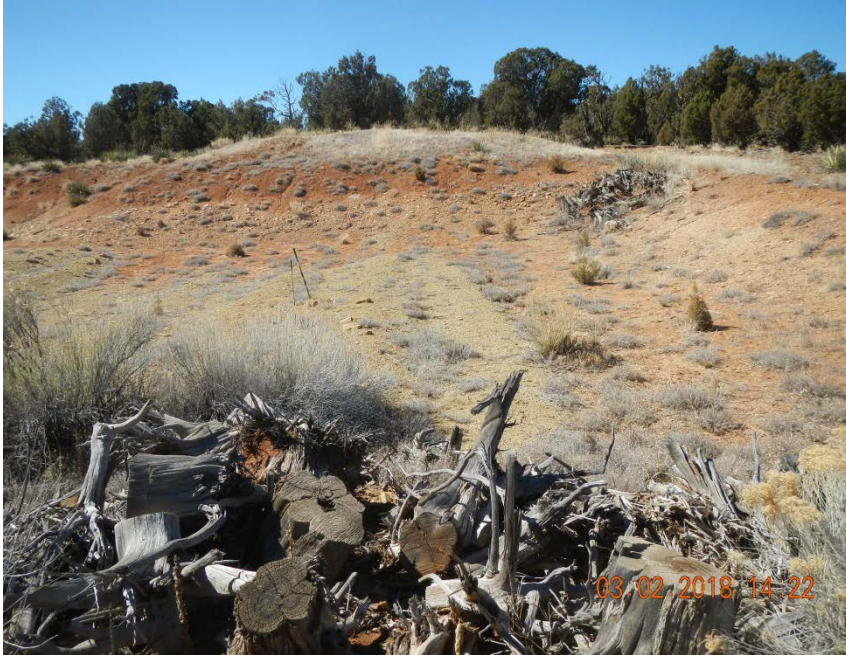
Woody debris on east side of "pit area".

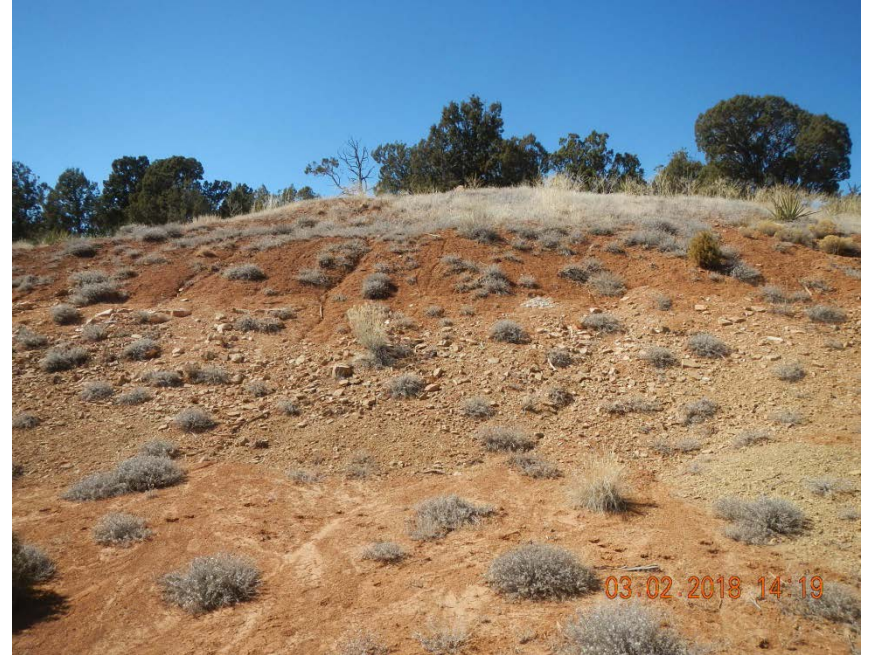
Cut slope on west side of "pit area".
