# Construction and Stormwater Inspection

February 14, 2018

Operator: EXTRACTION OIL & GAS INC - #10459

Inspection Photos  
Location Name: Trott /7-L  
Location ID: 452694

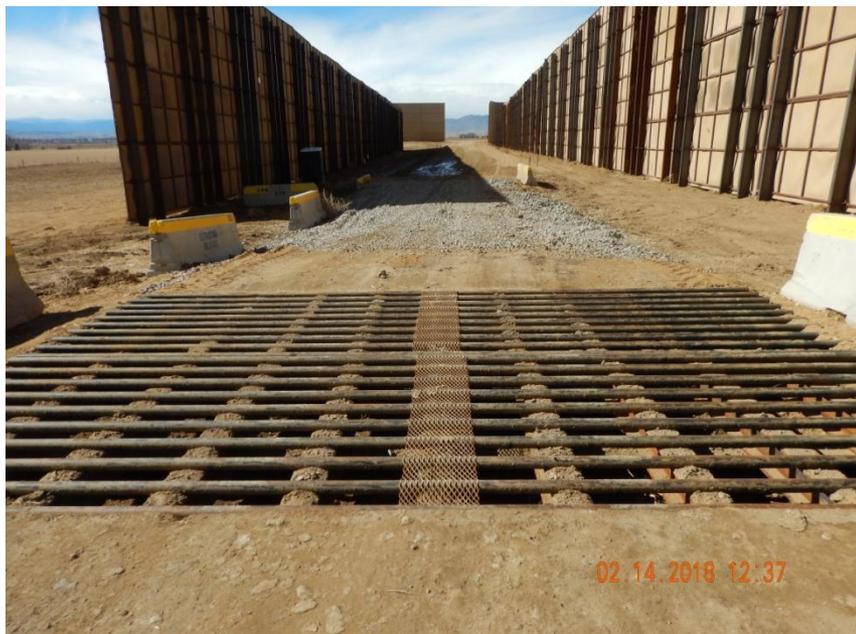
**Photo 1.** Photo taken from the entrance of location, facing West. Operator has installed tracking device BMPs.

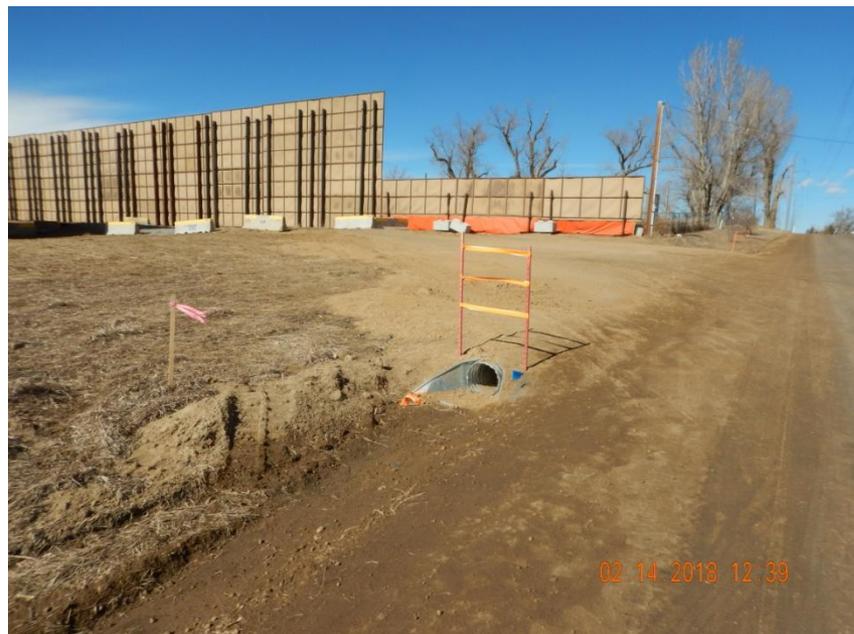
**Photo 2.** Photo taken from the entrance of location, facing North. Operator has installed a culvert along the roadside ditch.

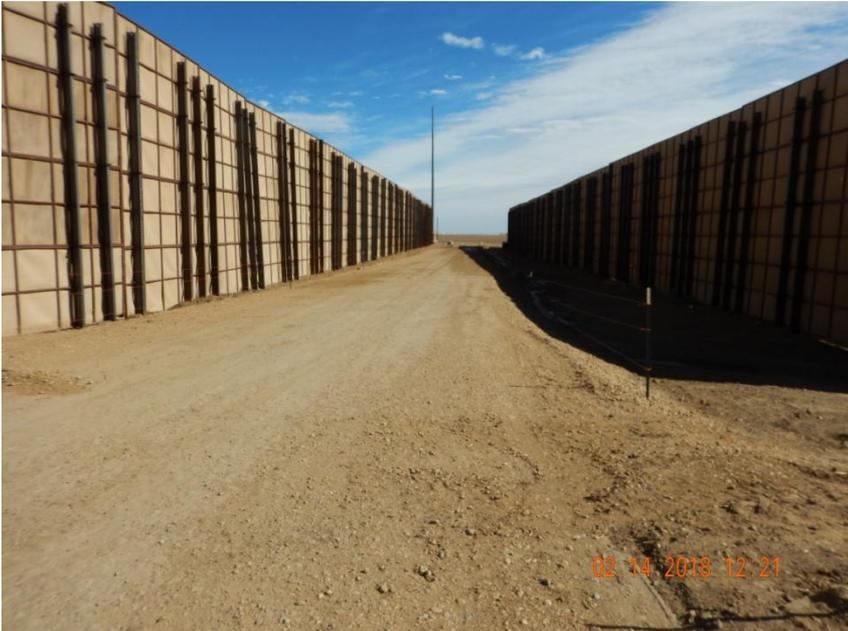
**Photo 3.** Photo taken from the entrance of the well location, facing East. Operator has installed sound walls along the access road, east and south well location perimeter, and a portion of the north and west well location perimeter.

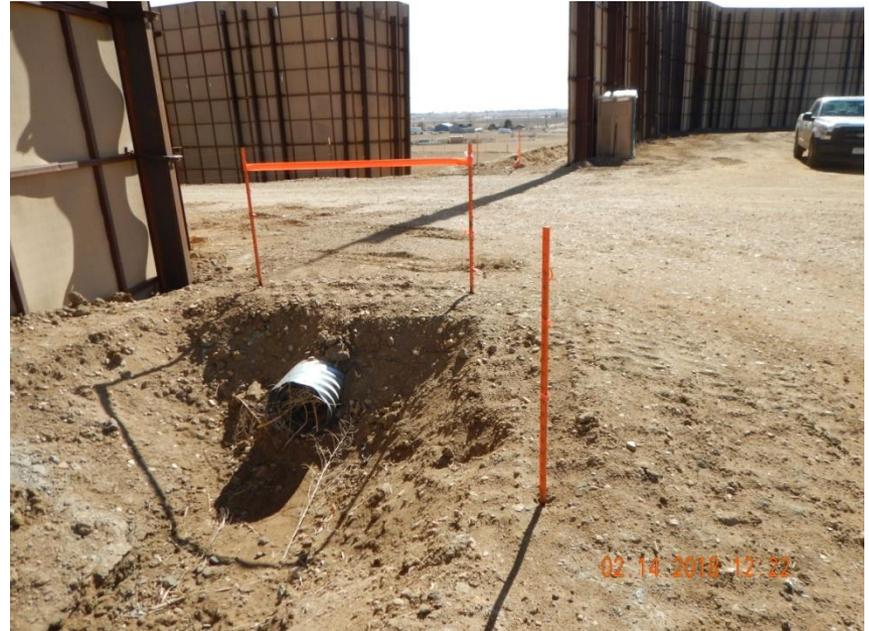
**Photo 4.** Photo taken from the entrance of the well location, facing South. Operator has installed a ditch BMP along the well location perimeter which is directed to retention areas.

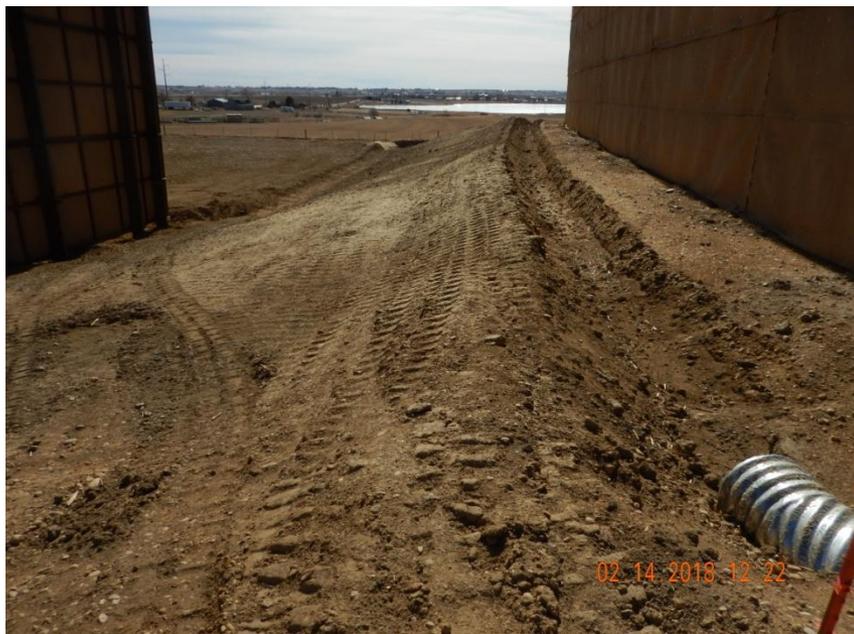
**Photo 5.** Photo taken from the southeastern well location, facing South. See comments under Photo 4.

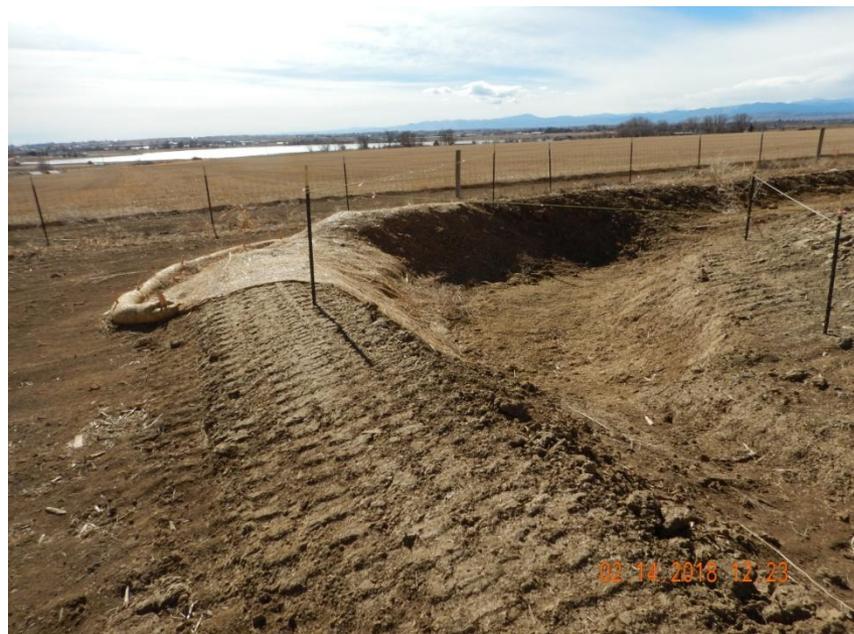
**Photo 6.** Photo taken from the southeast location perimeter, facing South. Operator has installed a stabilized outlet (spillway) along the outer perimeter ditch. It should be noted blankets used for a stabilized outlet would only be considered a temporary BMP. If the stabilized outlet is intended to be a permanent BMP, more appropriate material should be installed (i.e., riprap).

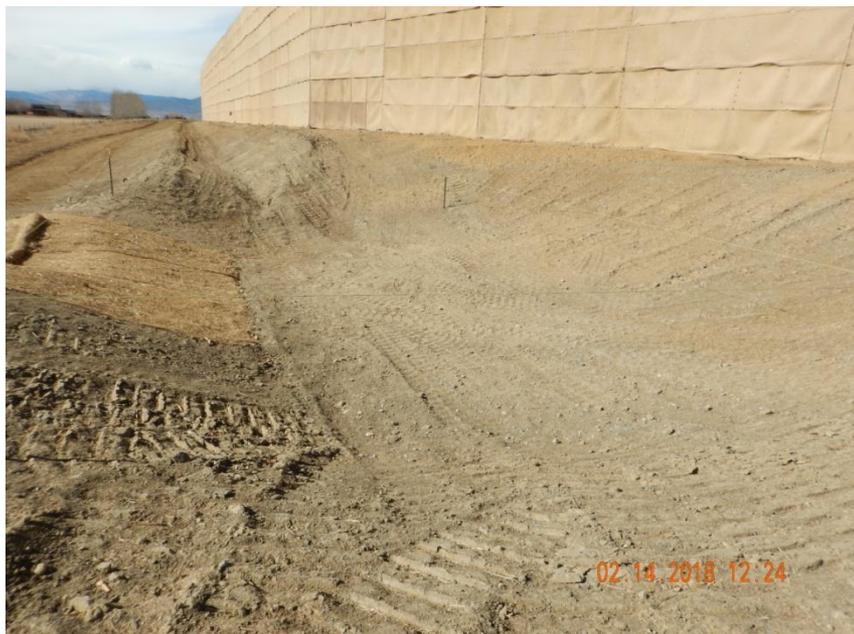
**Photo 7.** Photo taken from the southeast location, facing West. Operator has installed a retention area in conjunction to the well pad ditches.

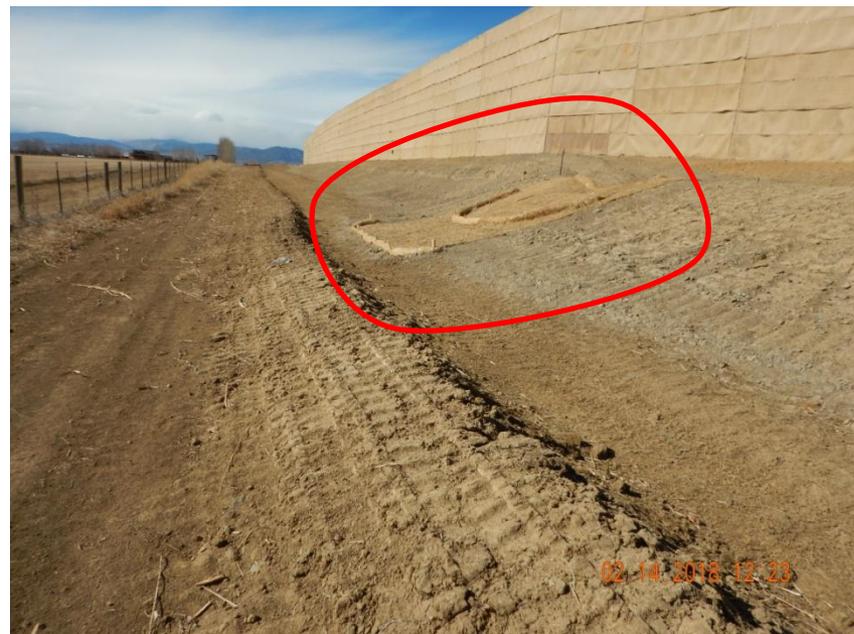
**Photo 8.** Photo taken from the southeast location, facing West. See comments under Photo 6 regarding the stabilized outlet (spillway).

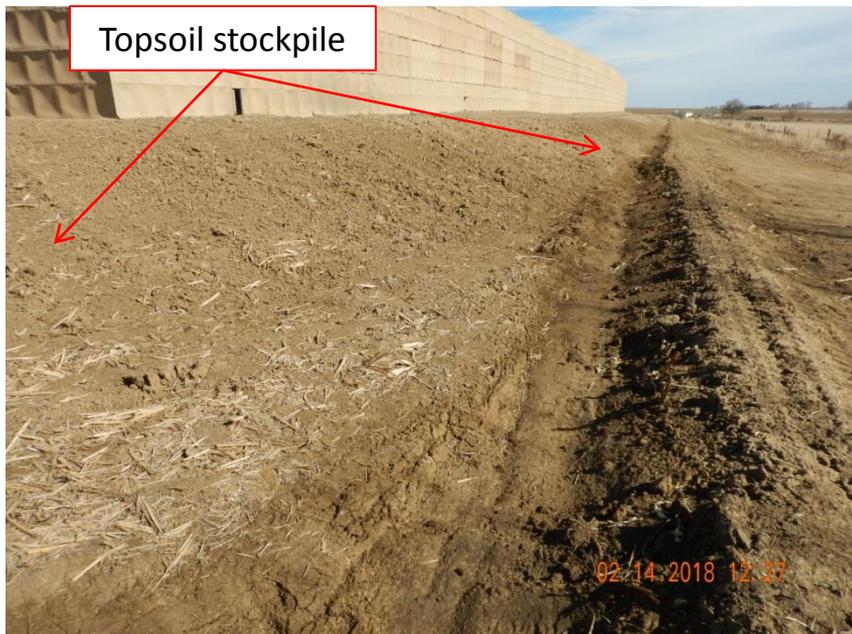
**Photo 9.** Photo taken from the southwest location, facing East. Appears topsoil has been salvaged and stored along the southern and western perimeter of the location.

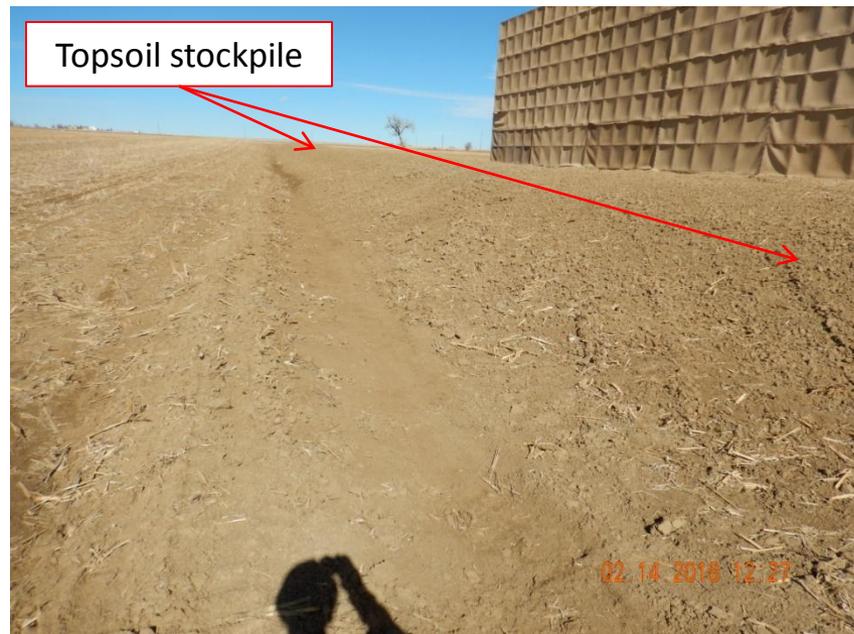
**Photo 10.** Photo taken from the southwest location, facing North. See comments under Photo 9.

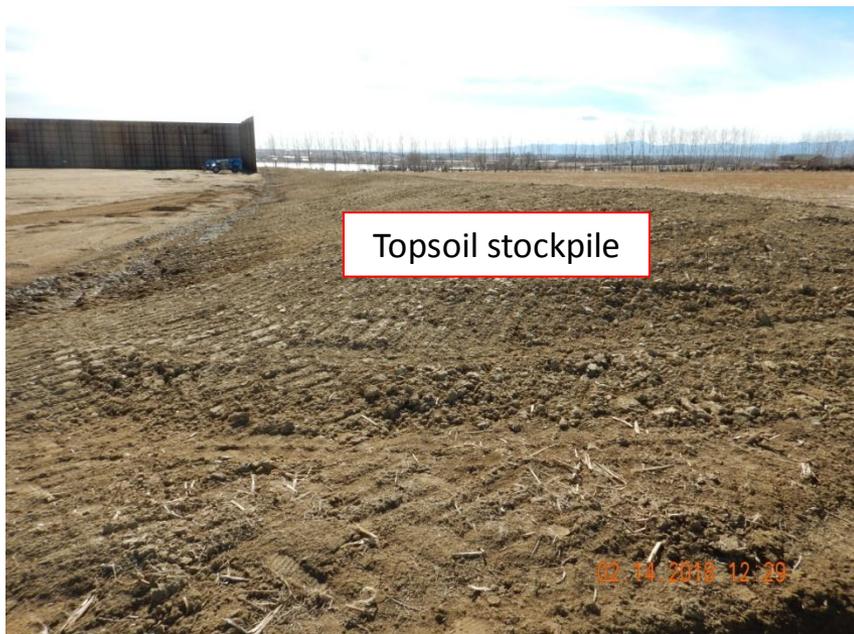
**Photo 11.** Photo taken from the northwest location, facing South. See comments under Photo 9.

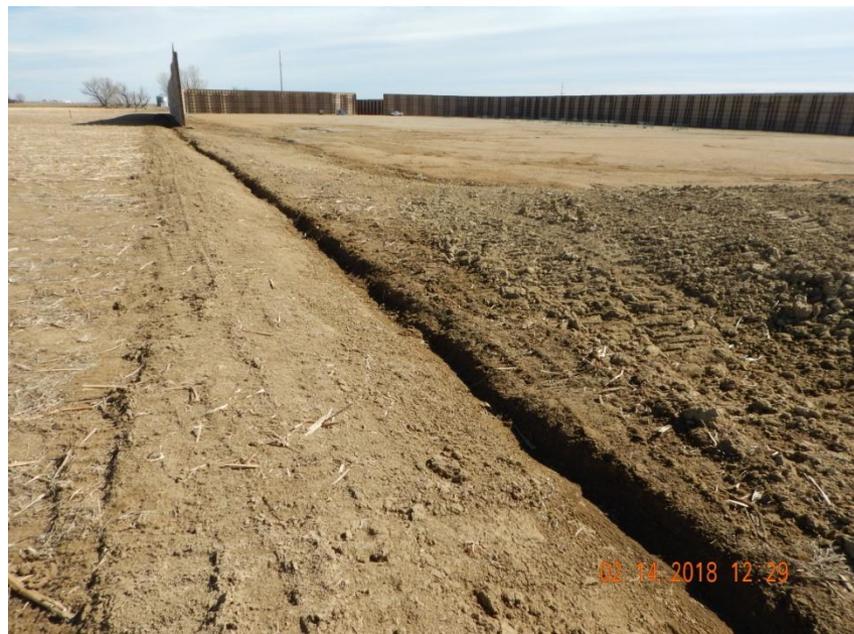
**Photo 12.** Photo taken from the northwest location, facing East. See comments under Photo 4.

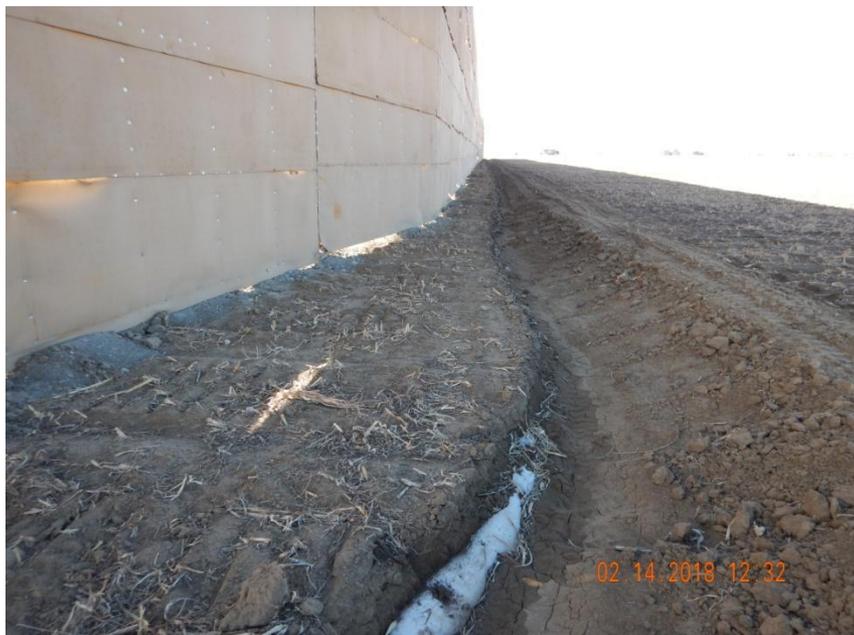
**Photo 13.** Photo taken from the northeast location, facing West. See comments under Photo 4.

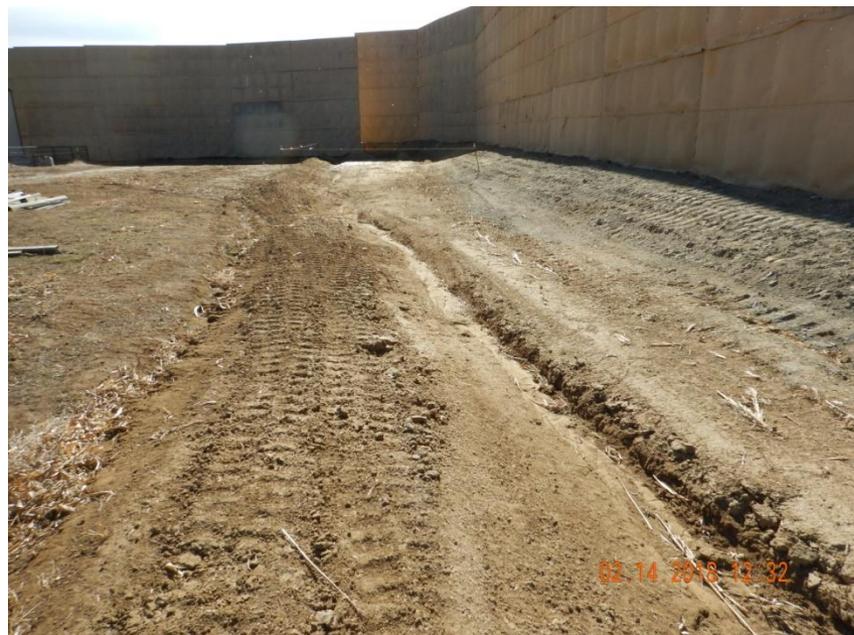
**Photo 14.** Photo taken from the northeast location, facing South. See comments under Photo 4.

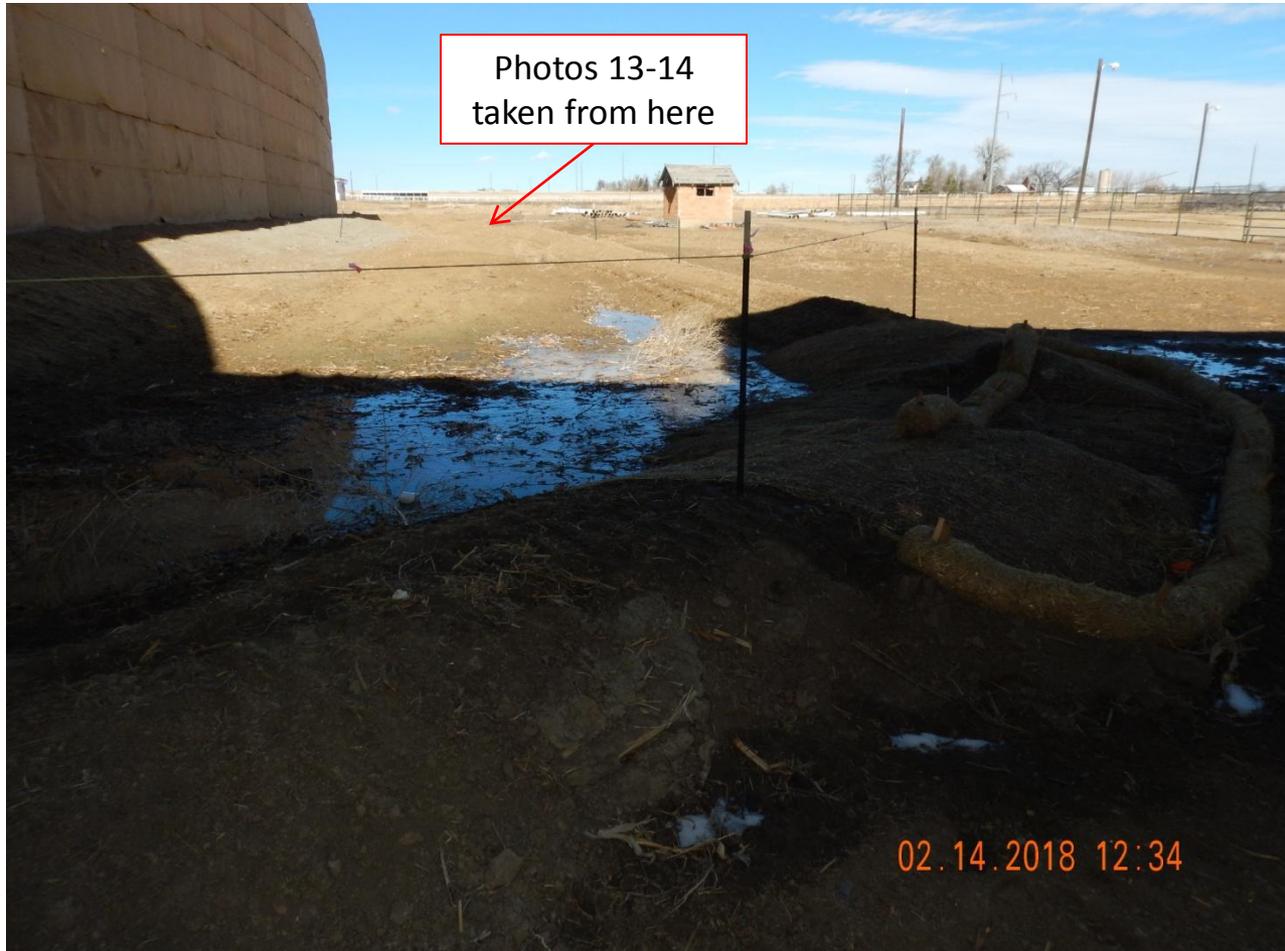
**Photo 15.** Photo taken from the eastern, facing North. See comments under Photo 6 regarding the stabilized outlet (spillway).
