FIELD INSPECTION SHEET

Operator Mexxon O&G Corp.
 Well Name & # 1 Hamm Canyon 14-26
 Lease # COC 20434
 OIL GAS CO₂ WC DEV
 Formation Hamm Canyon Field
 Pool _____
 Circulation Medium Mud Gas Air
 Road Length _____
 Width _____ Cut _____
 NEW _____ REHAB _____ W/W P/L _____
 New Road on Lease Length _____
 New Road off lease R/W Length _____
 Existing Road R/W Needed _____
 Length _____
 Inspected P/L on Lease: Yes No
 Length _____ Width _____
 Surface _____ Underground
 Inspected off Lease/Unit Pipeline:
 Yes _____ No _____
 Length _____ Width _____

Date 05/26/05
 Inspector LUCAS VARGO
 EA # COC 20434
 County, State San Miguel CO
 Location NWSW
 S. 26 T. 4S N., R. 18 W.
 Location Moved? Yes _____ No _____
 From: _____ To: _____
 Laydown _____ Pit _____
 Pad Size 1/3 of drilling
 Paint Color Tan Seed _____
 Start Date _____ Drill Time _____
 Cut _____ Direction _____
 Fill _____ Direction _____
 Water Source _____
 Dwelling _____
 Well _____
 Utility R/W _____
 Water _____
 Arch _____ Paleo _____
 RMP 1985 55 T & E _____
 SMA BLM
 Names of Individuals on Joint
 Inspection:

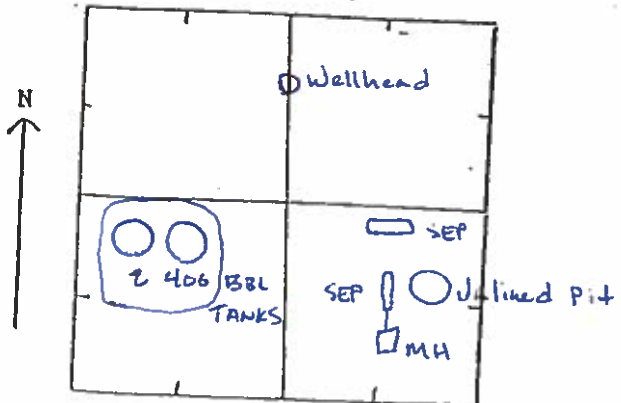
* Surface Ownership BLM
 Topography slope below mesas
 Arroyo/wash _____ Base of Cliff _____
 Bench _____ Canyon rim _____ Mesa _____
 Cliff/scarp _____ Valley bottom _____
 Hill top slope low rise
 Plain/flat _____ Ridge _____ Saddle _____
 Terrace _____
 Existing Vegetation sage, native
grasses, rabbit brush
 Soil Rocky _____ Gravelly _____
 Sandy _____ Clayey _____
 Other _____
 Slope _____
 Drainage generally to the west
 Land Use _____
 Special Stipulations
Excess equipment and trash
around wellhead needs to
be removed
55 gal drums - unlabeled
Access road was very recently bladed
old style meter chart
Treat weeds around facilities
Next to house - oil in unlined pit
Fencing ok. Berms ok.
Health/Safety ok.
Erosion control ok.

Paint facilities

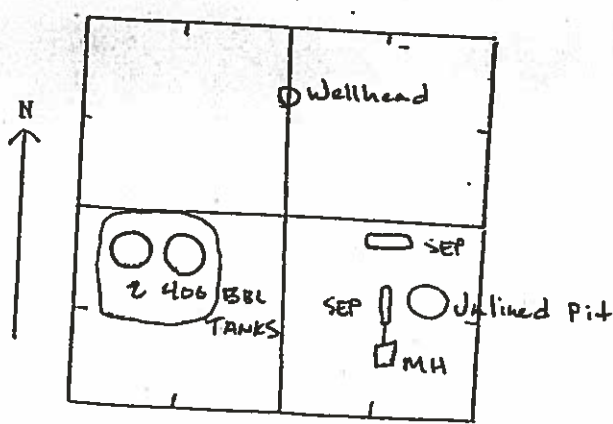
* Surface Ownership BLM
 Topography Slope below mesas
 Arroyo/wash Base of cliff
 Bench Canyon rim Mesa _____
 Cliff/scarp Valley bottom
 Hill top slope low rise _____
 Plain/flat _____ Ridge _____ Saddle _____
 Terrace _____
 Existing Vegetation Sage, native
grasses, rabbit brush
 Soil Rocky _____ Gravelly _____
 Sandy Clayey _____
 Other _____
 Slope _____
 Drainage Generally to the west
 Land Use _____
 Special Stipulations
Excess equipment and trash
around wellhead needs to
be removed.
55 gals drums - unlabeled.
Access road was very recently bladed.
old style meter chart
Treat weeds around facilities
Next to none - oil in unlined pit.
Fencing ok. Barms ok.
Health/Safety ok.
Erosion control ok.
Paint facilities
