Inspection Photos

API: 05-007-06185

Operator: SOUTHLAND ROYALTY COMPANY

Inspection Date: 2/28/2018

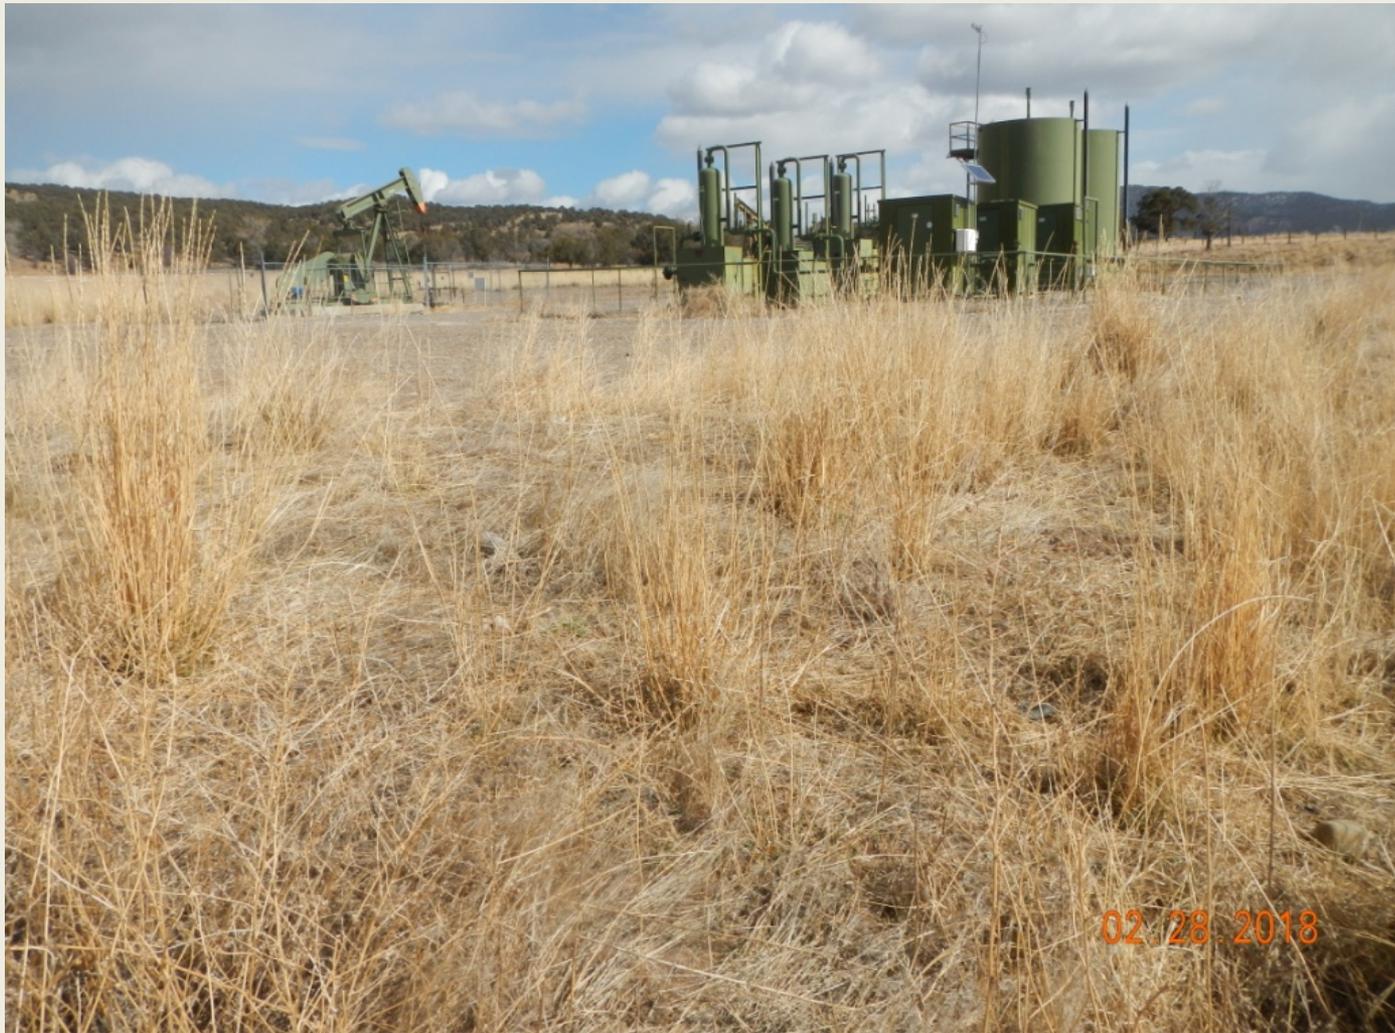
Photo 1. View of the project area from the southwestern corner facing center.

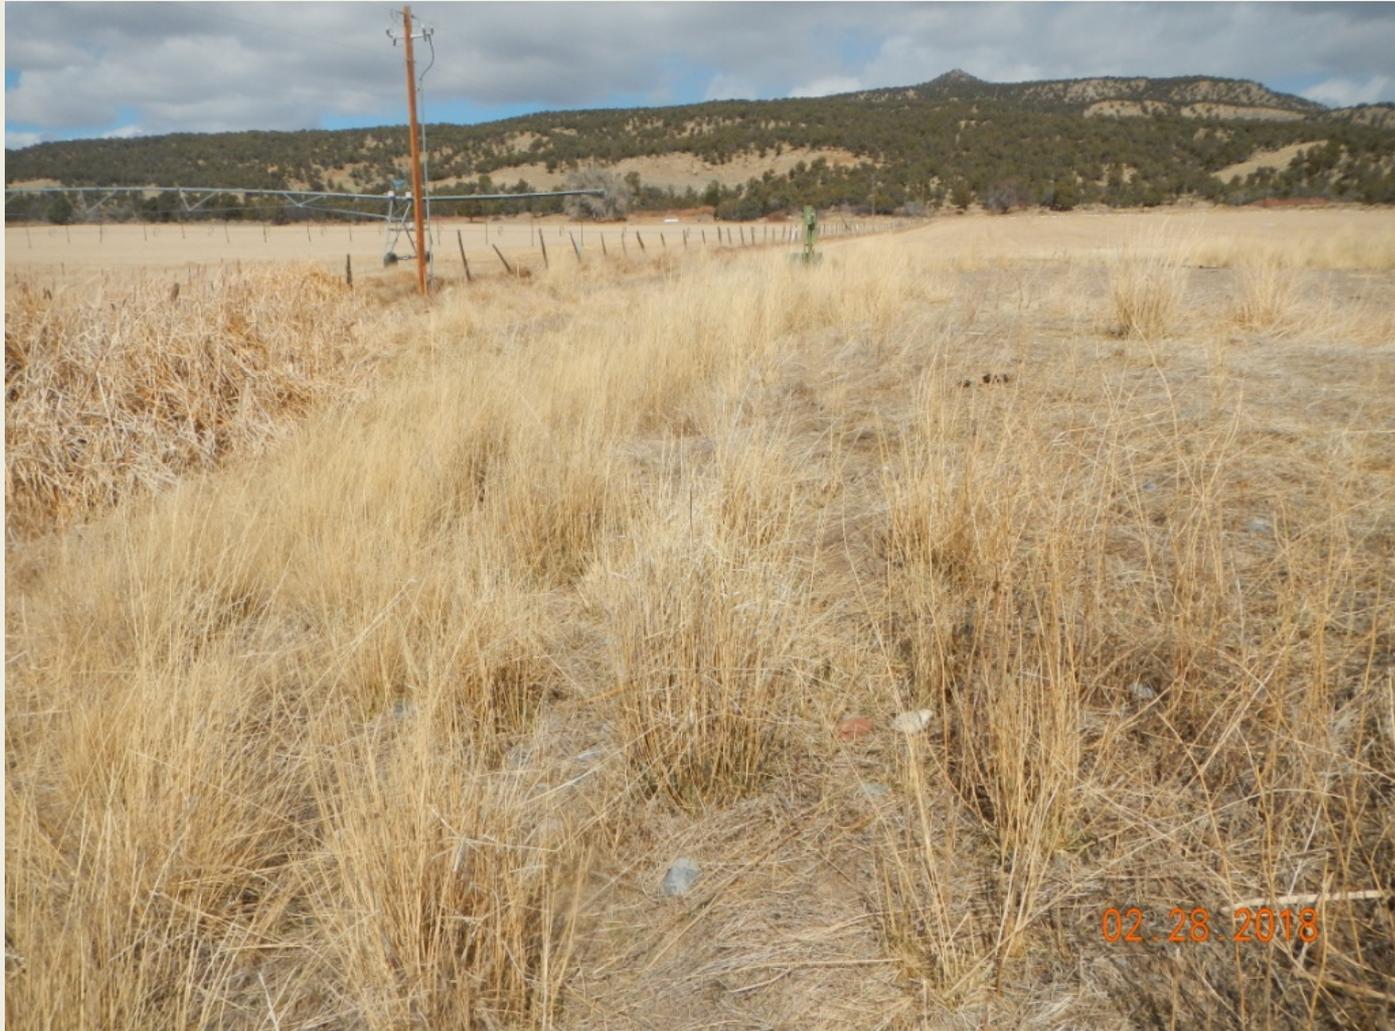
Photo 2. View of the western portion of the project area from the southwestern corner facing northward. Revegetation is progressing with grasses such as intermediate wheatgrass (*Thinopyron intermedium*).

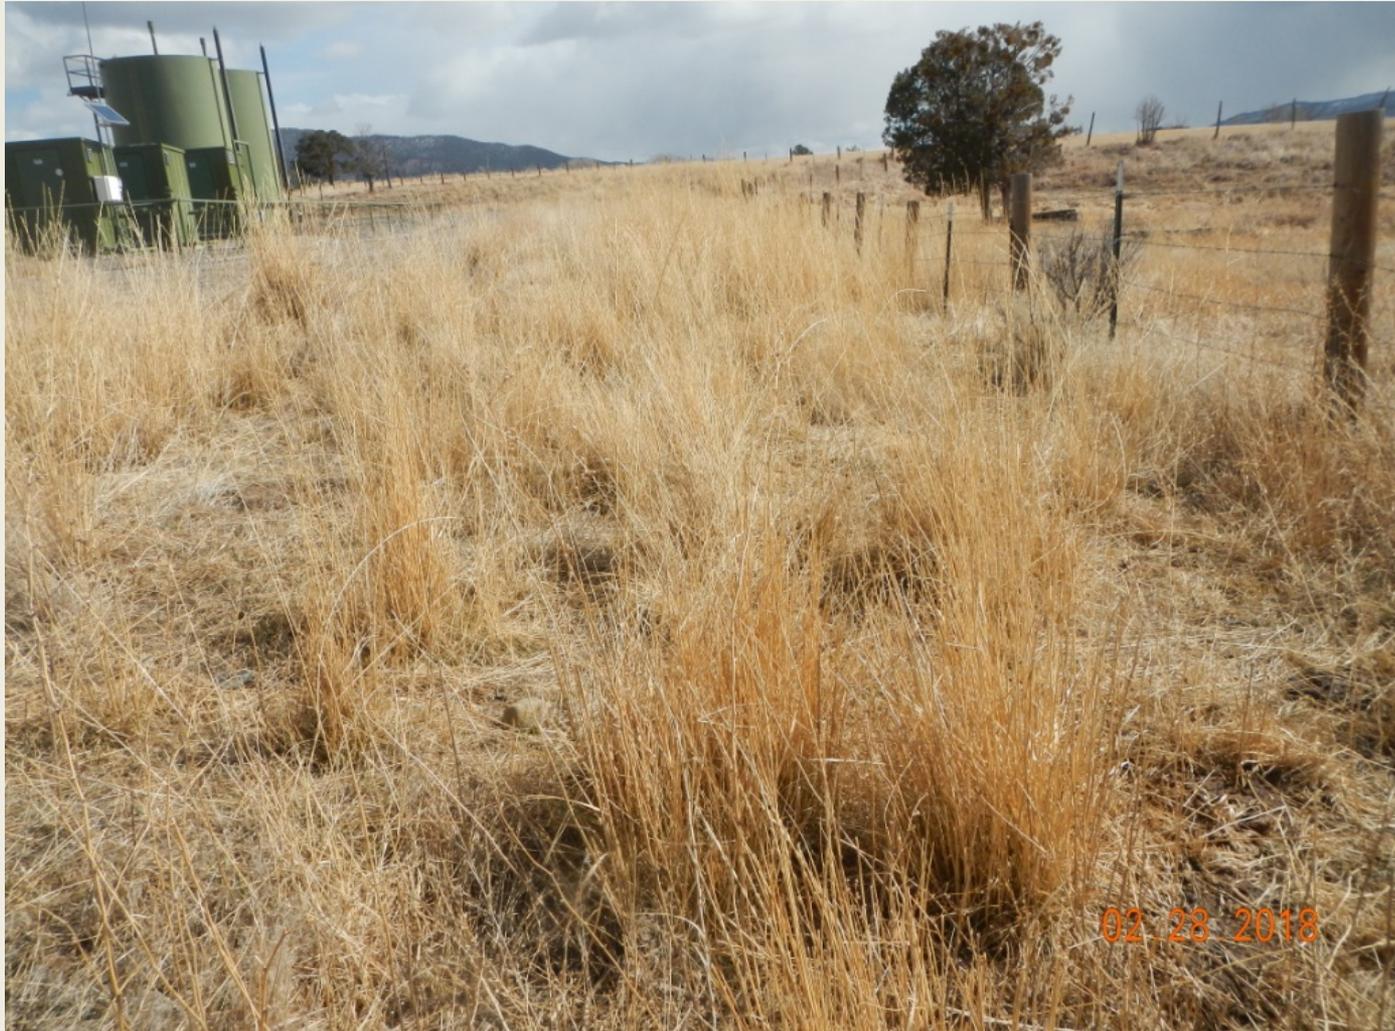
Photo 3. View of the southern portion of the project area from the southeastern corner facing westward. Kochia debris needs to be removed and properly disposed of.
