Inspection Photos
Location Name: Dwinell 4
API: 05-057-05134

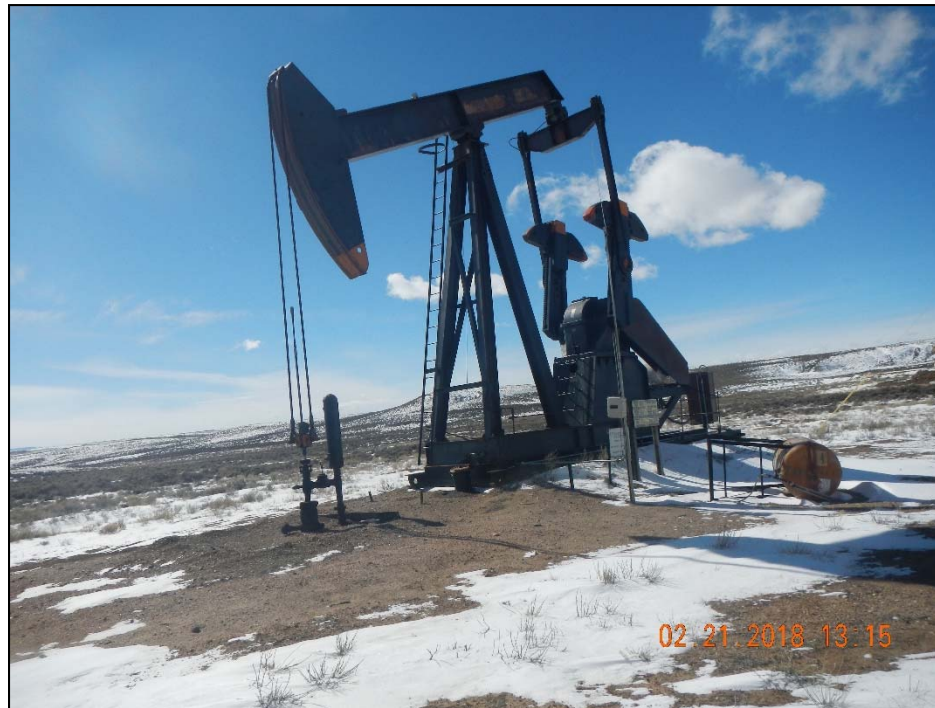
Photo 1. Overview of location taken at entrance facing southwest.

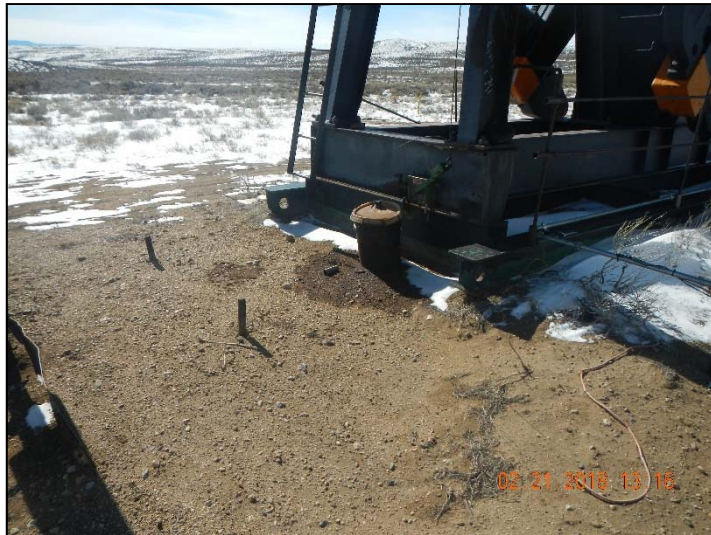
Photo 2. Lube oil without containment and leaking at wellhead.

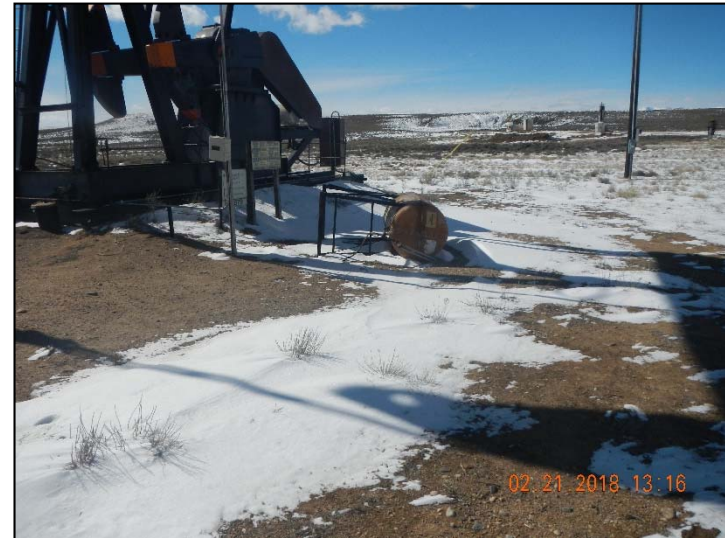
Photo 3. Knocked over container with no secondary containment.
