Inspection Photos
Location Name: Cody 1
API: 05-057-05135

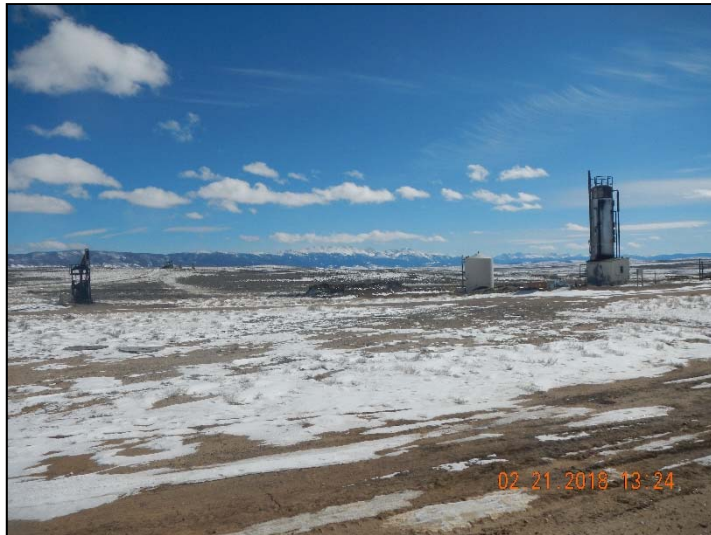
Photo 1. Overview of location taken at entrance facing southeast.

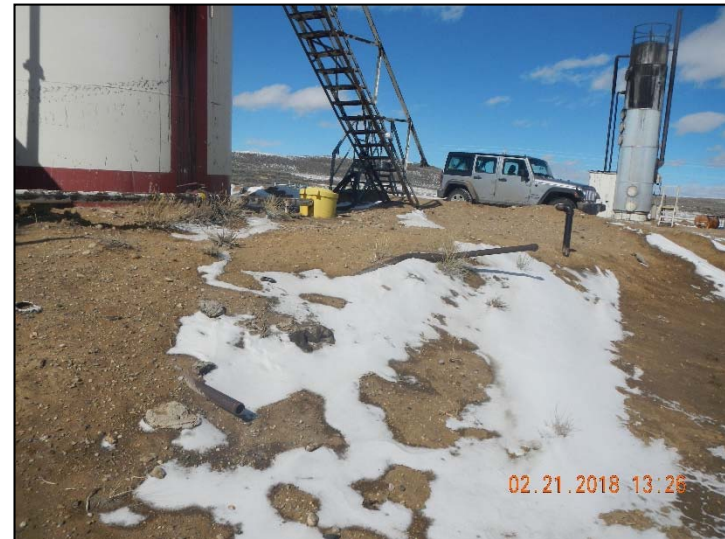
Photo 2. 1 – 3" and 2 – 2" steel risers not marked or LO/TO.

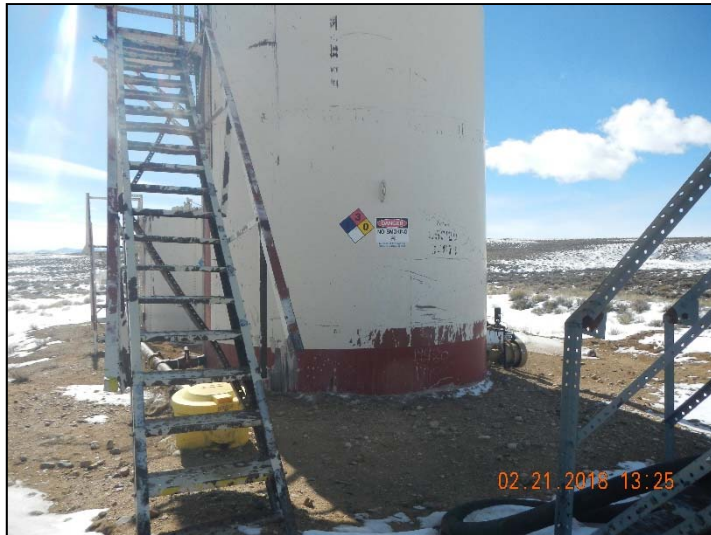
Photo 3. Incomplete tank label.

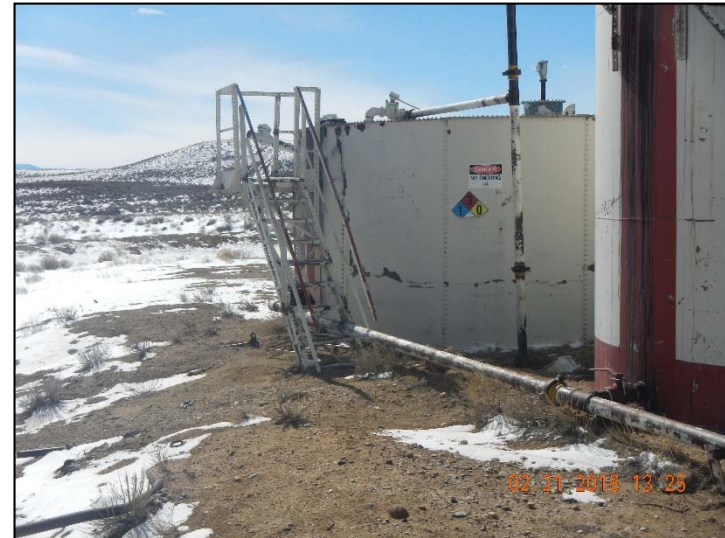
Photo 4. Incomplete tank label.

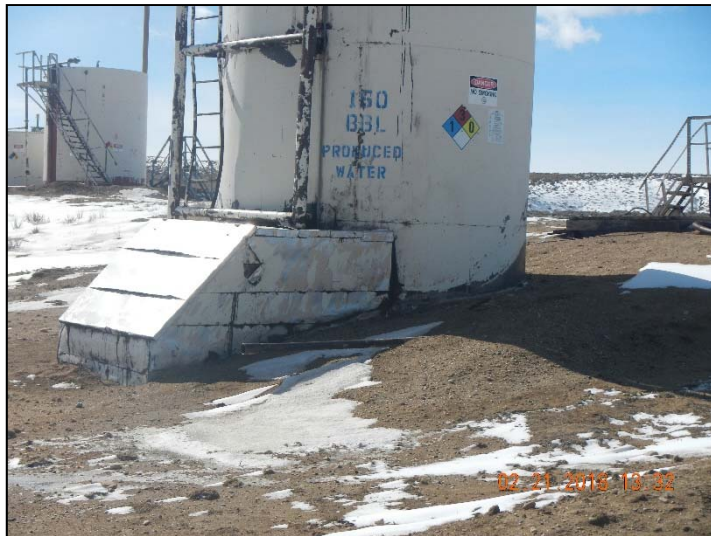
Photo 5. 1 – 2" steel risers not marked or LO/TO.

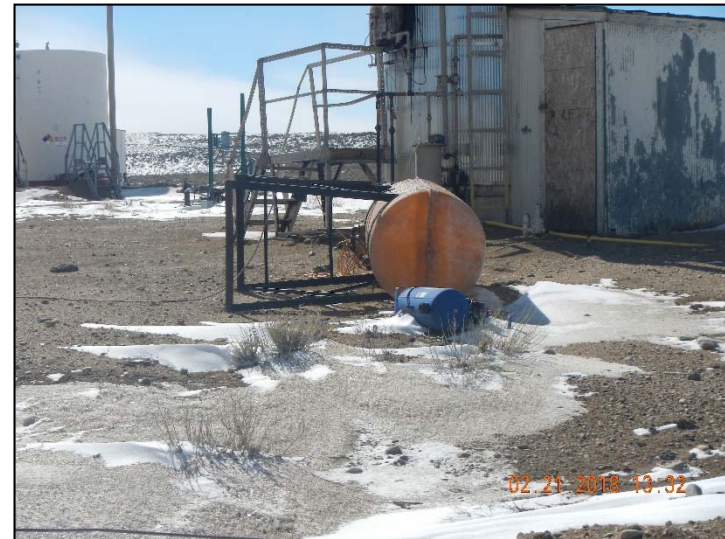
Photo 6. Knocked over container with no secondary containment.

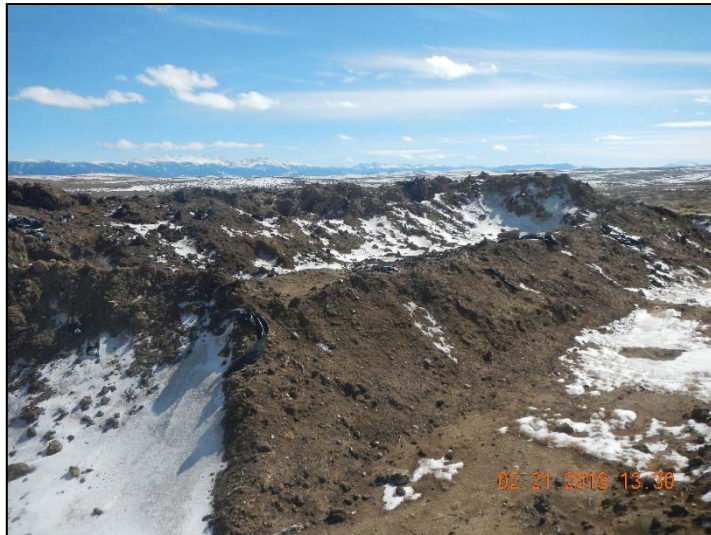
Photo 7. Landfarm.

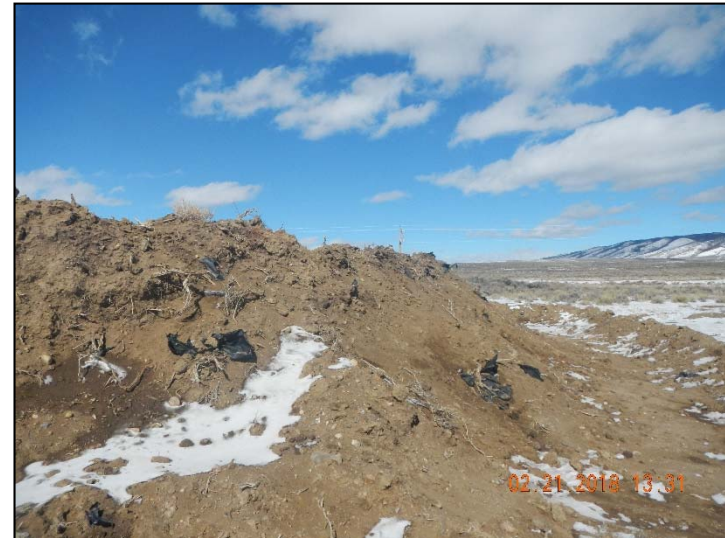
Photo 8. Landfarm.
