# Final Reclamation Inspection

Operator: EXTRACTION OIL & GAS INC - #10459

API: 05-123-11395

Inspection Photos  
Location Name: HIPPEN #1-32  
API: 05-123-11395

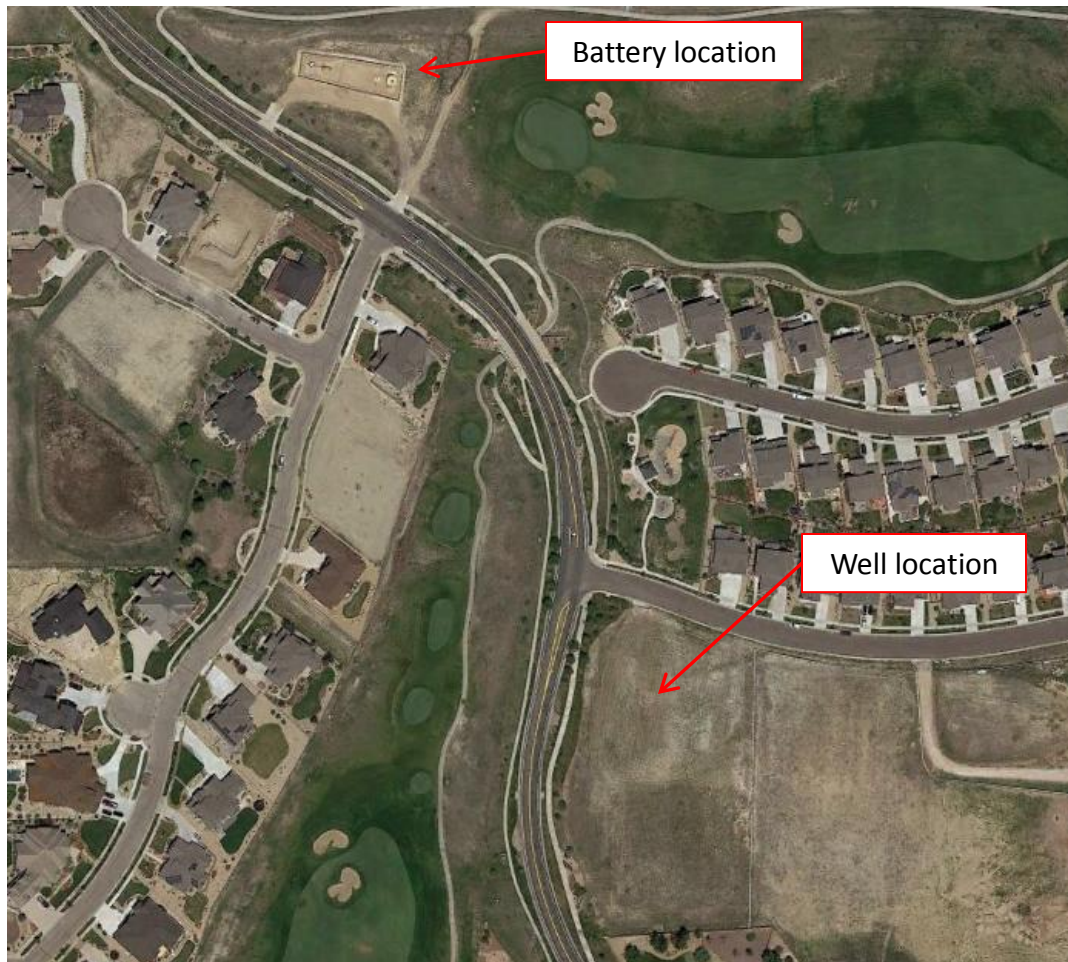
Google Earth aerial imagery taken June 9, 2017, post plugging, illustrates equipment was left at the battery location at least eighteen months post plugging operations. Well was plugged 12/5/2015. See the following image for a close-up of the battery location.

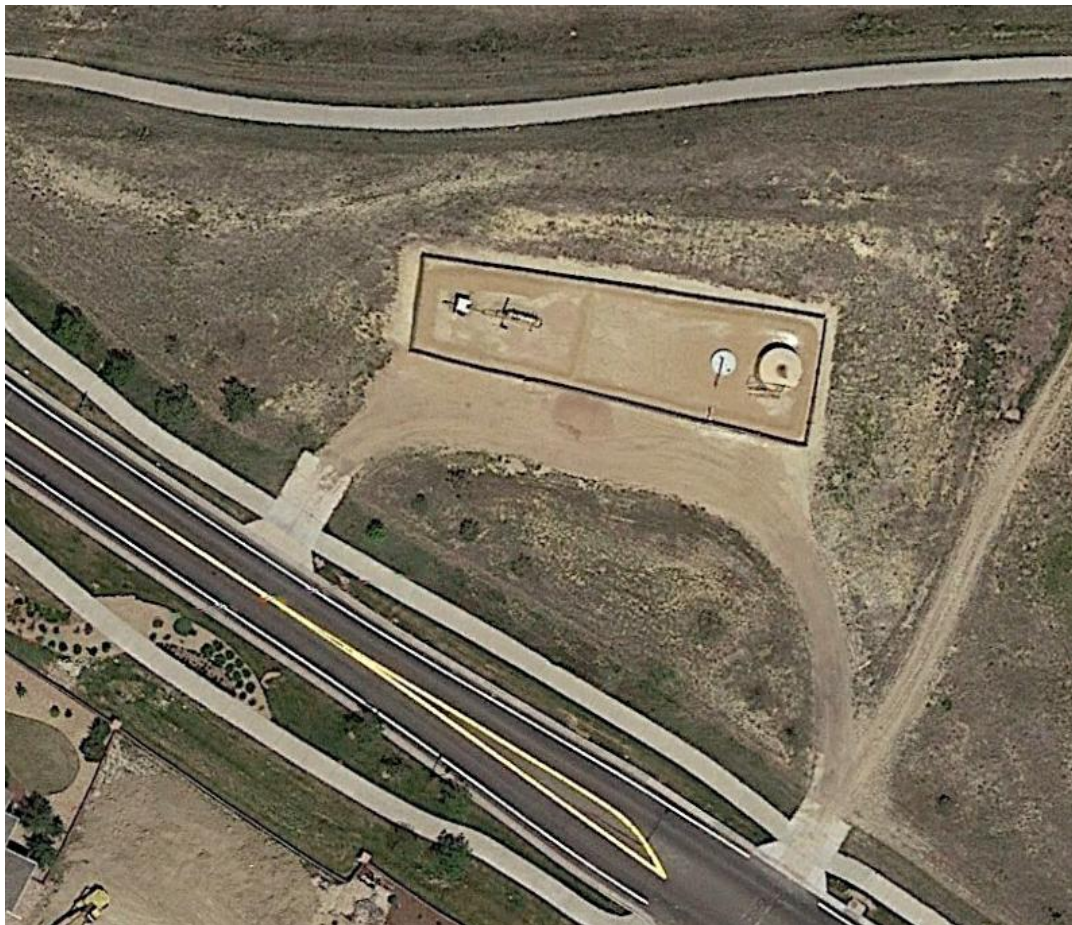
Close-up Google Earth aerial imagery from the battery location taken June 9, 2017, post plugging, illustrates equipment was left at the battery location at least eighteen months post plugging operations. At the time of this inspection, an abandoned riser remains at the battery location- see Photos 7&8.

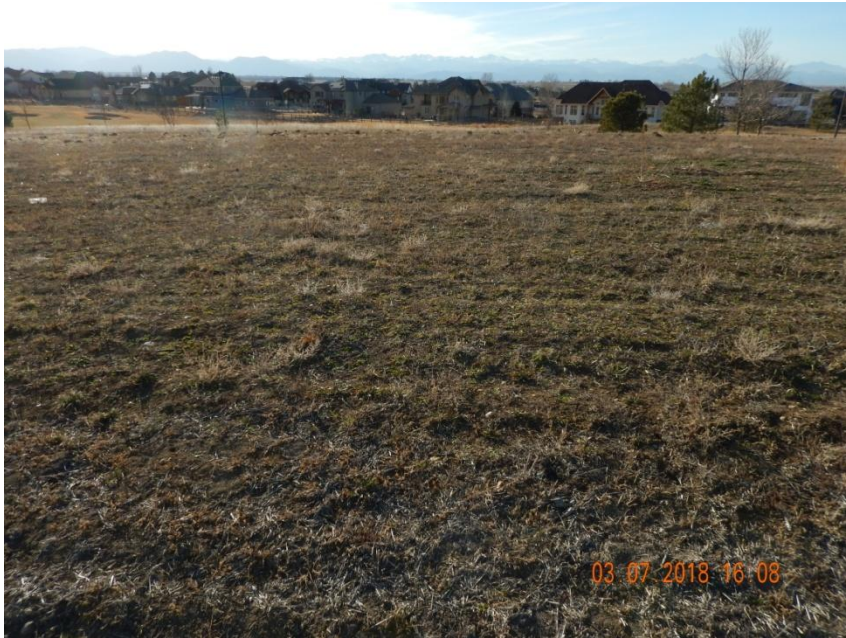
**Photo 1.** Photo taken from the approximate well location, facing West. No visual evidence of equipment on the well location. Appears the Operator has performed final reclamation activities. Undesirable weedy annual vegetation (Kochia) appears to be establishing throughout portions of the disturbance area. Germination of desirable vegetation did not appear uniform throughout the disturbance area. Operator may need to conduct additional reclamation activities.

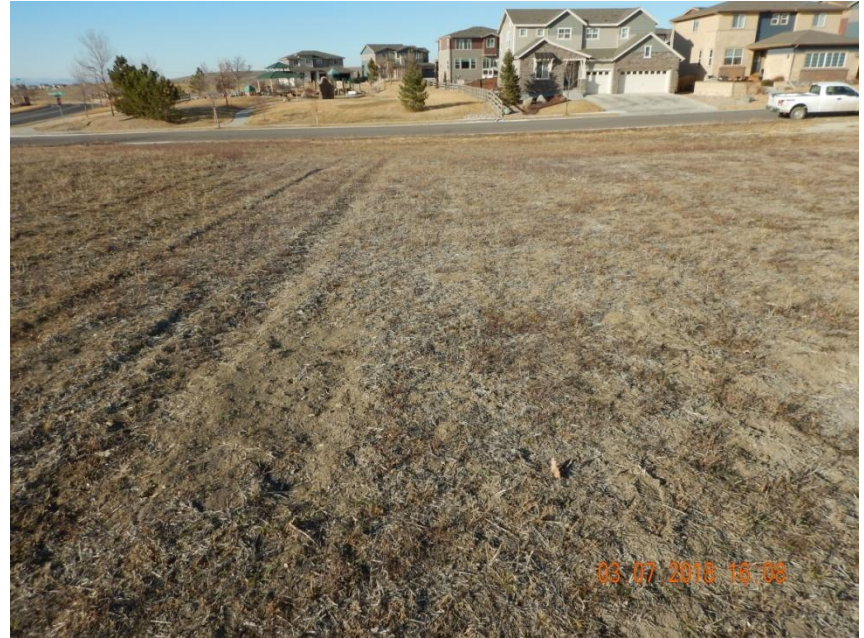
**Photo 2.** Photo taken from the approximate well location, facing North. See comments under Photo 1.

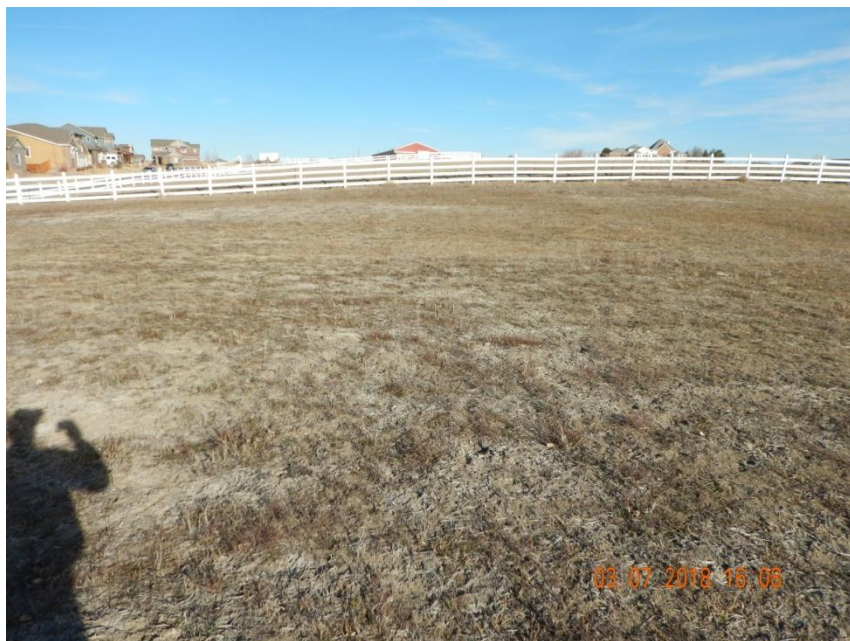
**Photo 3.** Photo taken from the approximate well location, facing East. See comments under Photo 1.

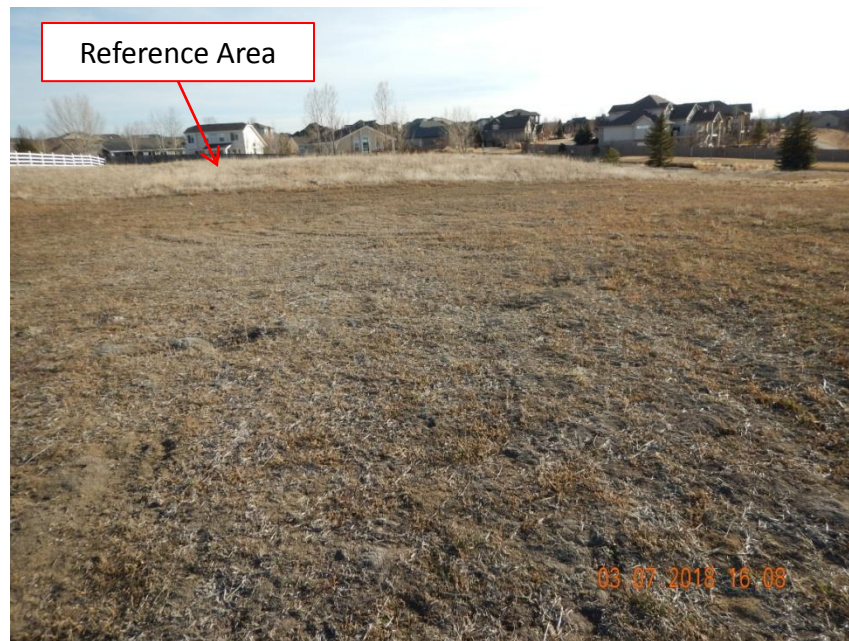
**Photo 4.** Photo taken from the approximate well location, facing South. See comments under Photo 1.

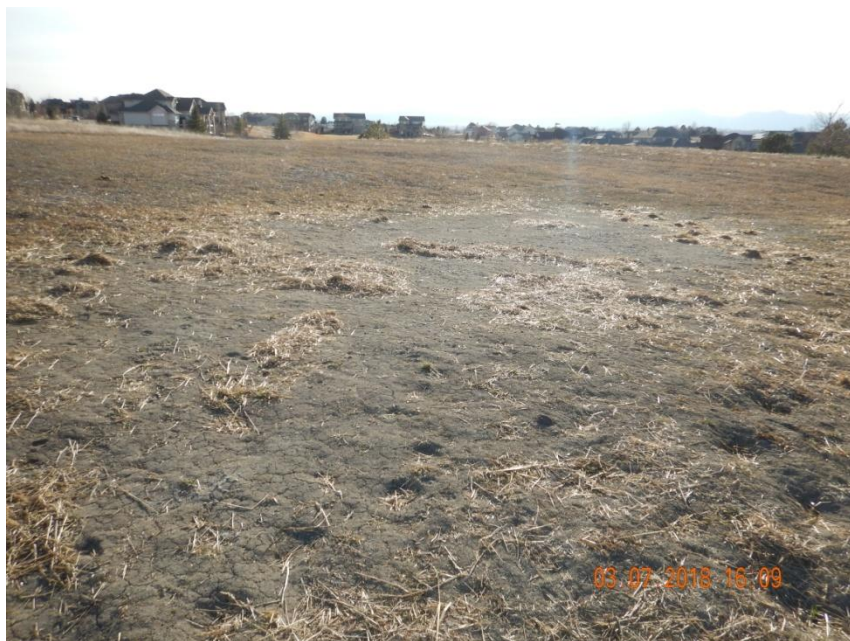
**Photo 5.** Photo taken from the northeast well location, facing South. A patch of bare ground (~20'x~20') evident with no germination.

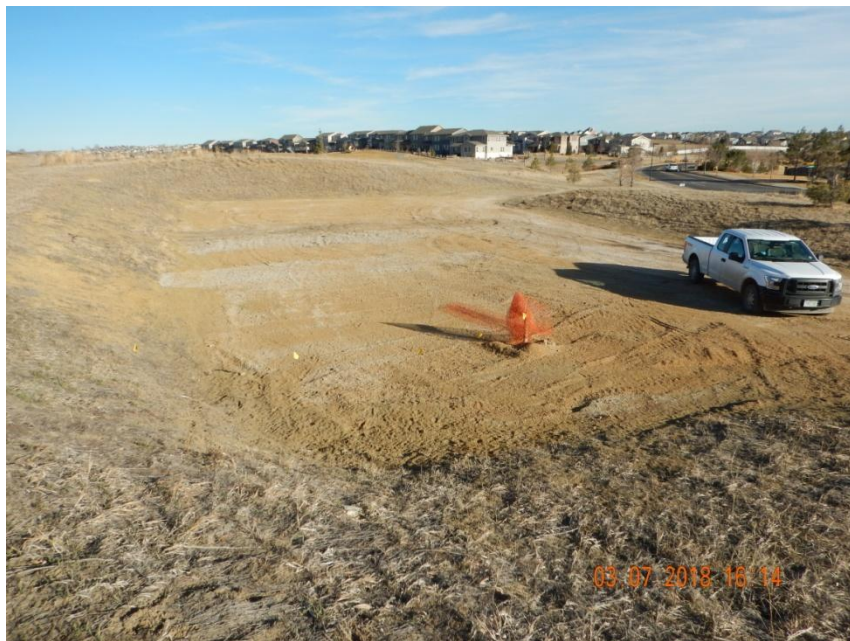
**Photo 7.** Photo taken from the western battery location, facing East. Operator has failed to remove an abandoned riser and failed to perform final reclamation activities.

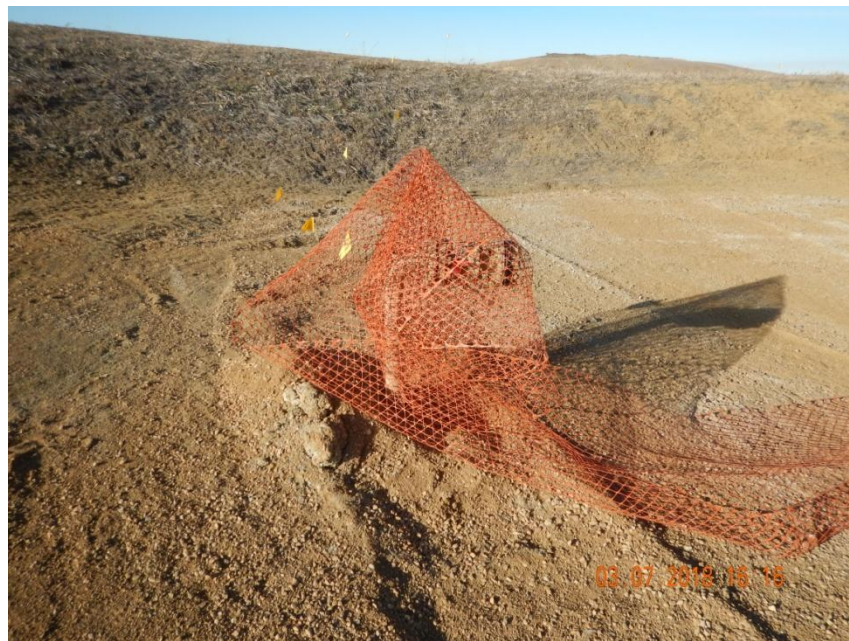
**Photo 8.** Close-up photo taken of the abandoned riser. Riser was locked out/tagged out with an Extraction contact.
