Inspection Photos
Location Name: Haley-Ray #13-21
API: 05-123-22935

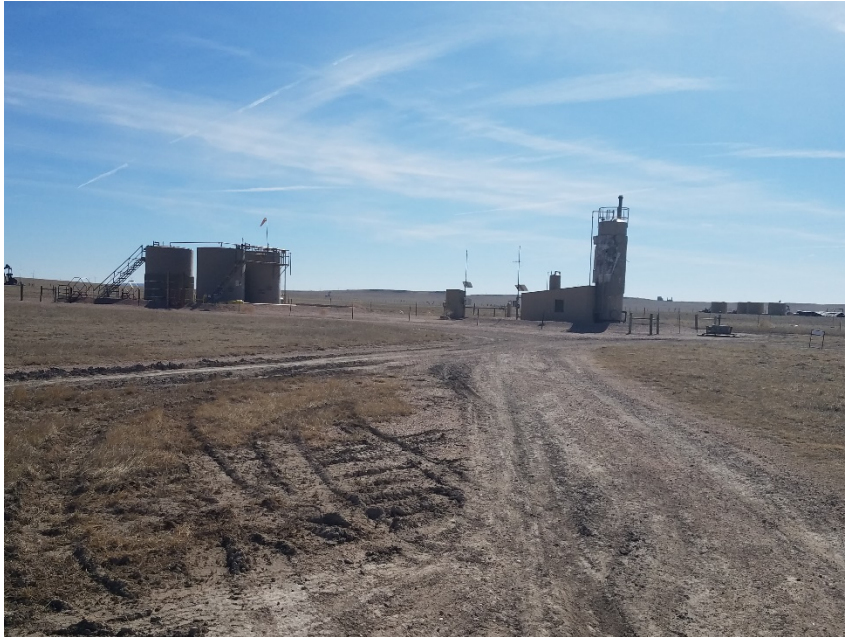
Photo 1: Looking SE at site location

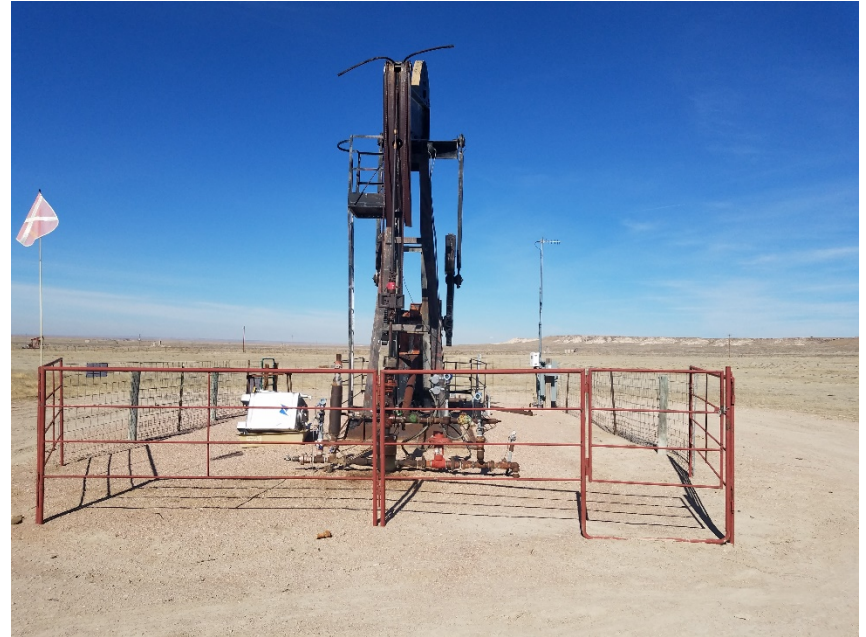
Photo 2: wellhead looking N.

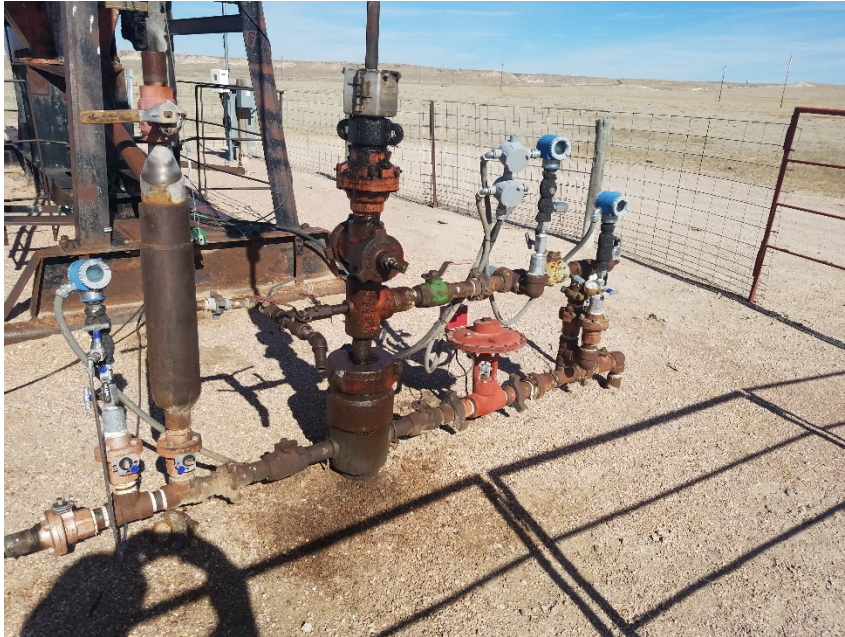
Photo 3: stained soil at wellhead

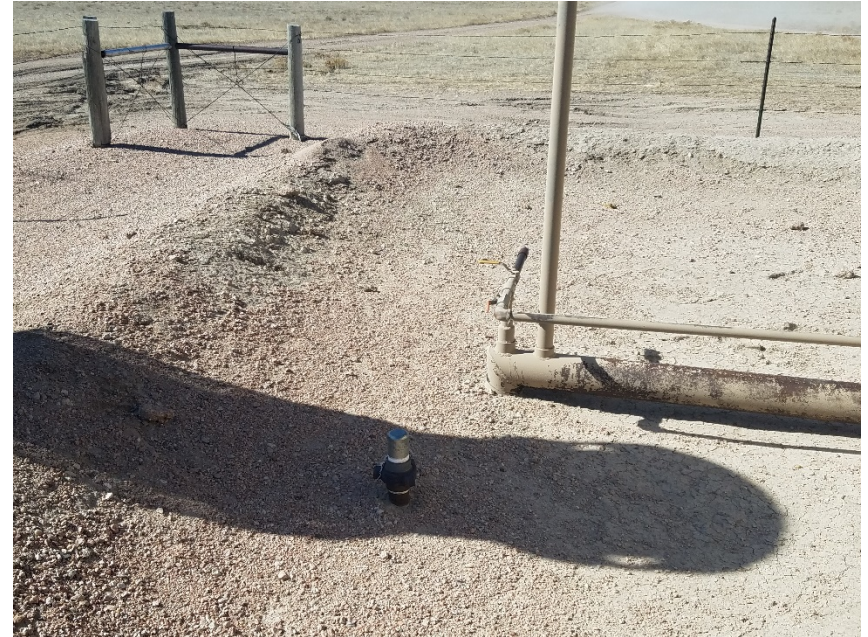
Photo 4: Unused 2" plugged riser

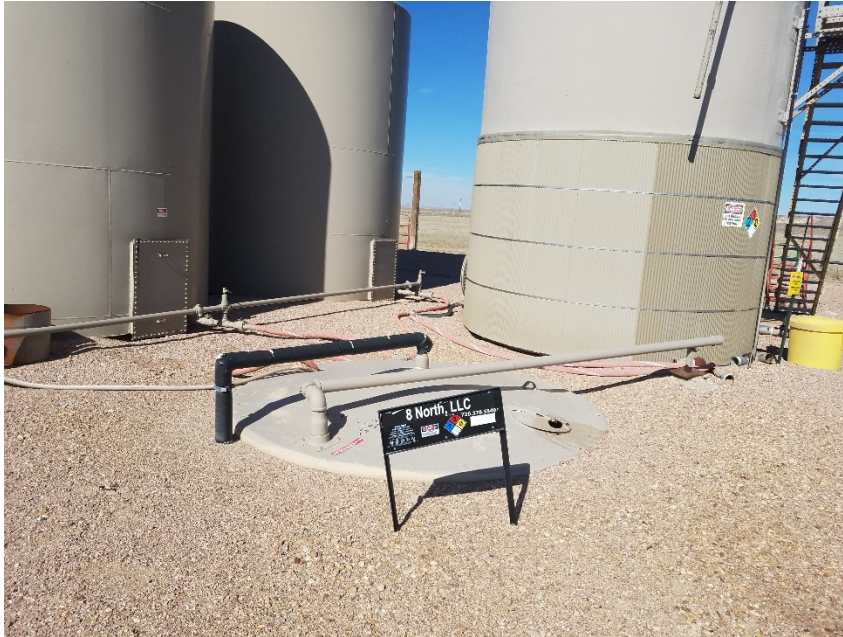
Photo 5: Water vault capacity not shown

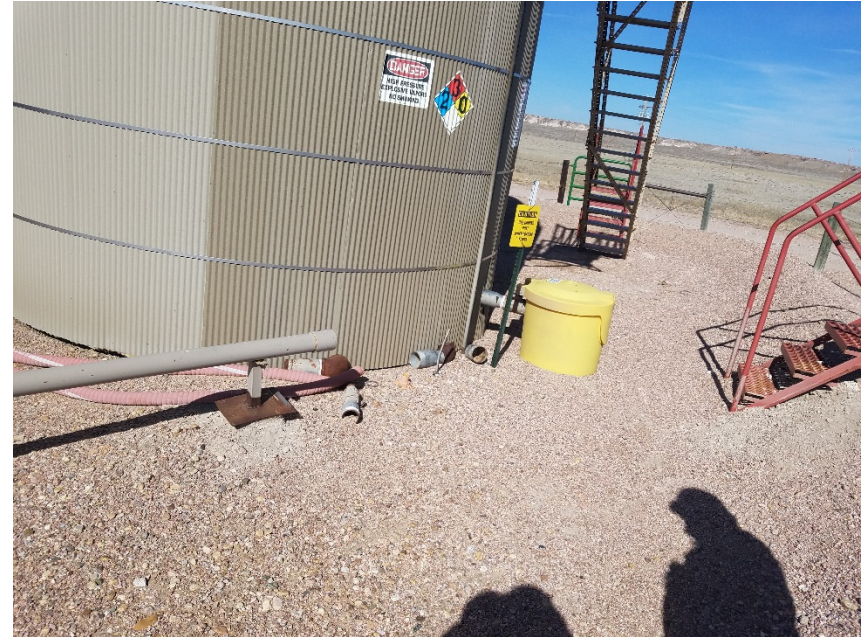
Photo 6: Unused fittings

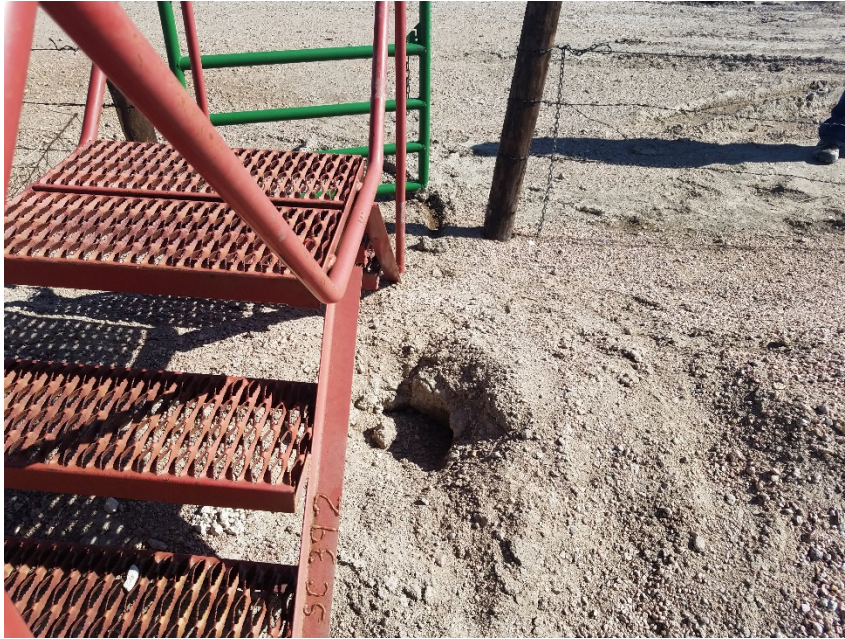
Photo 7: Burrows in berm

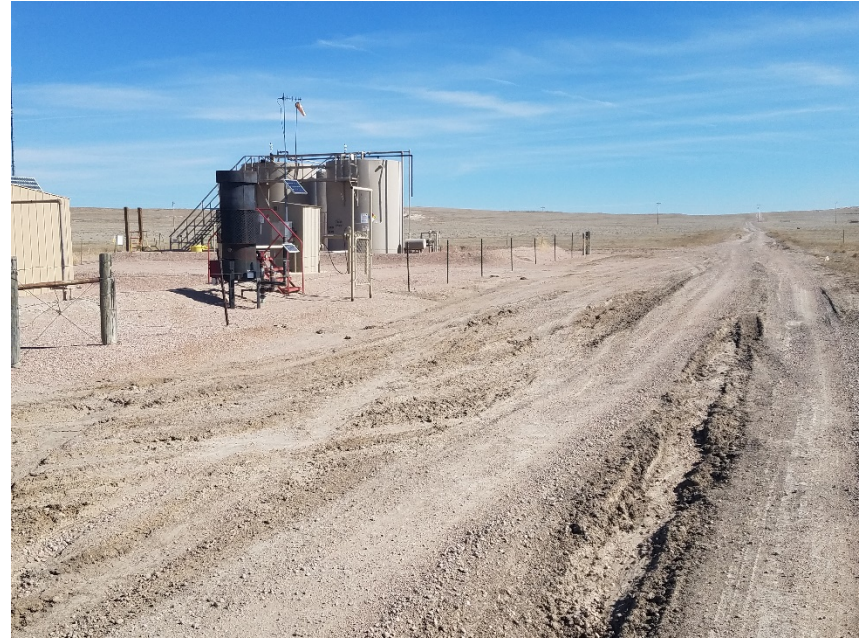
Photo 8: Stormwater erosion on S. side of location
