Inspection Photos
Location Name: State 6-81-24-4
API: 05-057-06510

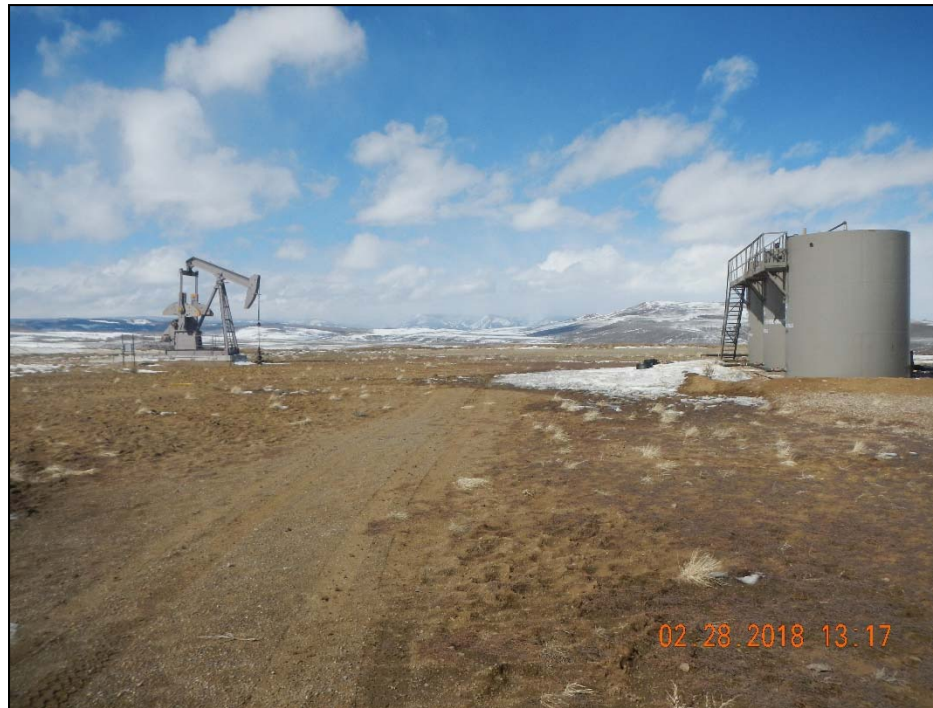
Photo 1. Overview of location taken at entrance facing west.

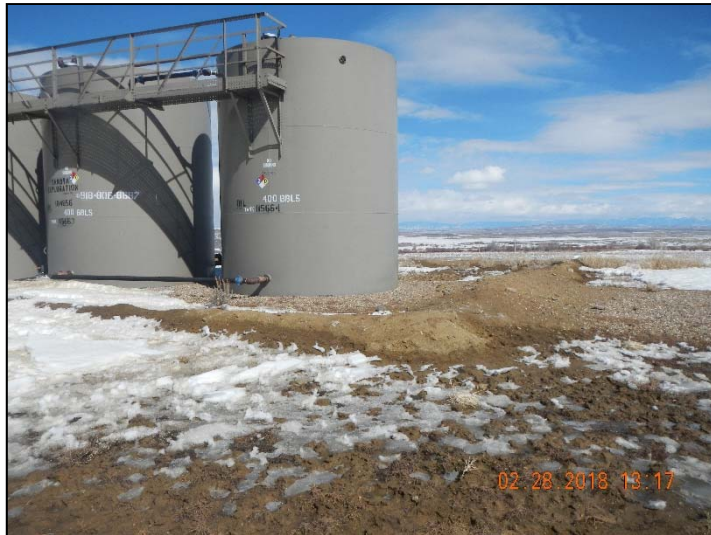
Photo 2. Uncompacted berm.

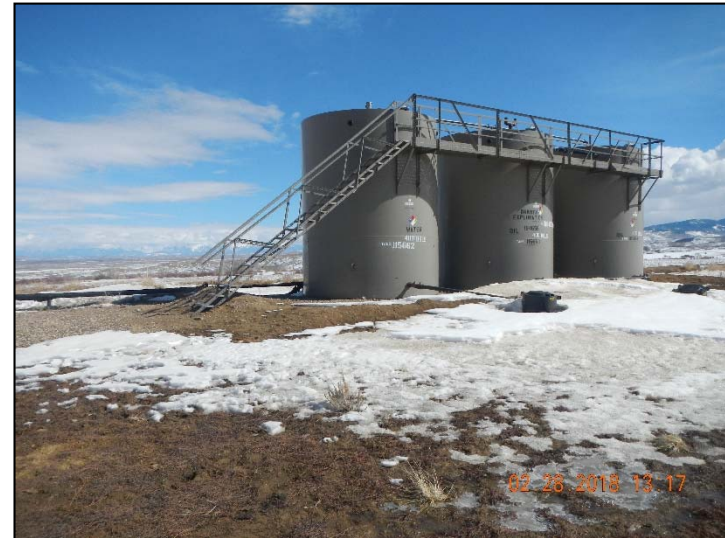
Photo 3. Uncompacted berm.

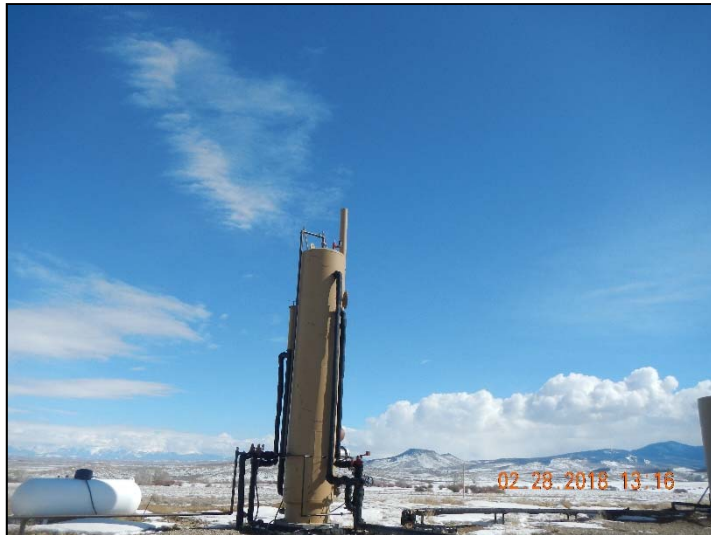
Photo 4. No wildlife protection apparent.

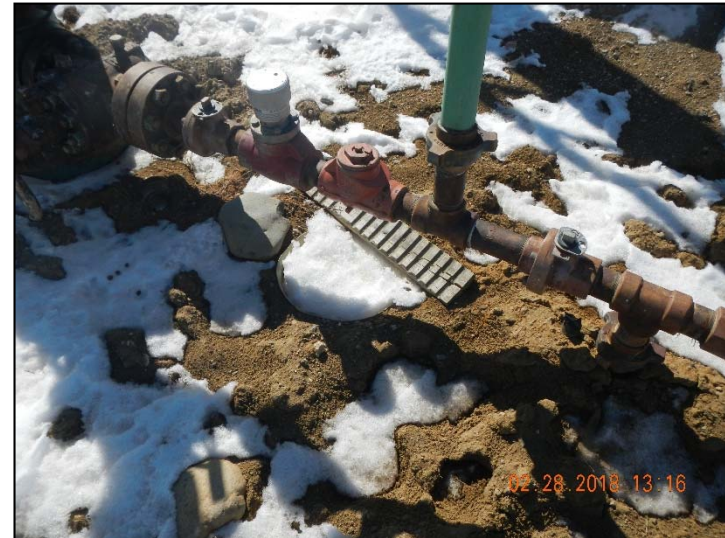
Photo 5. Open rat hole.

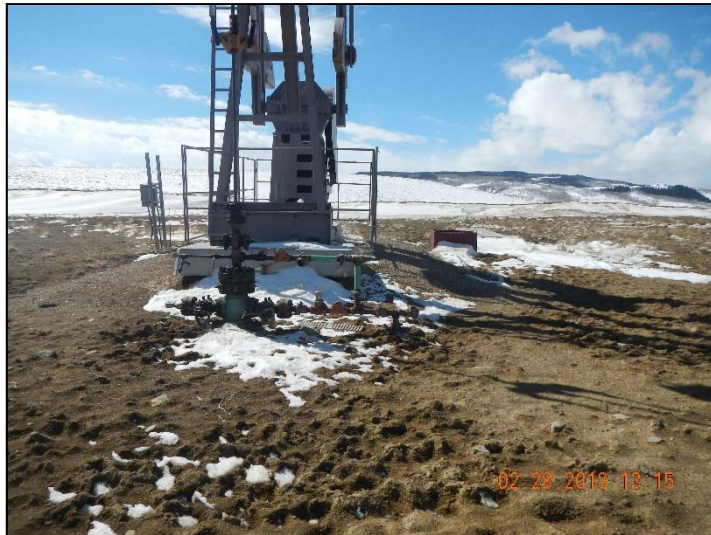
Photo 6. No wellhead sign, concrete base and metal container stored on location.

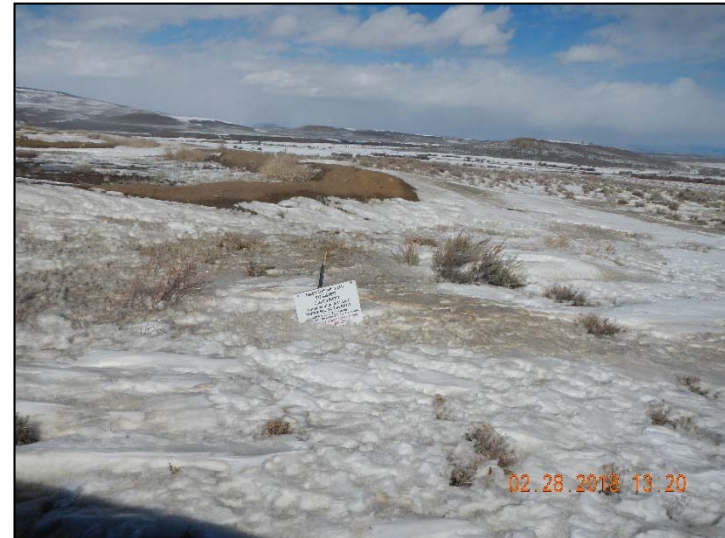
Photo 7. Battery sign falling off post with incorrect well name.
