Inspection Photos

Location ID: 453917

Operator: BP PRODUCTION COMPANY

Inspection Date: 2/28/2018

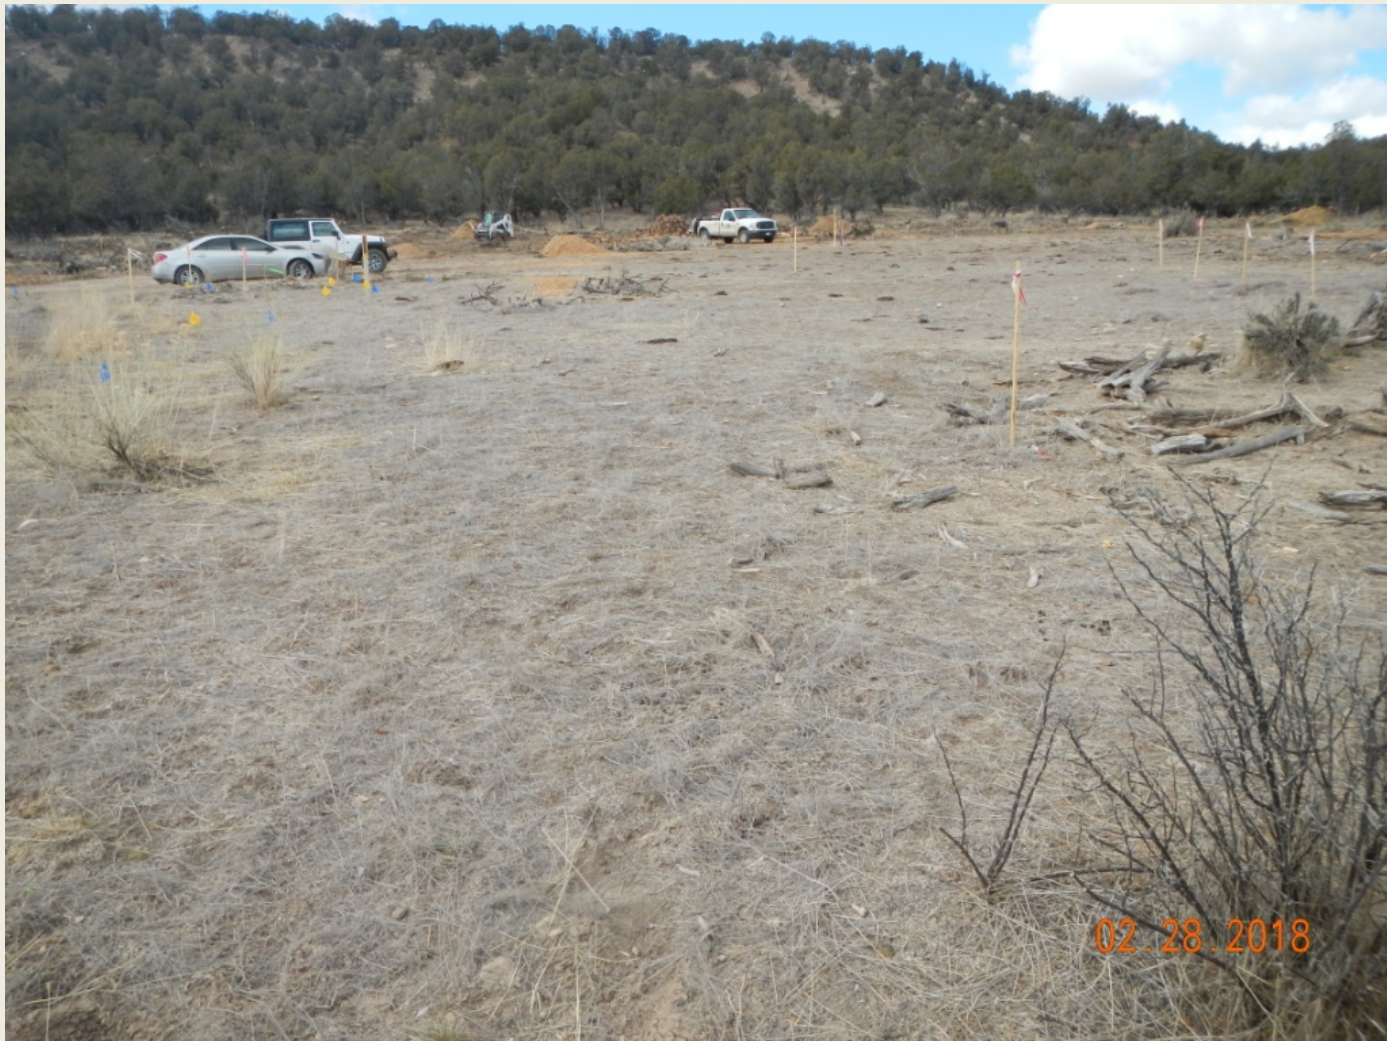
Photo 1. View of the project area from the southeastern corner facing center. Tree clearing operations occurring at the time of the inspection.

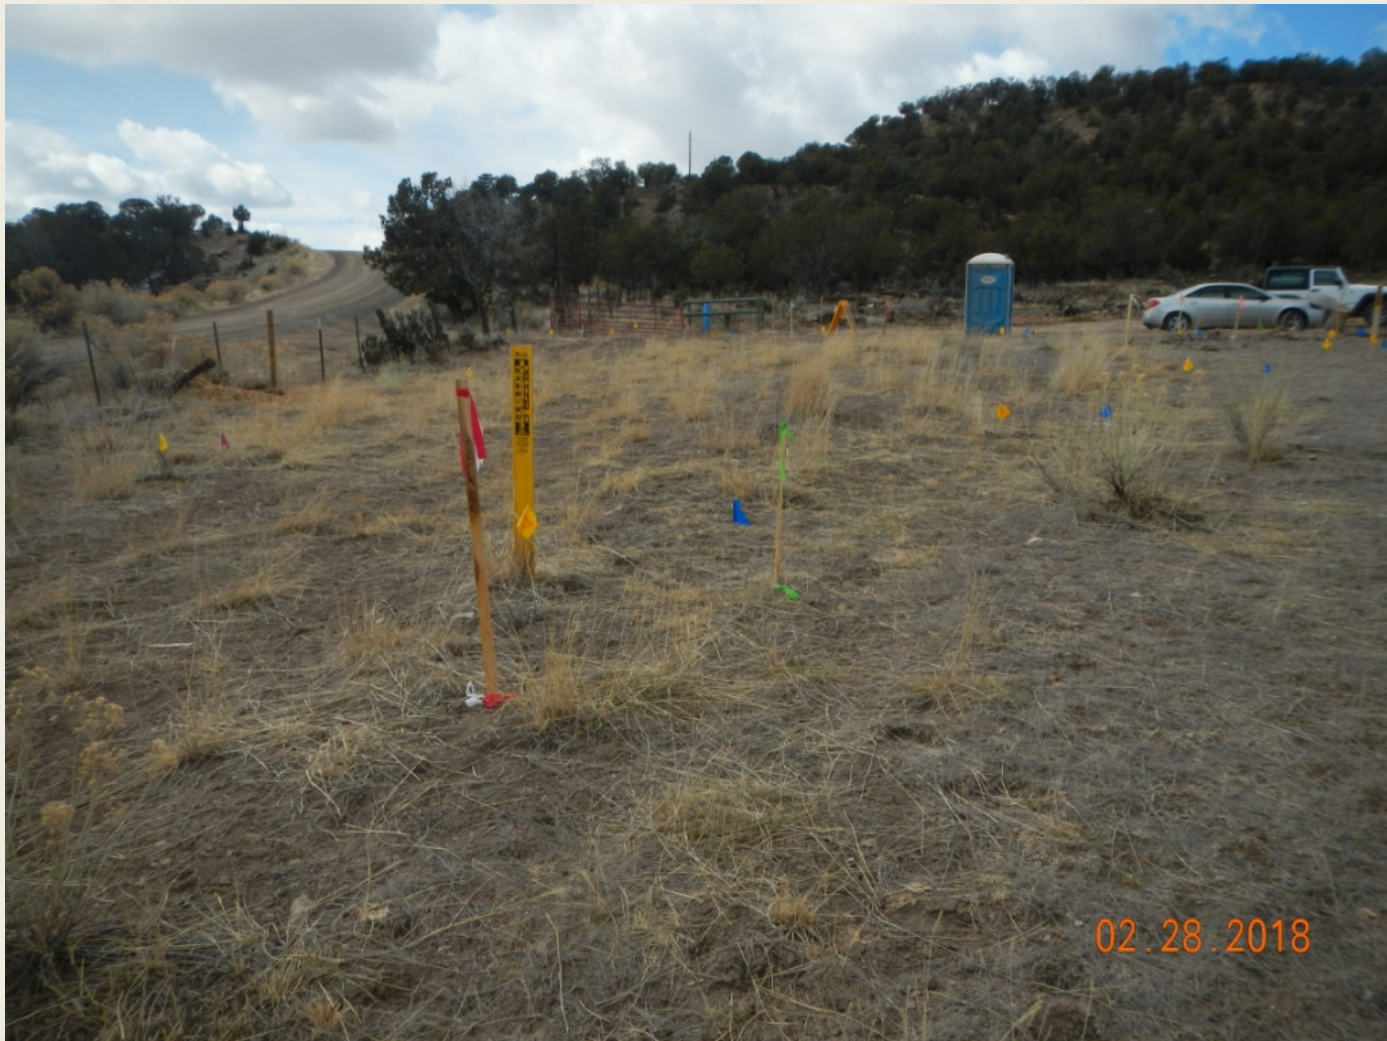
Photo 2. View of the southern portion of the project area from the southeastern corner facing westward.

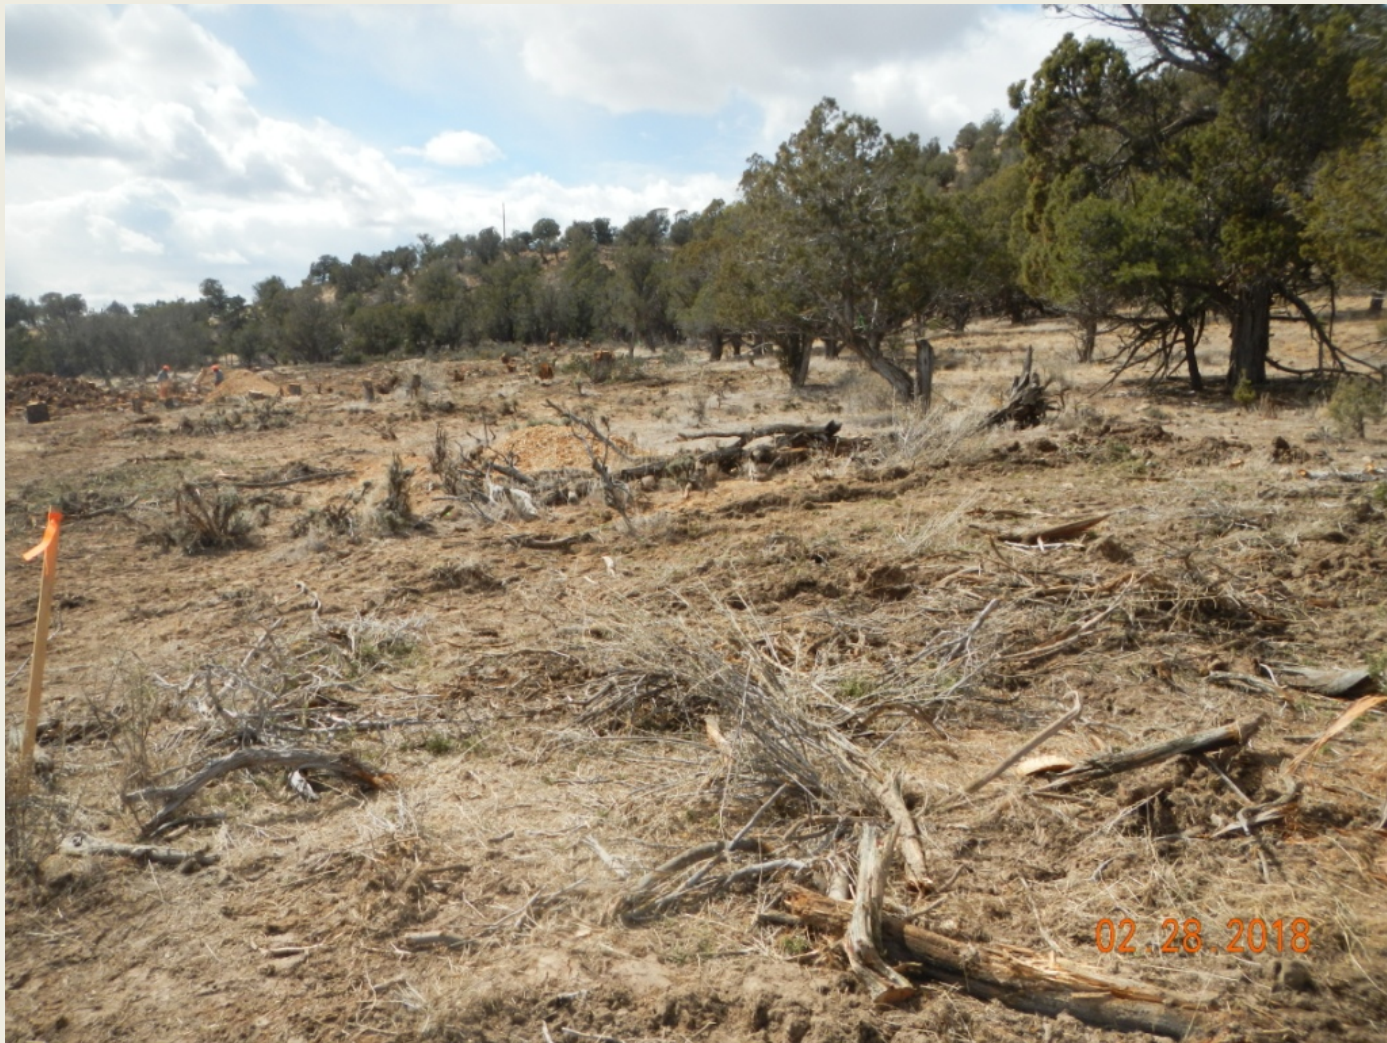
Photo 3. View of the southern portion of the project area from the southwestern corner facing eastward. Vegetation within the project area is largely comprised of sagebrush (*Artemisia tridentata*), juniper (*Juniperus* sp.), pinyon (*Pinus edulis*), wolfberry (*Lycium pallidum*), blue grama (*Bouteloua gracilis*), Prickly pear (*Opuntia* sp.), and cheatgrass (*Bromus tectorum*).

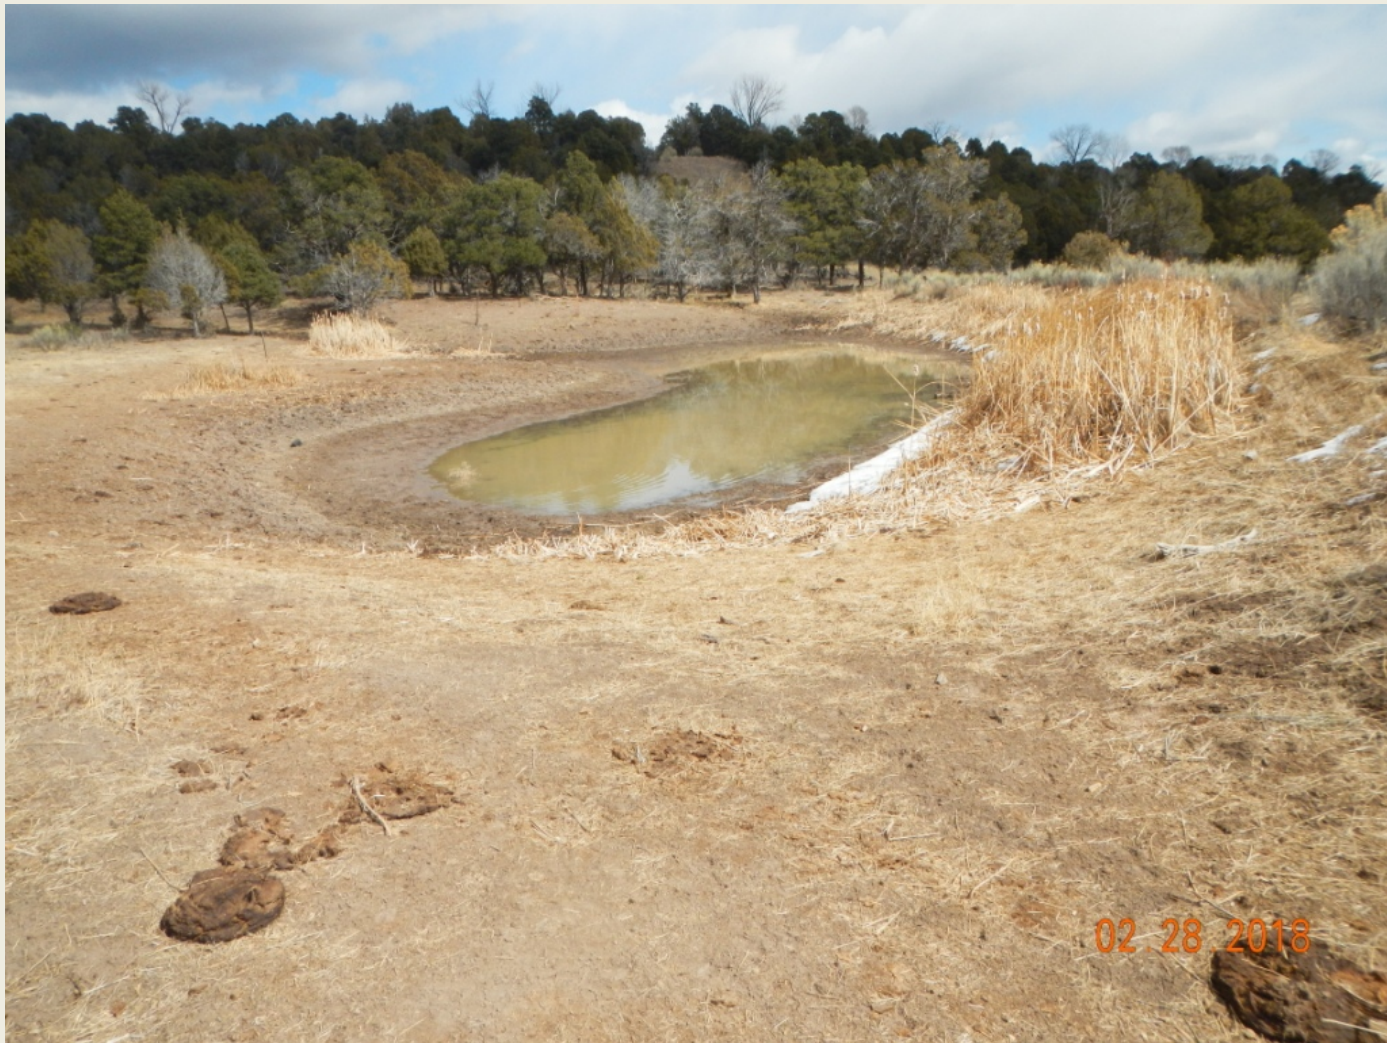
Photo 4. View of cattle pond northeast of the project area.
