Inspection Photos
Location Name: Clovis B #2
API: 05-067-08680

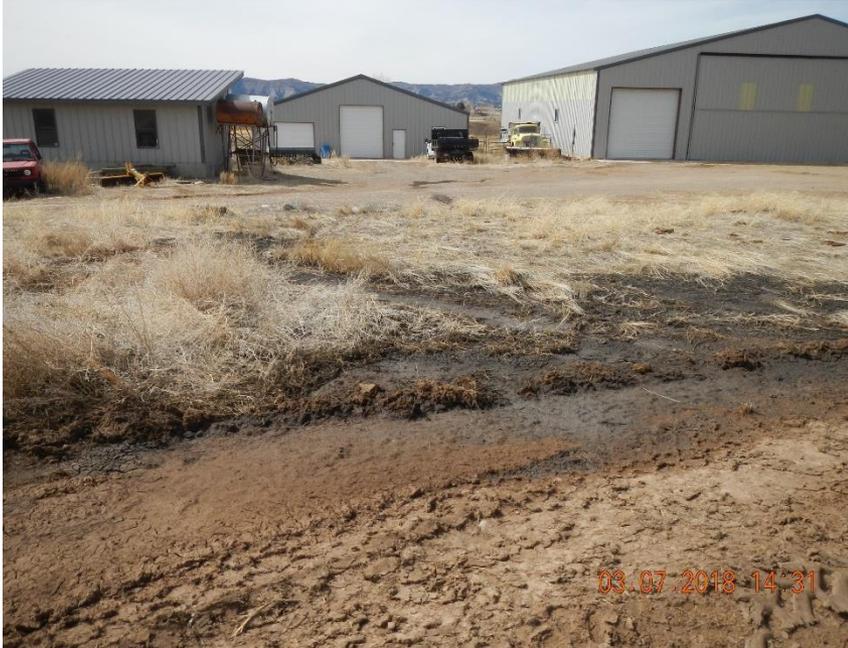
Black material near the southwest edge of location.

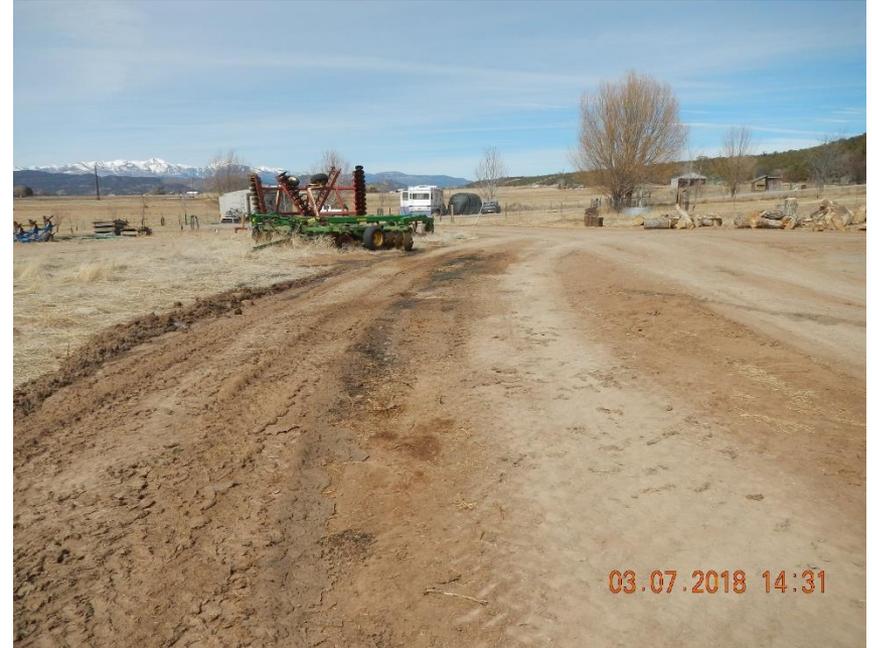
Photo looking north from unidentified spill area.

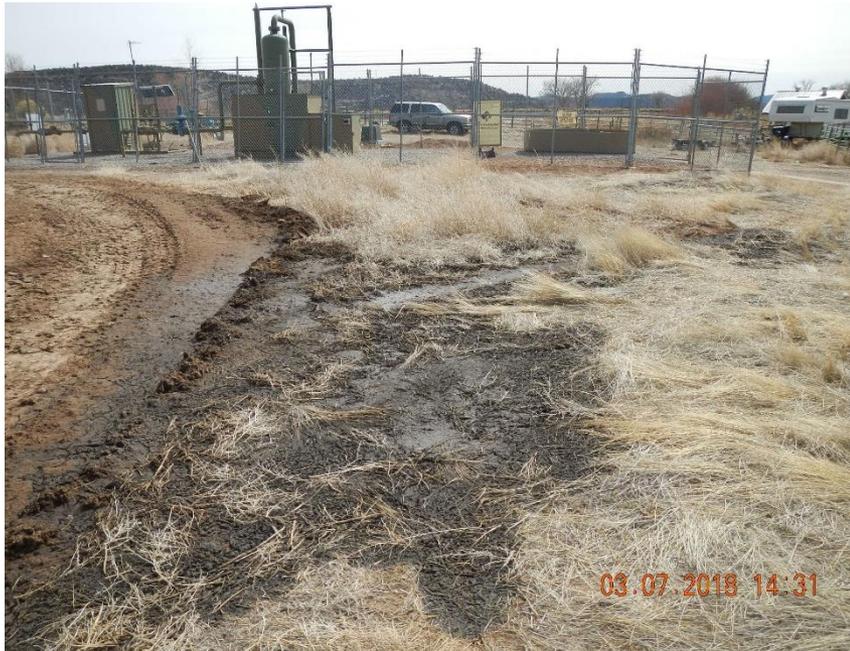
Unidentified spill area.

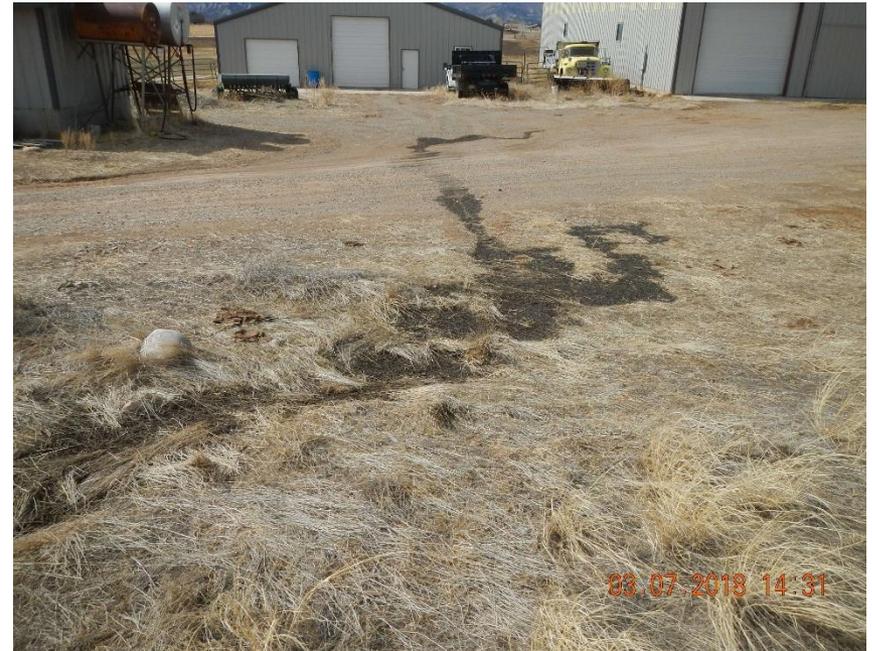
Flow path from southwest corner of location toward the west.

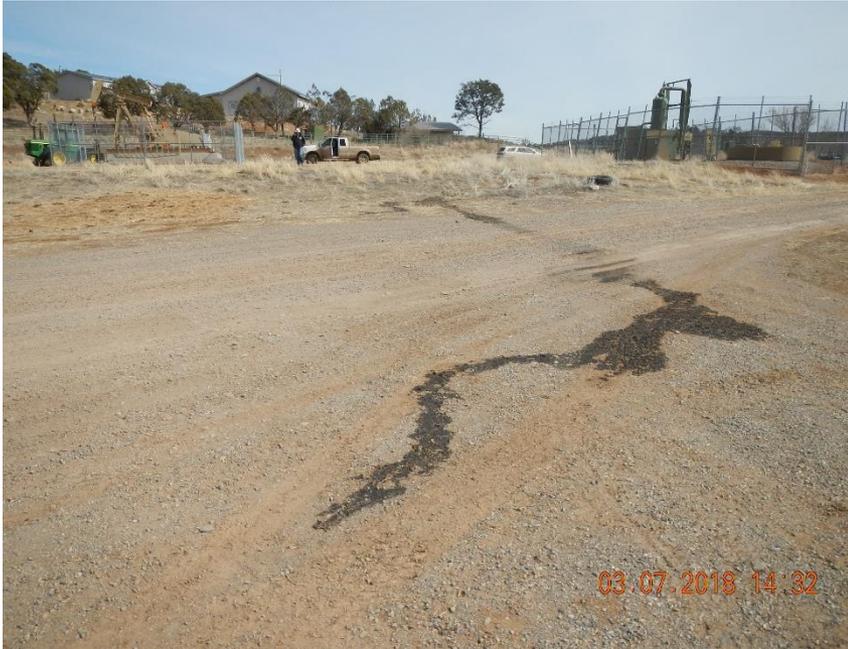
Terminus of flow path.

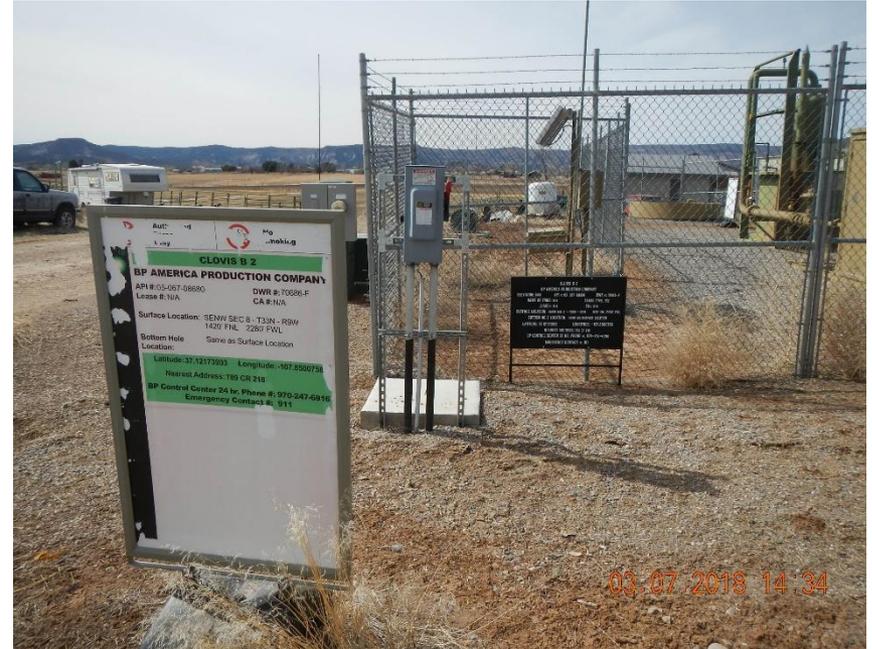
Old location sign remains on site.

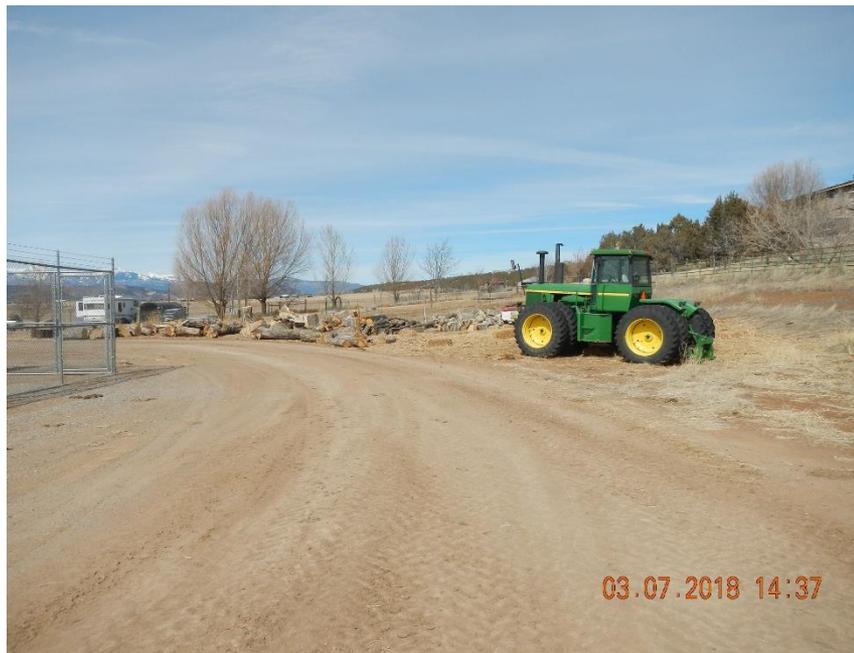
Landowner equipment in northeast corner of location.

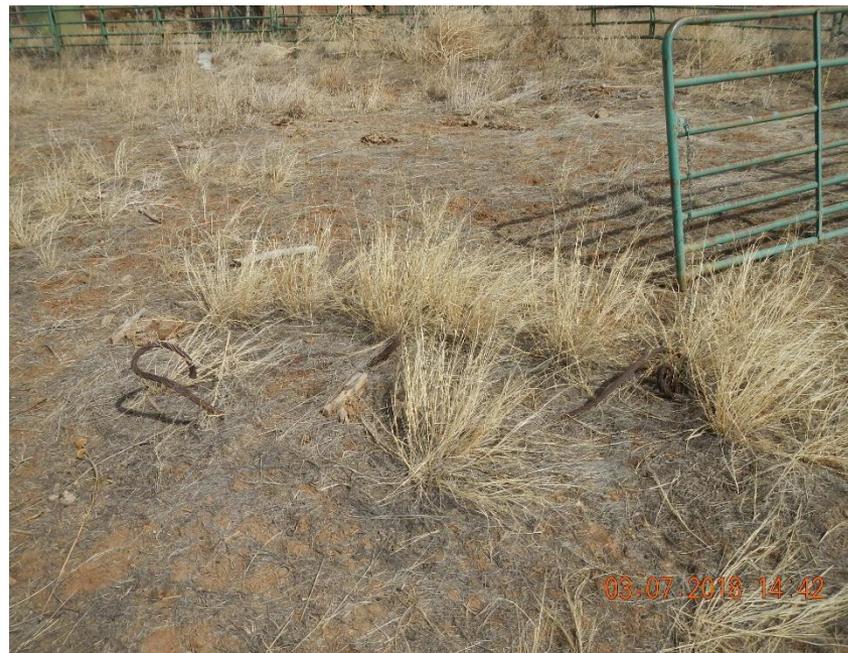
Debris near entrance to location.
