**Inspection Photos**  
**Location Name: Payne-Schmitt #1**  
**API: 05-067-06814**

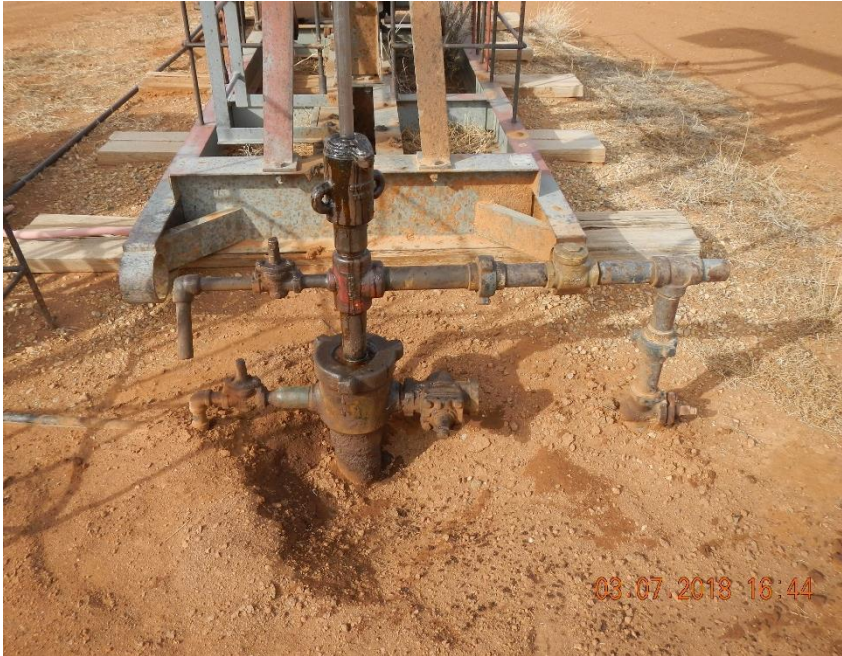
**Payne-Schmitt #1 well head and stained soil.**

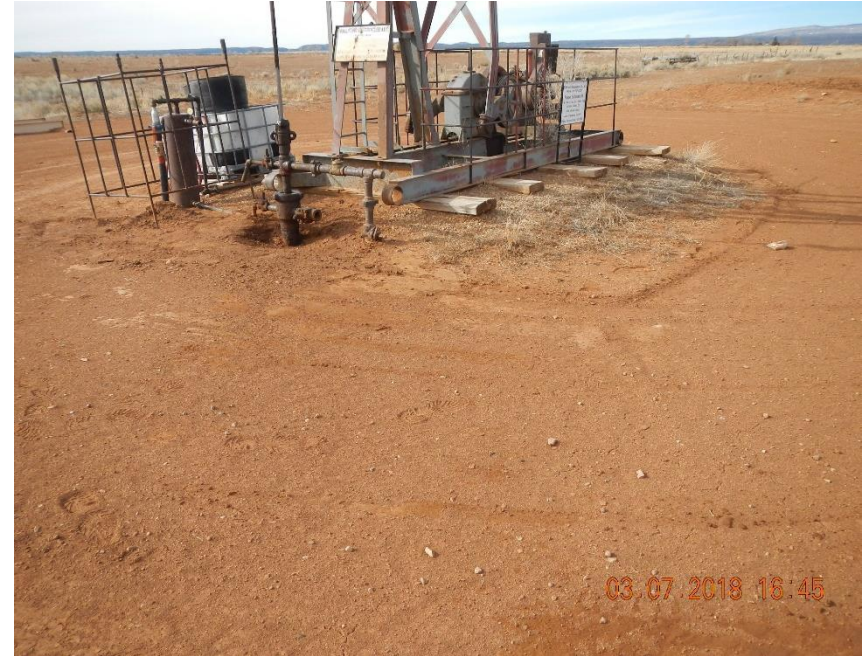
**Location appears to have recently been dragged.**

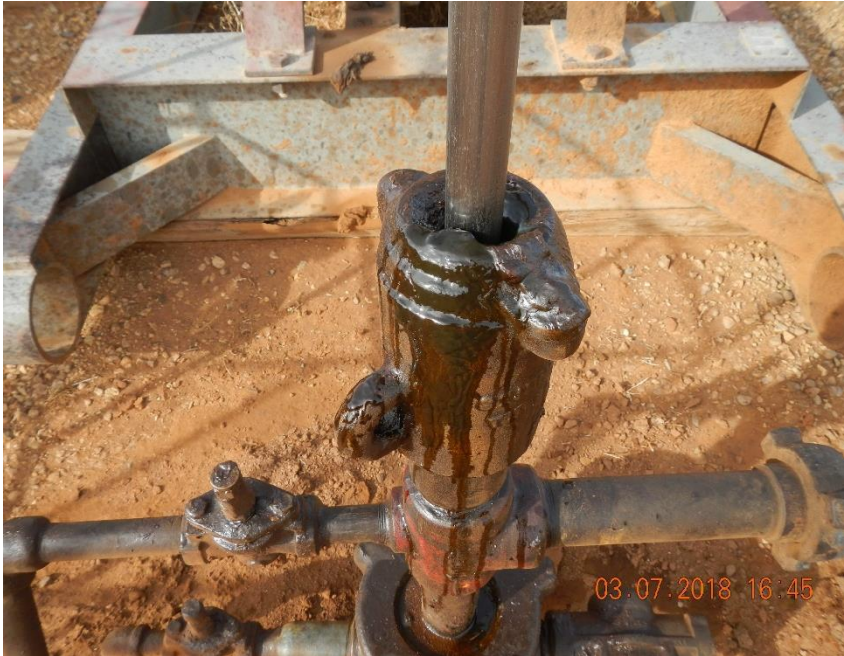
**Close up of fluids leaking from well head.**

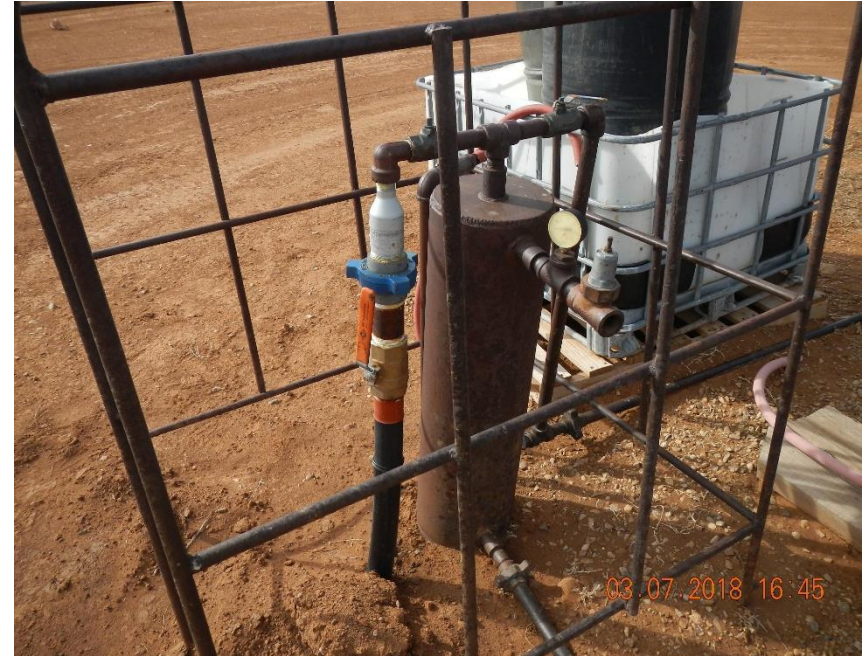
**Drop out tank with gas supply line.**

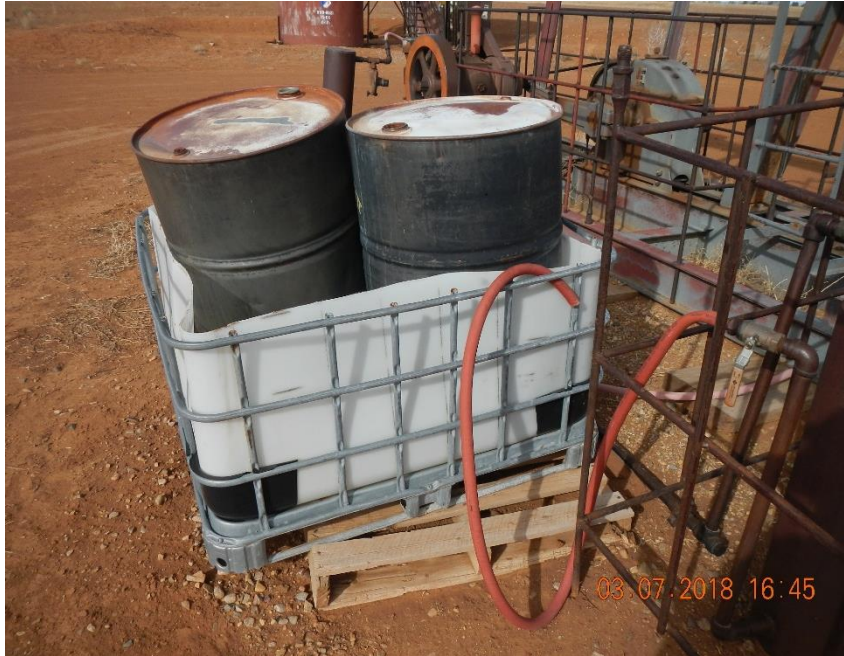
**55 gal. drums in secondary containment.**

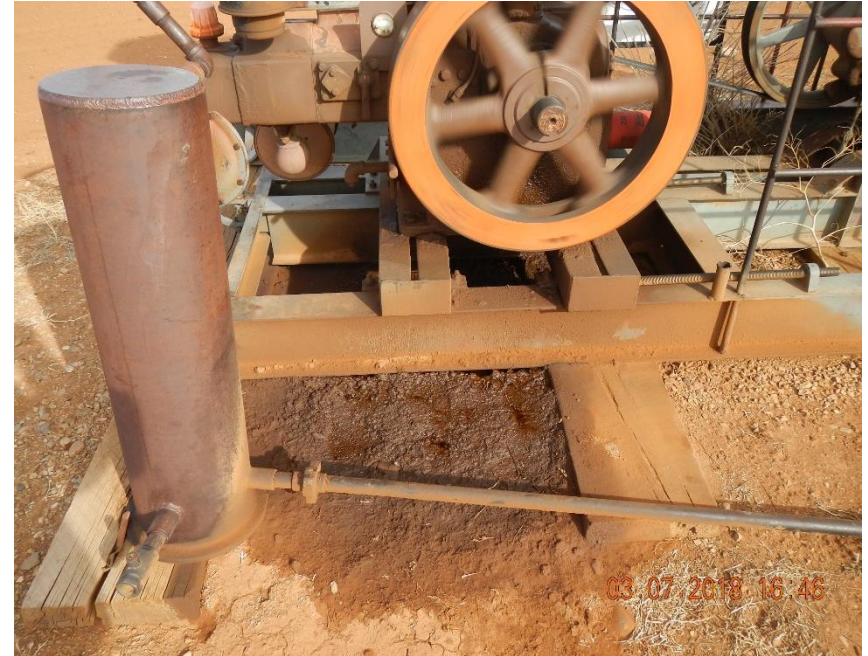
**Stained, wet soil underneath prime mover.**

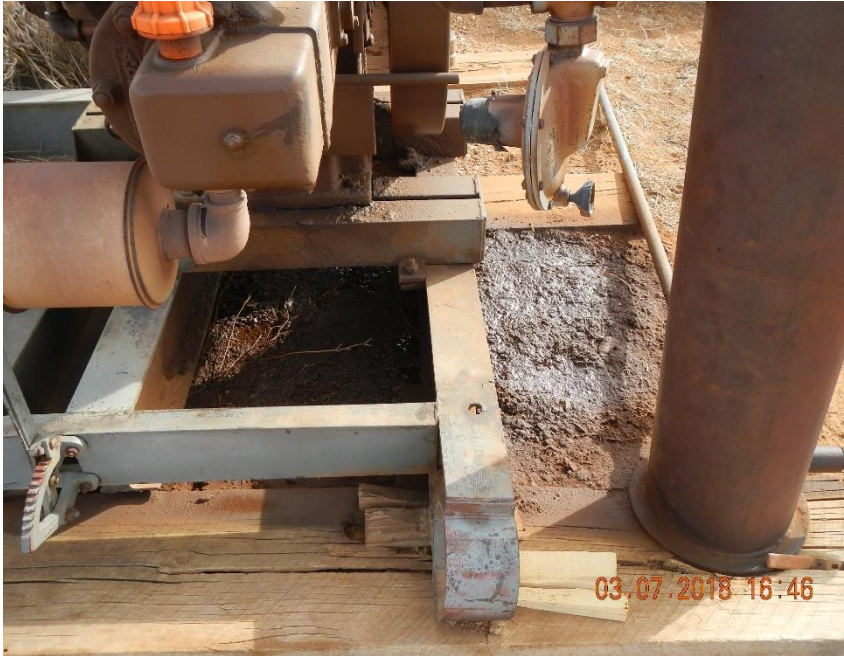
**Alternate view of stained soil beneath prime mover.**

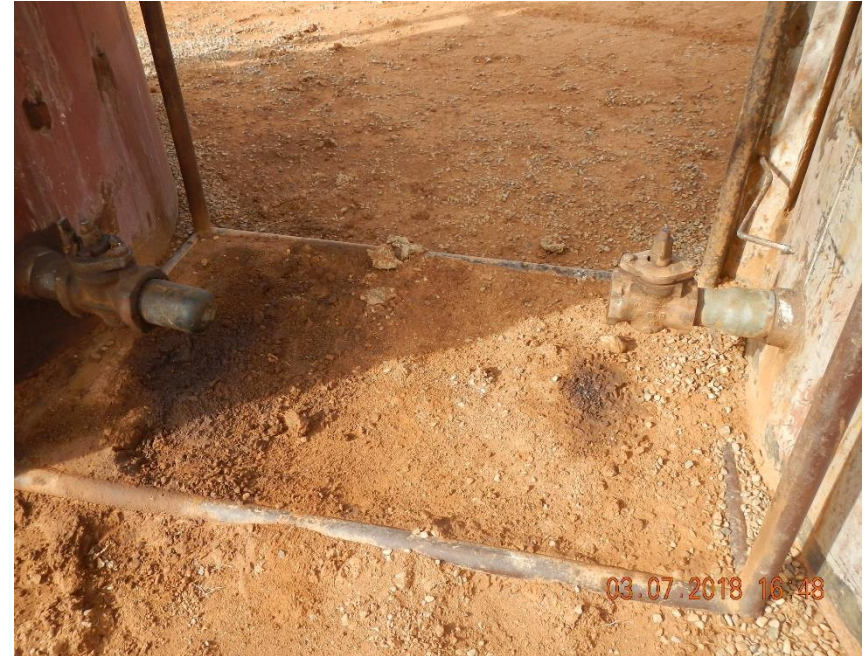
**Stained soil beneath tank load out valves.**

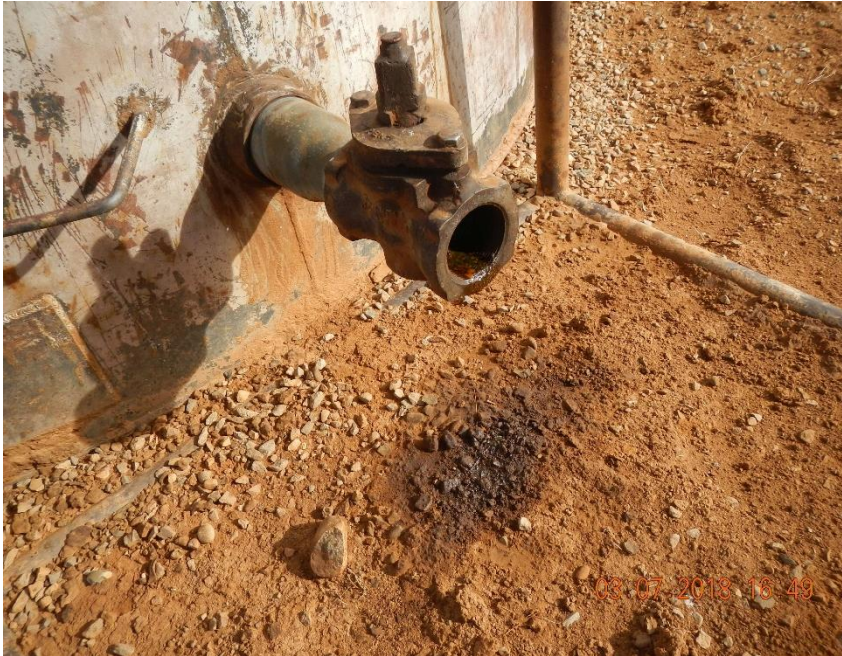
**Stained soil beneath load out valve on eastern tank.**

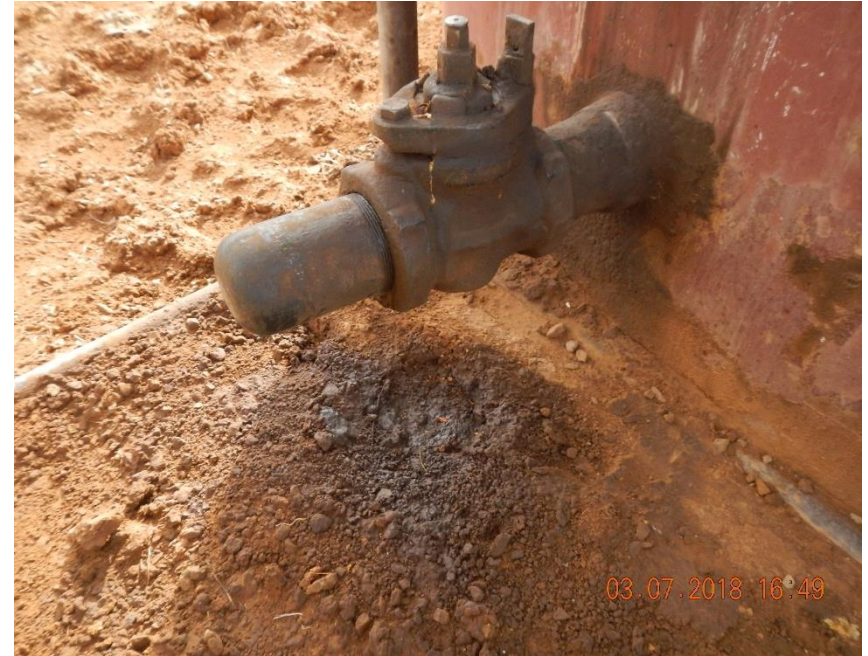
**Stained soil beneath load out valve on western tank.**

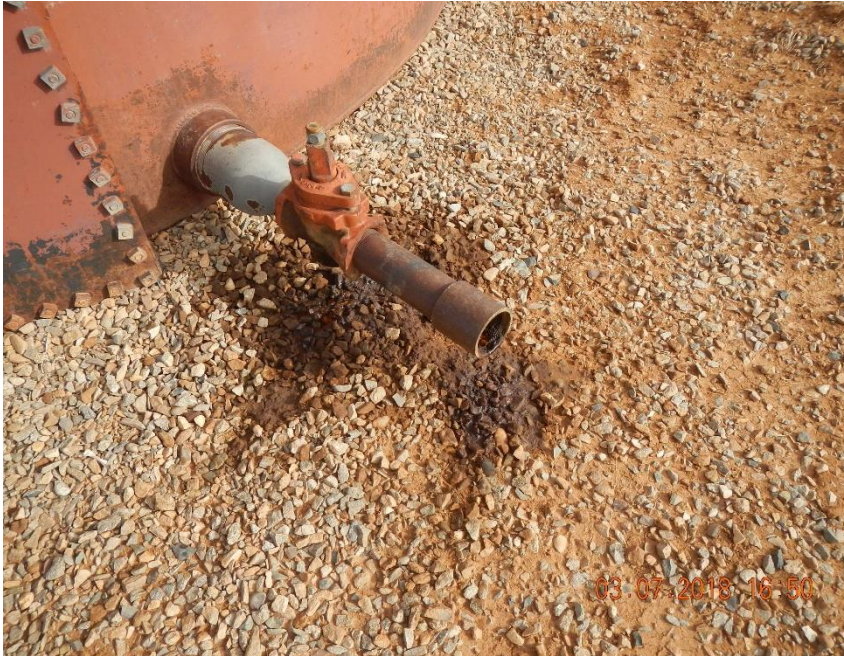
**Additional valve on western tank with stained soil.**

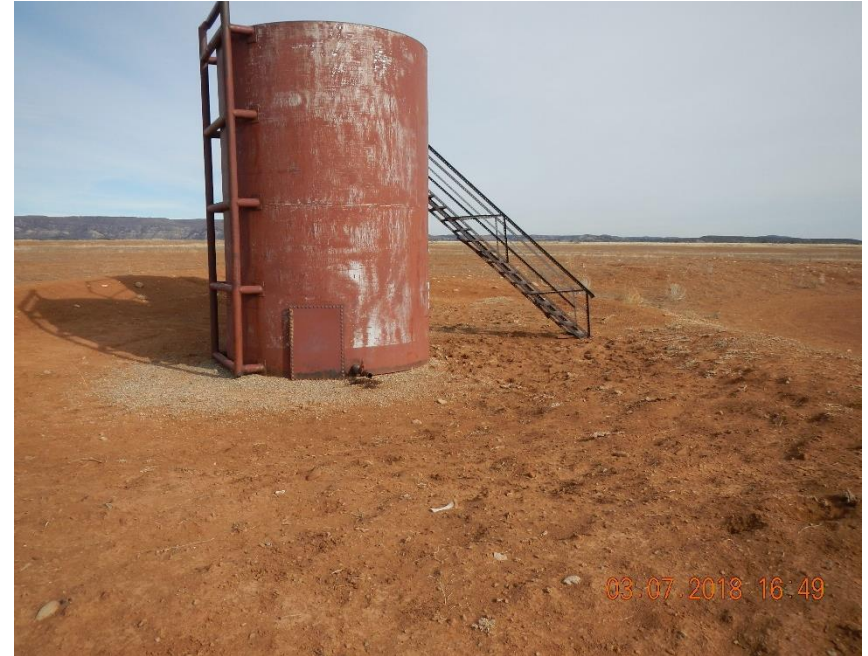
**Inadequate secondary containment berm capacity.**
