Inspection Photos  
Location Name: USA-Clark Millison 1  
API: 05-081-07006

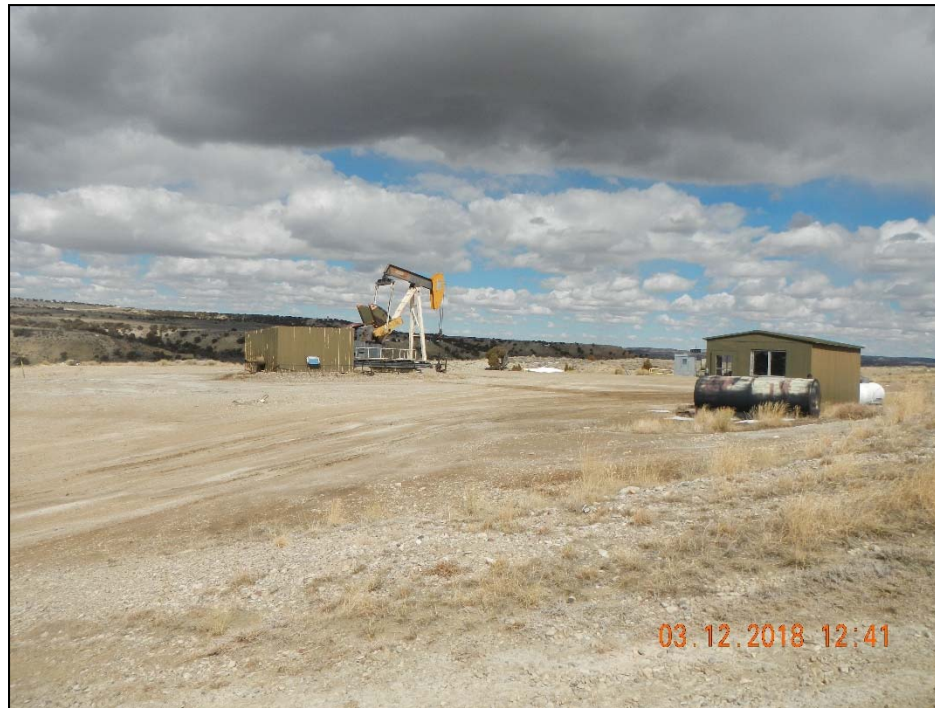
**Photo 1. Overview of location taken at entrance facing northeast.**

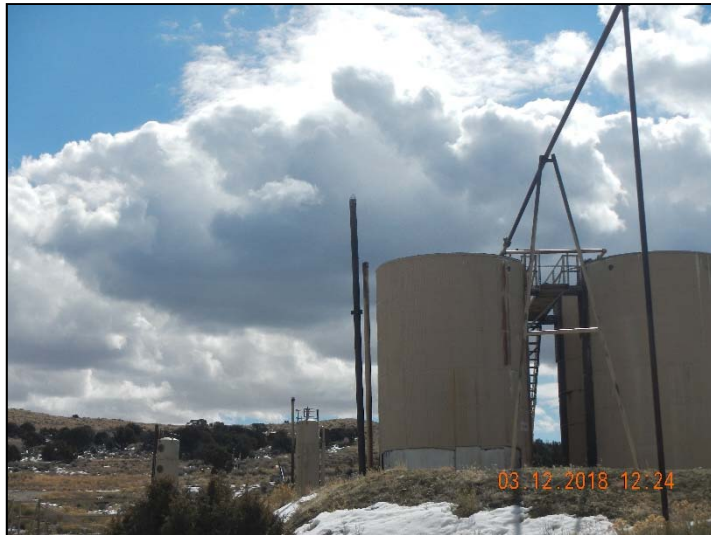
**Photo 2. No wildlife protection apparent on all exhaust.**

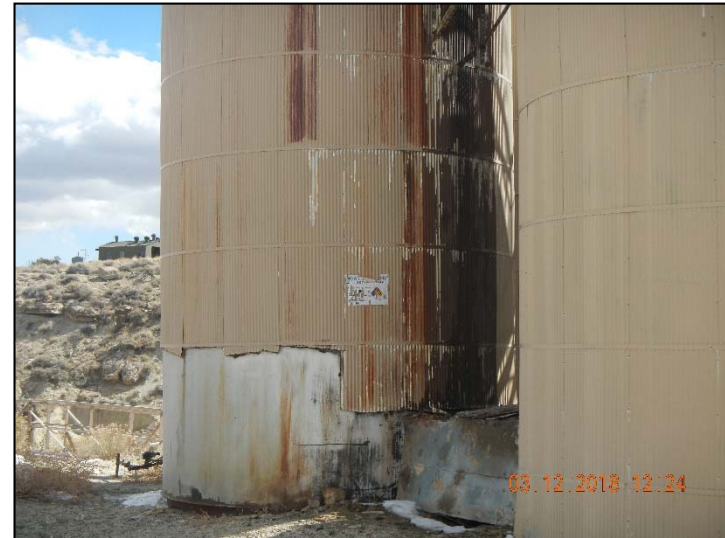
**Photo 3. Peeling tank label.**

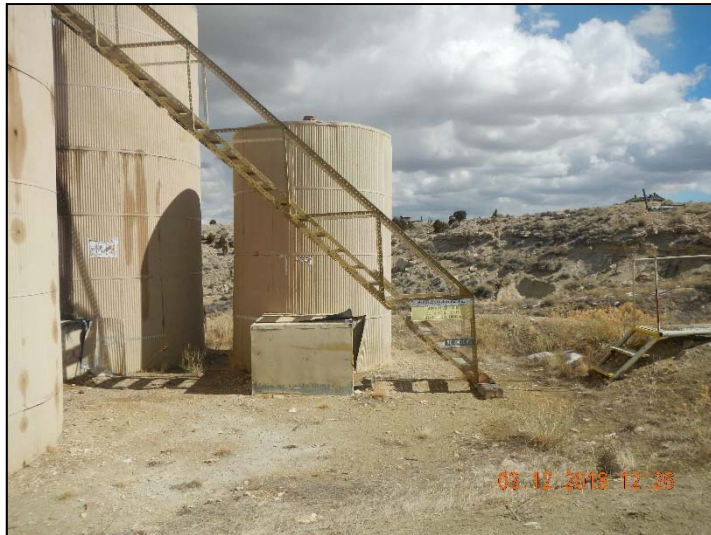
**Photo 4. No tank label.**

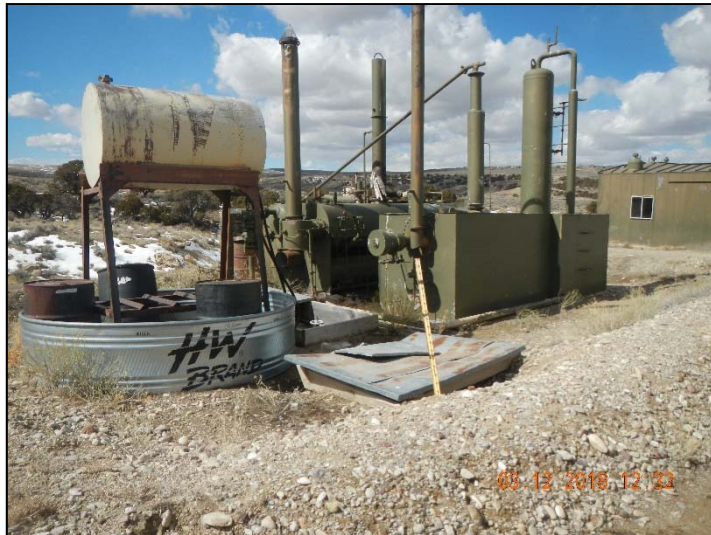
**Photo 6. Separator cluster. Unsure if all are in use.**

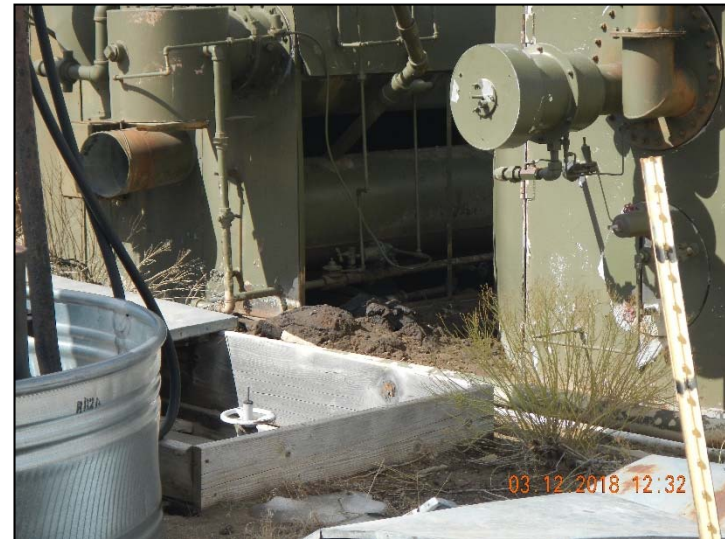
**Photo 7. Stained soil at separator.**

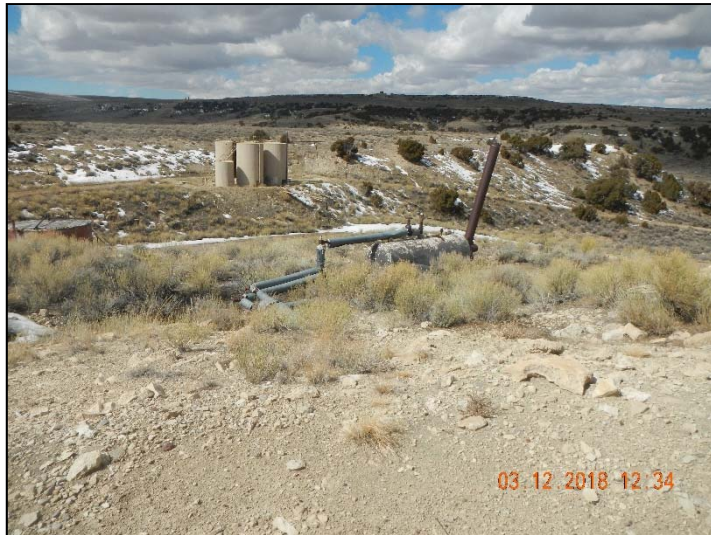
**Photo 8. Separator. Unsure if in use.**

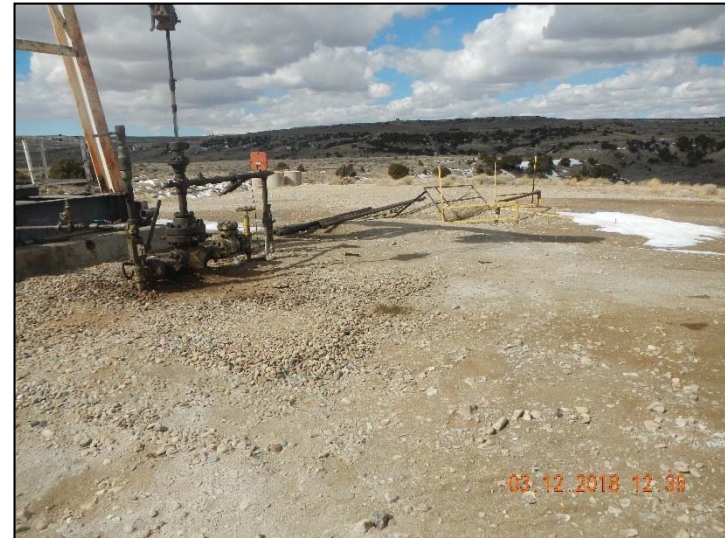
**Photo 9. No wellhead sign, tubing stored at wellhead.**

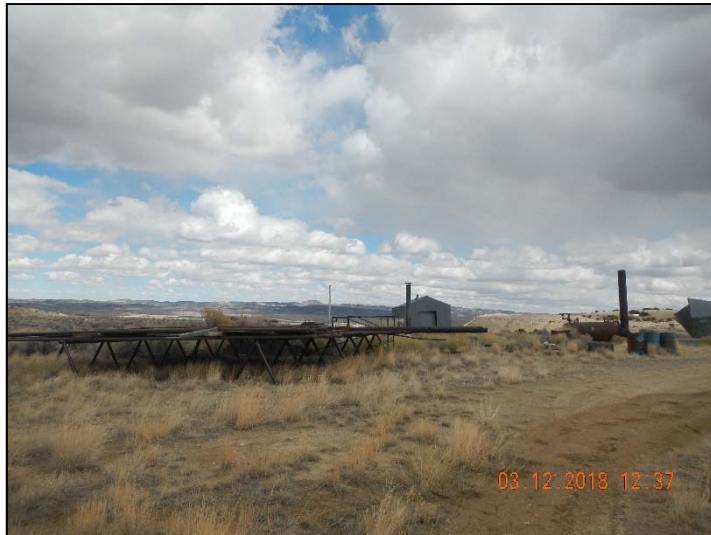
**Photo 10. One of multiple areas of stored/unused equipment.**

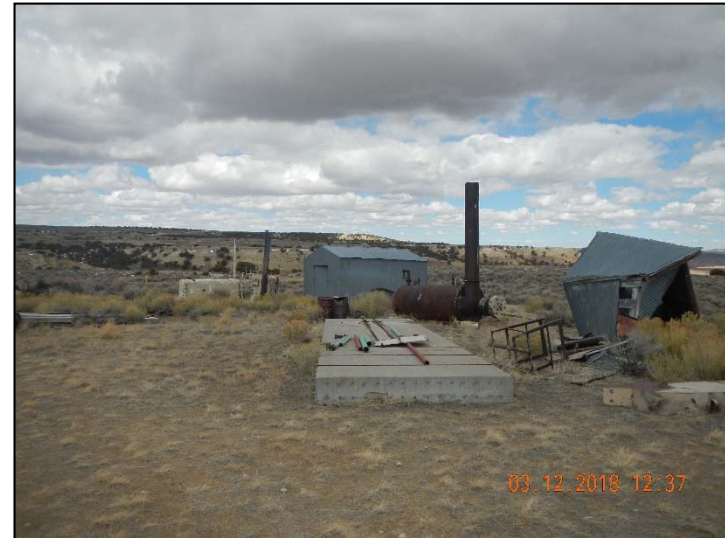
**Photo 11. Second view of one of multiple areas of stored/unused equipment.**

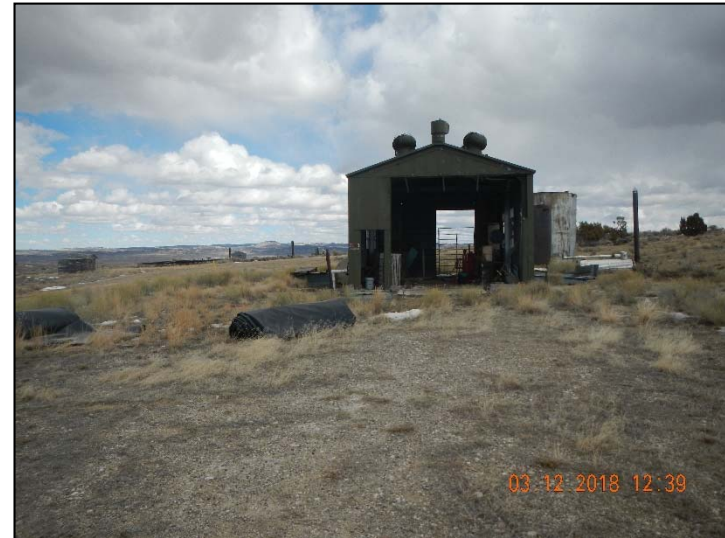
**Photo 13. Second of multiple areas of stored/unused equipment.**

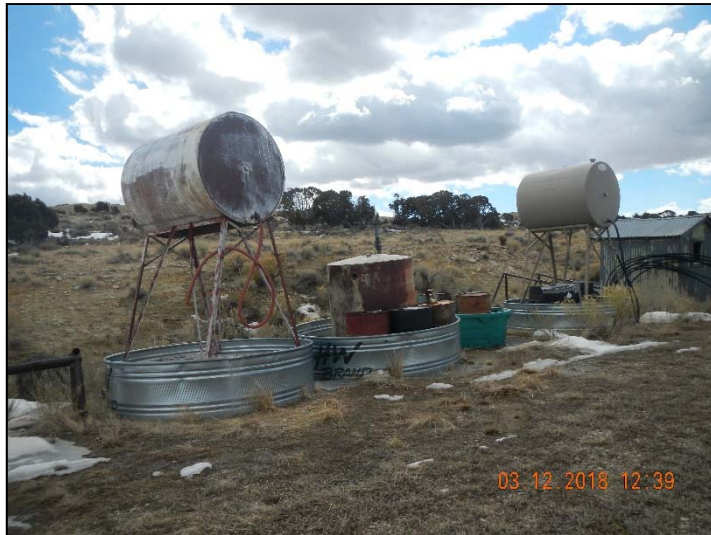
**Photo 14. Third of multiple areas of stored/unused equipment.**

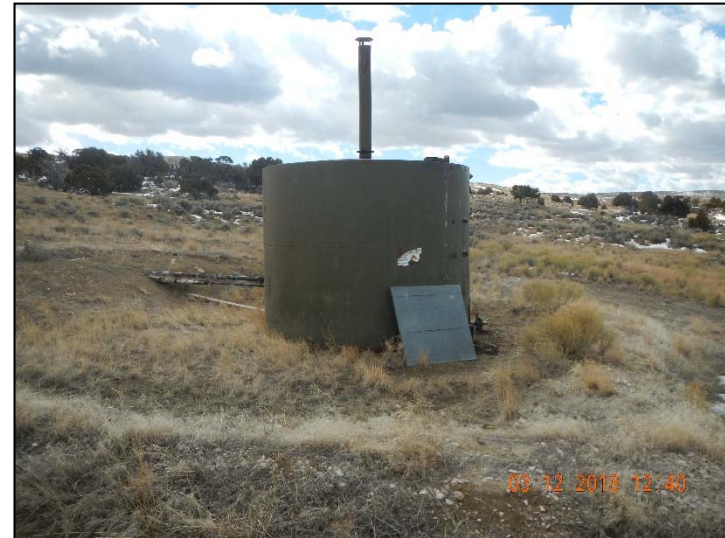
**Photo 15. Unlabeled tank.**
