# Inspection Photos

API: 05-067-05436

Operator: FAULCONER INC\* VERNON E

Inspection Date: 3/7/2018

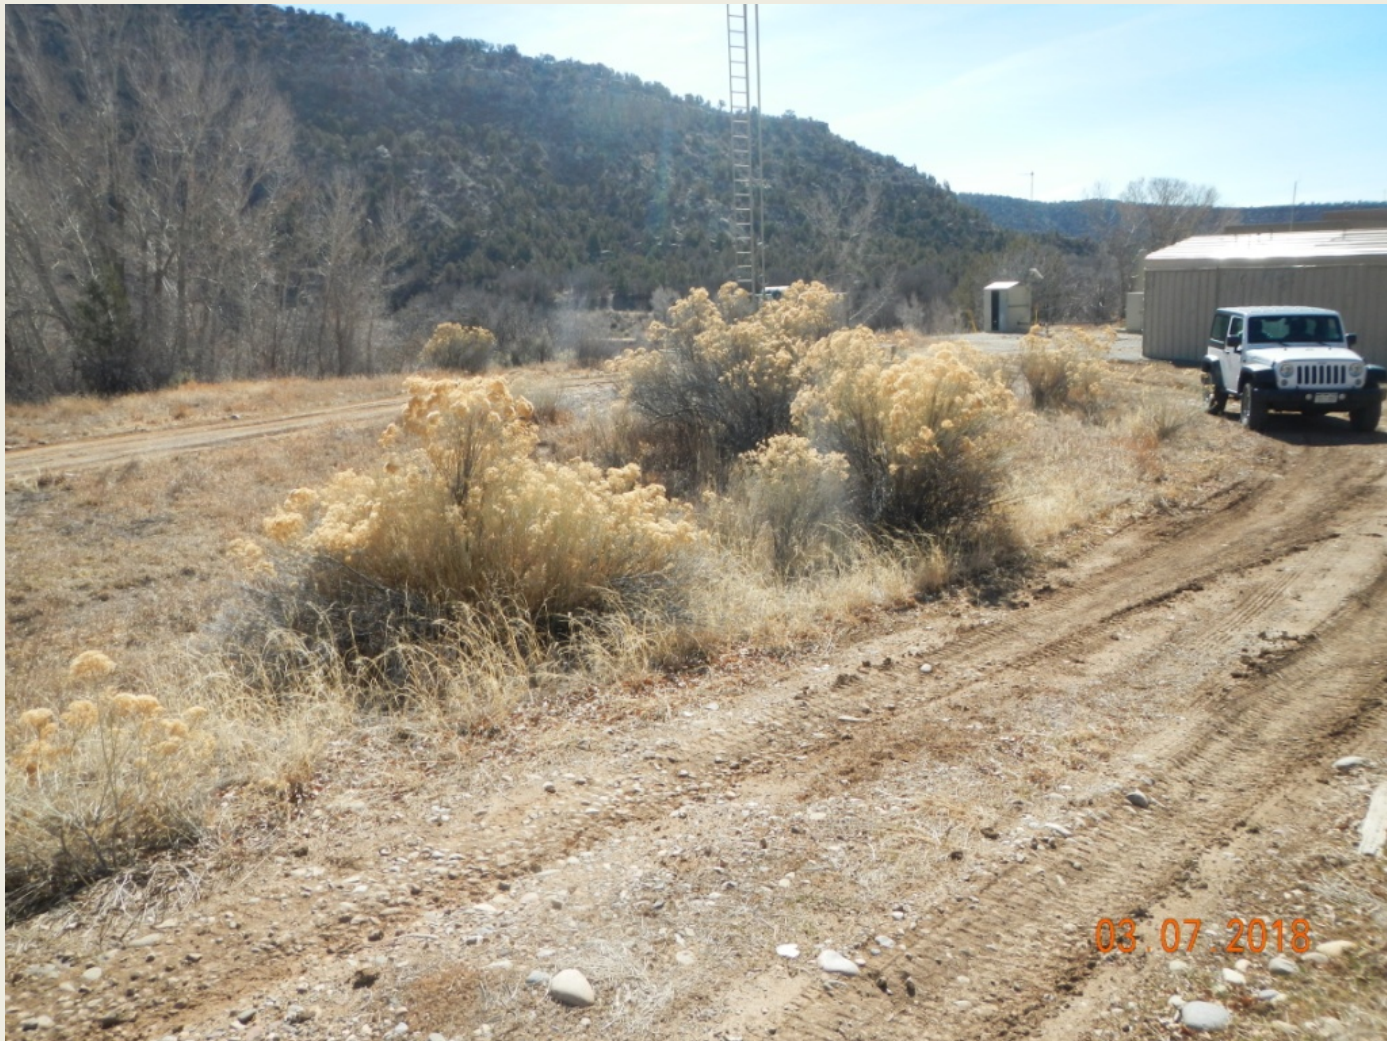
**Photo 1. View of the project area from the northwestern edge of the access road facing center. Tear drop is being revegetated.**

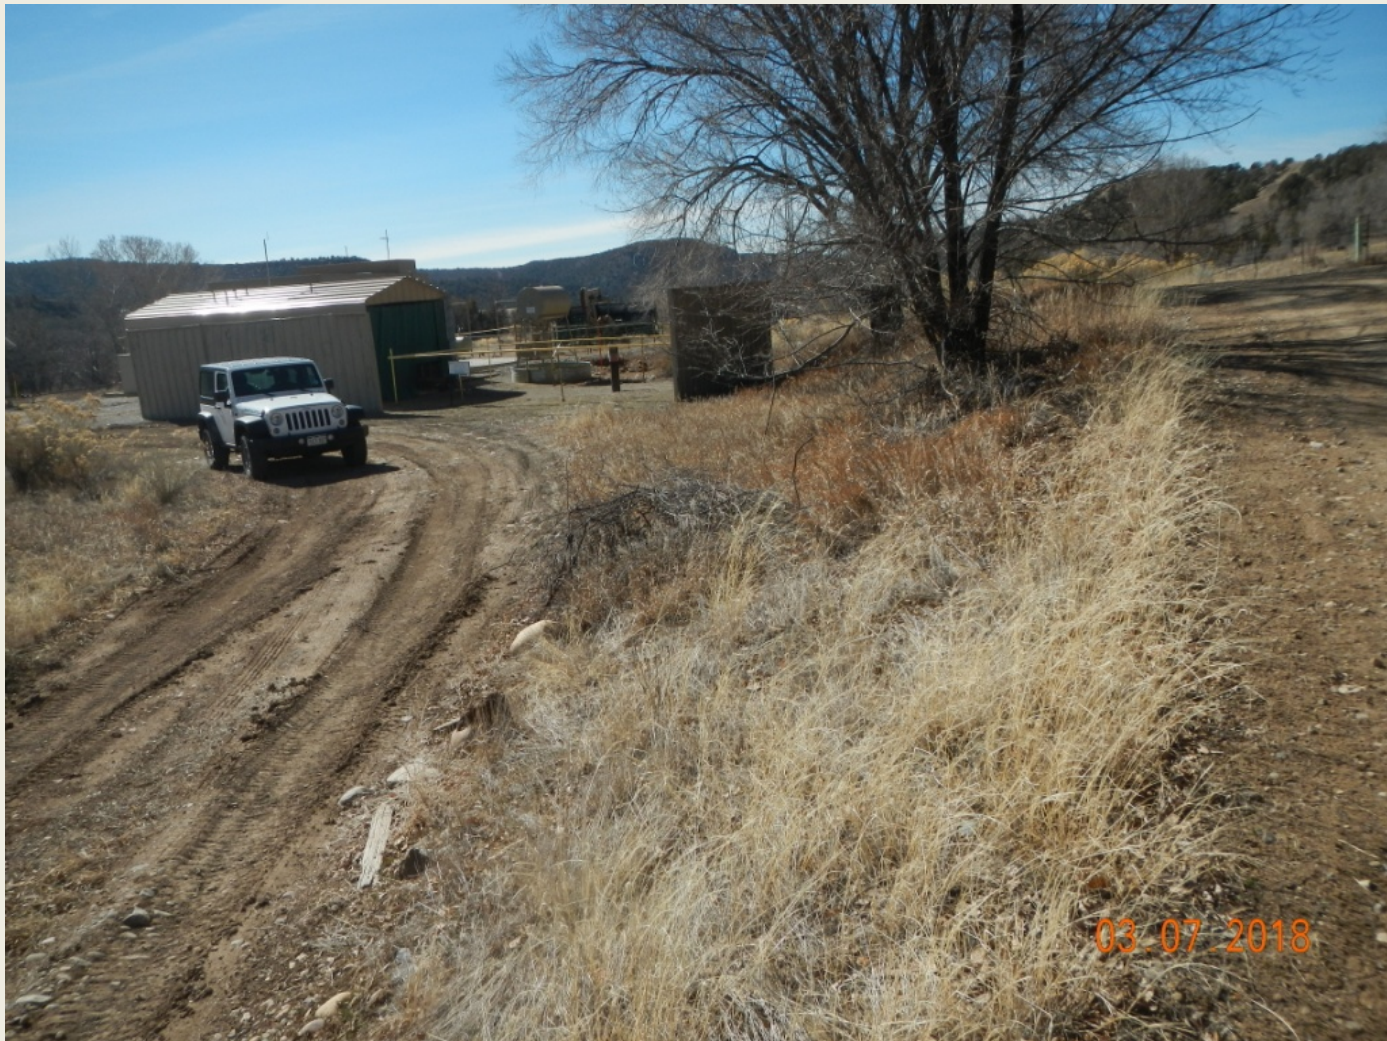
**Photo 2. View of the northwestern portion of the project area from the northwestern edge facing southward. Cut bank appears to be stabilized with perennial vegetation.**

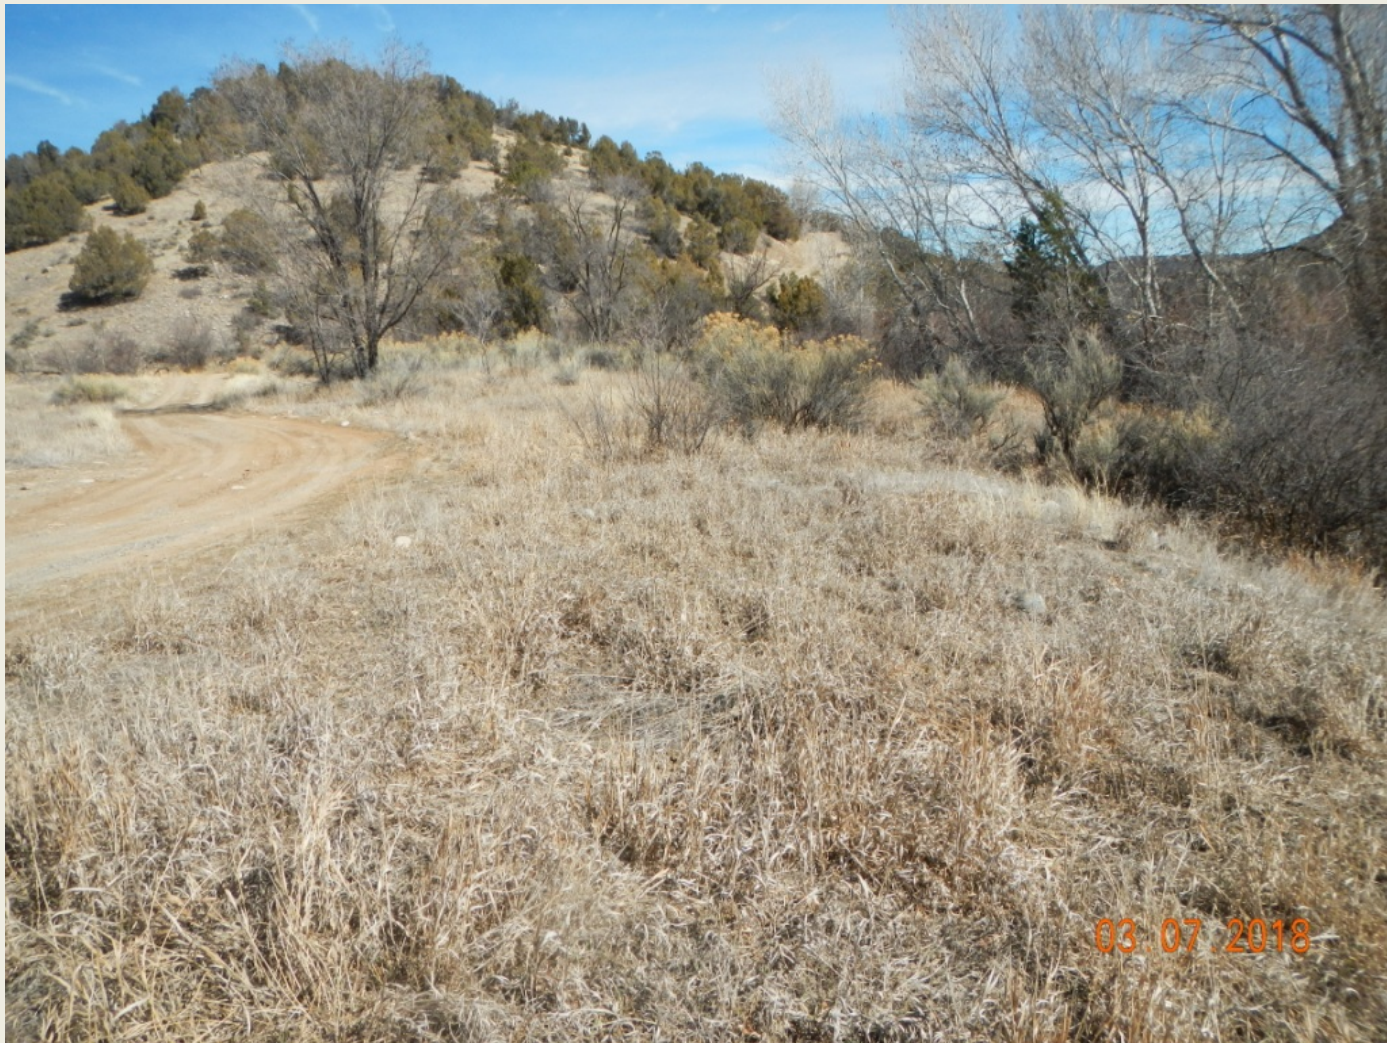
**Photo 3. View of the eastern portion of the project area from the southeastern edge facing northward. Revegetation is progressing with grasses such as smooth brome (*Bromus inermis*) and sand dropseed (*Sporobolus cryptandrus*).**
